DRAFT MEMORANDUM

То:	Linda Berry-Maraist, Pope Resources/Olympic	Date:	December 6, 2016			
	Property Group					
From:	Kathy Ketteridge, Ph.D., P.E., and John Laplante, P.E., Anchor QEA, LLC					
Cc:	Clay Patmont, Anchor QEA, LLC					
Re:	Port Gamble Bay Cleanup Project Coastal Engineering Evaluation of Shoreline					
	Erosion

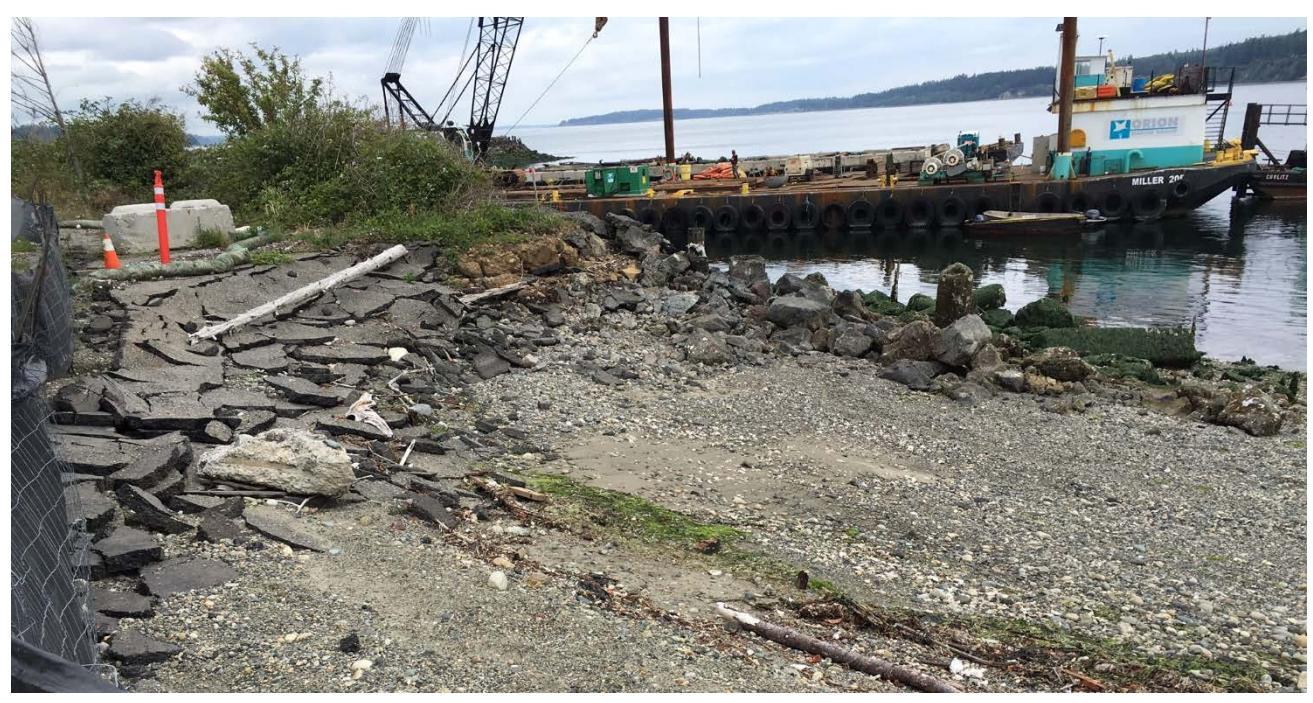
Photograph 1 Shoreline Erosion in Area 1

The shoreline erosion in this area occurred after creosote-treated piling were removed as part of Site remediation. The shoreline area above mean higher high water has eroded in this area, undermining asphalt paving at the top of the slope, as shown in Photograph 1. Figure 2e shows a pre- and post-storm survey transect that illustrates the erosion that has occurred at this location. In general, the slope of the beach in the upper intertidal area is adjusting to match the milder slope present in the lower intertidal area.

Design recommendations to address shoreline erosion in this area are shown in Figure 2e. These design recommendations are focused on preventing erosion of the entire slope from top of bank to the lower vertical extent of wave impact (where natural sediments could be eroded during storms). Damaged asphalt at the top of the slope will be removed and the shoreline armored from the top of the bank down to elevation of -5 feet mean lower low water, which is consistent with armoring extent designed for adjacent capping areas (see Port Gamble EDR, Appendix D). The armor will extend horizontally from the existing armored slope to the south of Area 1 (Area 2A) to the west to cover the entire pocket beach area. Armor will consist of a layer of Type 3 material covered with large salvaged armor rock.

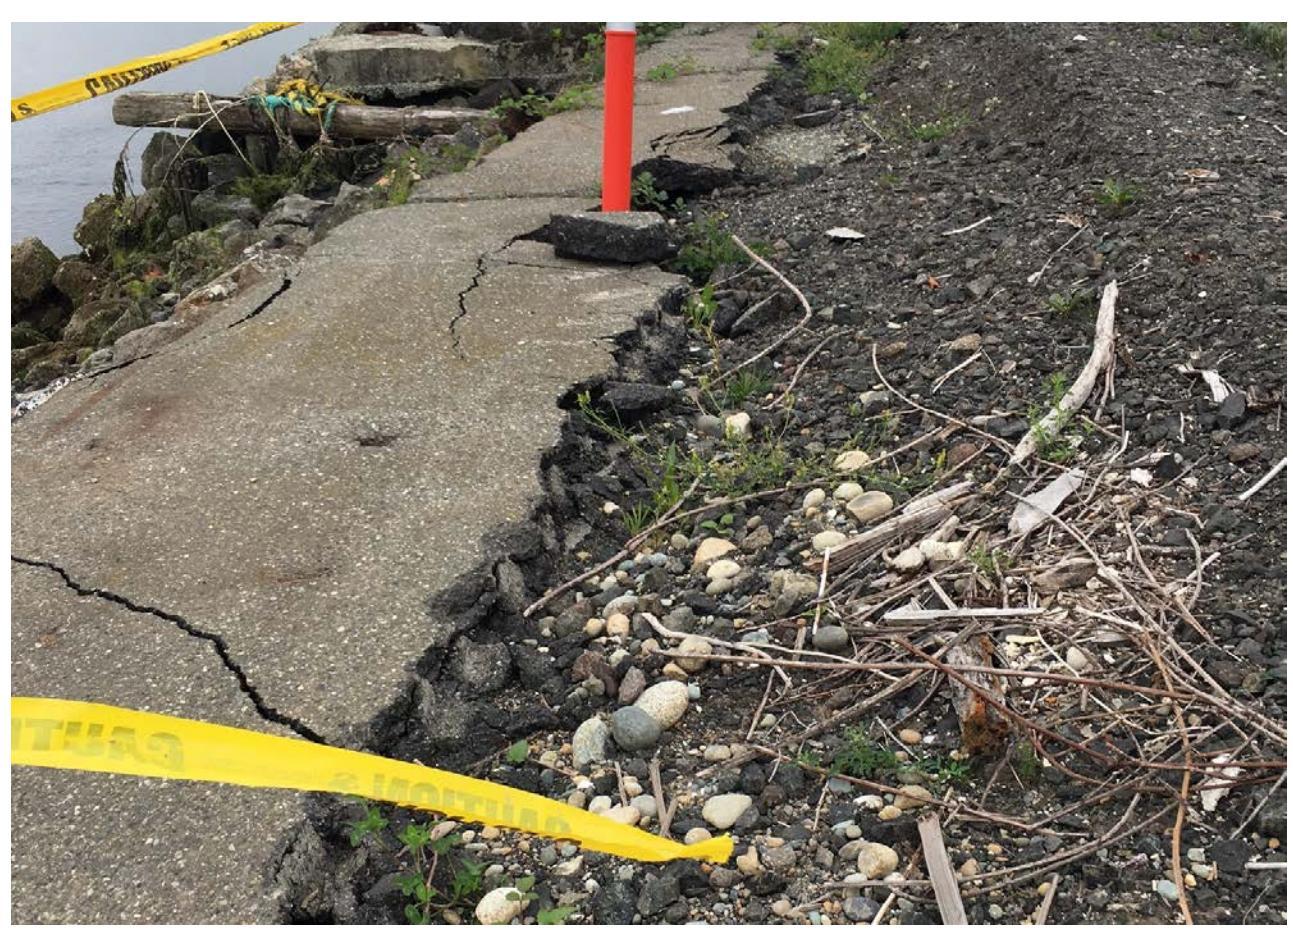
Photograph 2 Shoreline Erosion in Area 2

Similar to Area 1, asphalt at the top of the slope was damaged due to wave runup and overtopping, as shown in Photograph 2, which occurred after the structure in this area (the former Eastern Wharf) was removed. Figure 2d shows a pre- and post-storm survey transect that shows no movement of the armor rock on the slope occurred as a result of the storm events.

The following recommendations to address shoreline erosion (shown in Figure 2d) were carried out prior to publication of this memorandum:

- Damaged asphalt at the top of the armored slope was removed
- Armor rock at the top of the slope was left in place
- The area where asphalt was removed was armored from the top of the remaining armor rock on the slope to the top of the bank
- Placed armor consisted of a layer approximately 1 foot thick of Type 3 material covered with large salvaged armor rock (varied in size from 1 to 3 feet in diameter).

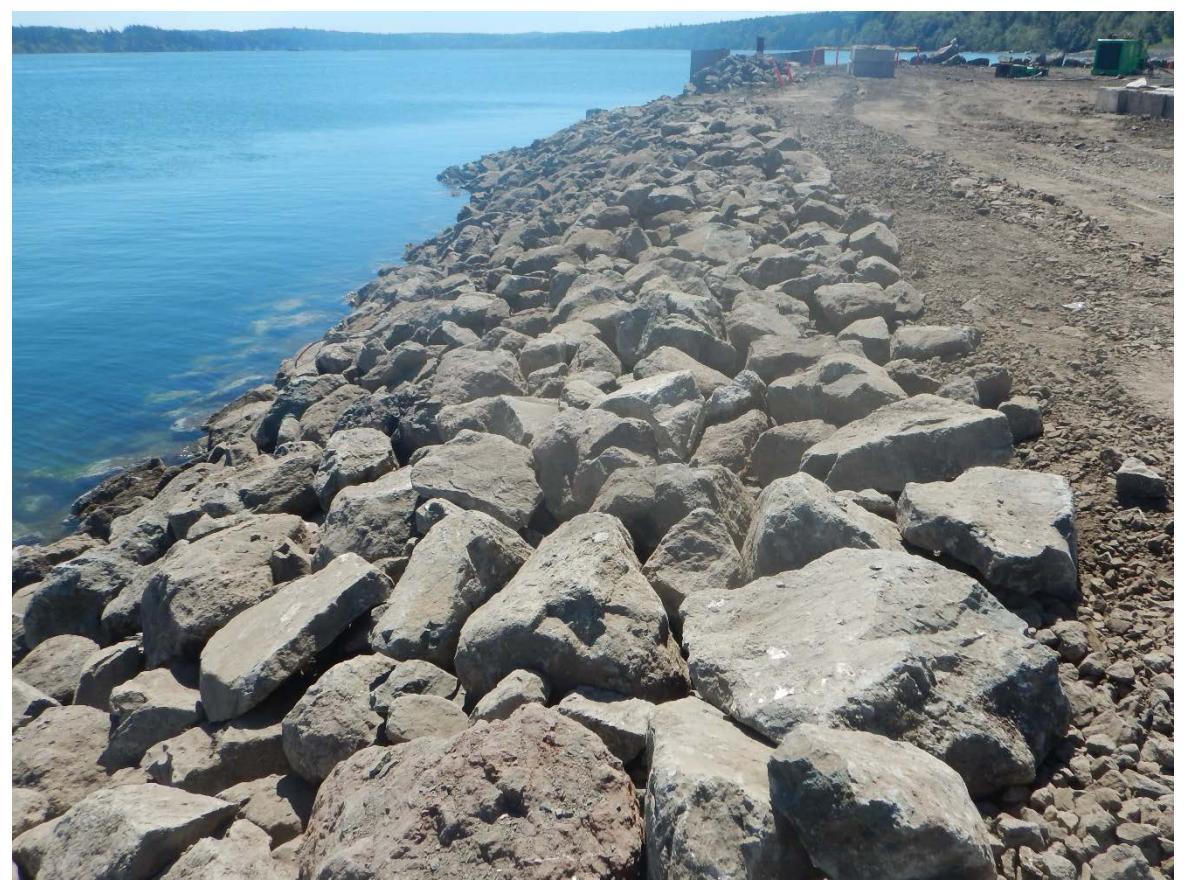
Photograph 3 Completed Shoreline Repair in Area 2

The work described above was completed on August 12, 2016. The completed stabilization work is shown in Photograph 3.

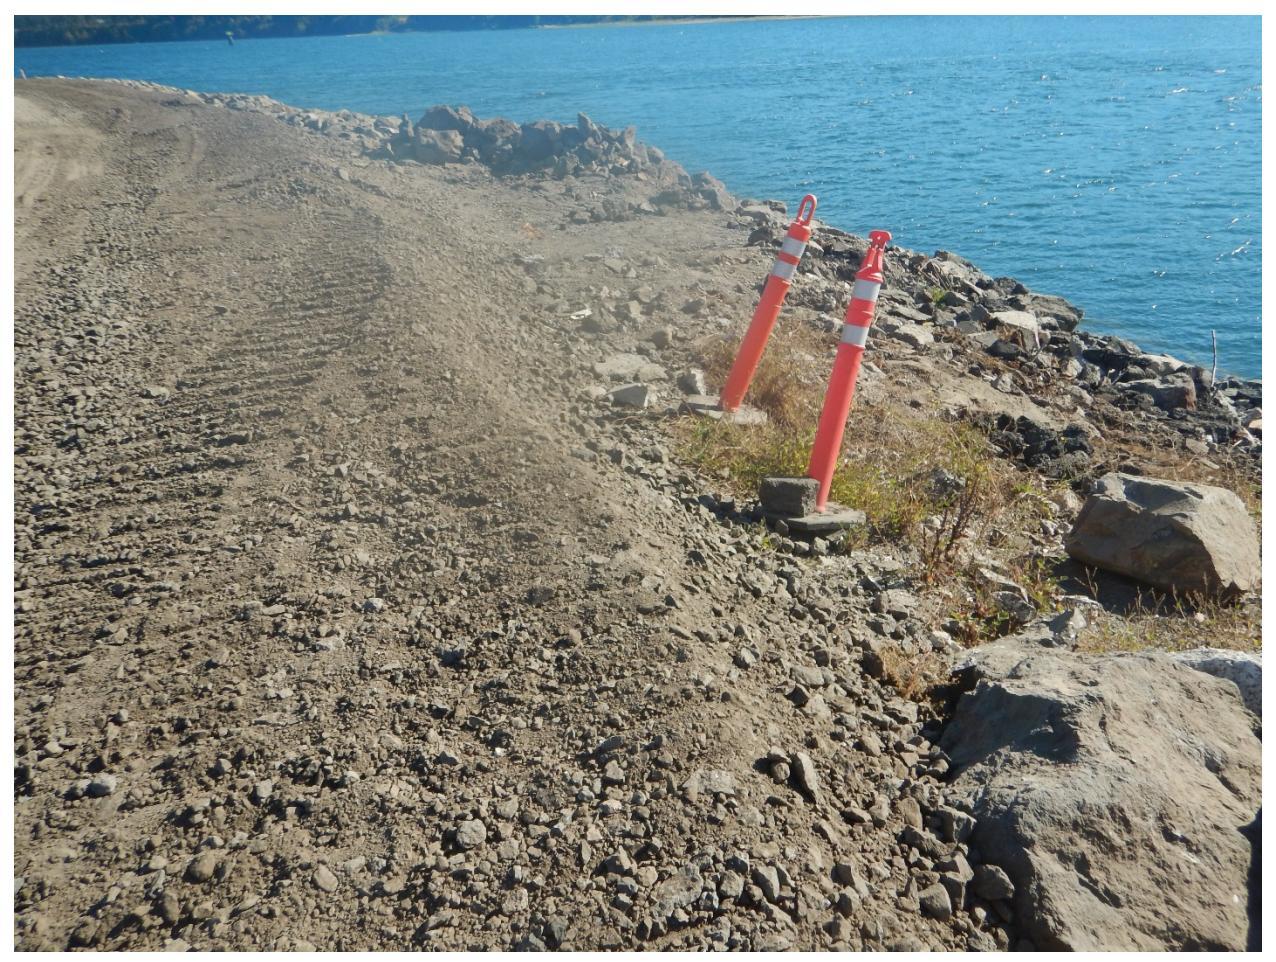
Photograph 4 Shoreline Area 2B Prior to October 2016 storm event

Erosion of the area during the October storm event was focused along the top of the bank and upper portions of the slope due to a lack of armoring in those areas, as shown in Photograph 4. Photograph 5 shows an image of this area following the October 2016 storm, which illustrates erosion of the top portion of the slope and bank line. Similar to other areas of erosion, the upper shoreline has eroded back to a milder slope to match the existing slope in the lower intertidal area.

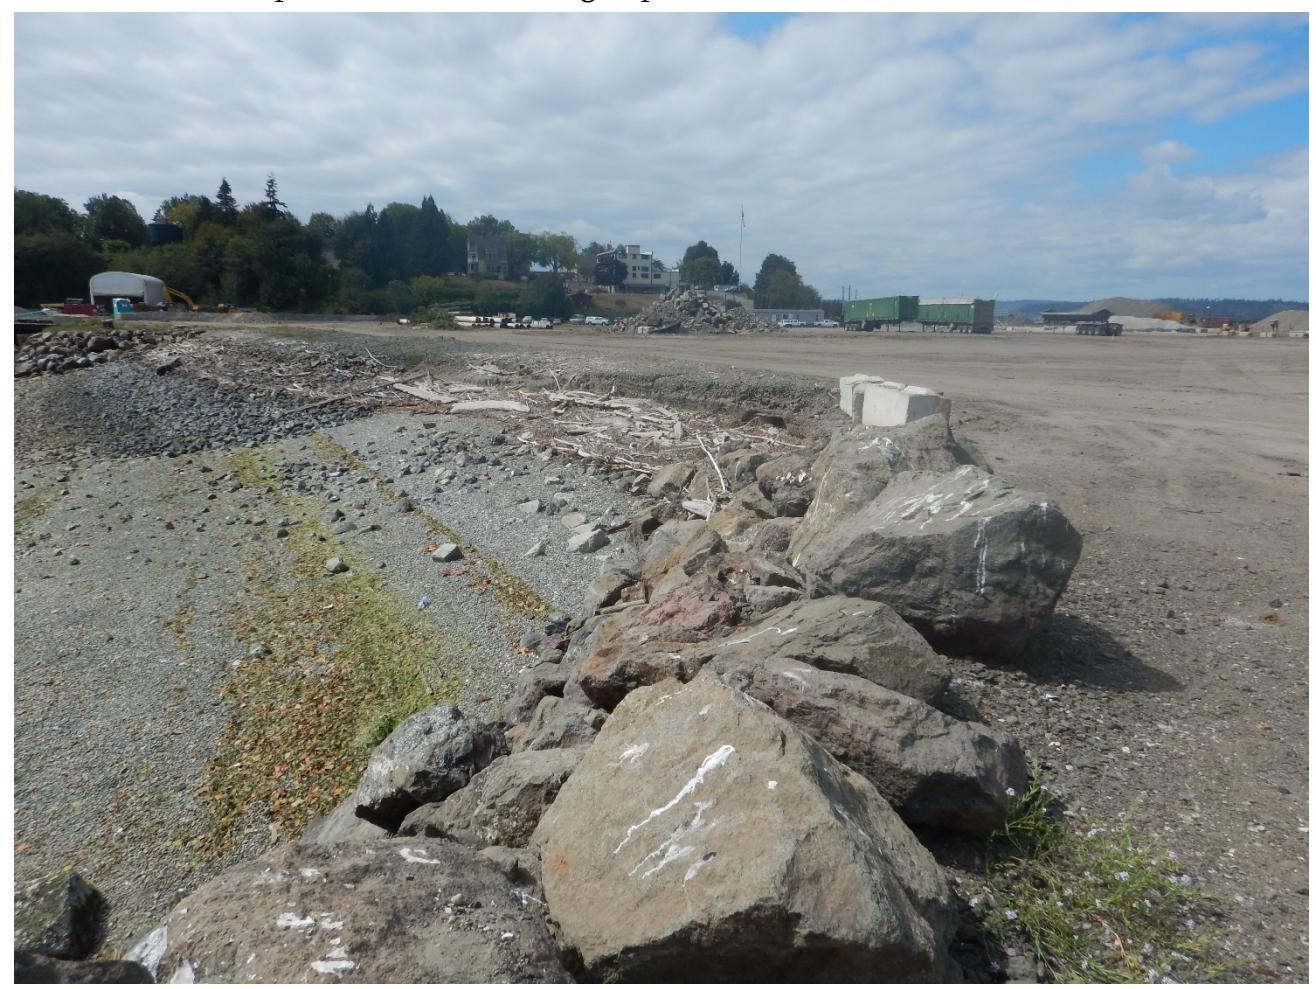
Photograph 4 Shoreline Erosion in Area 3

Erosion of the area during this storm event was intensified due to the two adjacent armored areas, as seen in Photograph 4. Figure 2c shows a pre- and post-storm survey transect that shows the shoreline erosion in this area. Similarly to Area 1, the upper shoreline has eroded back to a milder slope to match the existing slope in the lower intertidal area.

Design recommendations to address shoreline erosion in this area are shown in Figure 2c. These design recommendations are focused on preventing erosion of the entire slope from top of bank to the lower vertical extent of wave impact (where natural sediments could be eroded during stomrs). The shoreline in this area will be armored between the end of the Type 2 cap area and the armored shoreline at the location of the temporary transload area. Armor will consist of a layer of Type 3 material covered with large salvaged armor rock. The armor will extend from the top of the bank down to elevation of -5 feet feet mean lower low water, which is consistent with armoring extent designed for adjacent capping areas (see Port Gamble EDR, Appendix D).

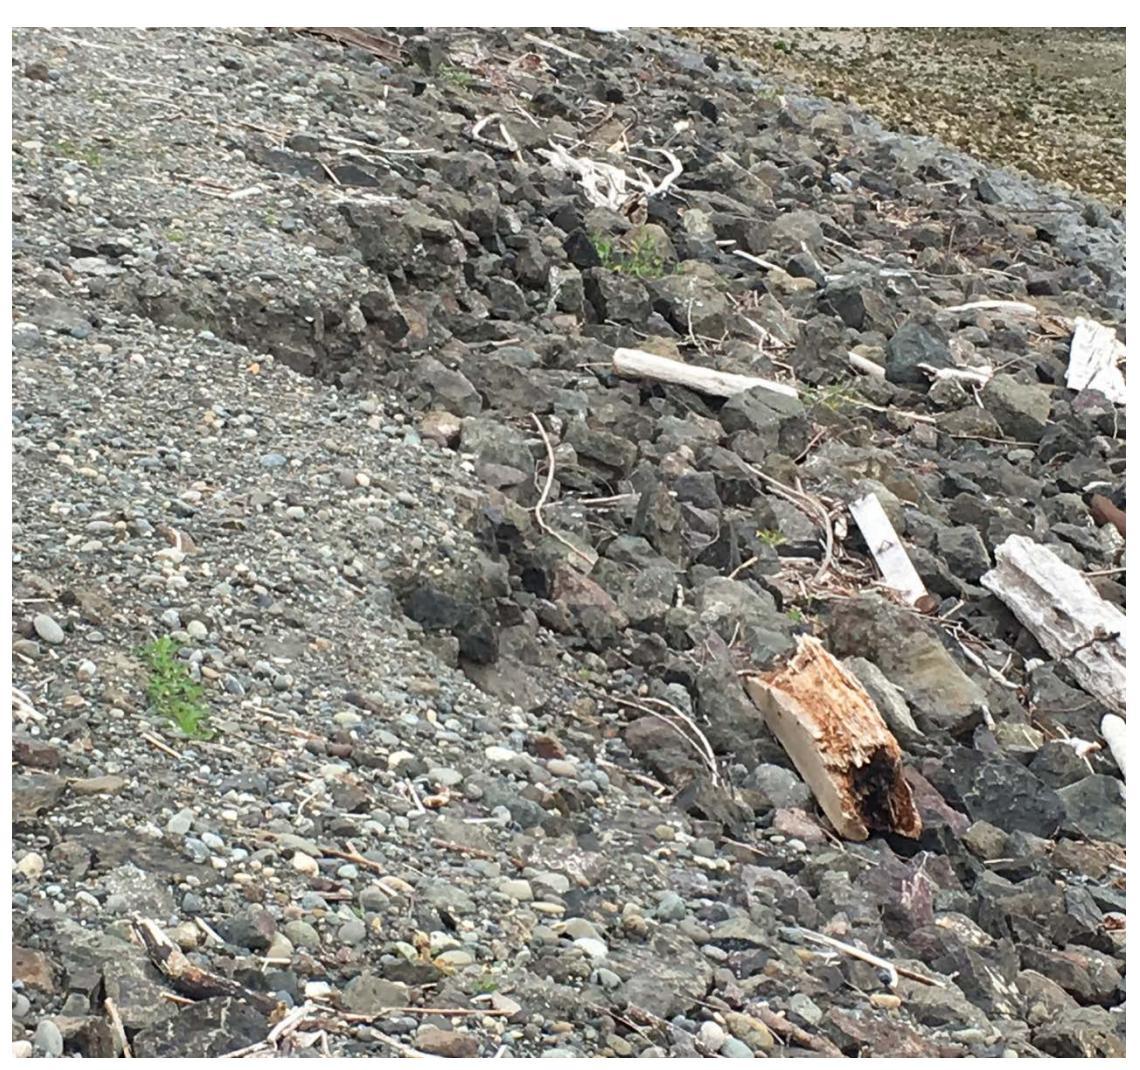
Photograph 5 Shoreline Erosion in Area 4

The upper intertidal shoreline in Areas 4 and 5 were capped with Type 2 armor rock. Some of the armor rock was displaced in the upper inner tidal zone due to wave impact from the storm events. As stated previously, localized movement of armor rock can occur during a design storm event; this design decision allows for a balance of using a more habitat-friendly armor rock size while still ensuring the protectiveness of the remedy. Specifically, the armor was sized to allow for "start of damage," or movement of some armor rock but not failure of the slope (USACE, 2002). The March 13 storm, as documented in Section 1, was up to a 100-year storm event based on wind velocity data, which was the design storm event for the slope. In addition, the high winds that occurred during that storm event lasted for approximately 32 hours, which is significantly longer than the typical design storm event in the Puget Sound area.

Figure 2b shows a survey transect within Area 4 that illustrates Type 2 rock movement where the majority of the design rock thickness was displaced. However, as seen in Photograph 5, the extent of this level of damage is small, affecting approximately 20 to 30 feet of shoreline.

Design recommendations to address movement of the Type 2 cap material localized within Area 4 include adding additional armor rock larger than the Type 2 rock previously placed in that area. As mentioned above, Type 2 rock was sized using design wave conditions (See Port Gamble EDR, Appendix D) assuming movement of some armor rock during the design storm event (100-year return period) but not failure of the slope (USACE, 2002). Ecology has expressed concerns about this area, and would prefer a more conservative armoring solution for this area. Therefore, a larger armor rock has been sized for placement in Area 4 assuming a "zero damage" factor as opposed to the "start of damage" factor used in the previous calculations to balance stability and habitat goals for the project. Using the same design significant wave height (2.7 feet) the armor rock size assuming "zero damage" (or no movement of the rock at all) is 1.5 feet. Based on this, Anchor QEA recommends placing two-layers of 1 to 1.5 foot rock within Area 4 where significant movement has occurred (the approximate extent of this damage is shown in Figure 1).

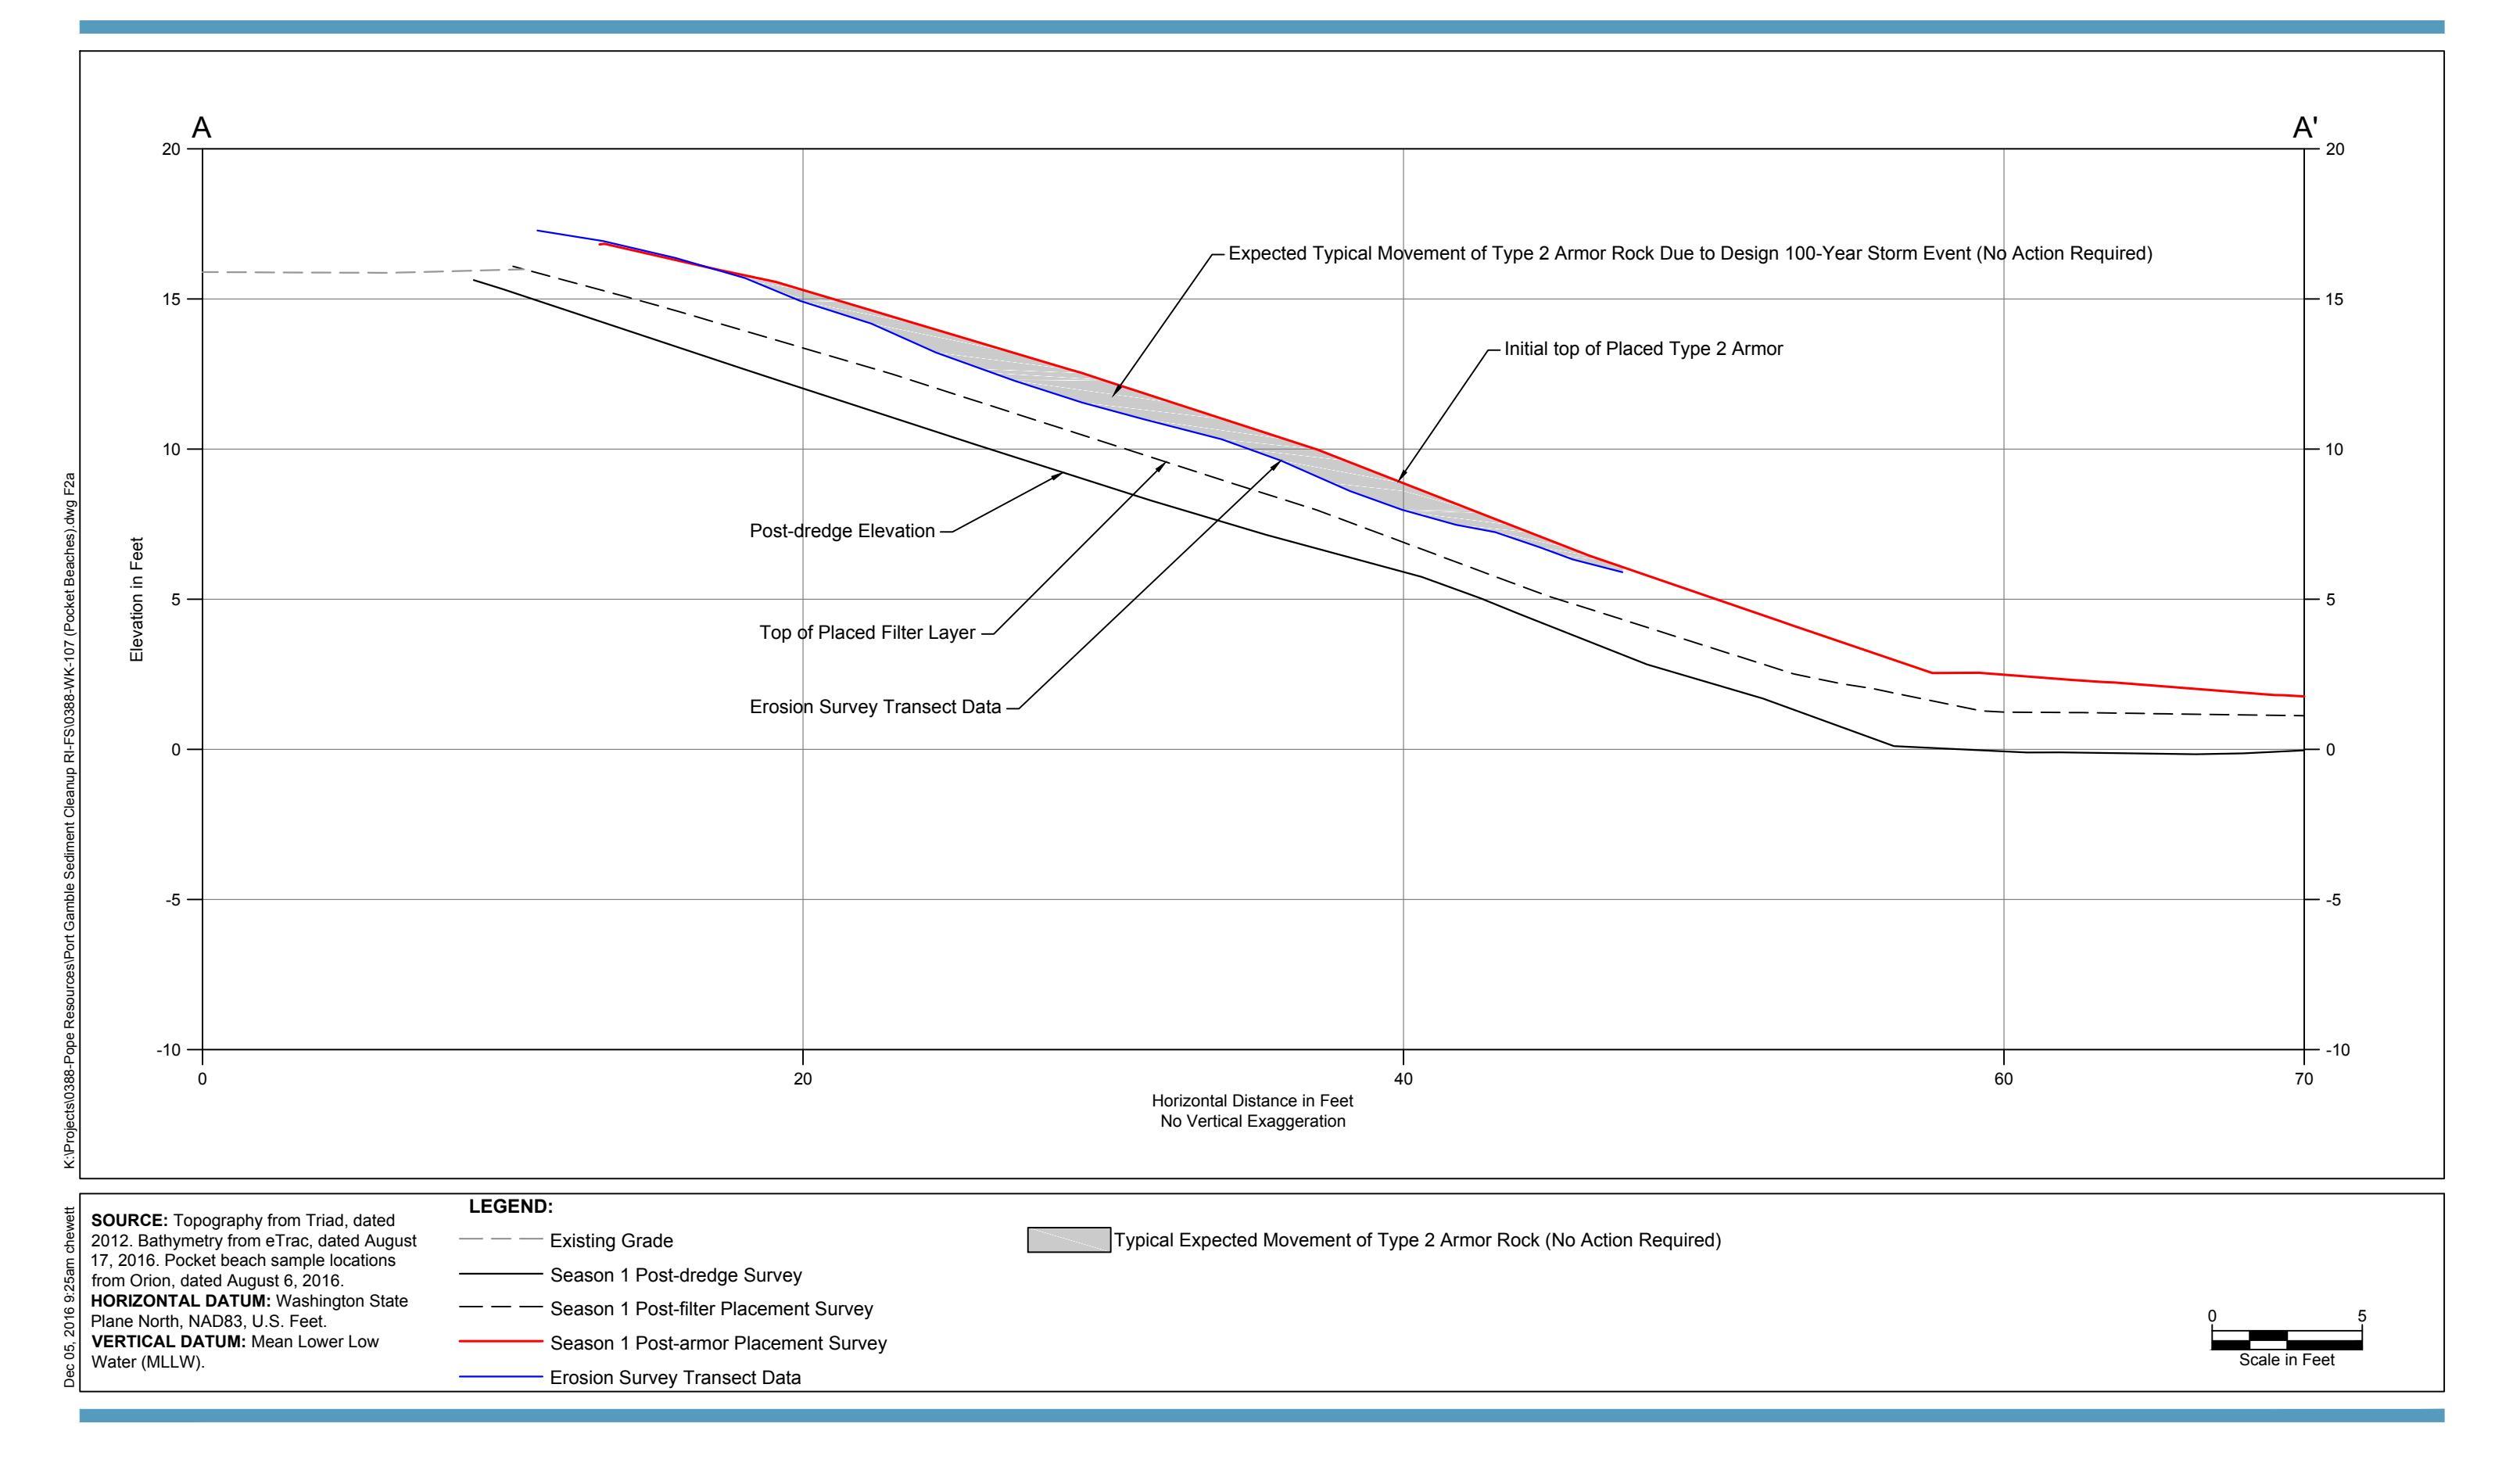
Figure 2a Cross Section A-A' Port Gamble Bay Cleanup Project

Figure 2a shows a survey transect in Area 5 that illustrates more typical and expected movement of rock on the slope; this area still has acceptable coverage of armor rock over the filter material.

No work is proposed along the majority of the upper shoreline in SMA-2, as characterized by Area 5.
