то:	Mr. Bryce Robbert
FROM:	Ryan Reich, L.G. RRC Tom Briggs, P.E. JB
DATE:	January 3, 2019
RE:	2018 Annual O&M Site Inspection Hamilton Street Bridge Site Spokane, Washington Project No. 0236042.000

Hamilton Street Bridge Site Spokane, Washington

Site Inspection Photographs

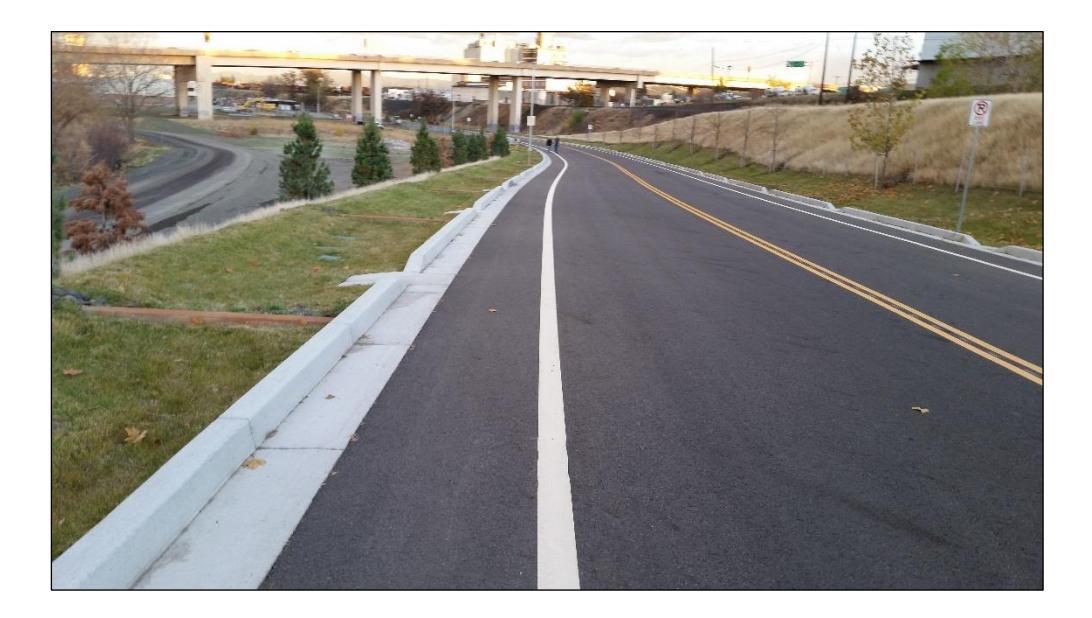
1. View of new MLK Jr Way on Hamilton Street Bridge Site (looking east from west site boundary). New Ben Burr Trail is to the left.

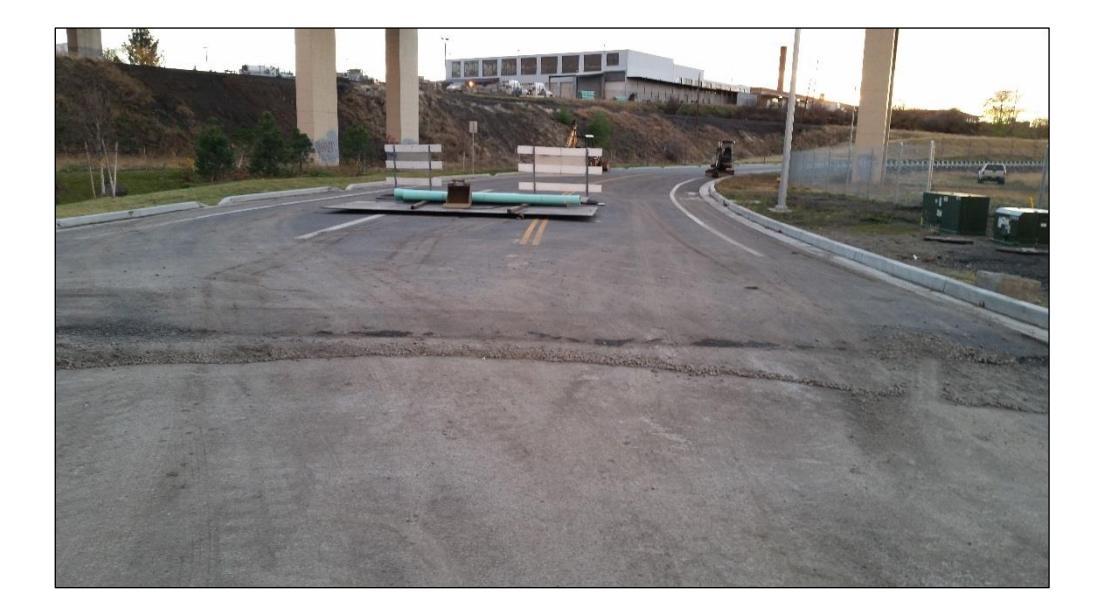
2. View of unfinished MLK Jr Way on Hamilton Street Bridge Site (looking west from east site boundary at North Erie Street).

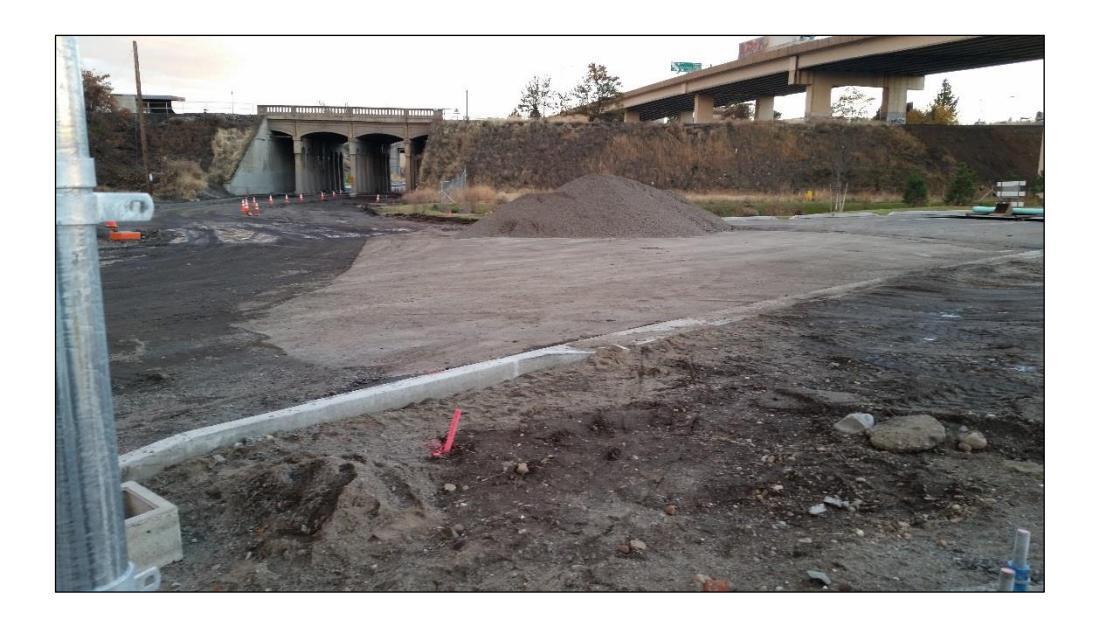
3. View of City of Spokane improvements, at east Site boundary, where MLK Jr Way intersects North Erie Street (looking south).

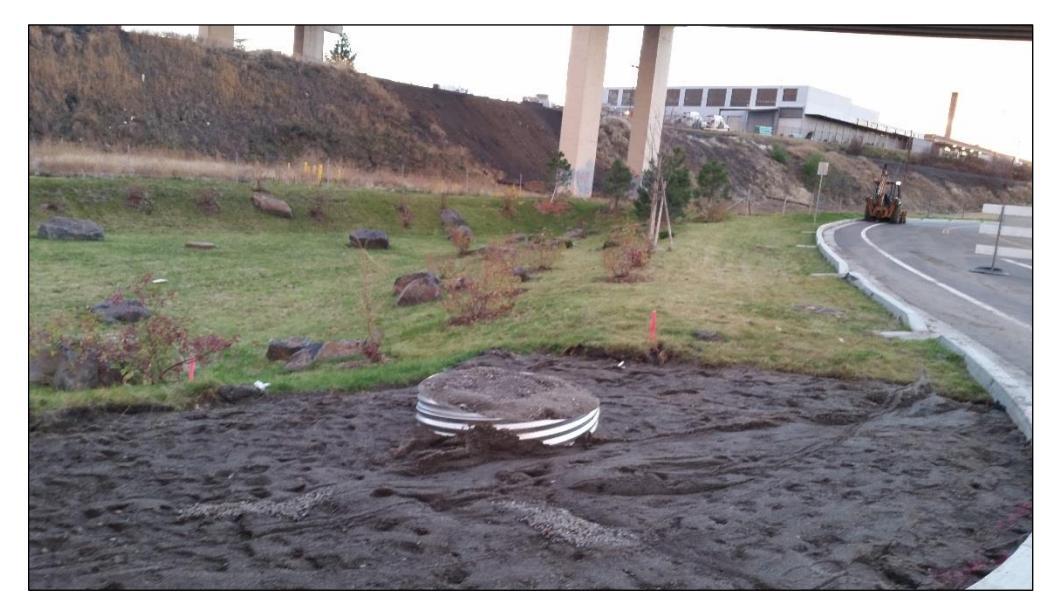
- Stormwater Facilities. The north and west detention basins, were observed to be in good overall condition, with no vandalism or erosion. The two drywells located within the north detention basin appeared to be functional and in good conditions. The City's evaporation pond was dry, contained healthy growing vegetation, and appeared to be in good condition.

4. View of City of Spokane stormwater evaporation pond on southeast corner of Site (looking west from North Erie Street).

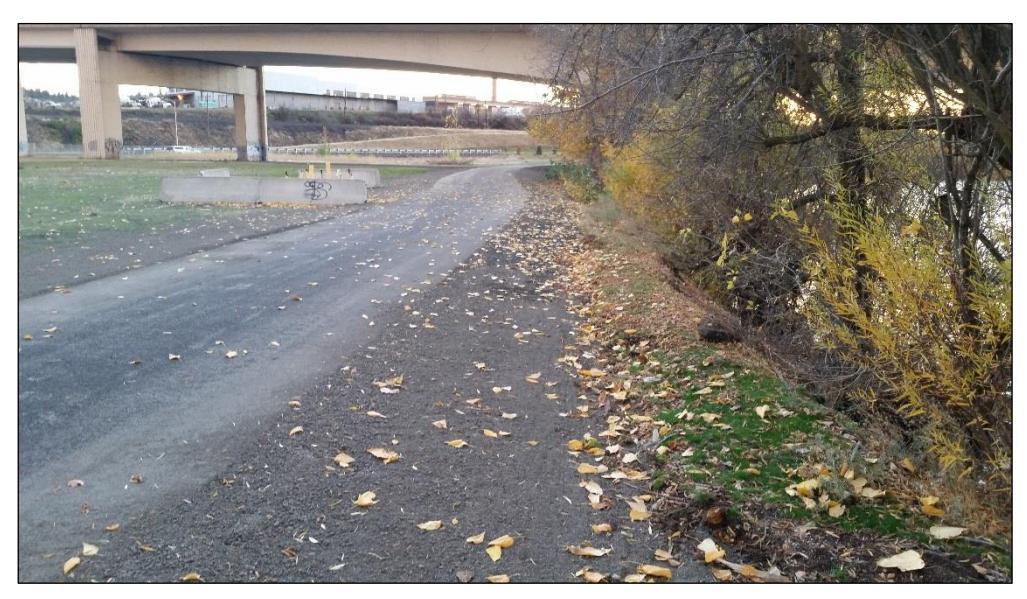
5. View of Ben Burr Trail and Spokane River shoreline at north Site boundary (looking west from northeast corner of site).

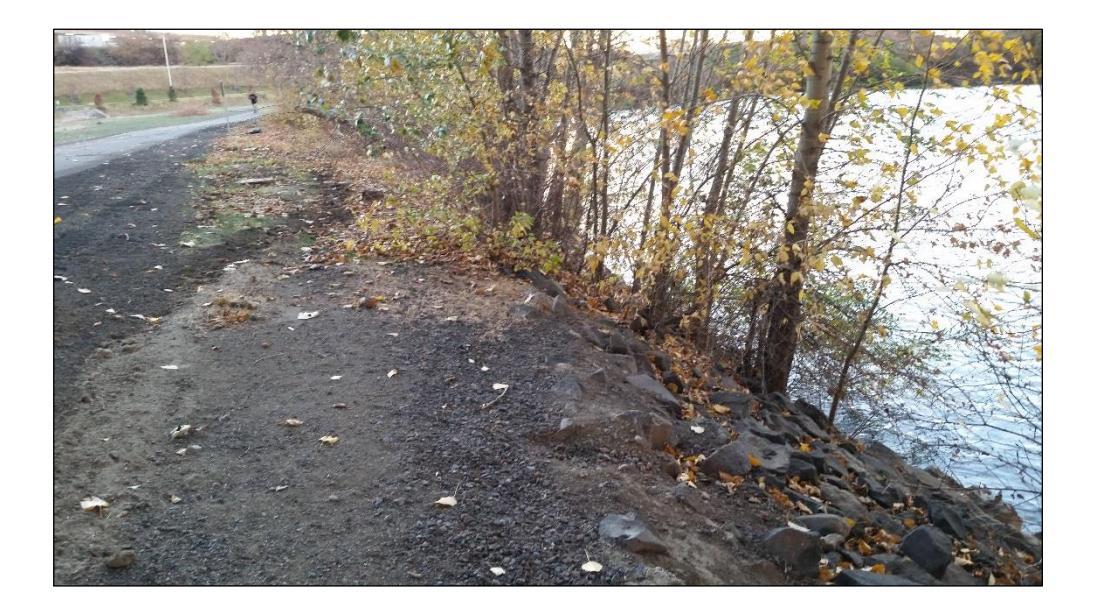
- Shoreline Bioengineering System. The shoreline riprap face, transition zone, and vegetative cover along the Spokane River appeared to be healthy and in good condition. No erosion, ponding, or loose boulders were observed, and mature trees growing from the bank appeared

stable and healthy. It was noted that a small abandoned transient camp was observed at the shoreline approximately 200ft west of James Keefe Bridge.

6. View of shoreline riprap and vegetation west of James Keefe Bridge (looking west from west side of James Keefe Bridge).

The presence of a small, abandoned, transient camp along a portion of the site riverbank, west of the James Keefe Bridge will be also monitored to assess whether impacts result from increased foot traffic occur.
