SITE HAZARD ASSESSMENT Recommendation for No Further Action

SITE NAME: Sears Auto Center Heating Oil Tank

Cleanup Site ID:	4669	Completed on 12/21/2018 for inclusion
Facility/Site ID:	46247836	on the August 2019 Hazardous Sites List.

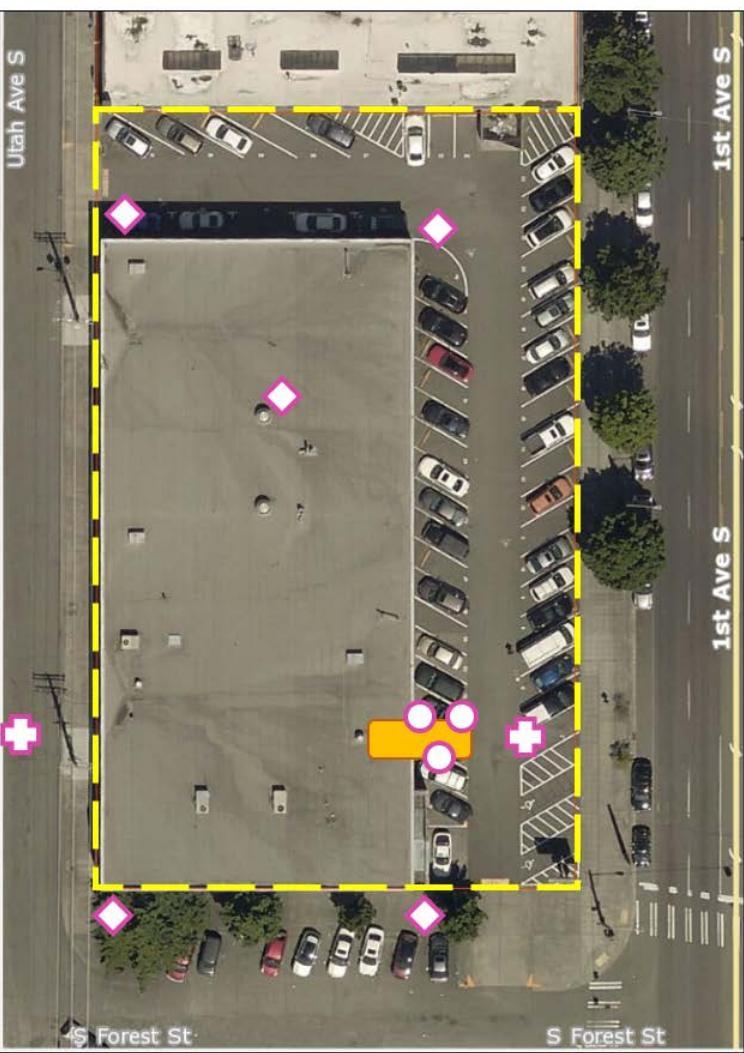
In November 2016, two monitoring wells were installed at the Site to investigate groundwater. MW-7 is located downgradient of the location of the heating oil UST and MW-8 is upgradient, relative to the current groundwater flow direction (to the west). No contaminants were detected above cleanup levels in soil from either monitoring well boring.

Figure 2. Locations of samples collected during investigations of the Site. The Site boundary, which is the same as the parcel boundary, is indicated with the dashed line. (basemap from King County iMap)

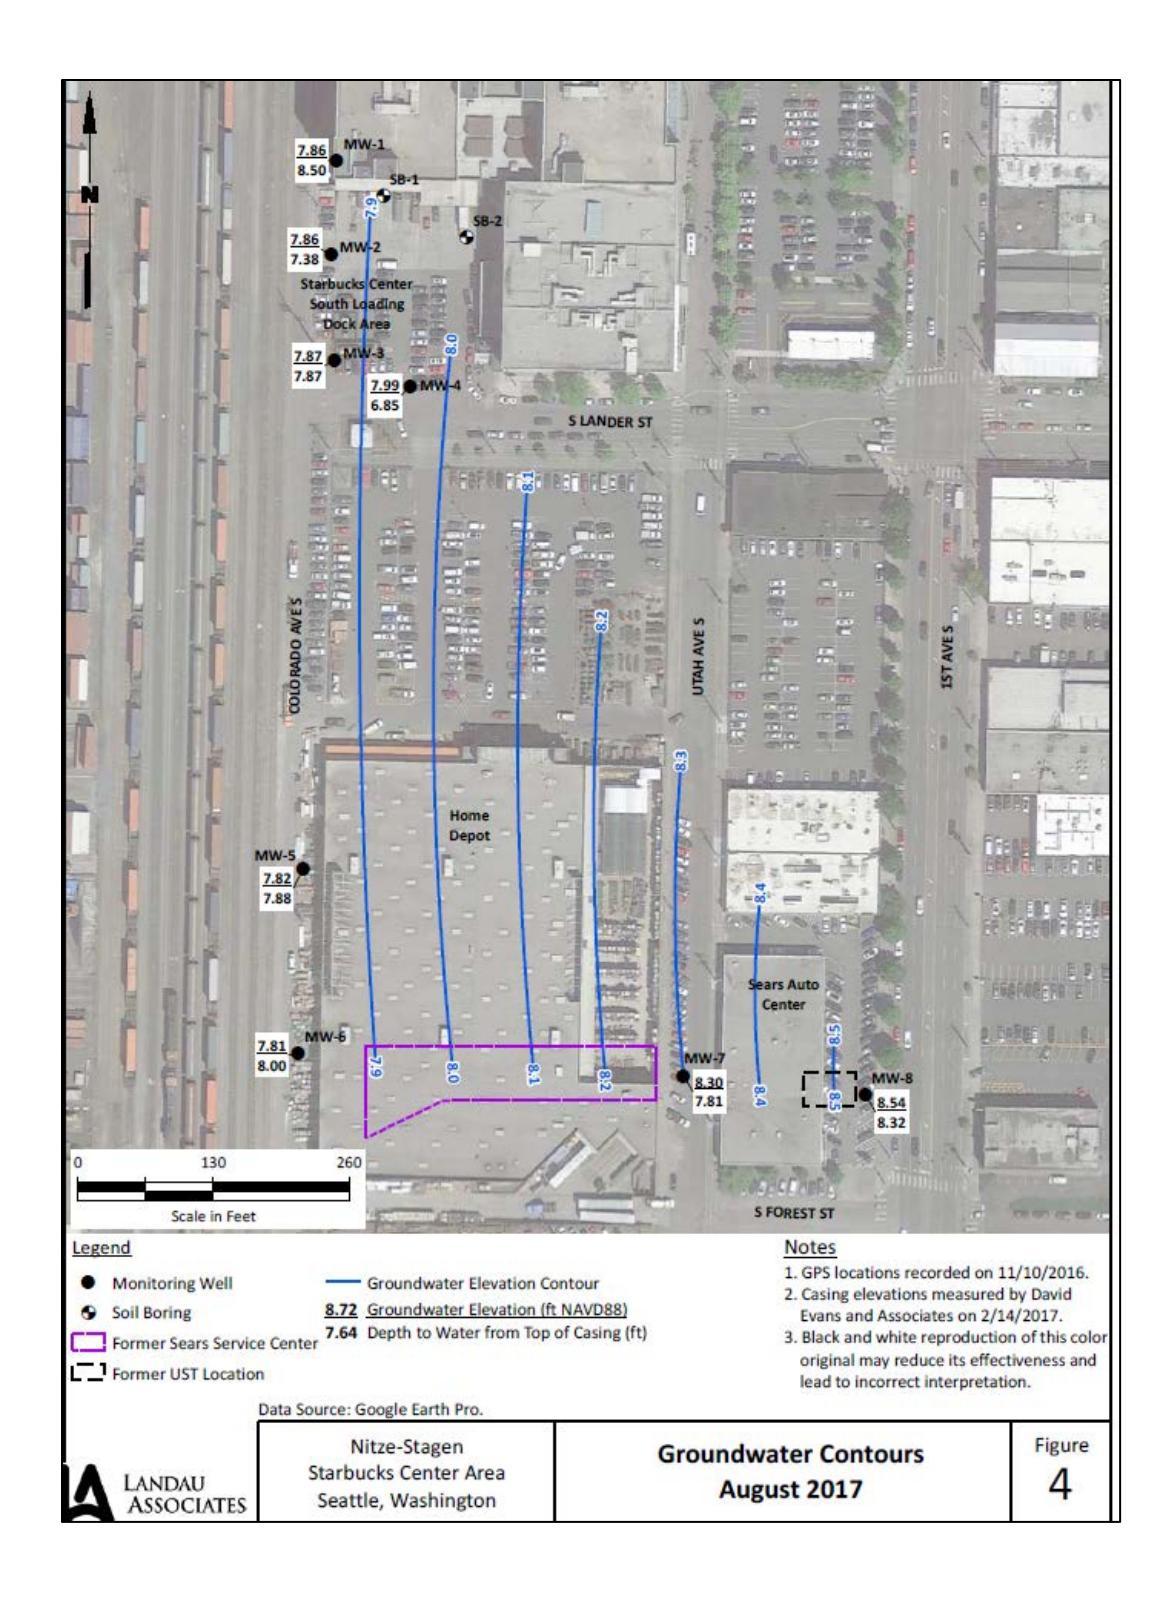
While a groundwater gradient cannot be established from only two wells, groundwater sampling occurred at additional sites within the same block at the same time as the sampling of MW-7 and MW-8. A total of eight wells were used to establish groundwater flow direction (see figures).

Figure 3. Groundwater contour map from 2017 sampling confirming groundwater flow to the west. Monitoring wells used to assess contamination status at multiple cleanup sites close to the Site were included in this sampling event and used to determine groundwater contours. Only data from MW-7 and -8 were used to assess current contaminant conditions at the Site.
