Underwater Habitat Survey

Anacortes Custom Plywood Benthic Study

Anacortes, Washington

November 2007

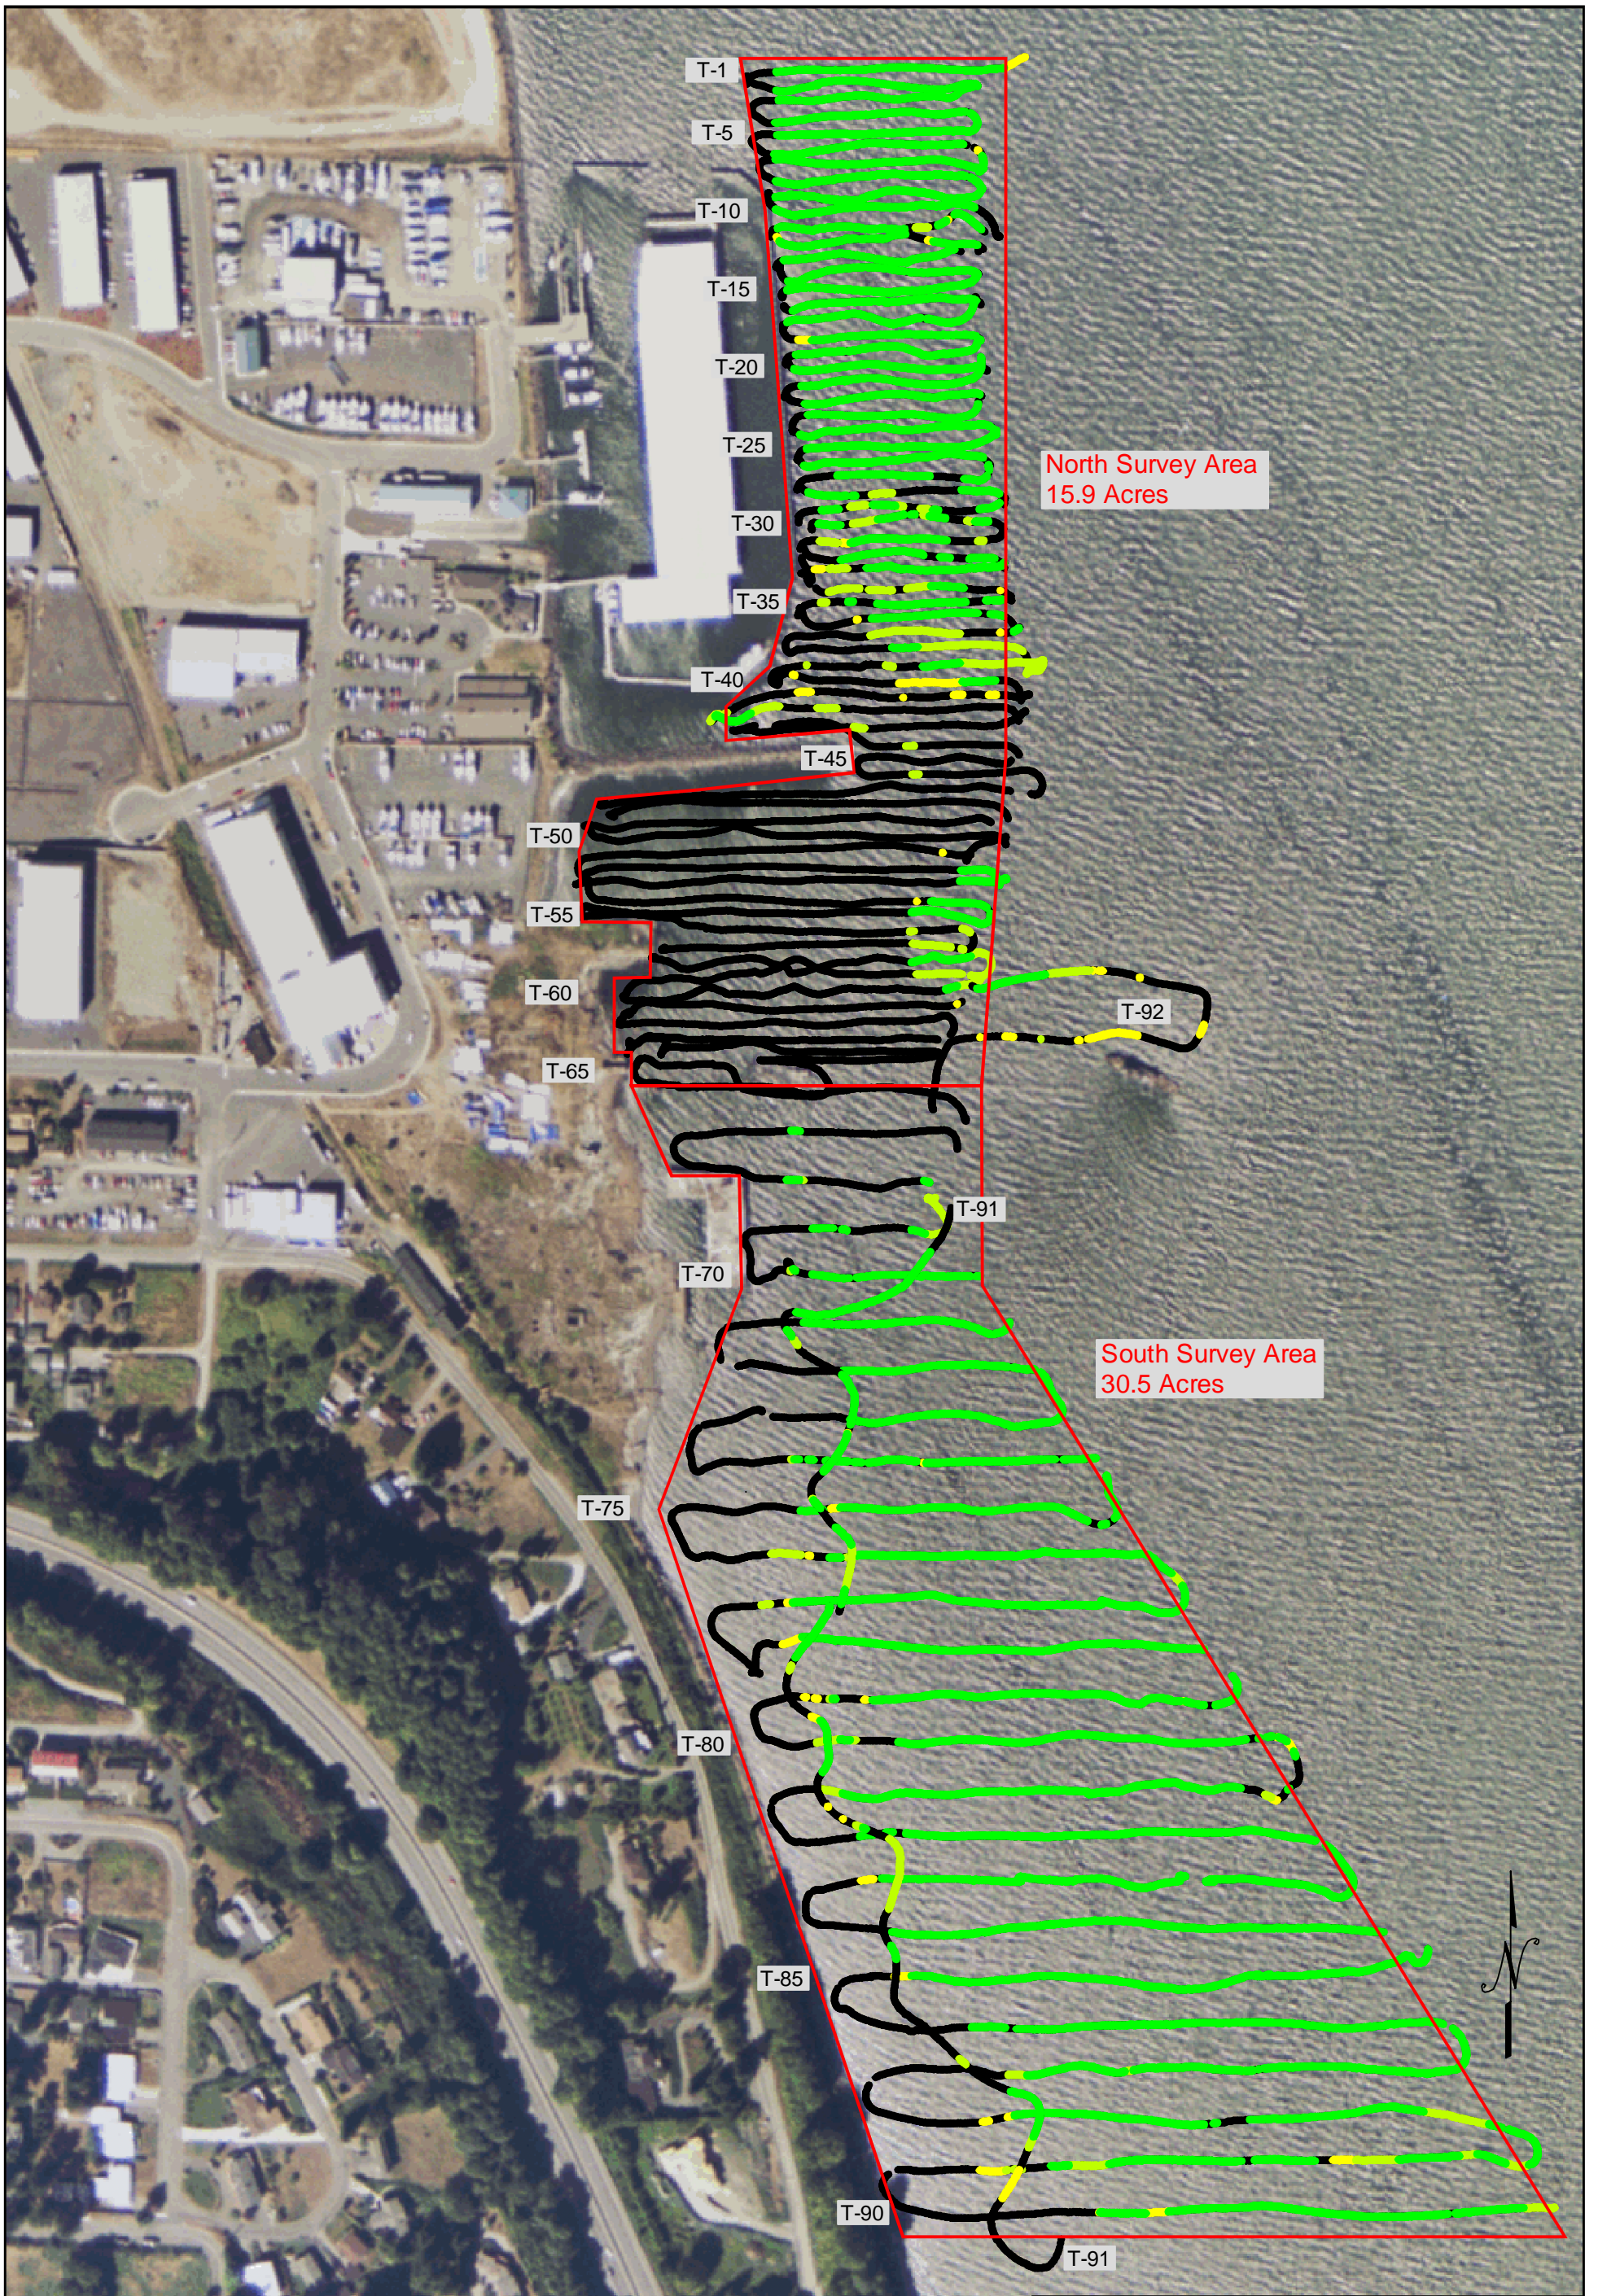
Figure 4

Three primary patches of eelgrass were found during the survey (Figure 4). In the North Study Area, the main patch of eelgrass extended from Transect T-1 to T-40 and covered approximately 7.6 acres. The eelgrass in this area was exceptionally tall, with an estimated height of up to 6 feet. A second, small patch of eelgrass covering approximately 0.6 acre was observed in the southern portion of the North Survey Area approximately 400 feet offshore of the former plywood mill (Transects T-92 and T-53 to T-59). The total eelgrass coverage in the North Survey area was 8.2 acres of the 15.9-acre survey area (52 percent coverage). The third eelgrass bed extended from Transect T-69 to T-90 in the South Survey Area and occurred on approximately 23.3 acres of the 30.5-acre survey area (75 percent coverage).

All three eelgrass beds extended outside of the survey area to the east. There were other isolated patches of eelgrass; however, the majority of the eelgrass occurred in eelgrass beds that were nearly contiguous.

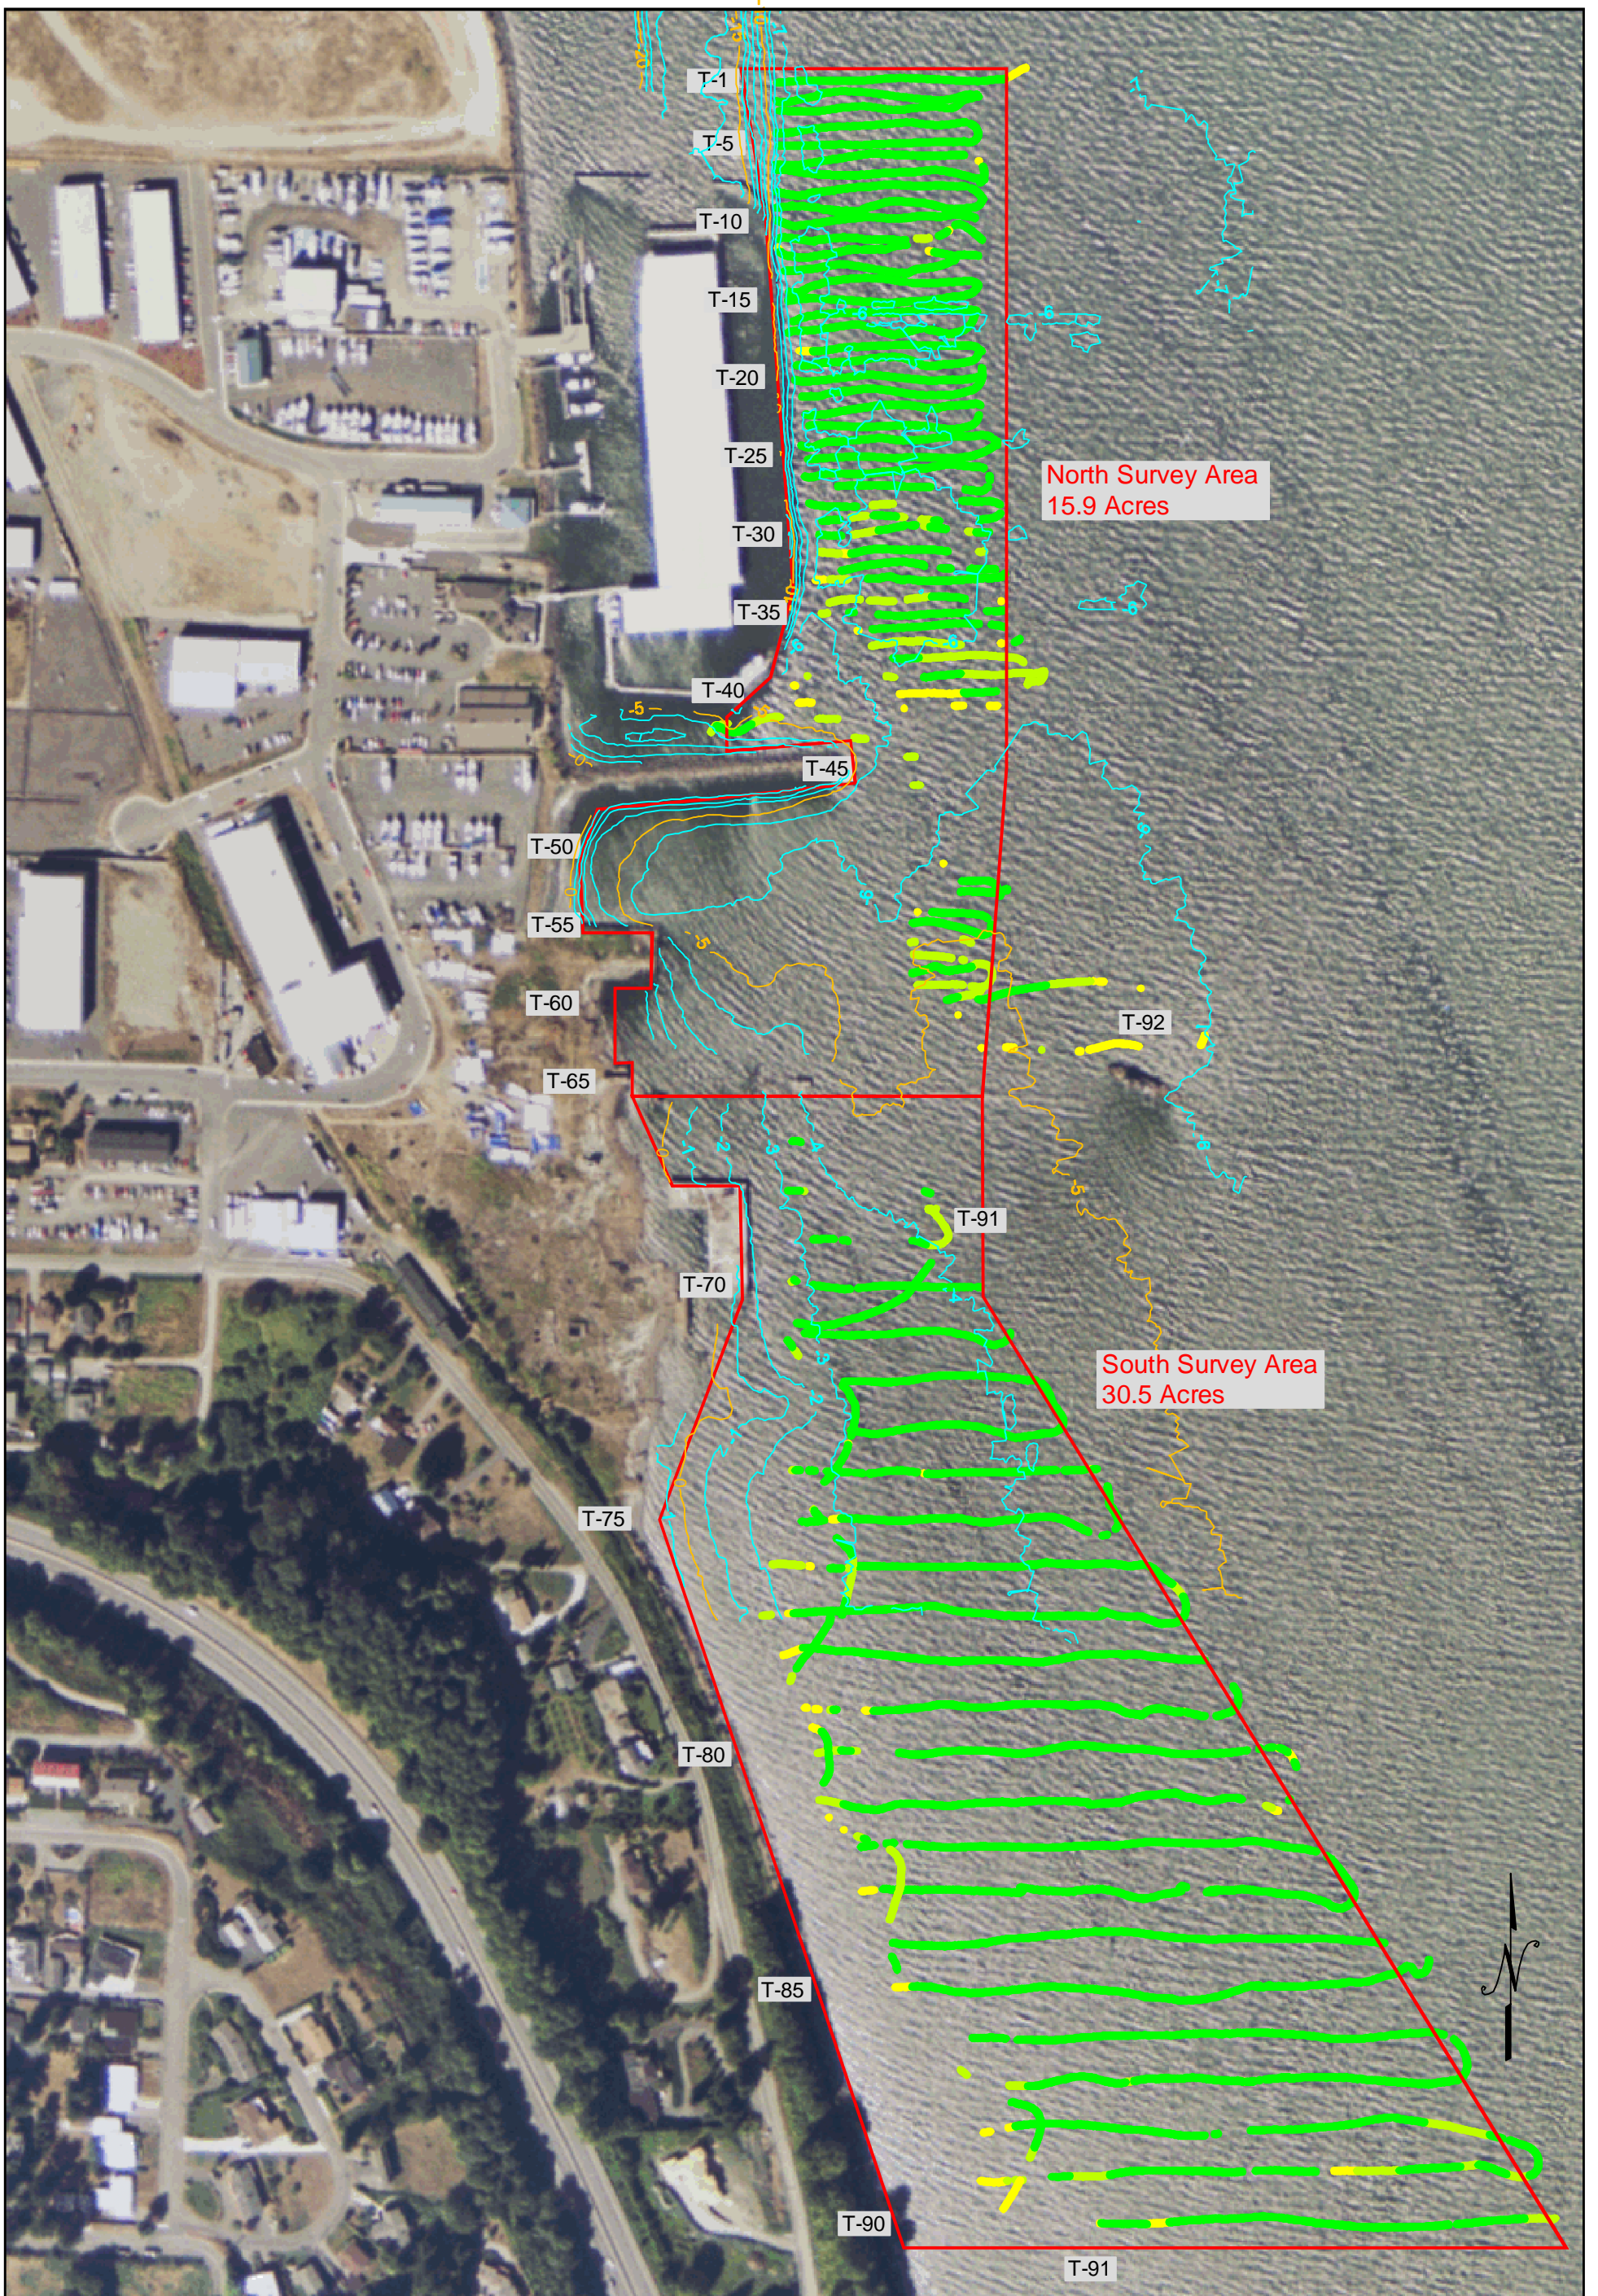
Figure 5

The shore-side edge of the eelgrass bed observed in Transects T-1 through T-35 was apparently defined by an elevation change or by the limit of reflected wave energy along the channel and seawall of the Fidalgo Marina (Figure 5). No clear reason for the lack of eelgrass in the nearshore areas was apparent on Transects T-36 to T-70. Between Transects T-70 and T-75, it appeared likely that wood debris is impacting the eelgrass nearest to the shore (Figure 6). On Transects T-76 through T-90, the shore-side edge of the eelgrass appeared to be defined by shallow water.

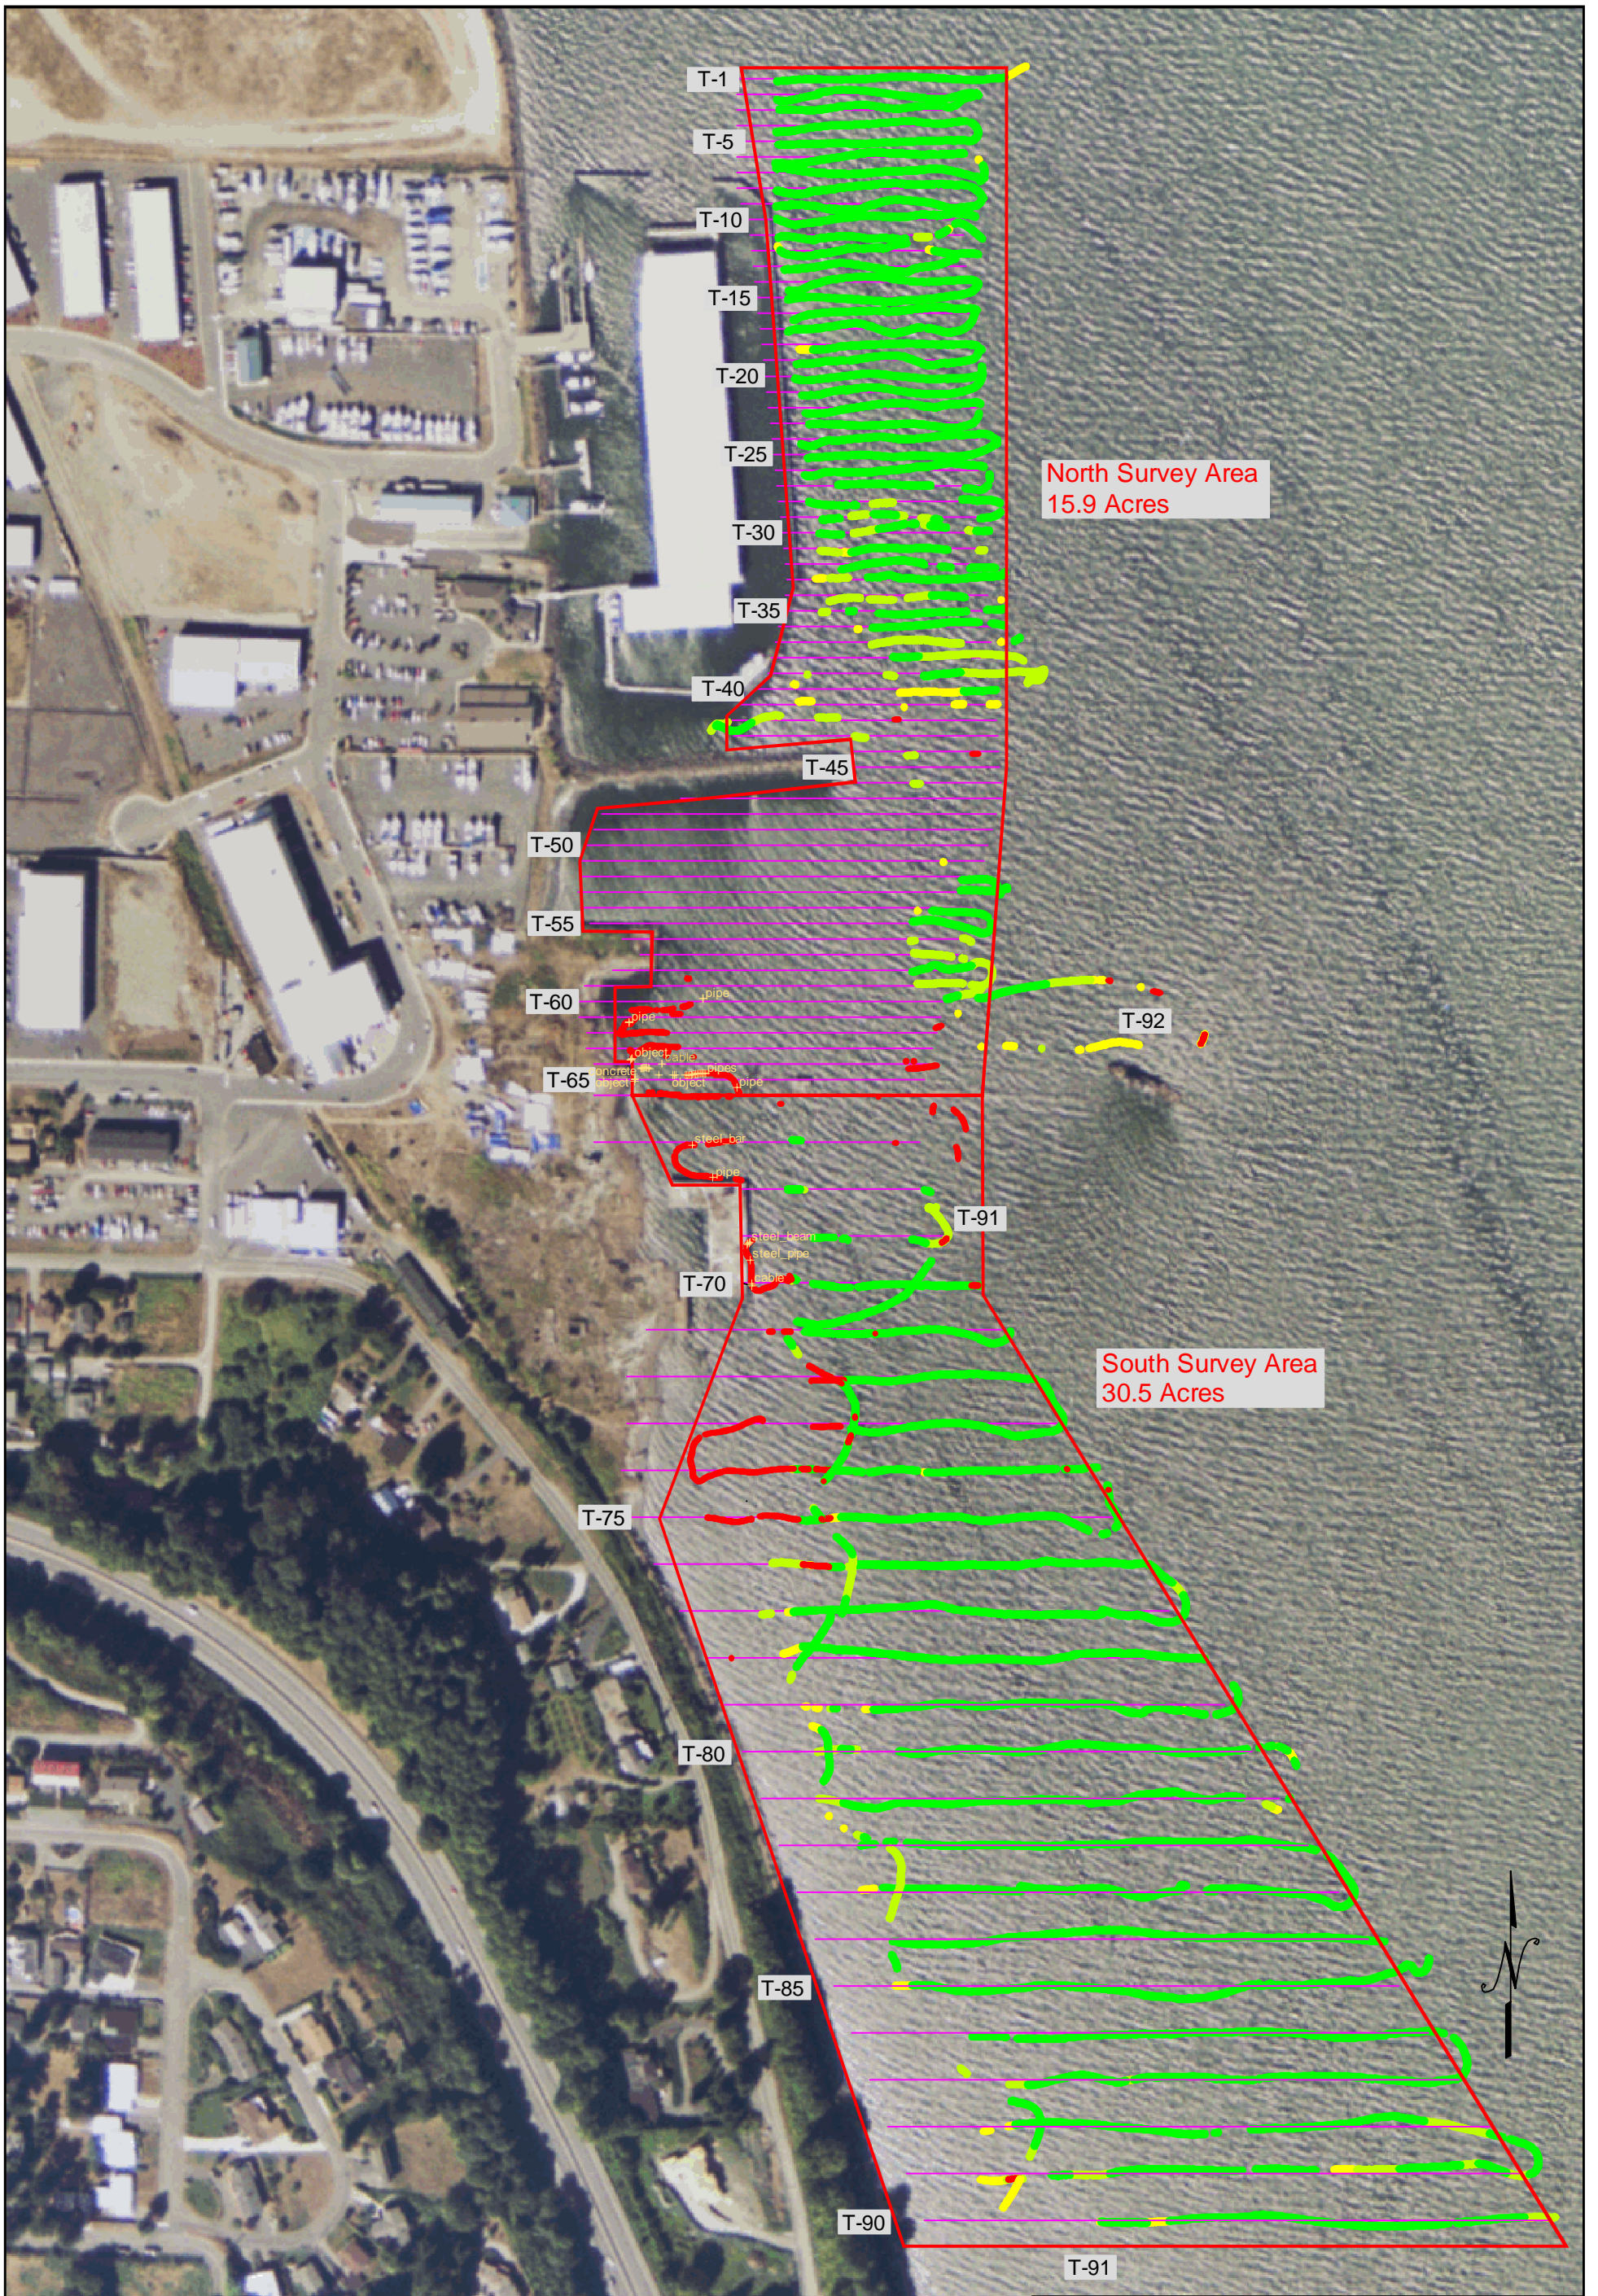
Figure 6 shows the locations where visible debris laying on the bottom was observed in relation to the mapped eelgrass beds. Small amounts of metal debris were observed in the vicinity of the abandoned pier structures (Transects T-60 through T-70). This metal debris consisted of pipes, cable, an iron "I" beam, and a concrete ledge.

Most of the wood debris observed was located in the vicinity of the former plywood mill extending along the shoreline from Transects T-60 to T-76. Patches of wood debris were also observed near the collapsed finger pier that extends offshore near Transects T-64, T-65, T-66, and T-92. The wood debris consisted of pieces of bark, an occasional log, and lumber. The lumber debris was more common in the areas near the abandoned piers. With the exception of the concrete structure, all of the debris appeared small enough to be easily dredged out with a bucket dredge.

Because of poor visibility and/or macroalgae covering the bottom, the presence of wood debris could not be verified over large portions of the survey area. However, because heavy deposits of wood debris are likely to affect the distribution of eelgrass (eelgrass does not appear to colonize areas of heavy wood deposits), it is likely that the amount of wood debris within the eelgrass beds is low. *It is important to keep in mind that while this survey can confirm the presence of wood debris, it cannot detect obscured debris or wood debris that is buried in the sediment.*

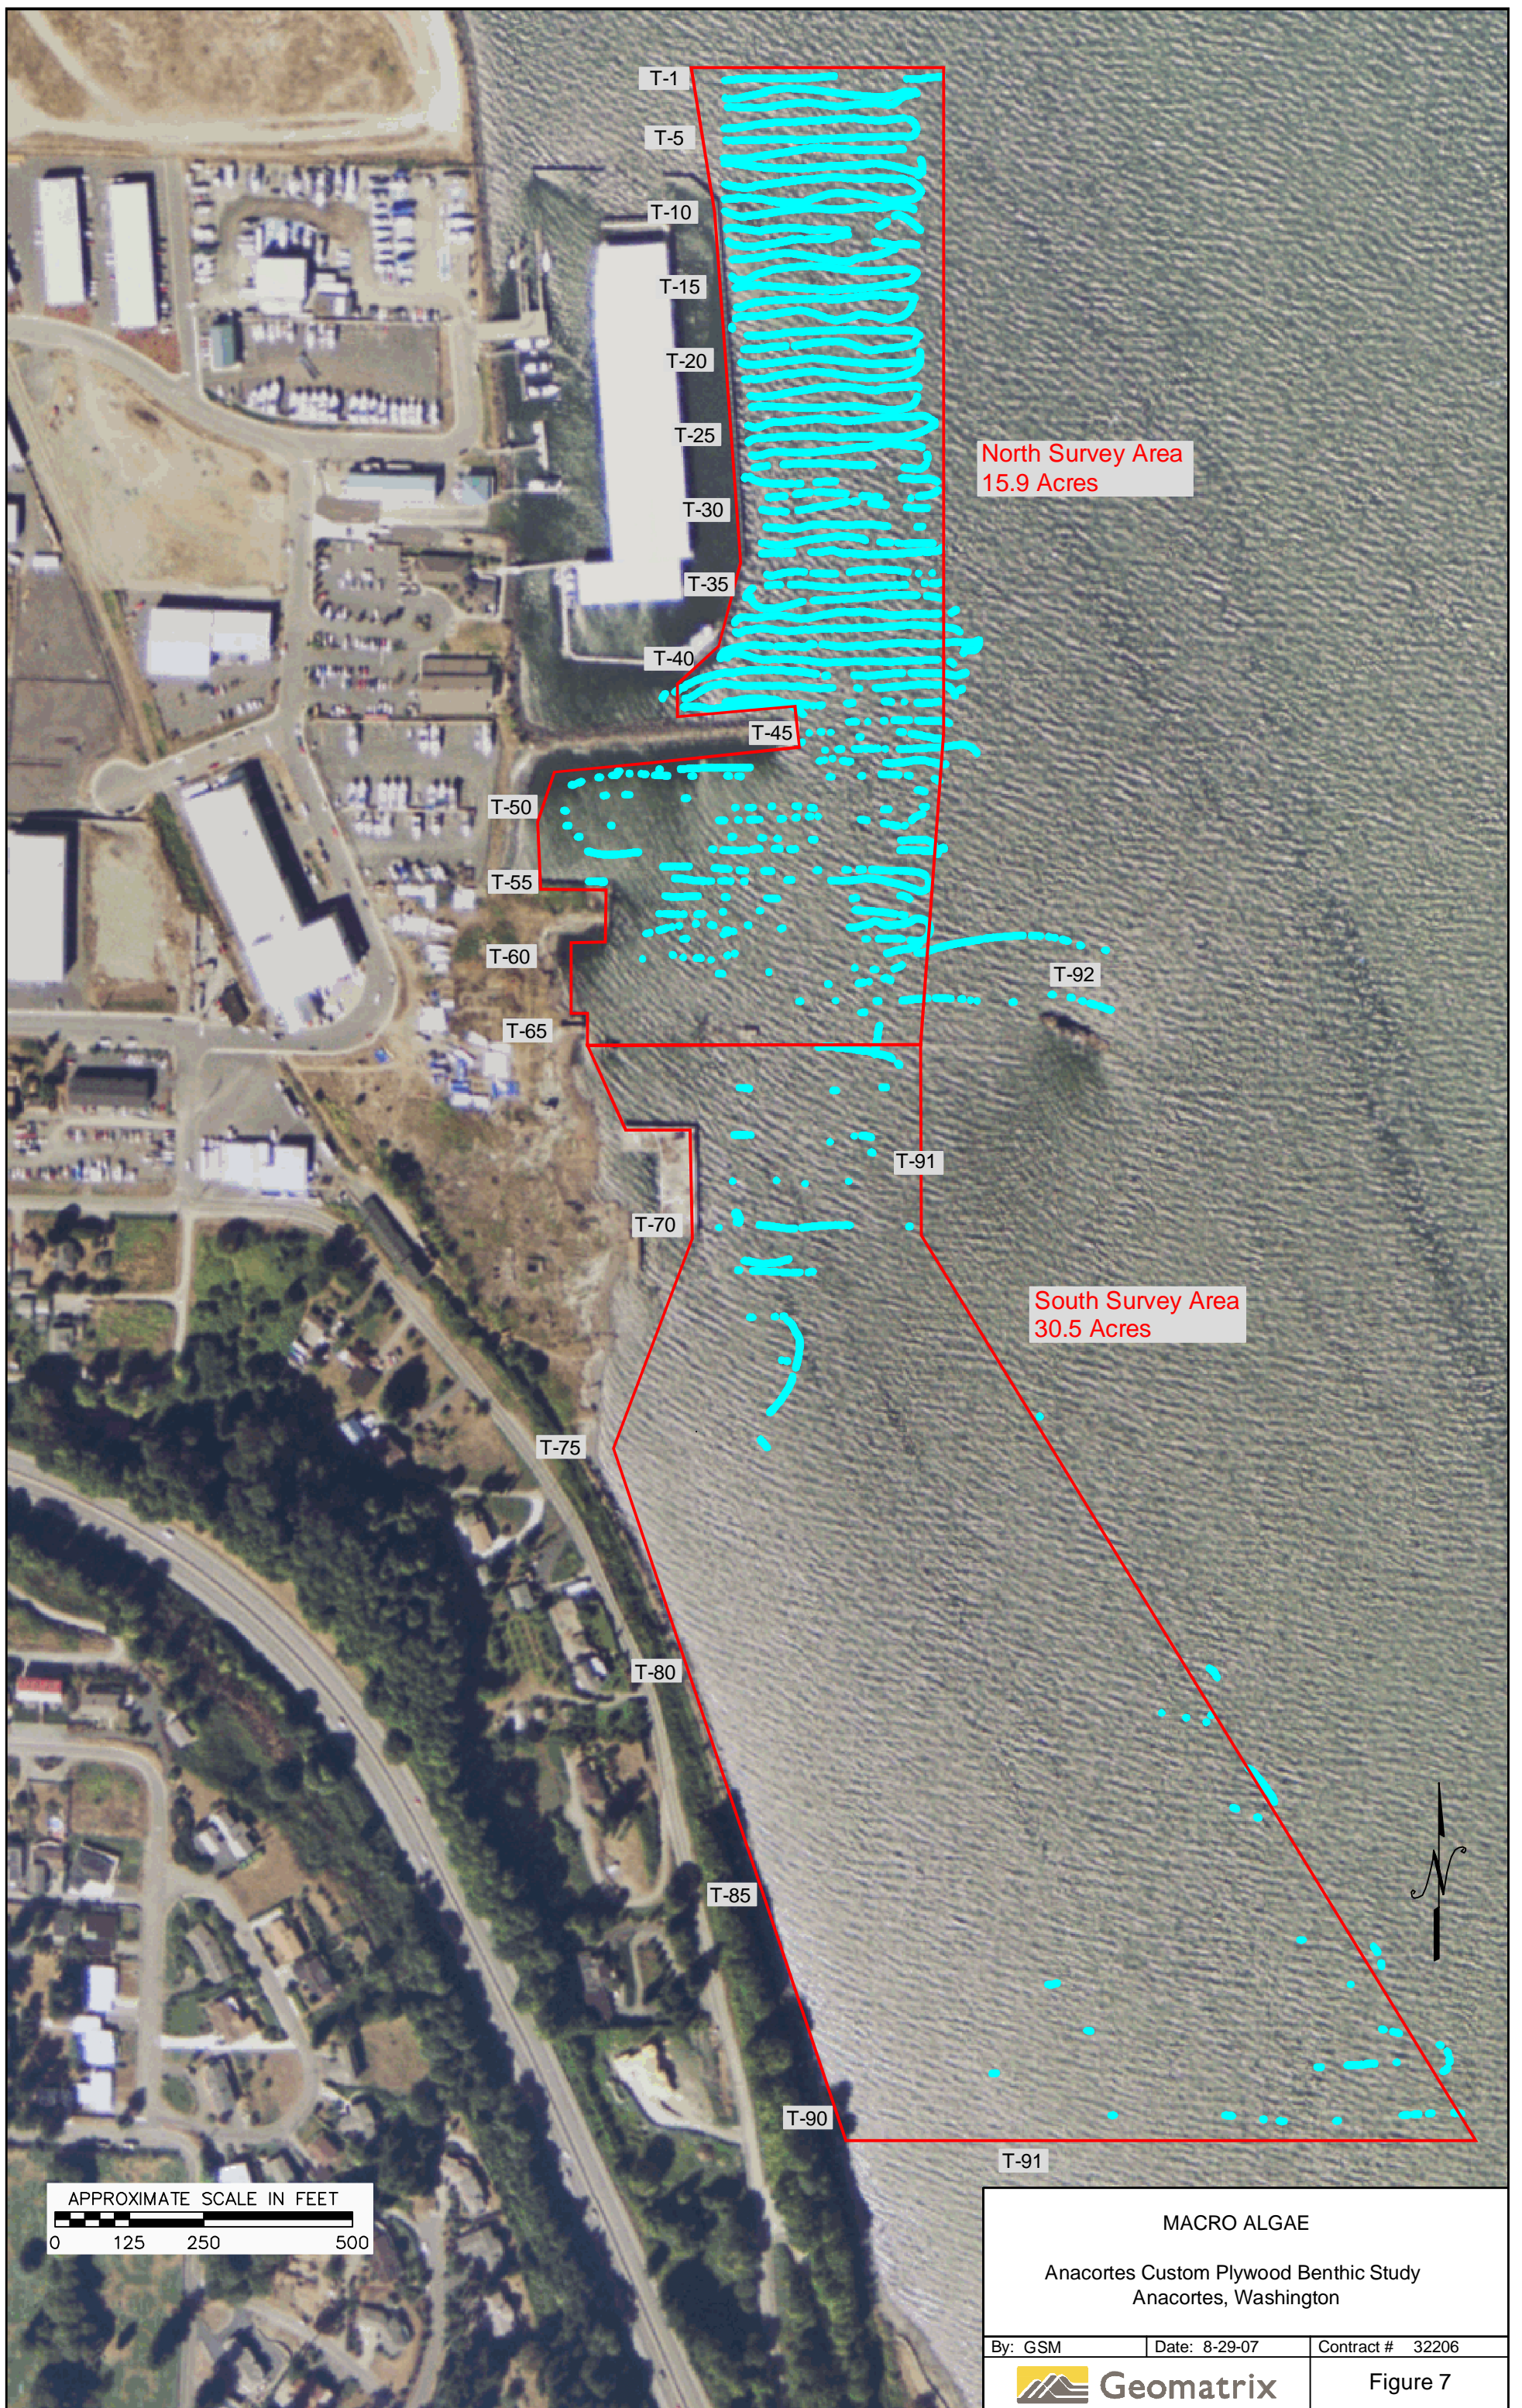
<p>MACRO ALGAE</p> <p>Anacortes Custom Plywood Benthic Study Anacortes, Washington</p>		
By: GSM	Date: 8-29-07	Contract # 32206
		<p>Figure 7</p>

In the North Survey Area, macroalgae were observed mixed in with the eelgrass. The amount of macroalgae diminished in the southern portion of the site (Figure 7). The macroalgae beds appeared to consist primarily of brown *Laminaria* sp. In the nearshore areas of the site, *Ulva* sp. became more common. *Ulva* sp. coverage was not included on the figures.
