STATE OF WASHINGTON
DEPARTMENT OF ECOLOGY

Re: Opinion pursuant to WAC 173-340-515(5) on Remedial Action for the following Hazardous Waste Site:

- **Site Name:** Rainier Mall
- **Site Address:** 4208 Rainier Avenue South, Seattle, WA 98118
- **Facility/Site No.:** 88987973
- **Cleanup Site ID:** 4187
- **VCP Project No.:** NW3261

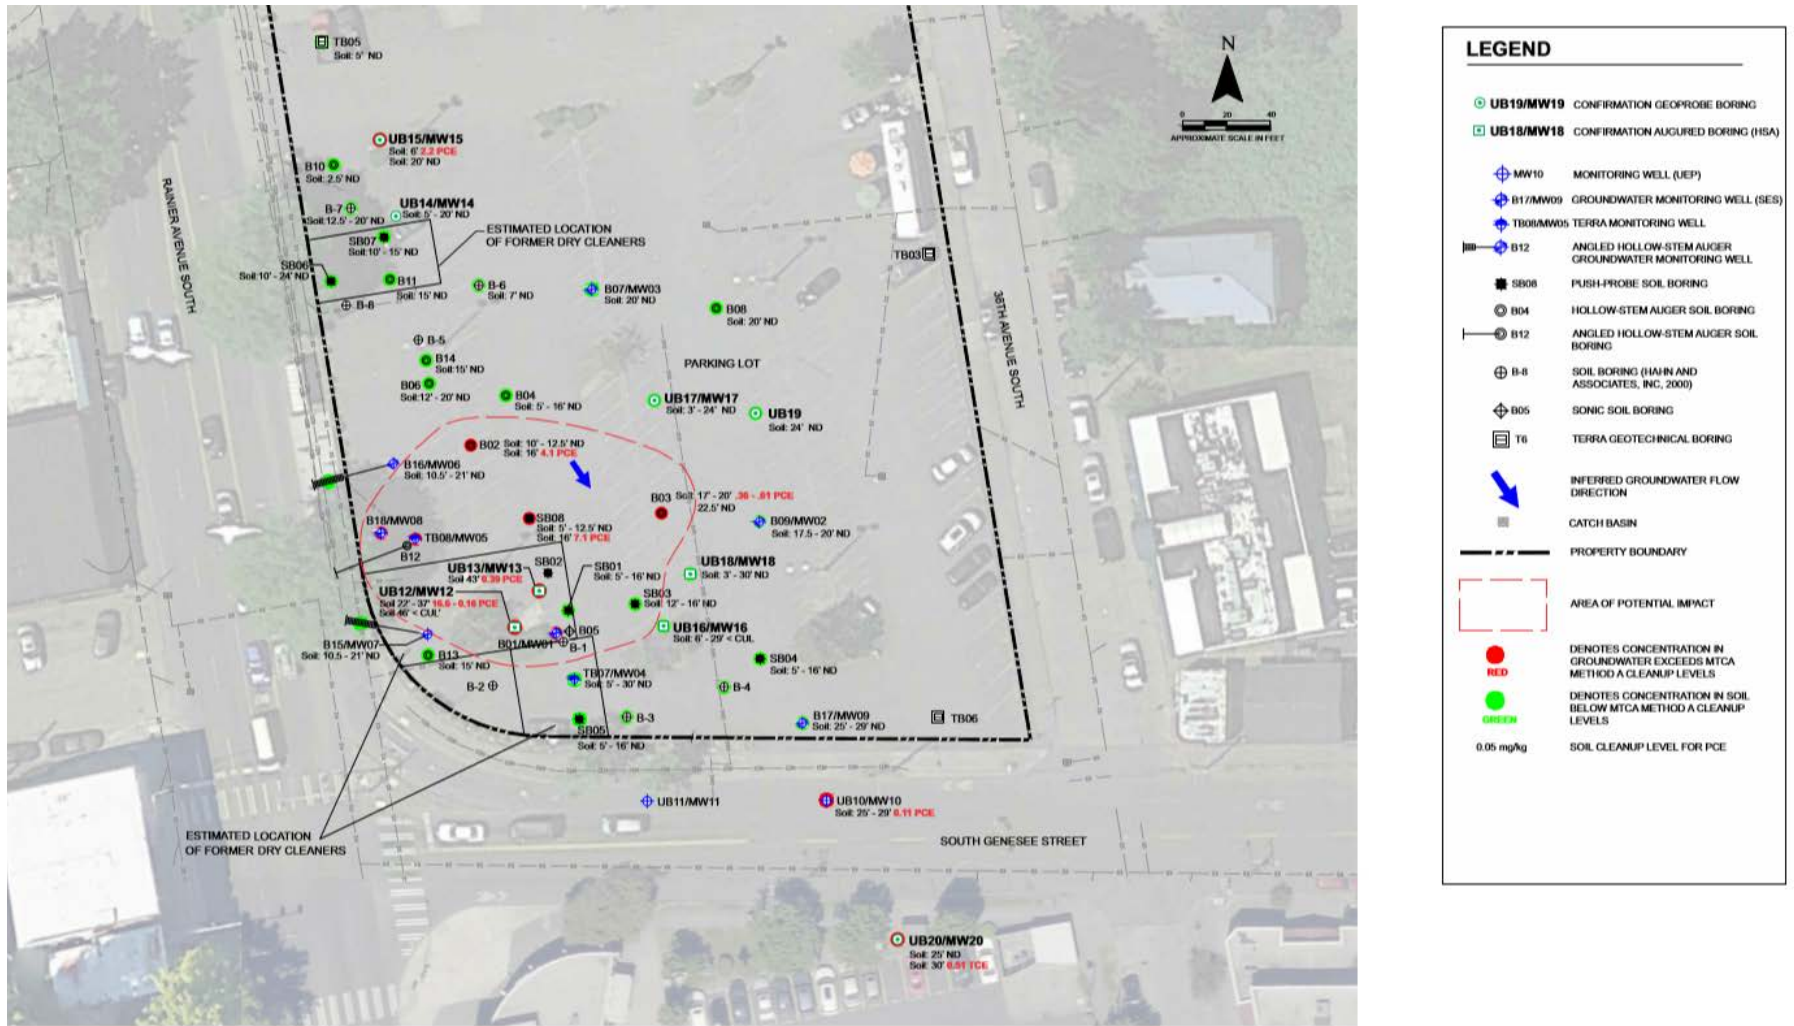
- The depth of cVOC impacts to soil in the southeastern portion of the site are not delineated. The highest cVOC soil concentrations measured from MW10 were at the deepest analyzed sample at 28 feet. Other soil borings in the southeastern part of the property (i.e. MW09, B-3, and SB04) were not sampled at depths greater than 20 feet. Soil impacts were first encountered at 25 feet bgs in MW10.

- MW10 is also the current southernmost and easternmost sampling location. Soil impacts exceeding cVOC cleanup levels indicate the western and southern soil impacts are not delineated.

Soil: Soil samples indicate that soil containing cVOC concentrations greater than MTCA Method A cleanup levels remains in the southwest portion of the Property. Deep cVOC soil impacts have been measured at approximately 30 feet bgs in the S Genesee Street right-of-way. TPH-O was detected in near surface soils, greater than MTCA Method A cleanup levels. Soil may be impacted by cPAHs from the treated wood piles beneath the vacant building on the Property.

Chlorinated VOC concentrations in soil samples collected from borings at the Site are shown on **Figure 4**.

Figure 4: cVOC soil data. While not represented in the figure, soil data from B-1, SB01, SB02, B04, B06, B12, B14, and B16 included PCE and/or TCE concentrations in excess of MTCA Method A cleanup levels. From Urban Environmental Partners LLC (March 2020).

- Ground water delineation of the southeastern extents will likely resolve soil delineation concerns. Soil and ground water samples should be collected at depths sufficient to delineate the vertical extent of cVOC contamination.

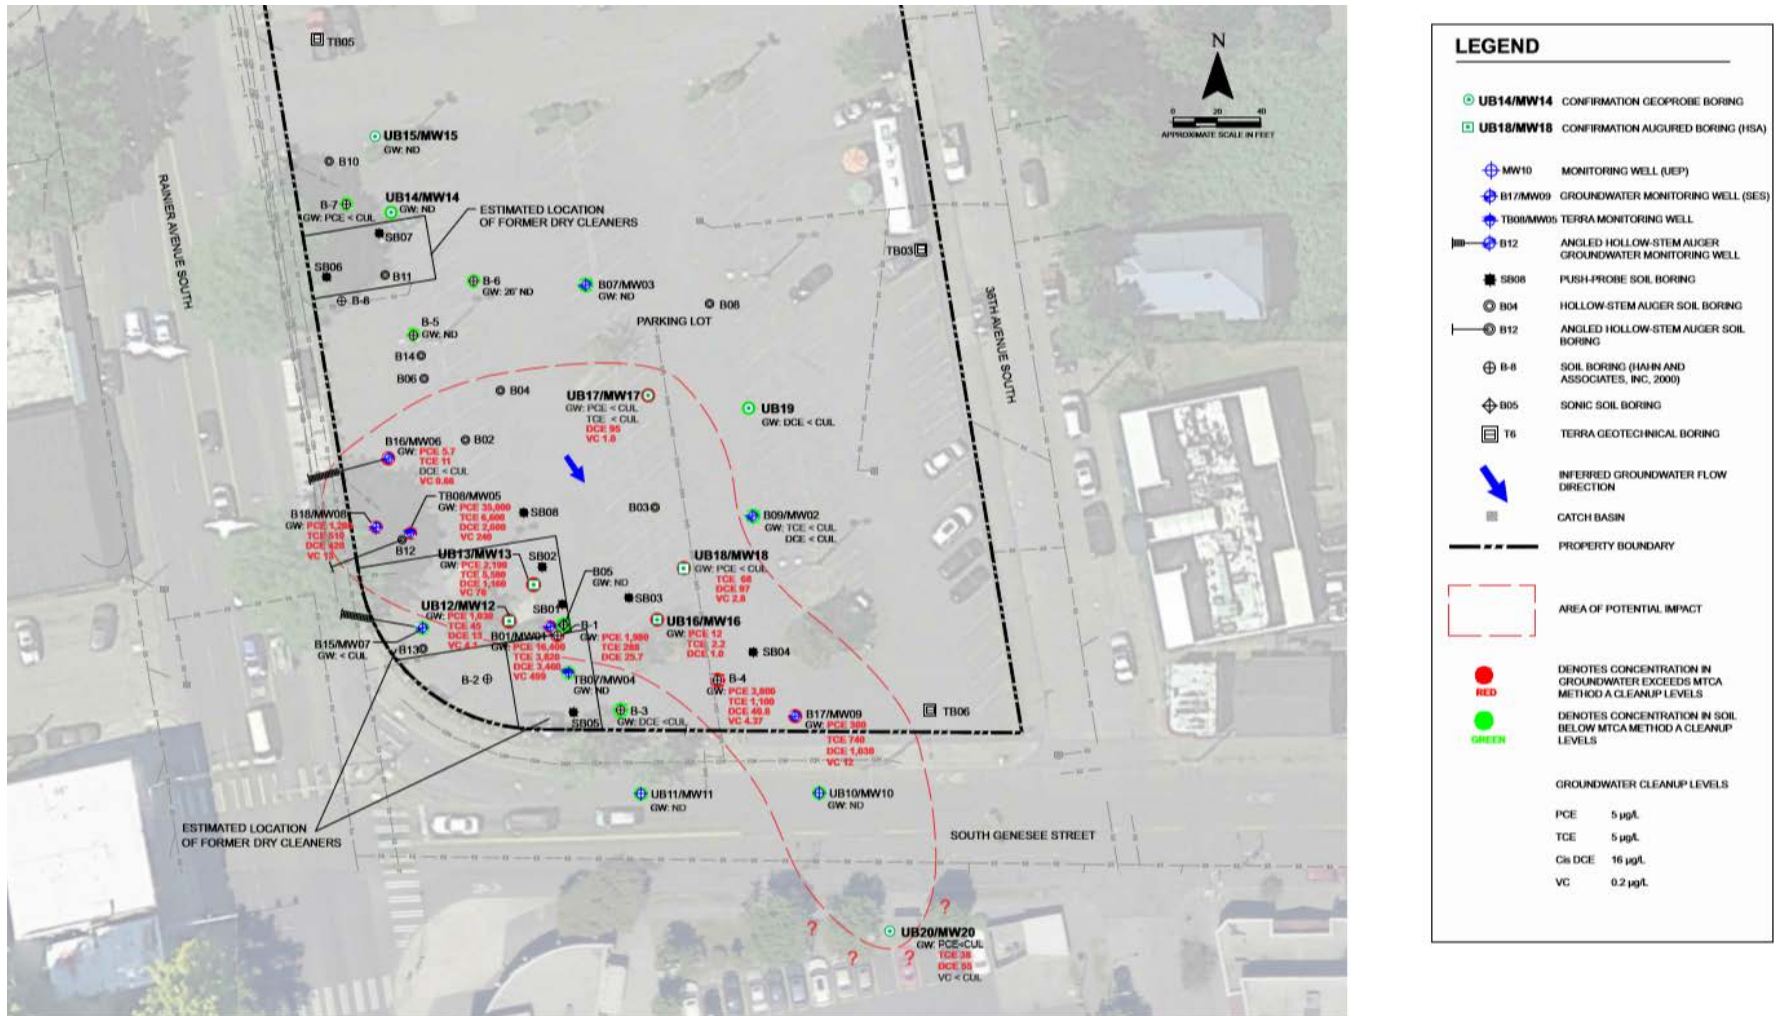
- Considering the direction of ground water flow suggested by the April 16, 2019 measurements, and all three easternmost wells having ground water analysis results exceeding cVOC cleanup levels, the eastern ground water plume extent has not been delineated.

- The western extent of groundwater impacts are defined by two wells installed by angle drilling methods and sampled once in 2010. Ground water samples from wells MW08 and MW05, installed between the angled wells, exceeded MTCA Method A cleanup levels by several orders of magnitude.

Ground Water: Ground water samples obtained from monitoring wells installed at the former location of the drycleaners and extending south into the S Genesee Street right-of-way contain PCE and/or breakdown products. Ground water PCE concentrations as high as 38,900 µg/L measured from developed wells on the Property suggest the potential for PCE as separate-phase product to be present.

Chlorinated VOC concentrations in ground water samples collected from monitoring wells at the Site are shown on **Figure 5**.

Figure 5: cVOC groundwater data. Data presented includes groundwater samples collected between June 2000 and March 2020. From Urban Environmental Partners LLC (March 2020).

necessary to delineate the eastern extent of the groundwater plume, including soil samples analyzed for cVOCs. Soil and ground water samples should be collected at depths sufficient to delineate the vertical extent of cVOC contamination.

- Collection of samples for cVOCs in ground water is necessary for monitoring wells MW06, MW07, and MW08.
- As shown in Figure 7 of the *Work Plan*, the soil impacts along the western property boundary have not been delineated. The sanitary sewer line directly adjacent to the observed soil impacts has potential to be a preferential pathway, particularly if there is still a connected lateral in the area of MW08 as shown in the figures.

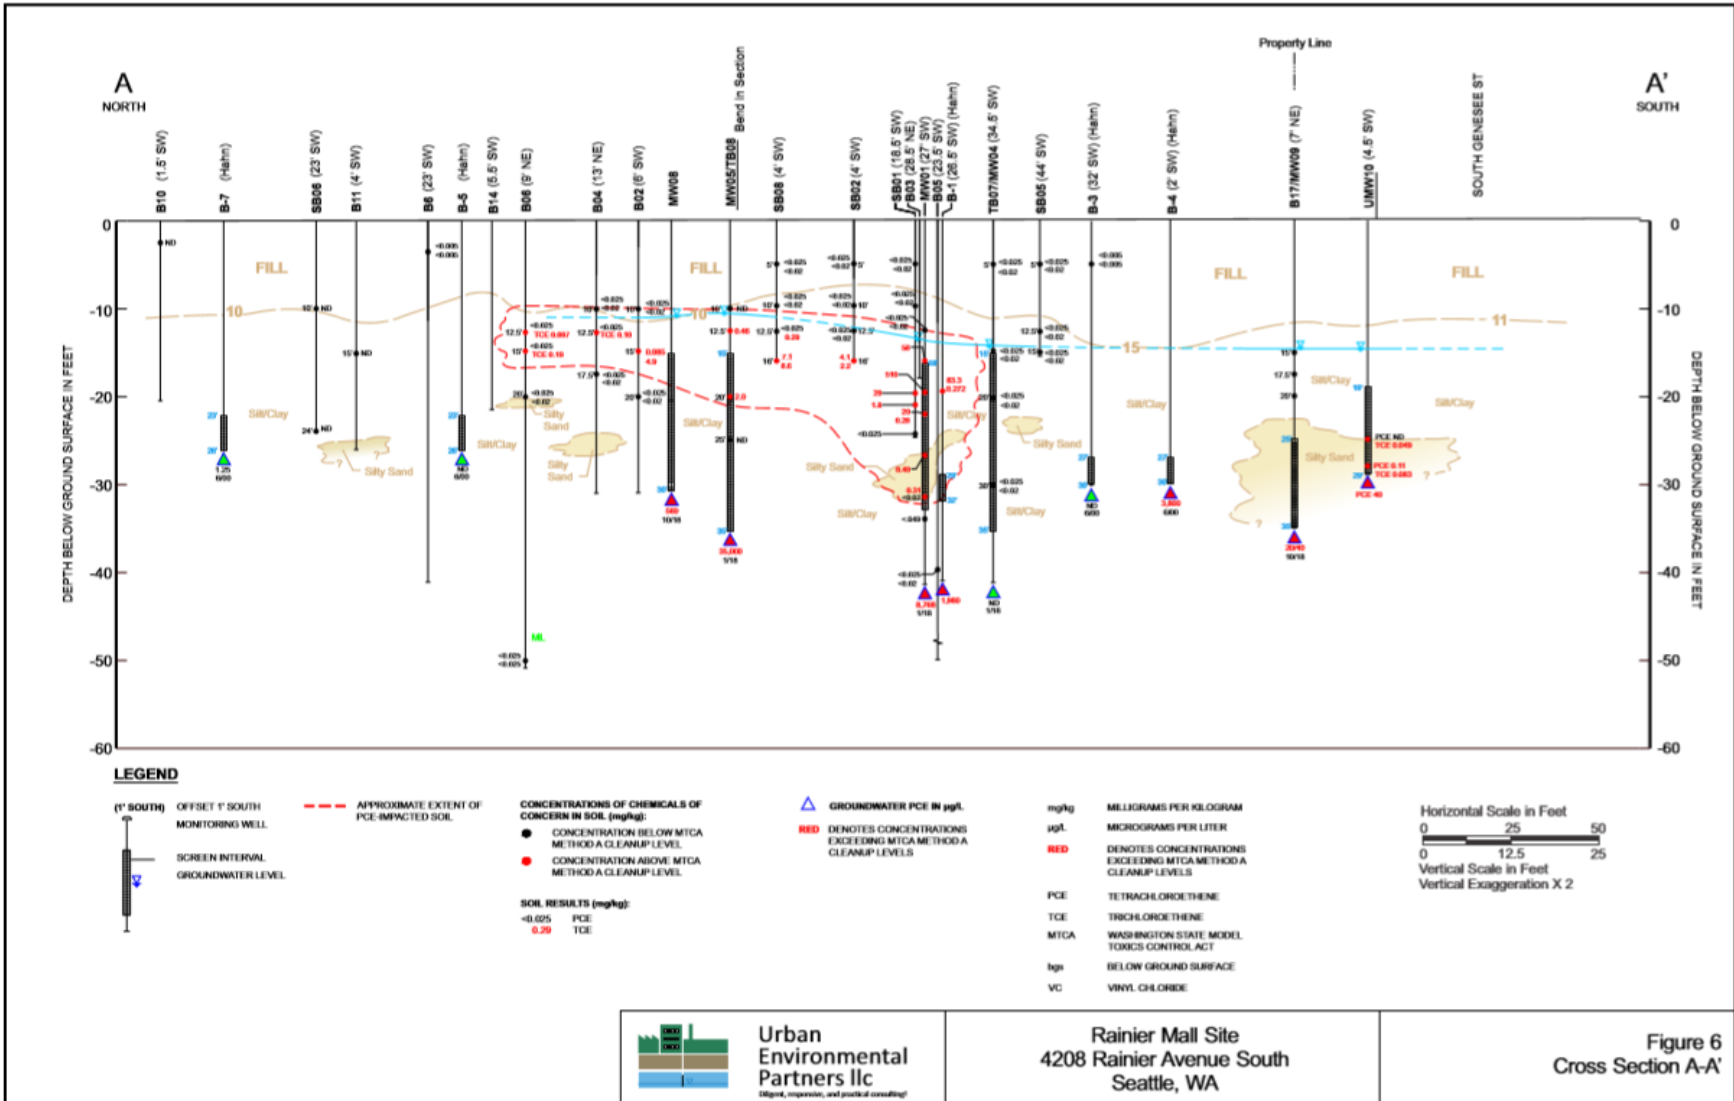
- Cross Section A-A' (Figure 6)
 - B03 should be labeled SB03; B03 was extended deeper and included analytical results exceeding cleanup levels.
 - Include projection distances for MW05 and MW08.

- Include SB04 and SB07 in the cross section.
 - Include B14, MW08 (B18), and TB08 at 17.5 feet bgs with chemical

- The vertical scale on all cross sections should be elevation relative to mean sea level (NAVD88), rather than depth below ground surface.
 - Show ground water levels and dates for any temporary and permanent wells shown on the sections.

- Show the elevations at which ground water samples were collected.
 - Include the total depth and stratigraphy for deep boring B05, which was drilled to a depth of 90 feet bgs.

data Cross sections should be based on elevations to represent site conditions.

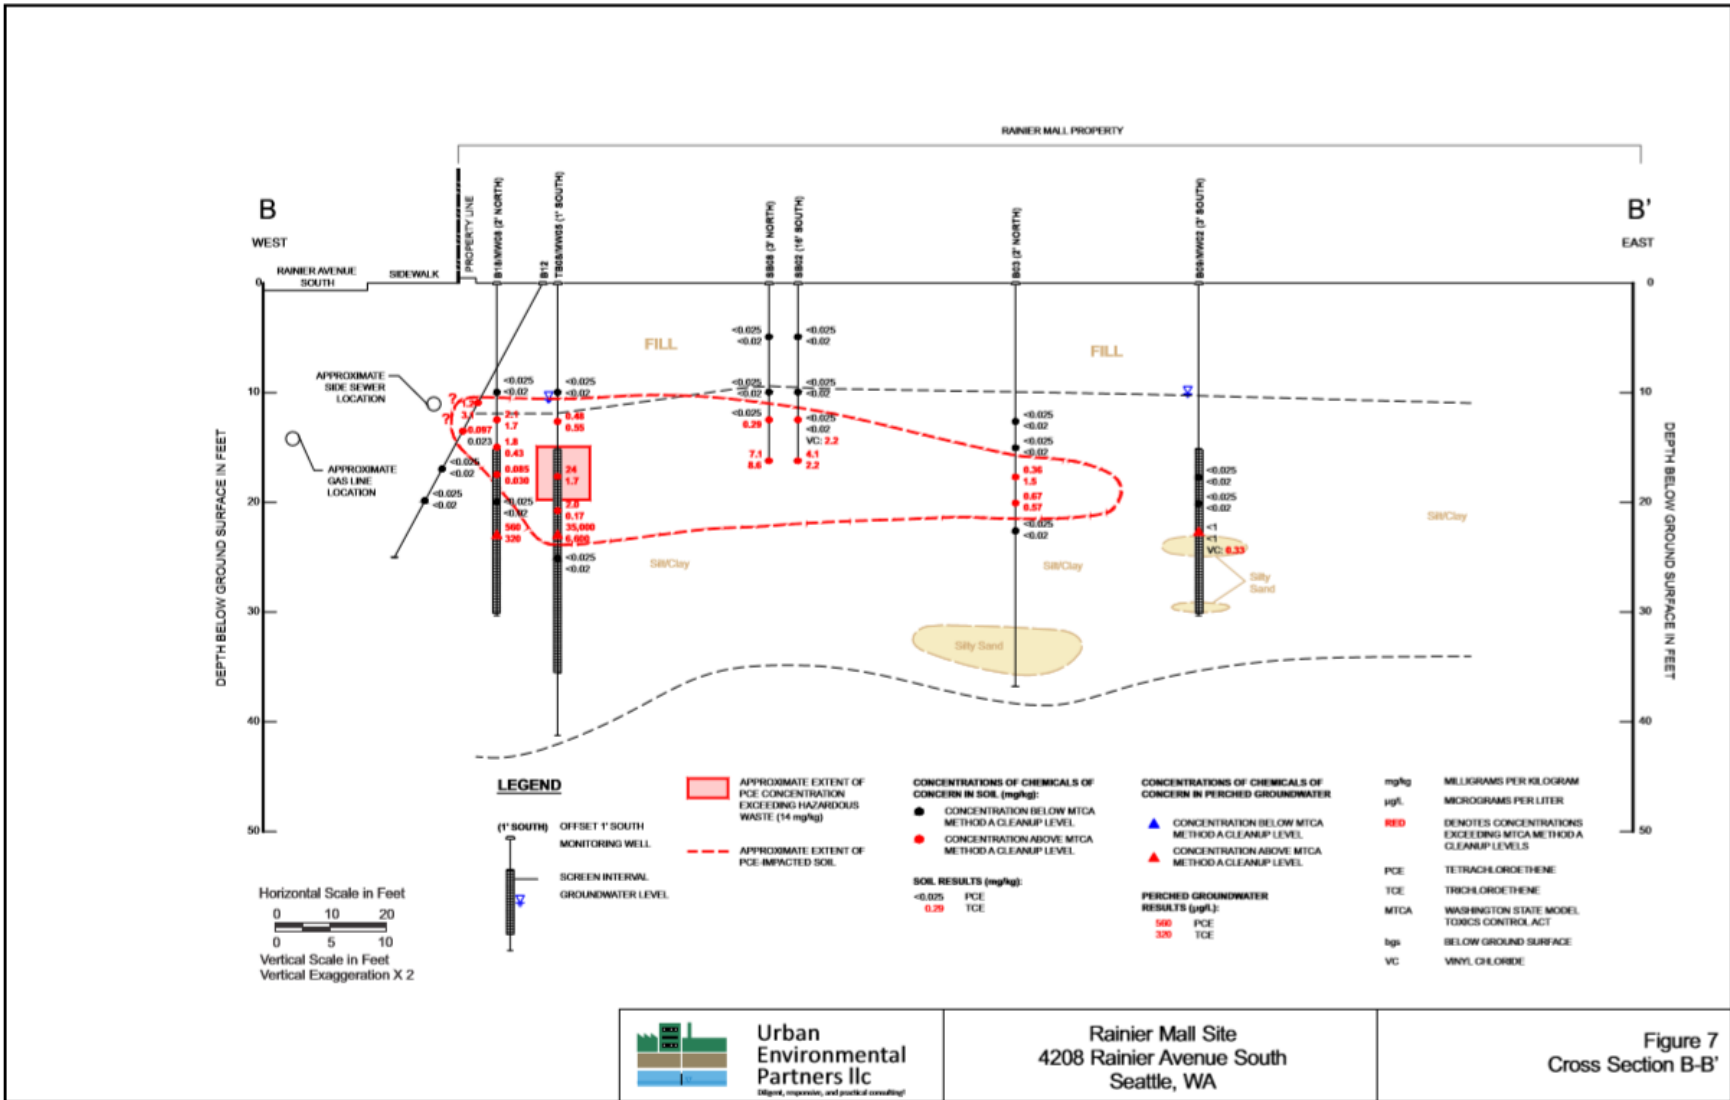
Figure 7
Cross Section B-B'

- Cross Section B-B' (Figure 7)
 - Use of the term “perched groundwater results” is premature until the CSM determines if the uppermost zone of saturation is a perched ground water condition.

- A quantitative gas sample from the sanitary sewer line near MW08 and/or a quantitative soil gas sample in the area of the former northern dry cleaner location, analyzed for cVOCs, is necessary to assess the sanitary sewer line as a potential preferential pathway. There is a concern that cVOC vapors may become elevated in the sanitary sewer during remedial activities.

- Incorporate above changes in cross sections included in the RI Report, if appropriate.
- Font size on Tables and maps should be at least 10 point so they are legible.
