PERIODIC REVIEW REPORT FINAL

Automotive Service, Inc. Facility Site ID#: 4380 Cleanup Site ID# 5210

2327 W Mill Plain Boulevard Vancouver, Washington 98660

July 2020

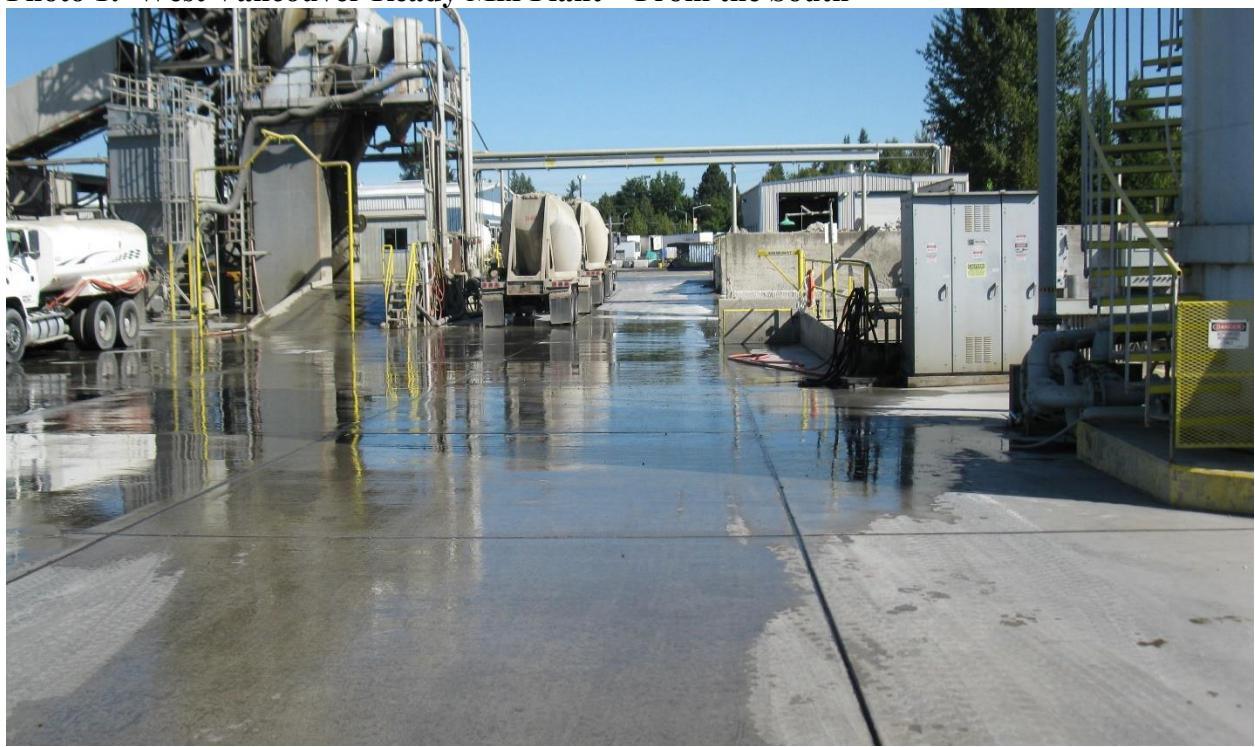
Photo 1: West Vancouver Ready Mix Plant – From the South

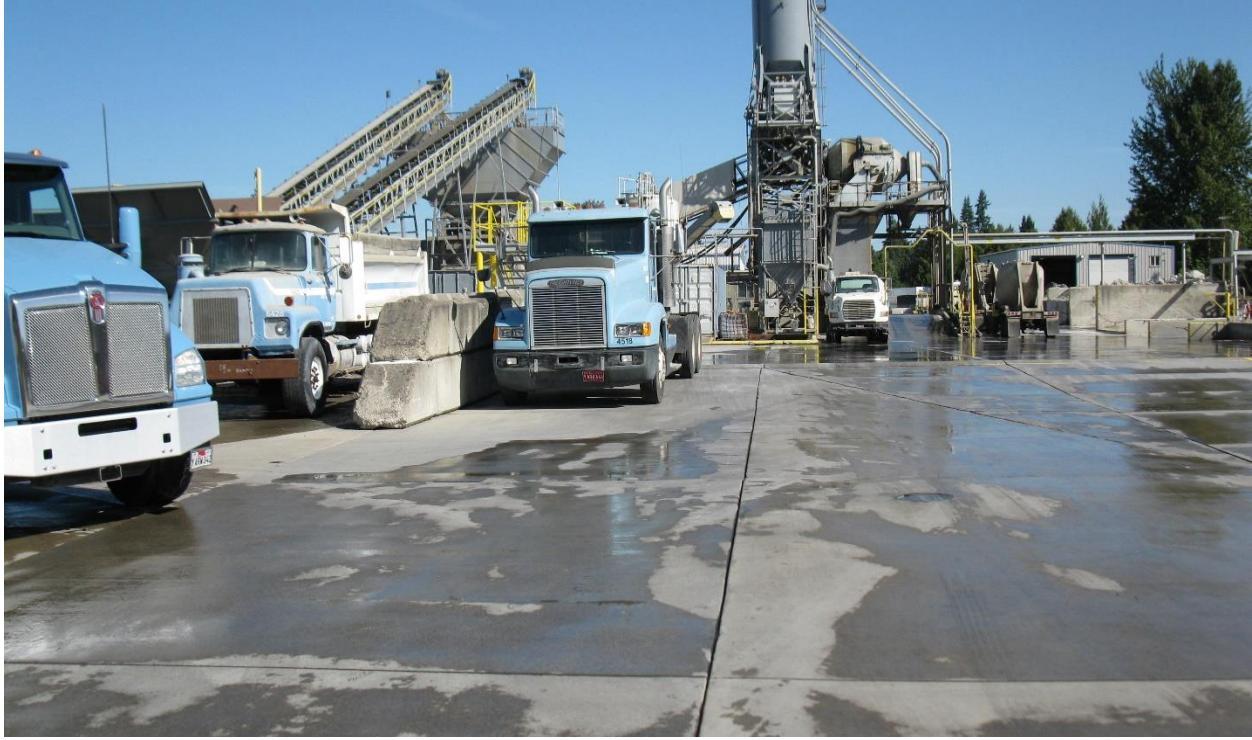
Photo 2: West Vancouver Ready Mix Plant - From the Southwest

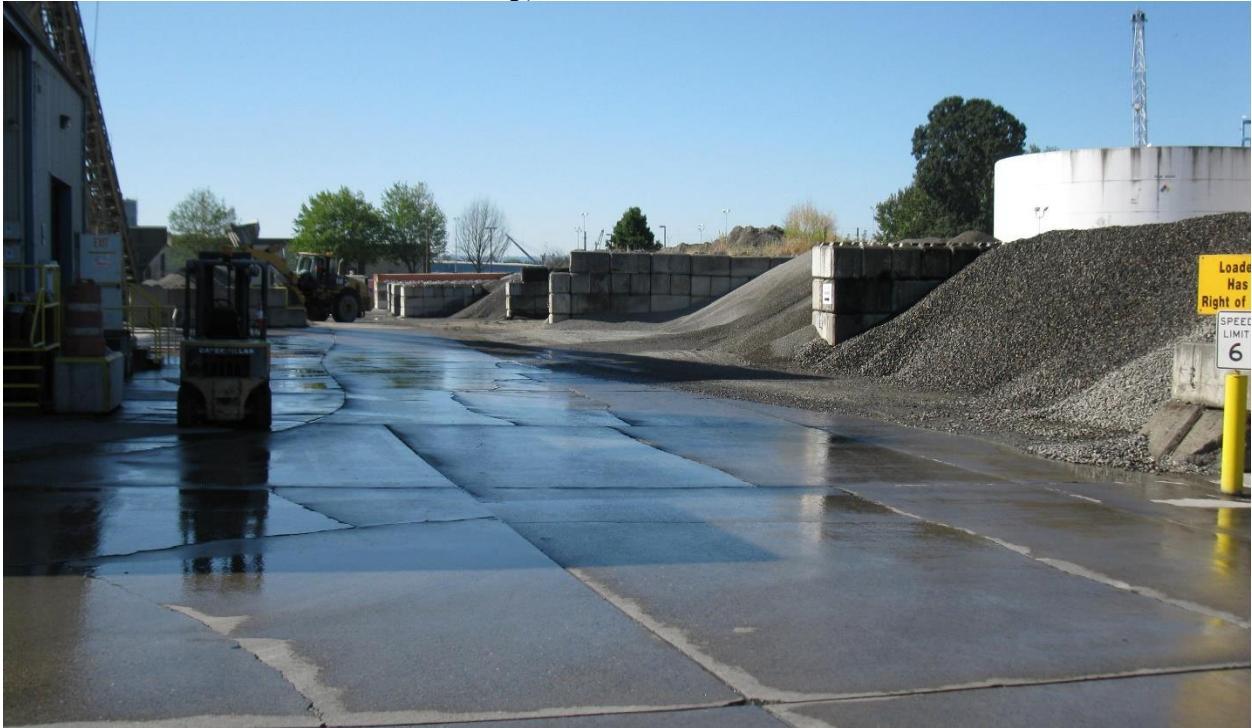
Photo 3: Area of Residual Kerosene and/or Diesel Contaminated Soil (below Gravel and Sand Piles and Concrete Cap) - From the Northeast

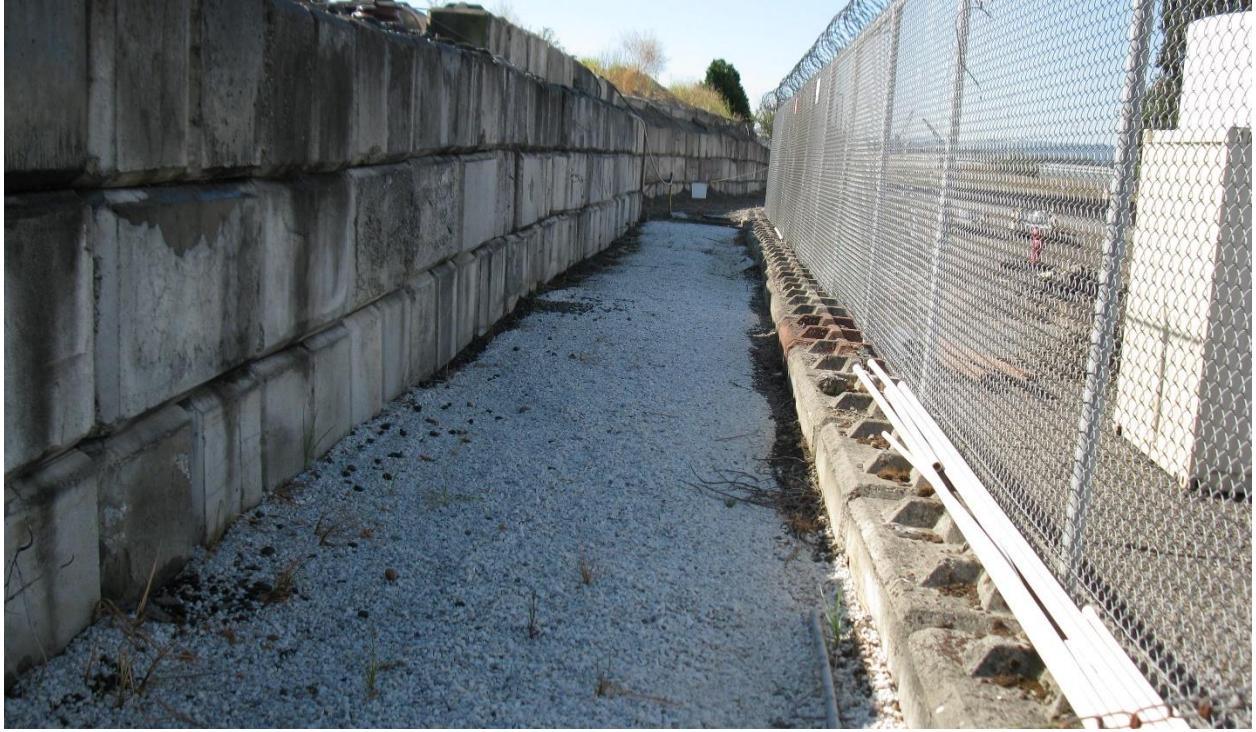
Photo 4: Area of Residual Diesel Contaminated Soil, Adjacent to Tesoro Facility – From the North

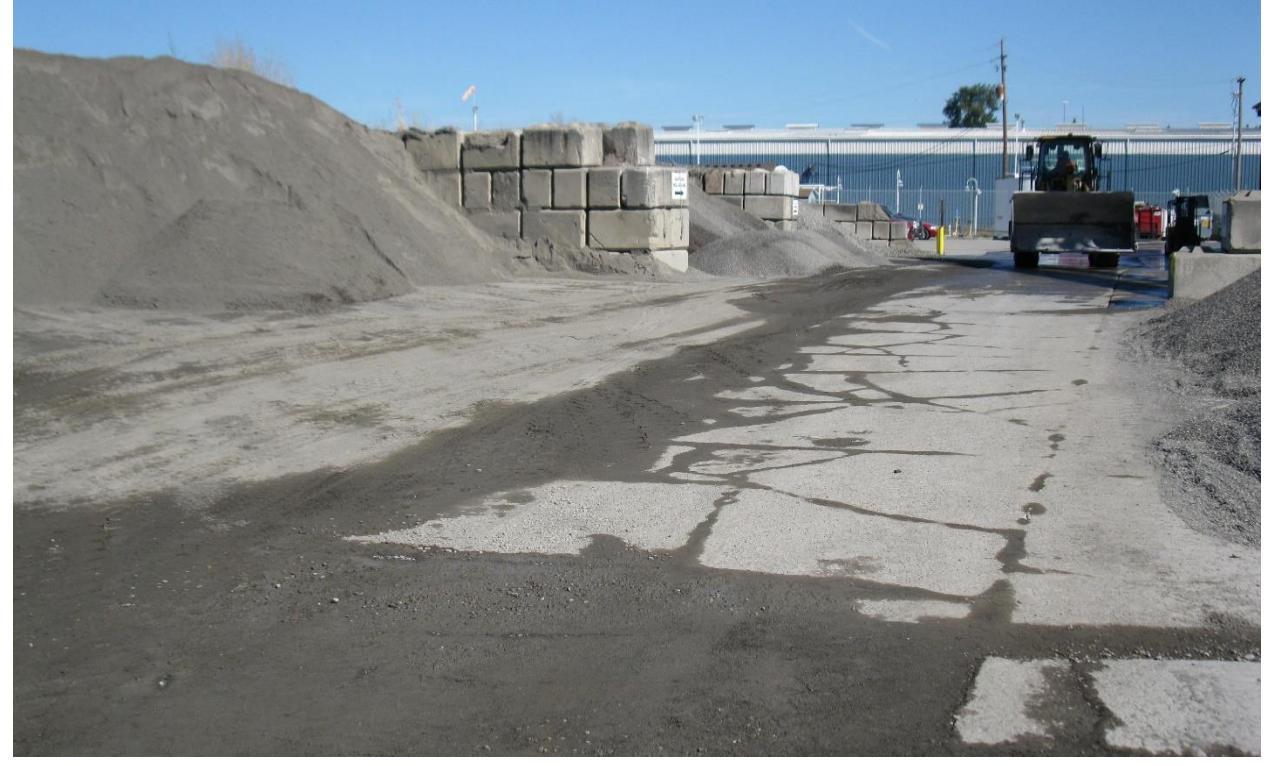
Photo 5: Area of Residual Kerosene and/or Diesel Contaminated Soil (below Gravel and Sand Piles and Concrete Cap) - From the Southeast

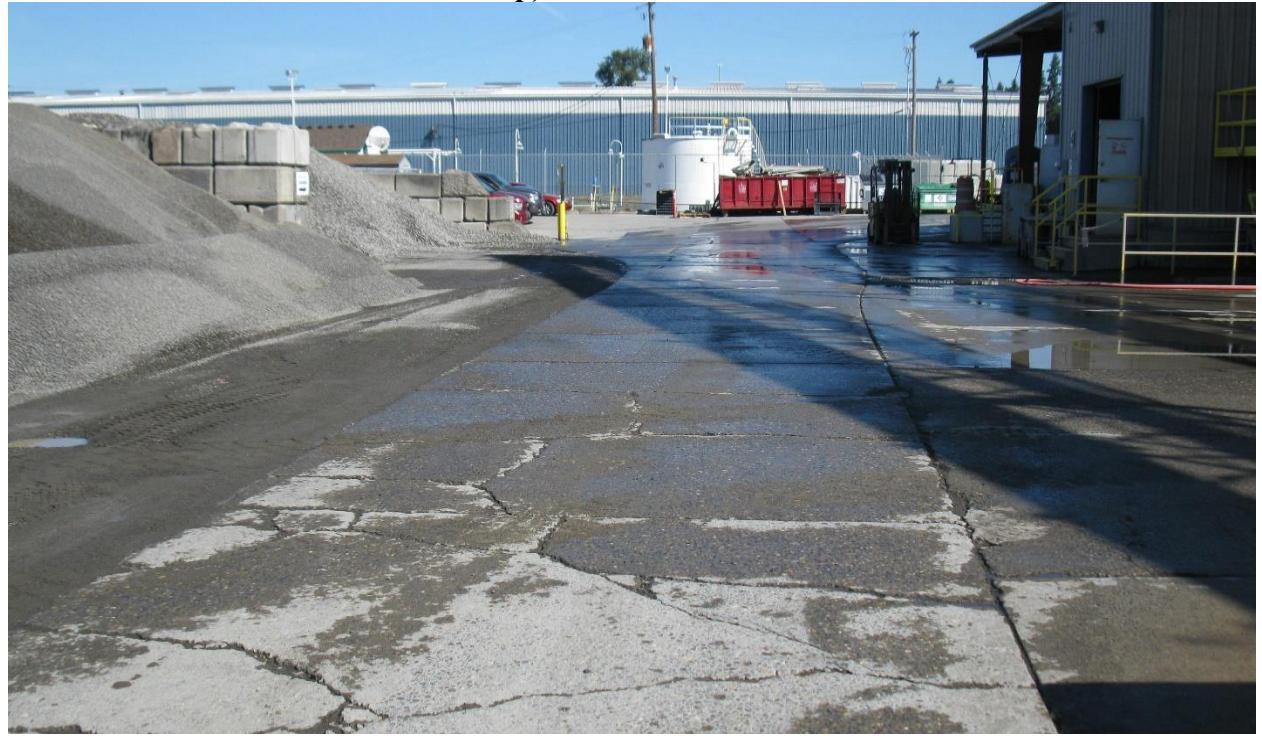
Photo 6: Area of Residual Kerosene and/or Diesel Contaminated Soil (below Gravel and Sand Piles and Concrete Cap) - From the South

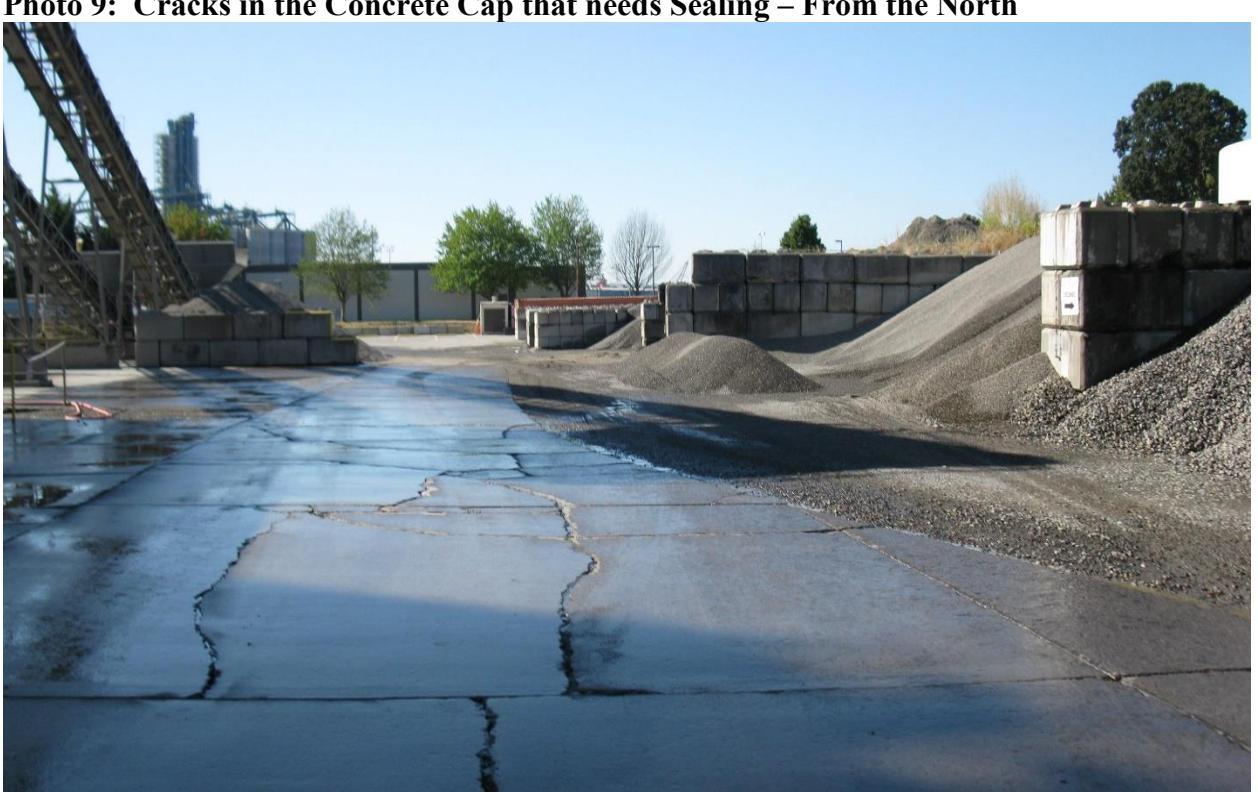
Based upon the Site visit conducted on August 28, 2019, the asphalt pavement continues to provide an adequate barrier to direct exposure pathways (ingestion and direct contact) to the contaminated soils. Asphalt pavement is in satisfactory condition and no repair, maintenance or contingency actions are required at this time, except in a small area in the northwestern portion of the Site where few cracks needs to be sealed (Appendix 6.18, Photo 9). However, these cracks will not affect the overall integrity and performance of the cap. The Port is in the process of sealing these cracks. A photo log is available as Appendix 6.18.

Photo 9: Cracks in the Concrete Cap that needs Sealing – From the North

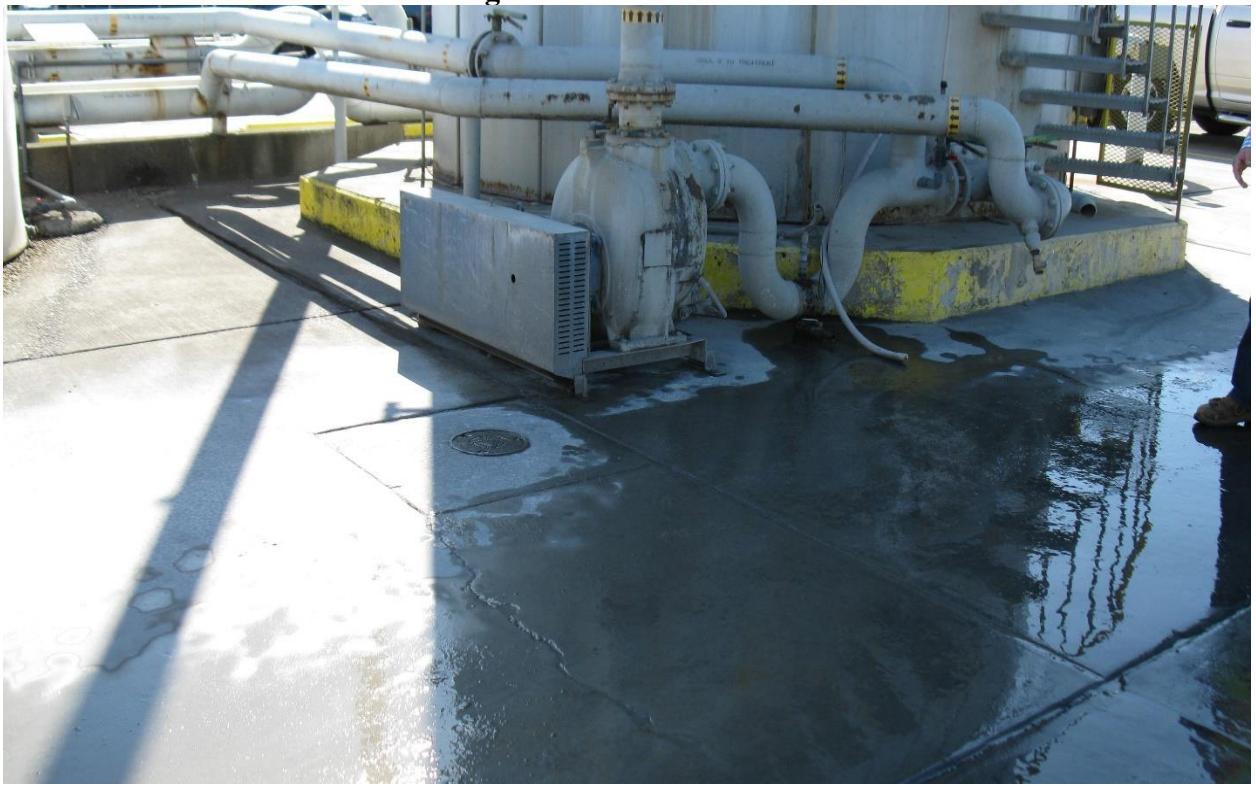
Photo 10: Groundwater Monitoring GL-4
