Memorandum

June 30, 2020

Re: Vapor Intrusion Evaluation Work Plan Addendum: Carson Cleaners, Inc.

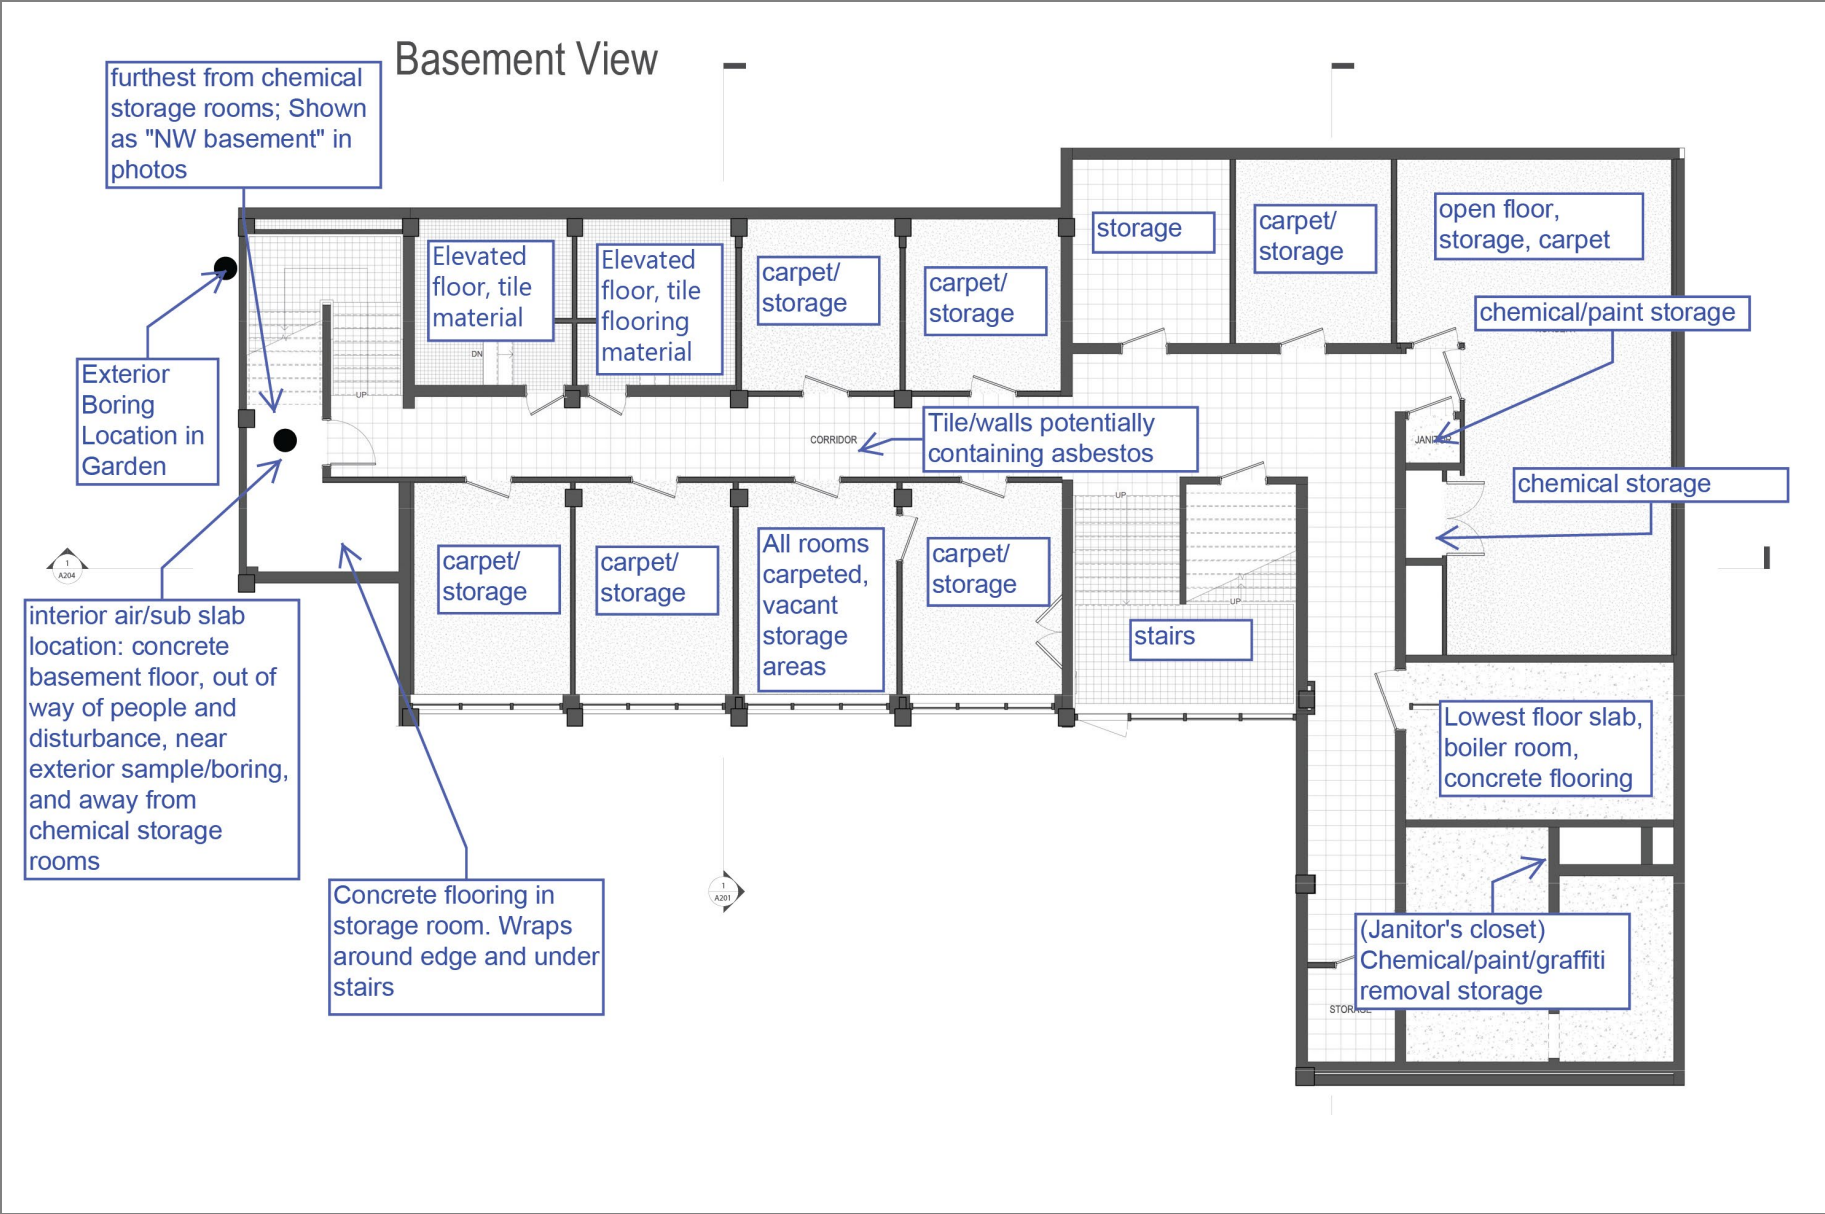
Figure 2
Christ Episcopal Church
 VI Evaluation Work Plan

Anchor QEA staff signed into the church property and proceeded on a guided tour starting on the northwest basement floor and moved from room to room to the southeast side of the basement. A floorplan sketch of the basement is provided in Figure 2.

The northwest basement storage room, which is currently not being accessed, was discussed as a potential location that would be undisturbed and would facilitate a concrete surface for sub-slab penetration with minimal impact to the building.

Tile floor in the hallway was suggested to potentially contain asbestos. The basement restrooms are on an elevated slab and contain tile floors. The basement rooms on the north and south sides of the hallway are primarily used for storage or as classrooms. All storage rooms have carpeted floors. None are currently in use. Some basic sanitizing chemicals were seen in storage rooms.

At the eastern end of the basement, the nursery room has a closet space containing cleaning and sanitation products. A hand-written note in the room recommended not to drill in the walls because of the potential for asbestos; this was mentioned in 2009 when the water pipes in the walls were replaced.

The area outside of the nursery room has a storage closet with a sink containing cleaning chemicals and used or unused painting products. The specific paint brands contain volatile organic compounds (VOCs). South of the nursery room is the boiler room, a concrete room at the lowest grade in the basement. The room contained a floor drain that appeared to be rusted. Petroleum-based lubricants and chemicals were observed.

South of the boiler room is the Sexton's office, which contained most of the cleaning and maintenance equipment. VOC-containing products including aerosols, graffiti removal products, paint products, petroleum products, and other chemicals were shelved in the Sexton's office.

Sub-Slab and Interior Air Location: Northwest basement, basic storage room farthest away from any chemical storage. Currently not being accessed, allows for undisturbed samples. Concrete floor allows sub-slab penetration, no damage to carpet or tile, and has electricity for equipment and space for an indoor air sample. The main hallway has tile that “may have asbestos” and the other rooms are carpeted or tiled. If a central location is required, cutting through carpet would be necessary. While the boiler room concrete floor is at a slightly lower elevation, it was not selected due to proximity to petroleum products, the relatively large chemical storage room to the south in the Sexton’s office, and storage of VOCs to the north in the janitor’s closet and nursery closet.

Exterior Shallow Soil Boring Location: Garden bed as depicted in Figure 2. There is a space about 10 feet south of the northwest corner of the property where 3 to 4 feet of garden soil is exposed and mostly clear of vegetation.

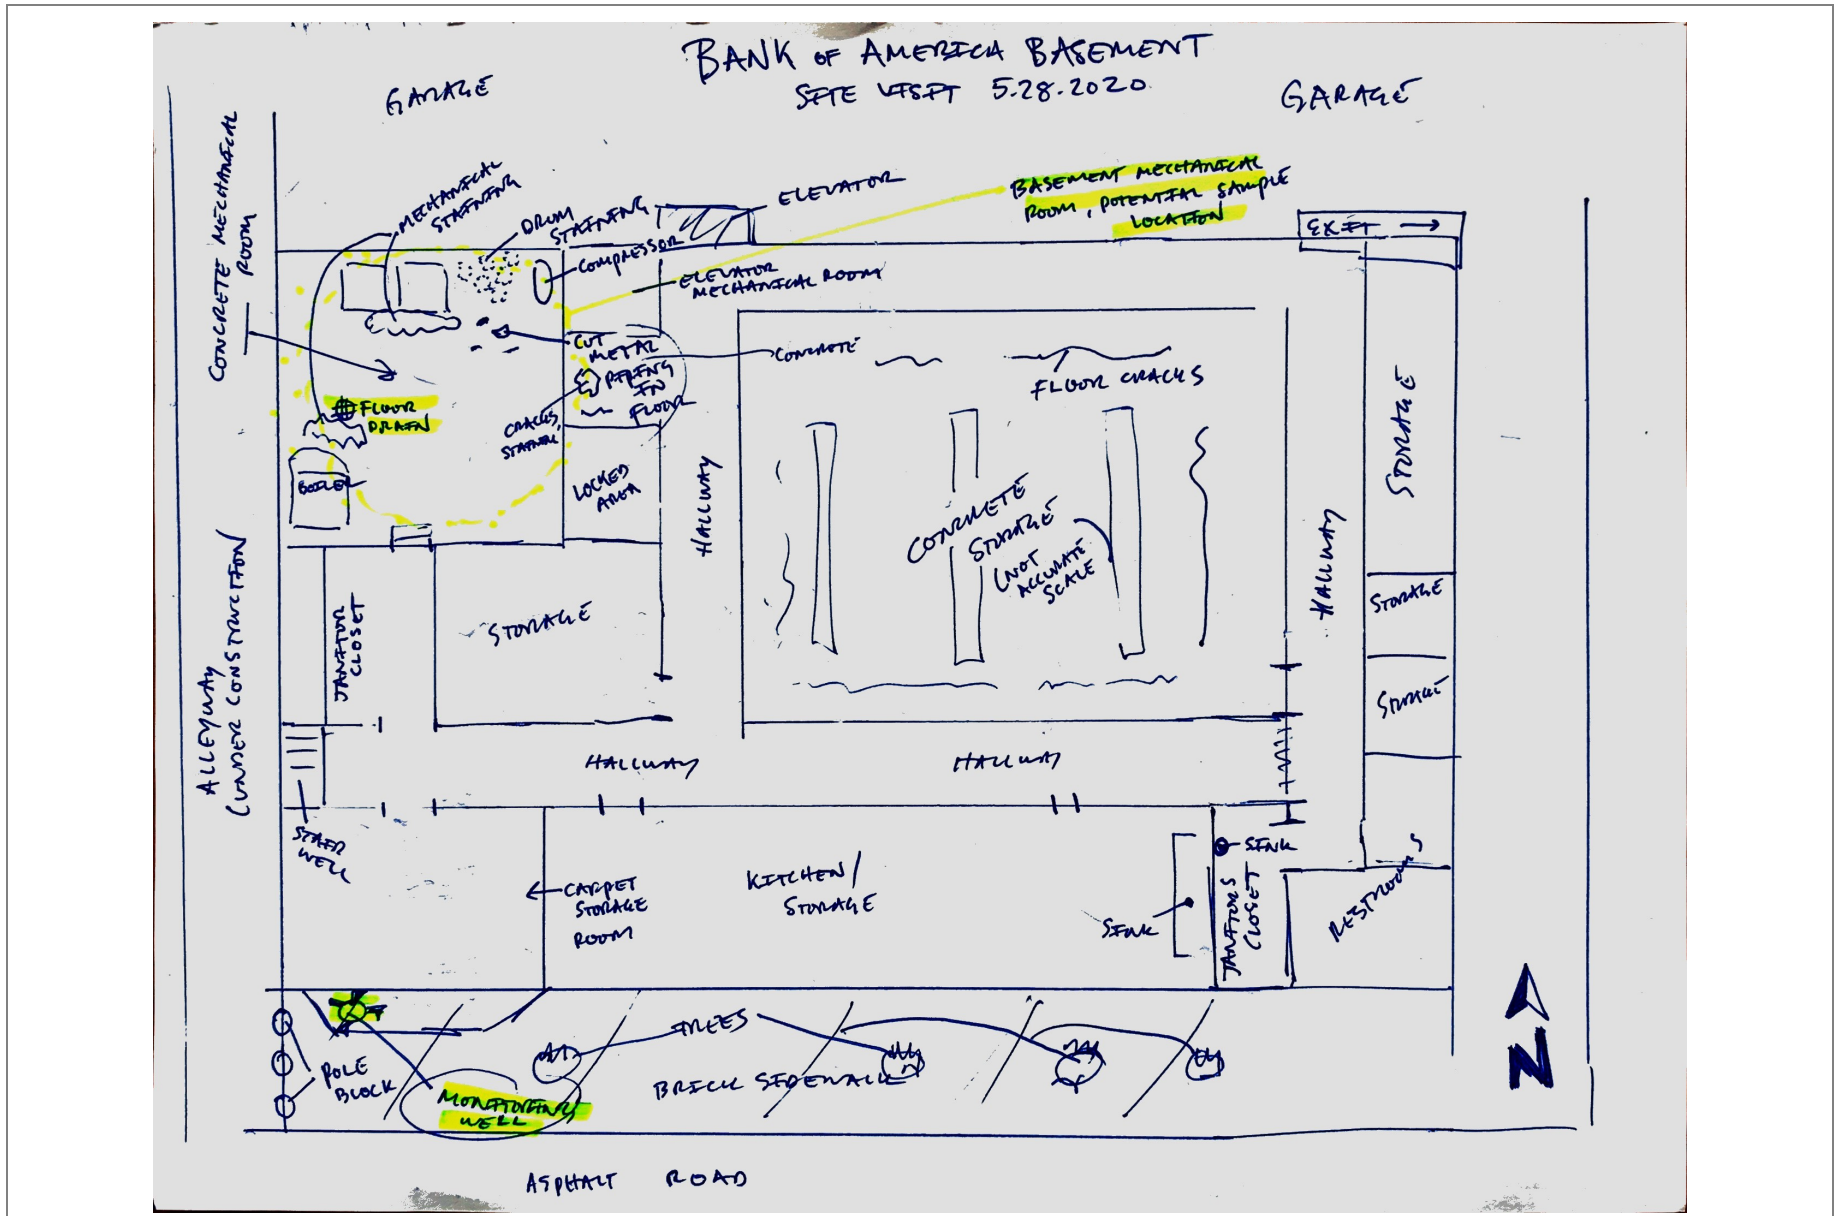
Figure 3
Bank of America Financial Center
VI Evaluation Work Plan

Anchor QEA staff met on the ground floor and were guided through the building, starting on the west side of the basement floor and moving east. A floorplan sketch of the financial center basement is provided in Figure 3. A stairwell is located at the westernmost point of the basement that connects to the main floor. In the northwest corner of the basement is the boiler and mechanical room. The room is concrete and graded about 2 feet below the basement floor. A compressor is present in the northeast corner of the room, with petroleum-based chemicals near it. Adjacent to the compressor are circular rust stains, potentially from 55-gallon drum storage. Near the drum storage was a small metal pipe, extending from the concrete floor, and cut about 1 inch above floor surface. No odors were observed near the exposed pipe. Several cracks were observed in the flooring. Mechanical staining was observed on the floor near a floor drain.

Exiting the boiler room to the south is a janitorial room with cleaning products including paints. To the east of the janitorial room is a locked storage area. Moving south from the janitorial room is the hallway extending to the east. Directly south of the janitor's closet, across the hallway, is a storage room with carpeted floors. To the east of the storage room is a larger carpeted room that has a kitchen area with a sink on the east side, and storage in the rest of the room. This kitchen area is accessed by employees and therefore an appropriate location for indoor air sampling.

Moving farther south in the basement is a janitorial closet, used for maintenance supplies and containing various cleaners and chemicals, as well as a sink. Outside the southeast janitorial closet, the hallway leads north. The rooms on the east side of the hallway are mostly used for storage, including one room with a sleeping cot, and another with primarily empty shelves. To the west of the hallway is a large storage room, with a concrete floor that has some visible floor cracks. Some paints are stored in this room. In the northeast corner of the basement is an exit that leads upstairs to the east. The hallway leads west toward the elevator, and adjacent to the elevator is the elevator mechanical room. The mechanical room has a concrete floor that is slightly abraded. A petroleum

odor was observed in the mechanical room, and petroleum-impacted rags were disposed in a cardboard box. A 5-gallon bucket of hydraulic oil was observed.

Indoor Air Location: Kitchen/storage area. While the boiler room is the lowest level of the building in the northwest corner, there are floor drains, previous drum storage staining, and cracks in the floor. Given the presence of fuel and indications of staining, we do not recommend sampling the boiler room. However, the kitchen/storage area for employees would be an appropriate location to obtain a representative sample of air conditions in a working area. The kitchen/storage area is distant from both janitorial closets and has few products that could cause sample interference. The area would allow for monitoring when the bank is closed.

Exterior Shallow Soil Boring Location: Alley. The alley appears be the best location for the boring. The entire front of the building is brick and has trees. A monitoring well is in the garden area to the southwest. Barriers separate the alley sidewalk to the bank sidewalk. The alley currently hosts construction workers for the building to the west (former Chevron).

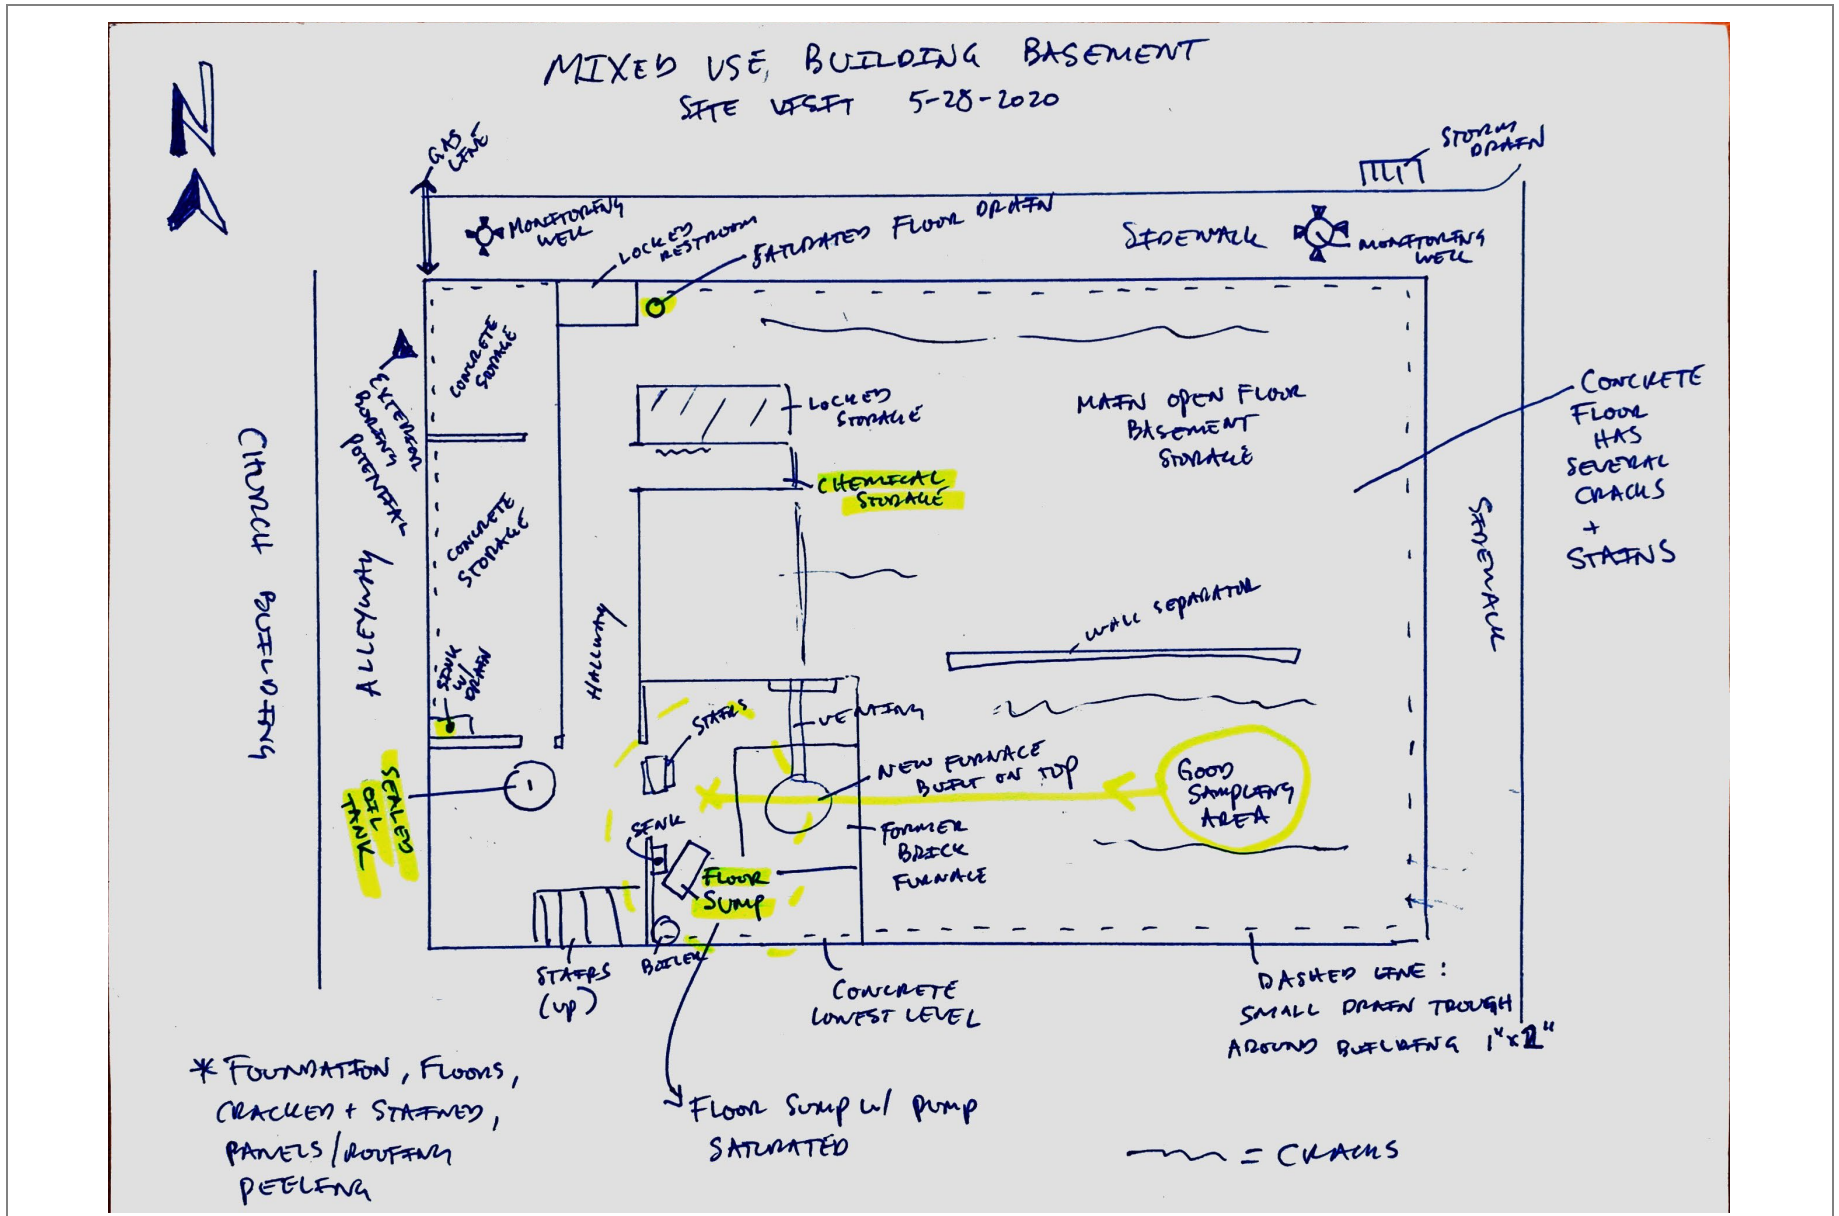
Figure 4
Mixed Commercial and Residential Building
VI Evaluation Work Plan

Anchor QEA staff met outside of the building and were guided through the building starting on the west side of the basement floor and moving east and back. Discussion with the property owner revealed the building is over 100 years old. A floorplan sketch of the building's basement is provided in Figure 4. The entire basement is concrete flooring. In the southwest corner of the basement, a sealed oil tank cap was observed. An oil tank was discussed as potentially connecting to the former brick furnace. The owner believes the oil tank was not removed and likely just sealed in place. North of the sealed oil tank cap are storage rooms. The most northwest corner is storage, and the storage room to the south contains a sink with a drain.

To the east of the oil tank cap, there is a boiler room approximately 2 to 3 feet below basement grade. The boiler room contains the former brick furnace, altered with venting for the current furnace system. The boiler is in the southwest corner of this room. On the floor is a sump, which was saturated, covered with plastic, adjacent to a sink.

Exiting the boiler room, a hallway leads north. Paints were stored in the hallway. On the east side of the hallway is a narrow chemical storage room with paints, lubricants, petroleum-based chemicals,

aerosols, graffiti removal tools, maintenance equipment, and tools. Several of the chemicals contain VOCs. To the north is a locked restroom no longer in use. To the east of the locked restroom we observed a saturated floor drain with no cover. An approximately 3-inch-wide trough runs along the entire edge of the basement footprint and is used to drain water accumulation. The entire east side of the basement is an open floor with various storage. The concrete floor has several cracks and stains. Most of the ceiling in the basement was significantly worn.

Sub-Slab and Interior Air Location: Boiler room. The concrete is at its lowest level in the boiler room. There is a floor sump with a pump cut into the floor where the sub-slab boring will be drilled. The indoor summa canister can be placed on the sink or shelf.

Exterior Shallow Soil Boring Location: Northern end of the alley, depending on the utilities located. There are two monitoring wells installed on the northern sidewalk: one on the northwest corner in front of the apartment entrance, and one to the northeast. This area is heavily trafficked. However, the alley separating the church and mixed-use building has low traffic and allows an exterior sample between two of the Subject Properties.

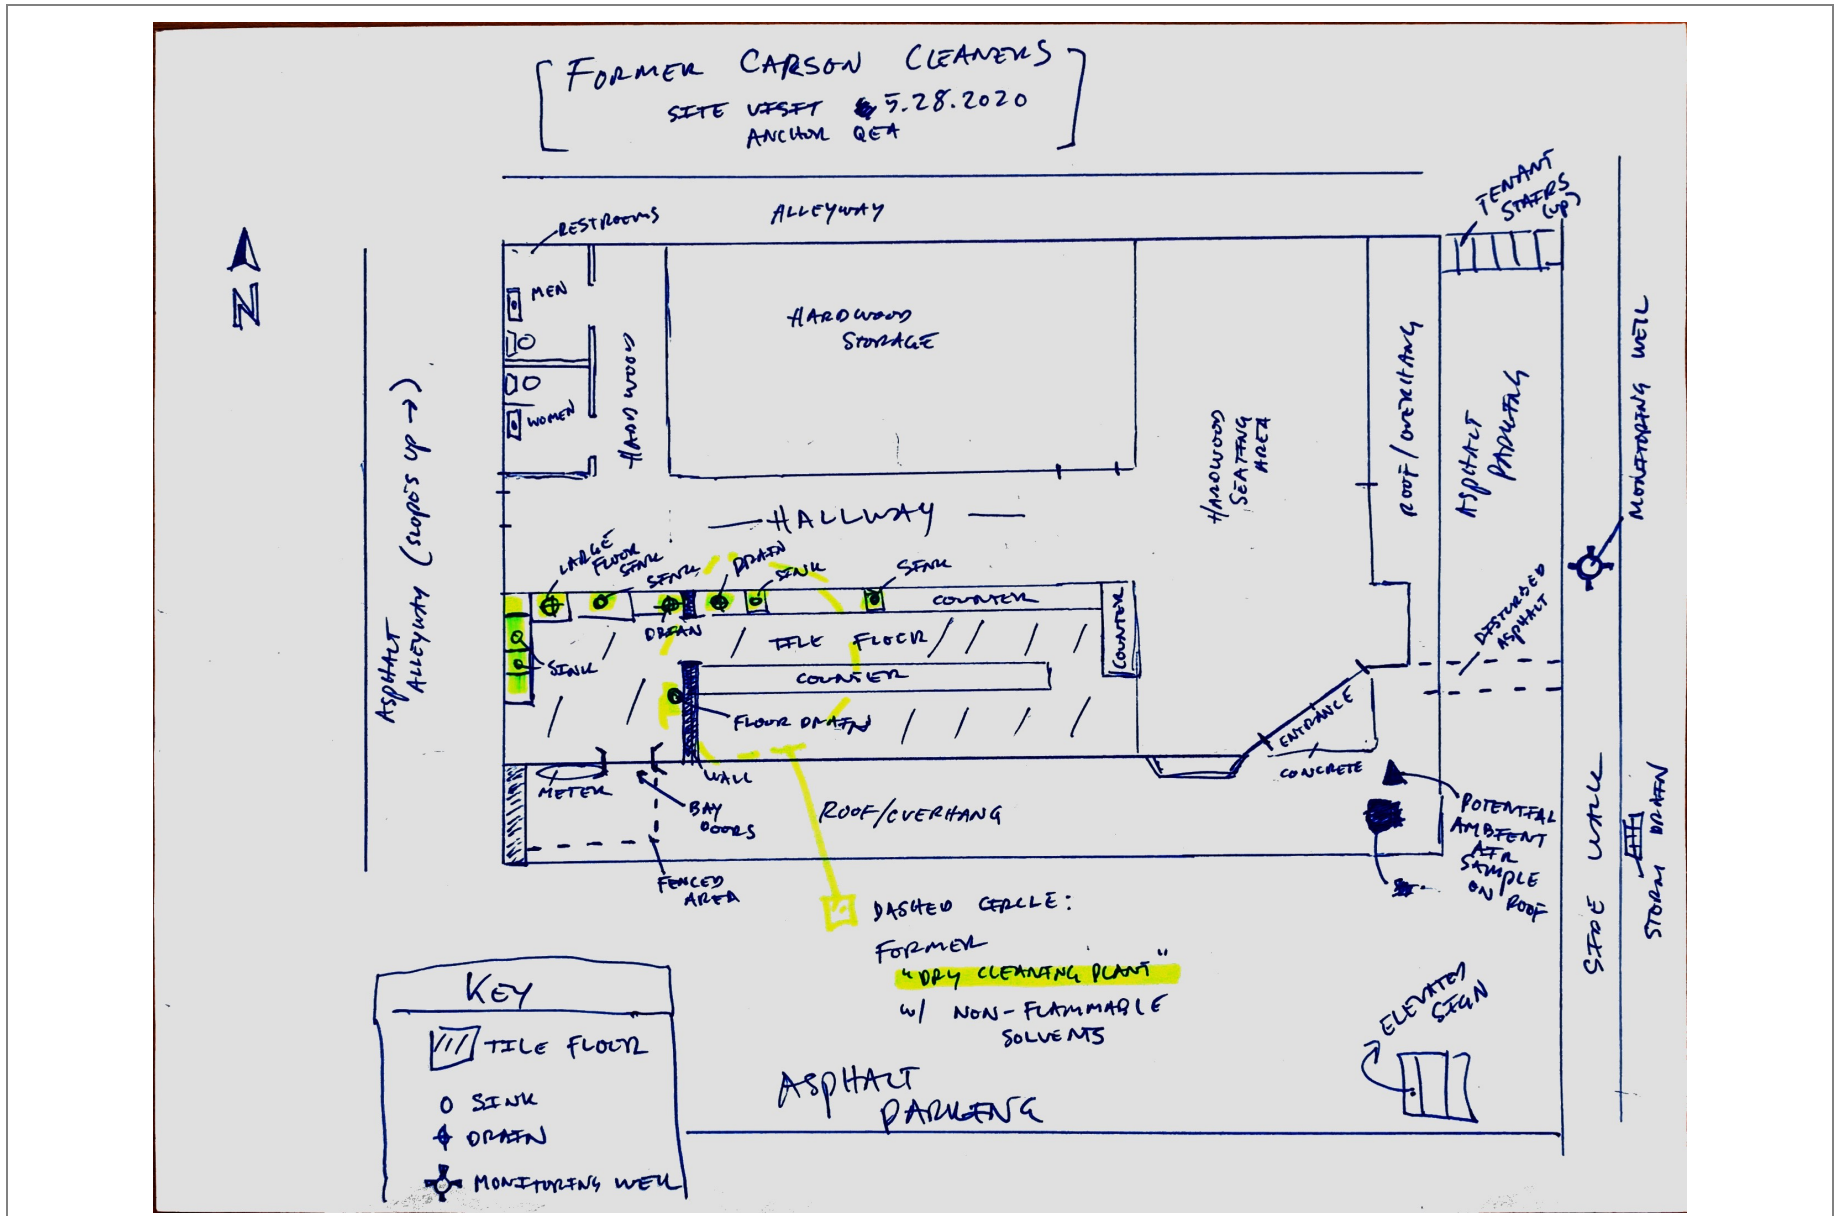
Figure 5
Former Carson Cleaners
VI Evaluation Work Plan

Anchor QEA staff met on the interior of the former Carson Cleaners building. A floor plan sketch is provided in Figure 5. We walked through the main storage areas and continued into the kitchen. The building looked recently renovated. No past use as a dry cleaner was observed. The entrance has an open wood floor used as a seating area with chairs and tables. A hallway leads to the west. At the end of the hallway are two restrooms. The northern storage room has wood floors and desks and a wall-mounted air conditioner. The kitchen area is tiled and spans most of the southern to southwest side of the building. Several sinks and floor drains were observed. Only basic cleaning and sanitation products were observed. Based on the historic floor plan, the kitchen area is located where the dry cleaning operation formerly took place.

We proceeded on to the exterior of the building and alleys. Outside of the entrance on the southeast corner of the building is an approximately 2-foot-wide area of disturbed asphalt leading east to the sidewalk. Several feet away to the northeast a monitoring well is located in the sidewalk. To the north of the property are the gated stairs to the apartments above the building. Surrounding the building to the east and south is an asphalt parking area. In the southeast corner is an elevated pole with a sign. On the southwest exterior of the building is a gated area with an electrical meter. Several used hypodermic needles and trash were observed in this area. An asphalt alley slopes up to the north on the west side of the building. A concrete alley runs east-west on the north side of the building.

Sub-Slab and Interior Air Location: Kitchen. The interior air sample can be placed on a countertop in the kitchen area. The sub-slab boring location can be in the southwest kitchen in the area of the former dry cleaning operations. The sub-slab boring would be installed through tile and would likely need professional repair.

Exterior Boring: Parking lot. For an exterior boring, the asphalt parking lot surrounding the property provides a large footprint for sampling. After utilities are marked, the sign in the southeast corner needs to be avoided due to overhead hazard. The exterior boring will ideally be placed in the southeast region of the asphalt parking area near the sign, allowing distance from the monitoring well on the eastern sidewalk.

Ambient Air Sample: Storefront. The roof or overhang of the storefront would be good for an ambient air sample to remain undisturbed. Tenant stairs are located nearby. Access would need to be granted, or a ladder can be used.
