TECHNICAL MEMORANDUM

To: Jim Carsner, PWS, U.S. Army Corps of Engineers Date: December 16, 2020
From: Phil Wiescher, PhD and Curtis Riley, RLA Project: NWS-2013-1209
RE: Port of Ridgefield Carty Lake Remedial Action (NWS-2013-1209) Year 5 (2020) Vegetation Monitoring

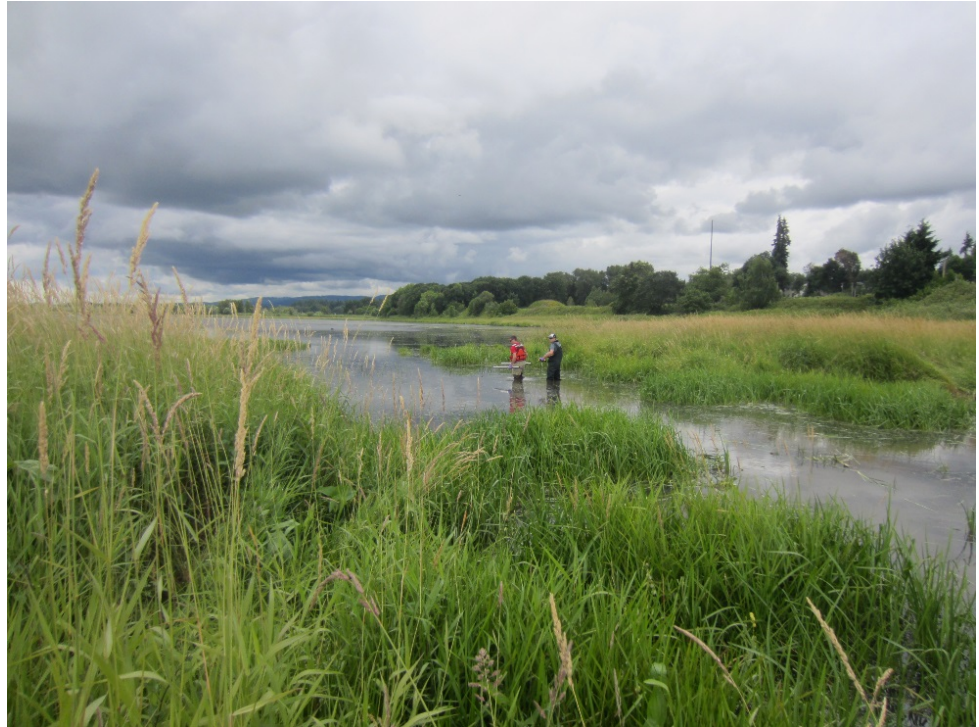
Photo No. 1.

Fall 2013.
Mitigation area
before
remediation.
Reed canary grass
is dominant
vegetation.
Looking
northeast.

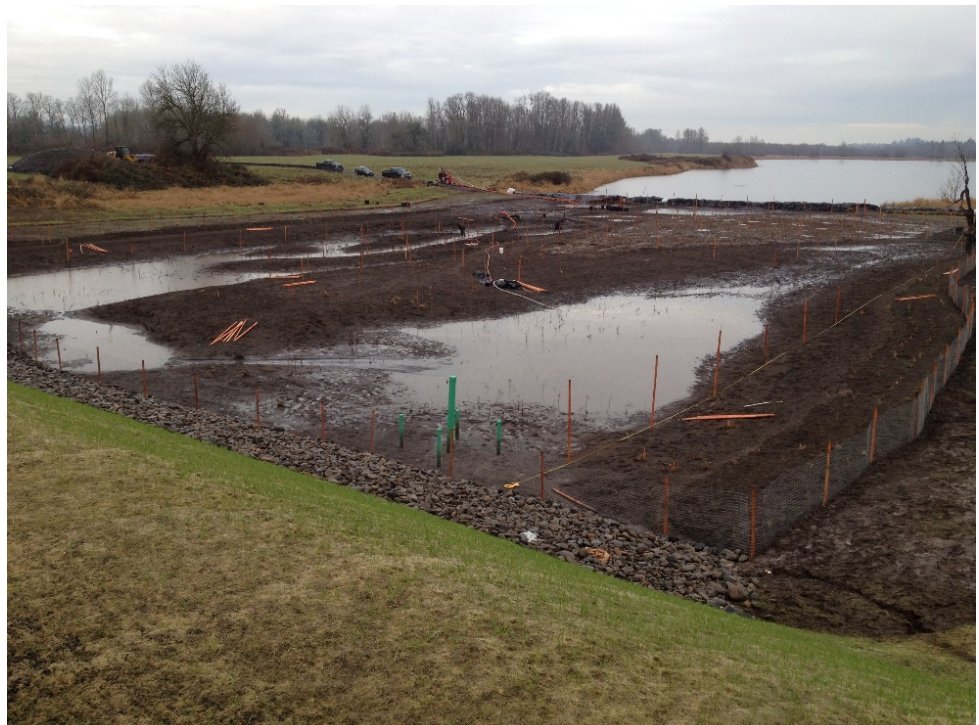
Photo No. 2.

Winter 2014/15.
Remediation area
before plantings
and temporary
dam removal.
Wildlife fencing
installed.
Looking
northwest.

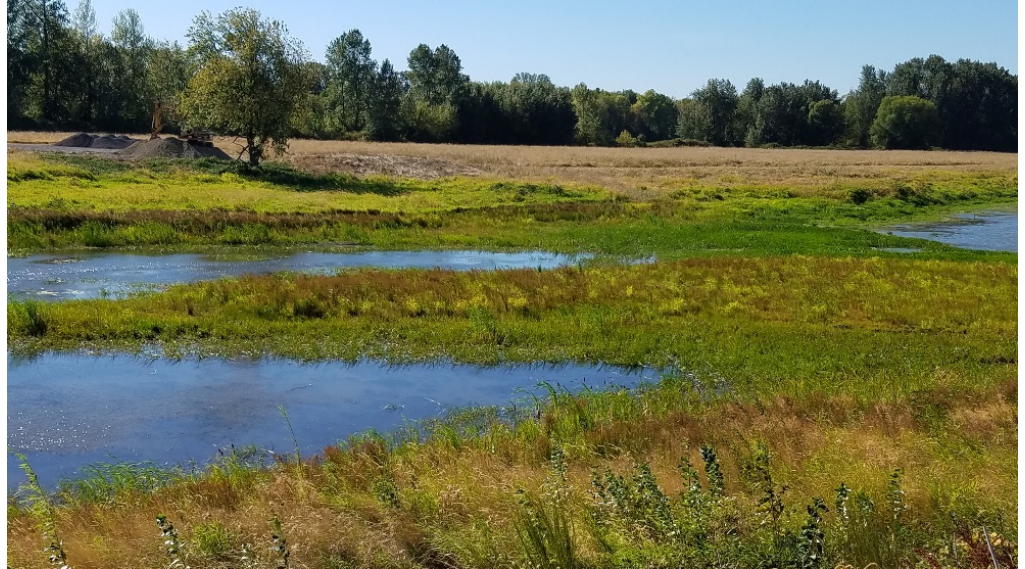
Photo No. 3.

August 2016.
Mitigation area.
Looking west.

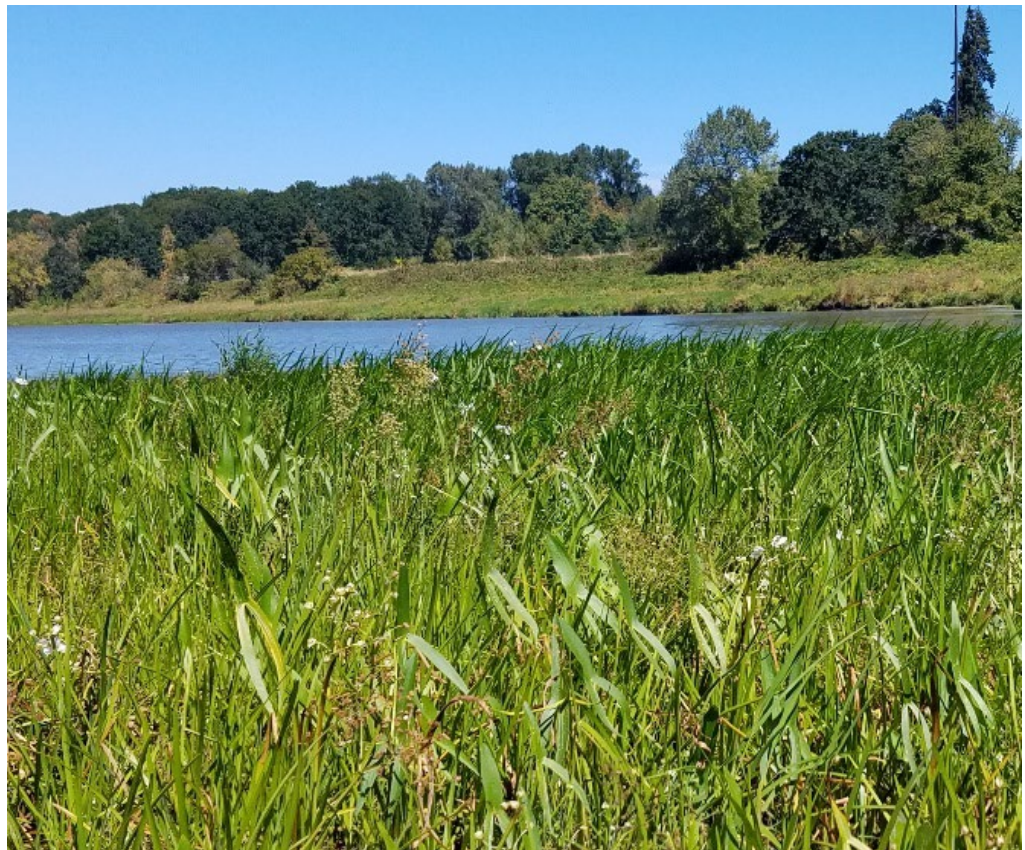
Photo No. 4.

August 2016.
Mitigation area.
Flowering
wapato and bur-
reed. Looking
northeast.

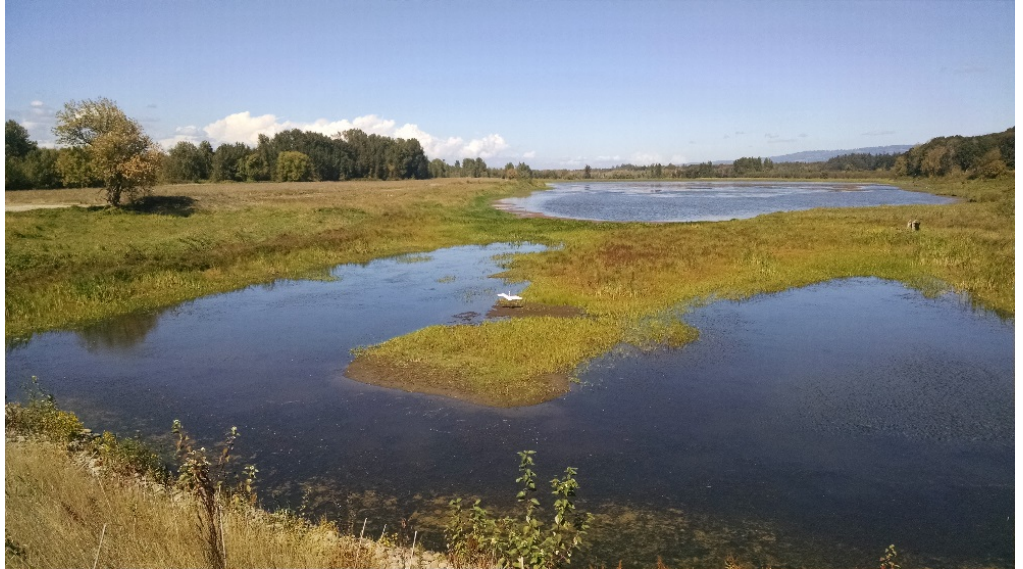
Photo No. 5.

August 2016.
South end of
mitigation area.
Looking north.

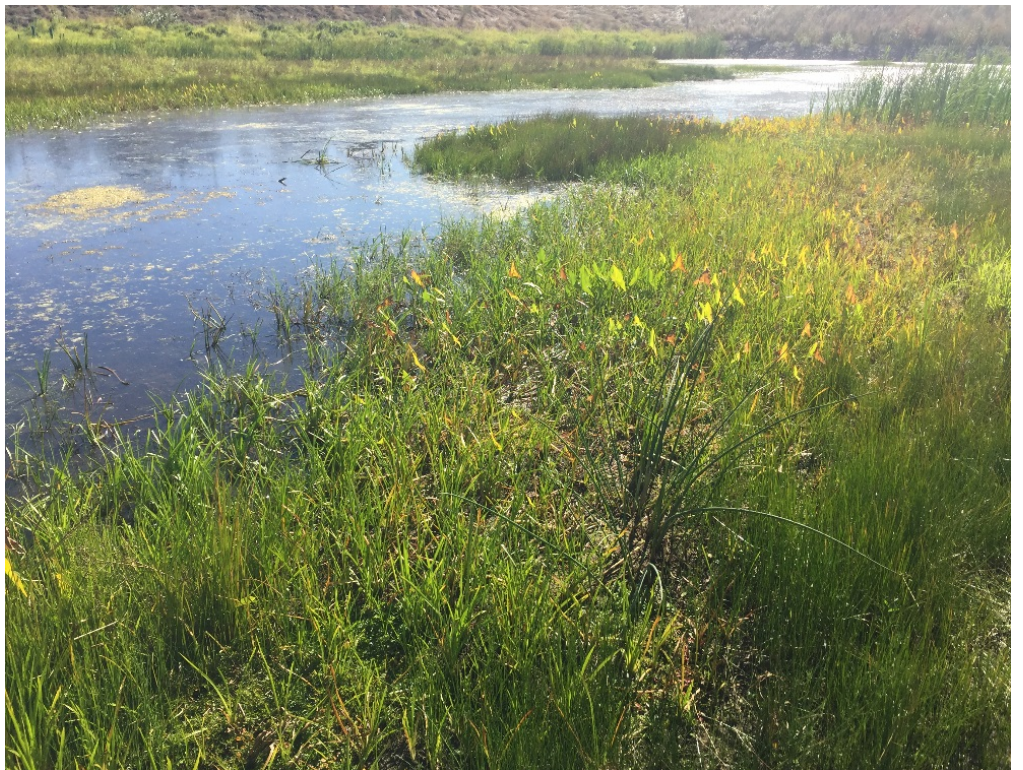
Photo No. 6.

September 2017.
North end of
mitigation area.
Looking
southeast.

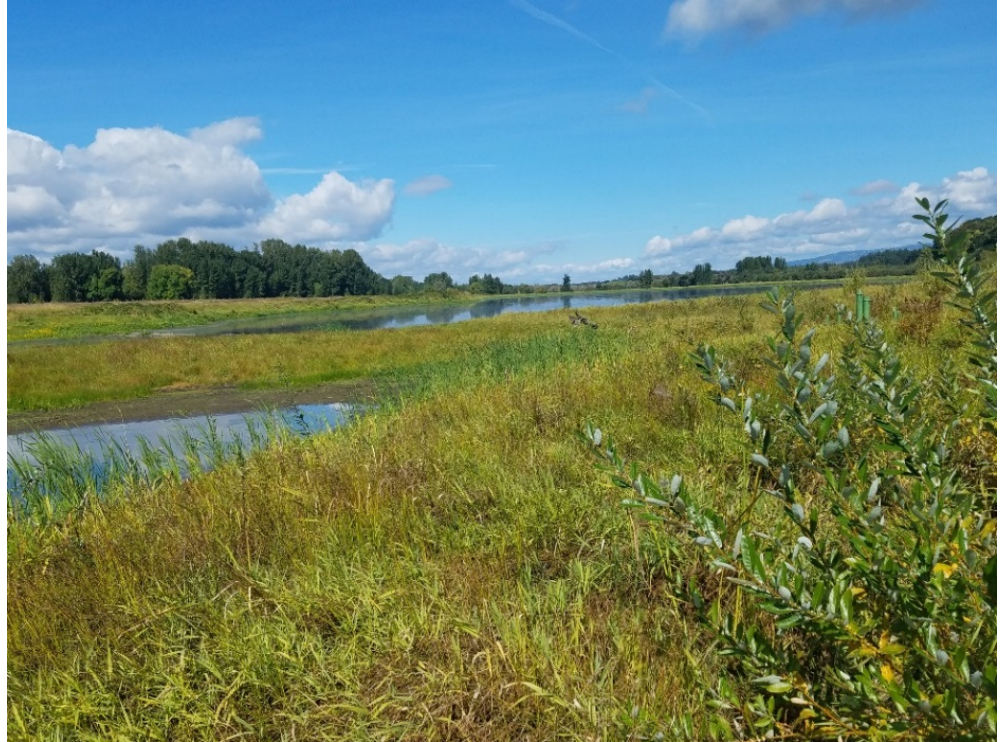
Photo No. 7.

September 2018.
East end of
mitigation area.
Looking
northwest.

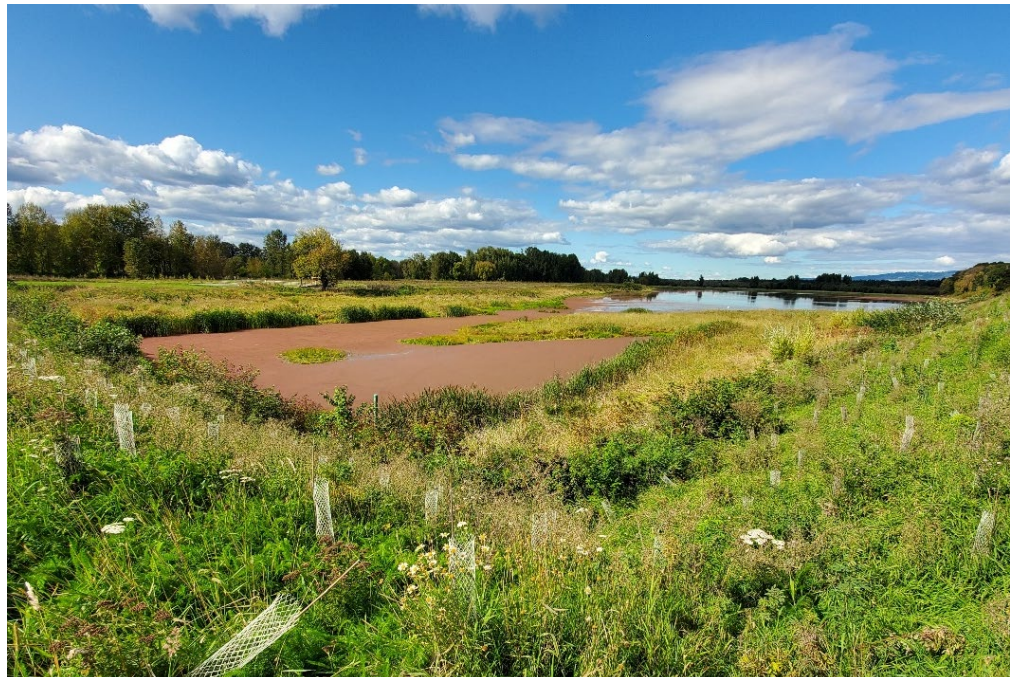
Photo No. 8.

September 2019.
Southeast end of
mitigation area.
Looking
northwest.

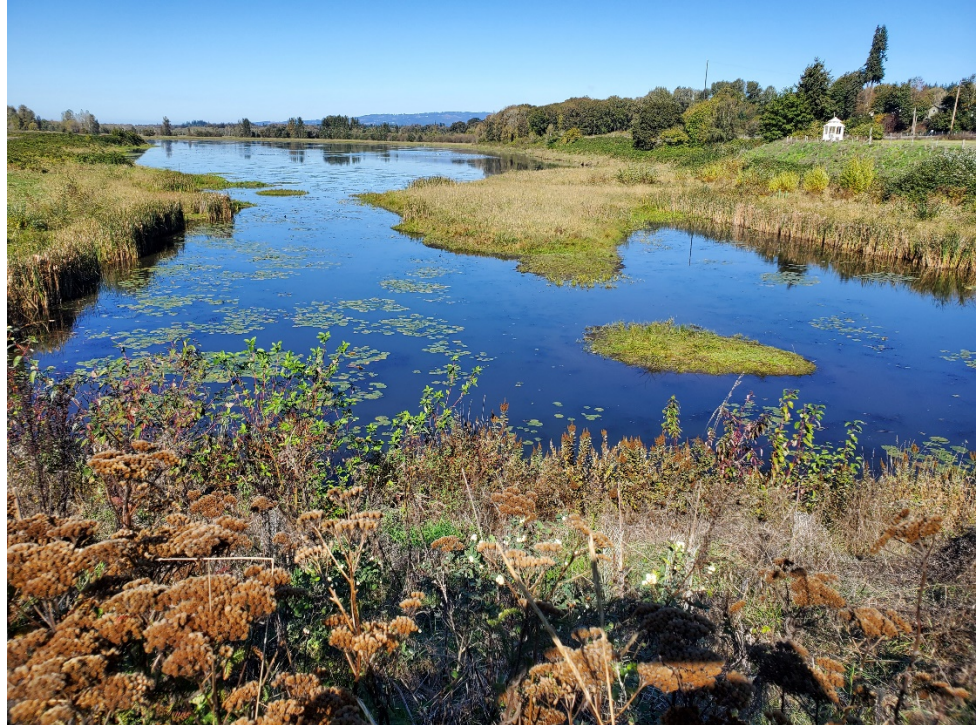
Photo No. 9.

October 2020.
South end of mitigation area, looking north.

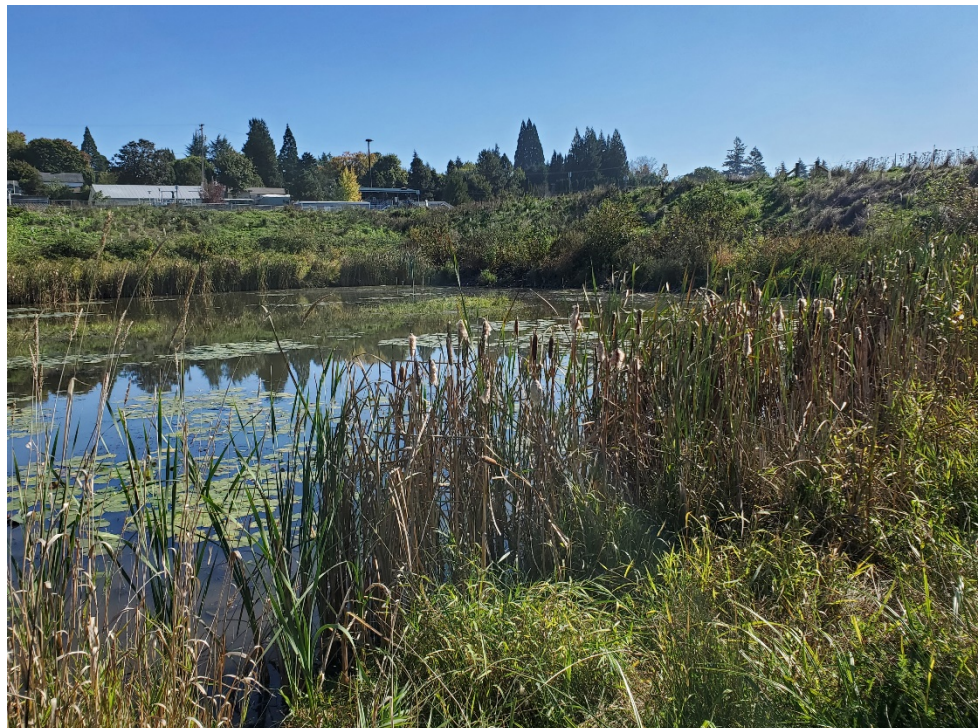
Photo No. 10.

October 2020.
Northwest end of mitigation area, looking southeast.

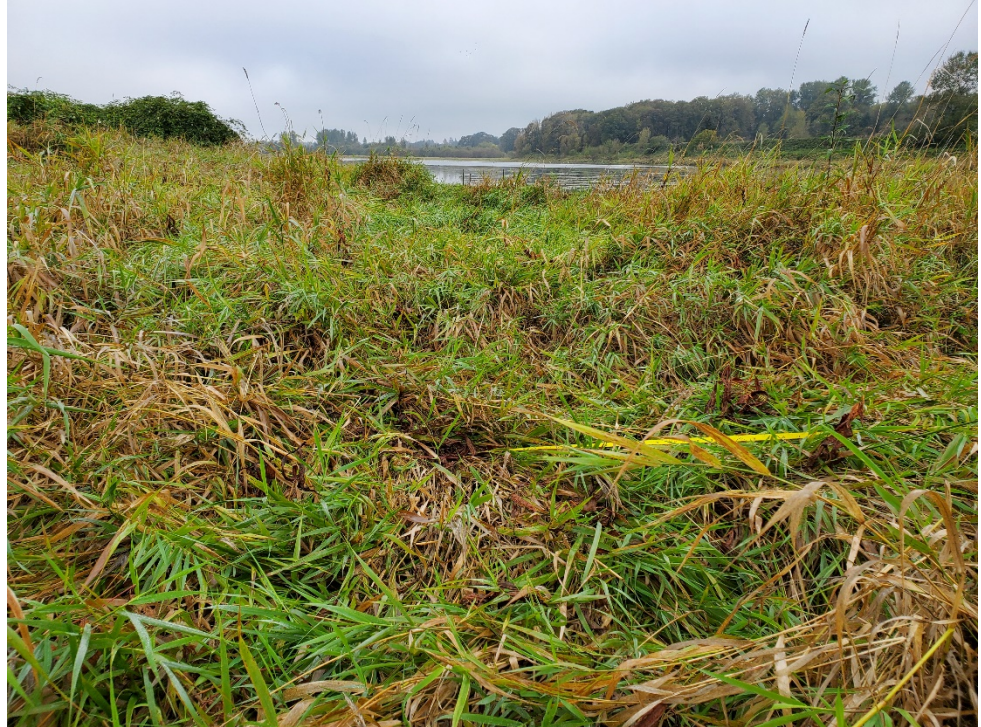
Photo No. 11.

October 2020.
Photo point C1.
Marginal zone.
Waterpepper,
bird's foot, and
reed canary grass
observed in
vicinity.

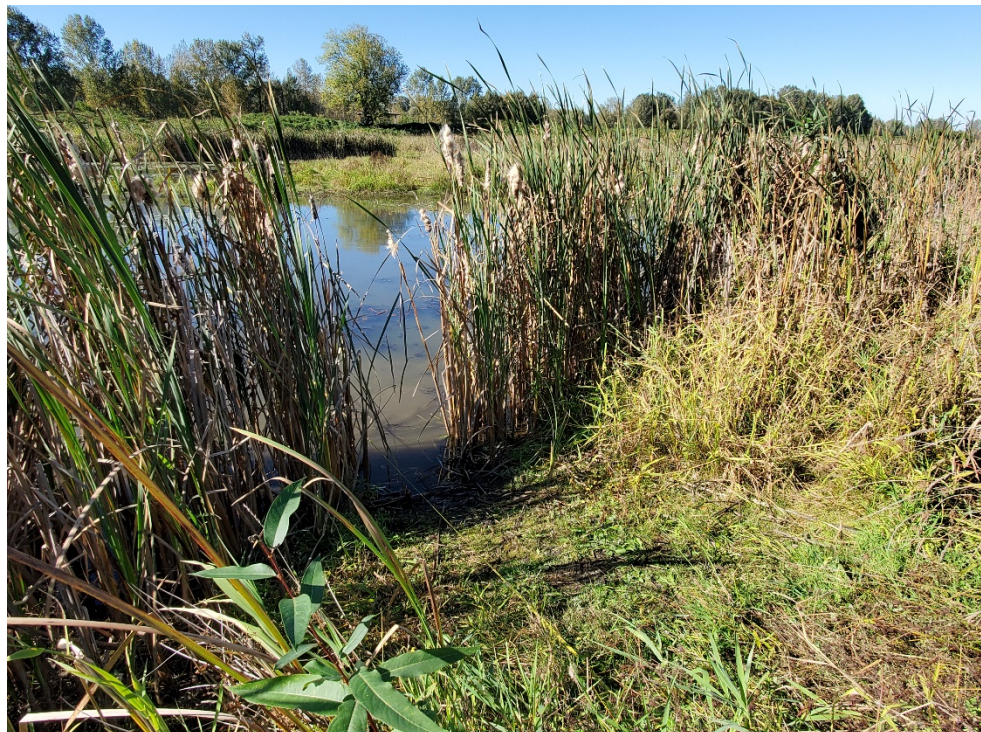
Photo No. 12.

October 2020.
Photo point B18.
Marginal zone.
Spikerush, *Juncus*
species, cattail,
bird's foot,
waterpepper,
willow species,
and reed canary
grass observed in
vicinity.

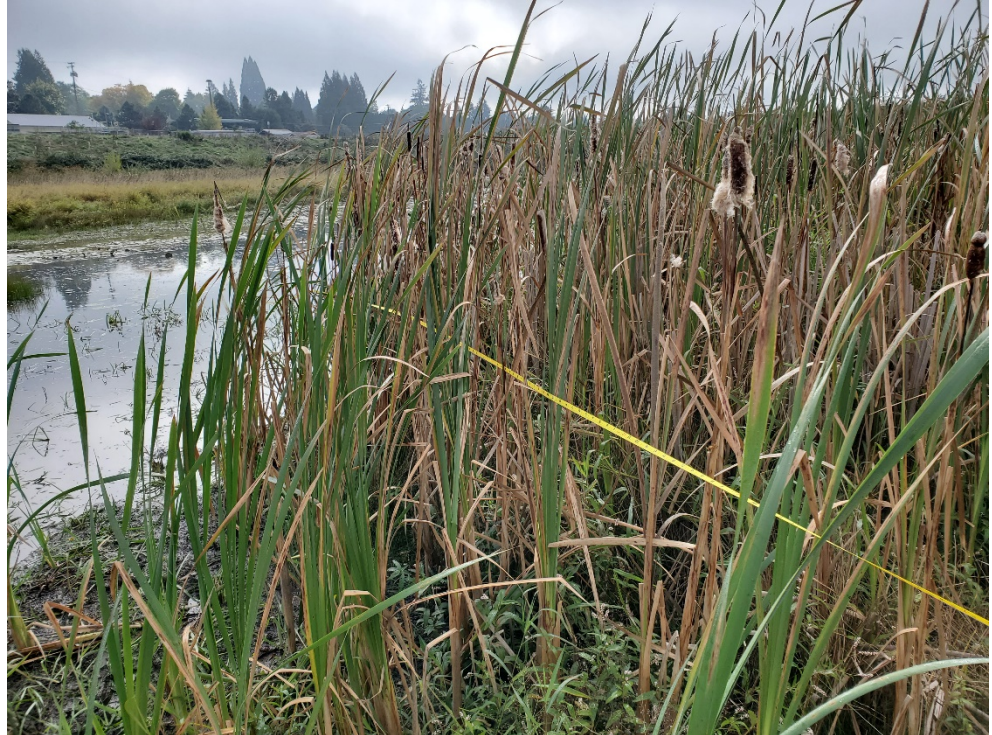
Photo No. 13.

October 2020.
Photo point C5.
Emergent zone.
American water
plantain, bur-
reed,
waterpepper,
nodding
beggartick,
cattail, spikerush,
and reed canary
grass observed in
vicinity.

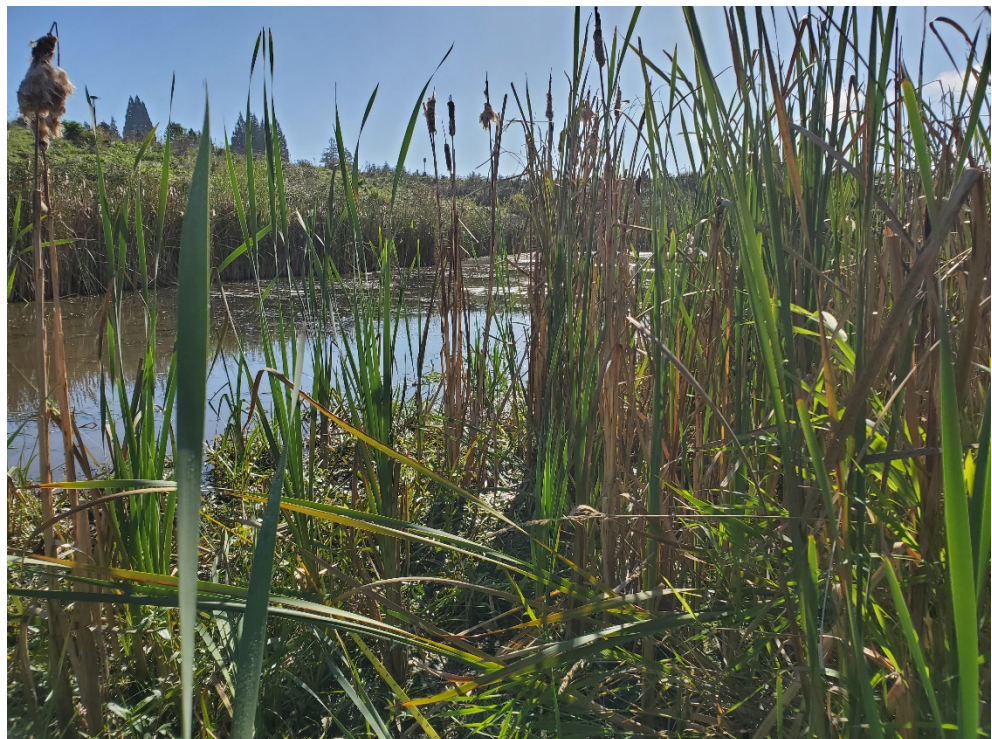
Photo No. 14.

October 2020.
Photo point C15.
Emergent zone.
Spikerush, bur-
reed, wapato,
cattail,
waterpepper, and
reed canary grass
observed in
vicinity.

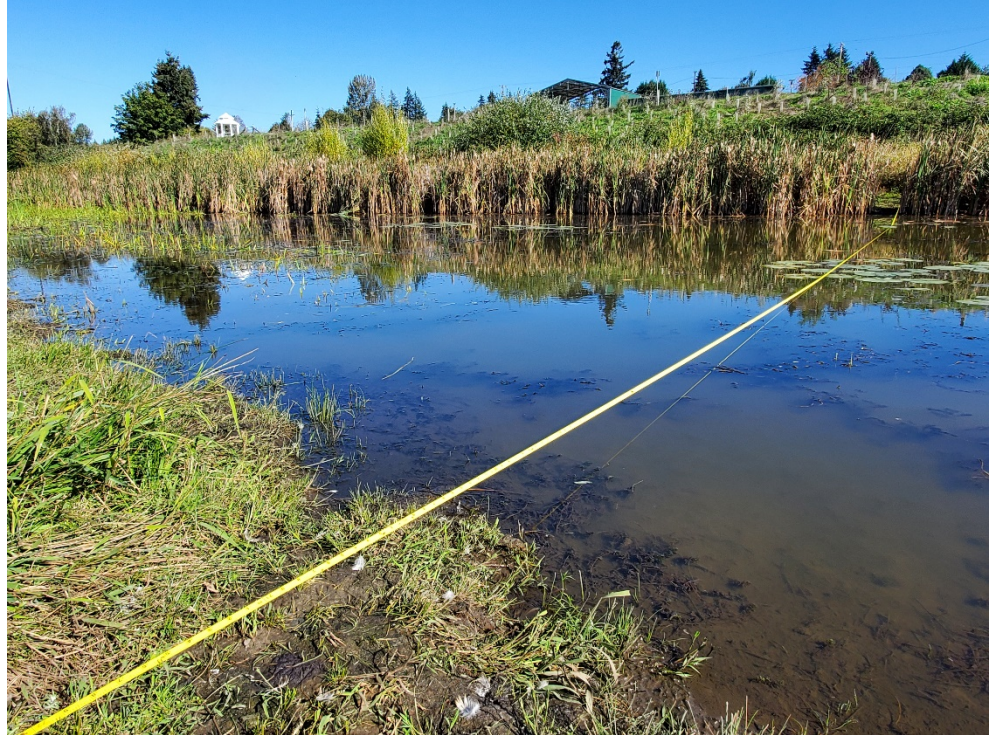
Photo No. 15.

October 2020.
Photo point B11.
Emergent zone.
Spikerush, bur-
reed,
waterpepper, and
reed canary grass
observed in
vicinity.

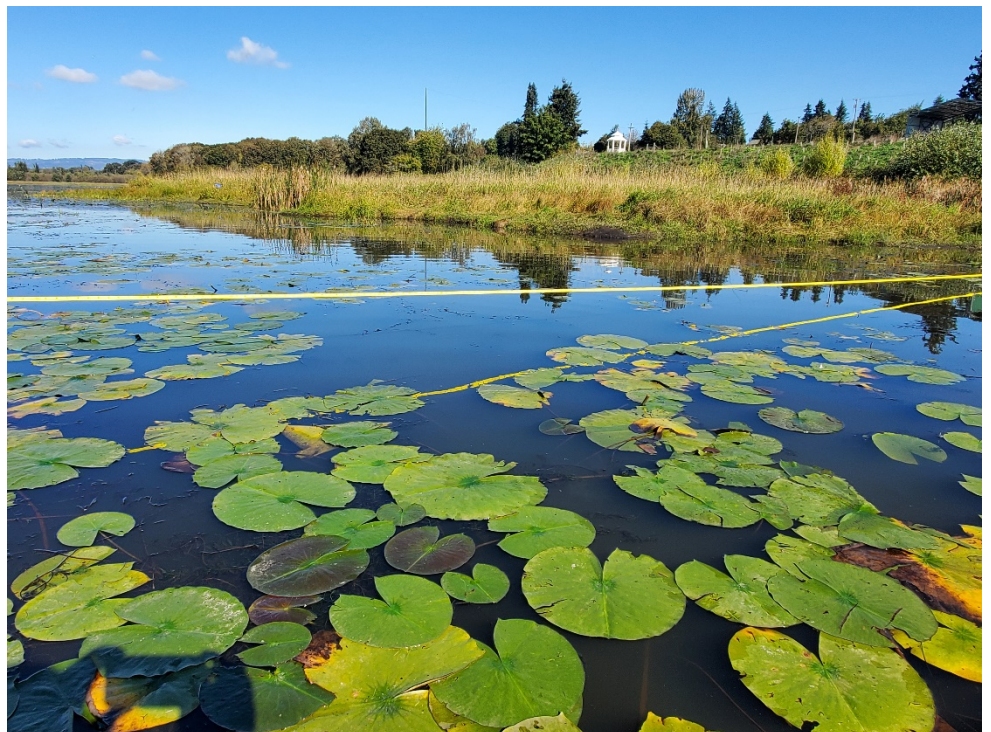
Photo No. 16.

Areal cover for transects A (100 percent), B (100 percent), and C (100 percent) are above 20 percent for invasive species, and the performance standard is not met at this time. This is due primarily to the

presence of the pondweed Eurasian milfoil, which has encroached from Carty Lake to the north of the mitigation area, as noted during prior monitoring efforts (MFA, 2018). Eurasian milfoil is a common invasive present in much of the RNWR and was observed in Carty Lake immediately north of the mitigation area; current USFWS budgets and staffing levels do not allow treatment of enough acreage to control spreading of invasives such as milfoil (USFWS, 2010). Eurasian milfoil can be controlled by raking or seining it from the water, but it can reestablish from any remaining fragments and roots, and these activities themselves can lead to further spreading. Chemical controls can be effective, but their use would require coordination with the USFWS and evaluation of the potential for associated impacts (e.g., oxygen depletion after decomposition of the dead plant material). In both cases, it is extremely likely that milfoil would reestablish quickly because of its presence throughout the RNWR and in Carty Lake.

October 2020.
Photo point B5.
Submergent
zone. Water lily,
Canadian
waterweed,
duckweed, and
Eurasian
watermilfoil.

MFA continues to recommend not removing milfoil, as this would, at best, result in temporary, short-term improvement at significant effort and cost.

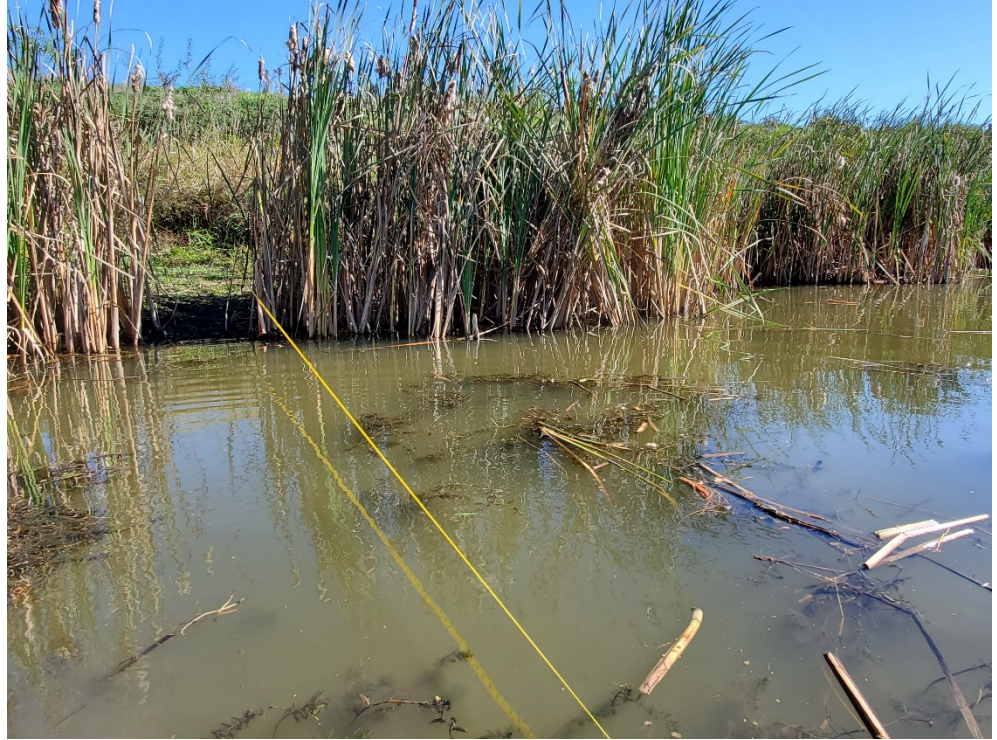
Photo No. 17.

October 2020.
Photo point B16.
Submergent zone. Mexican water fern, Canadian waterweed, duckweed, and Eurasian watermilfoil.

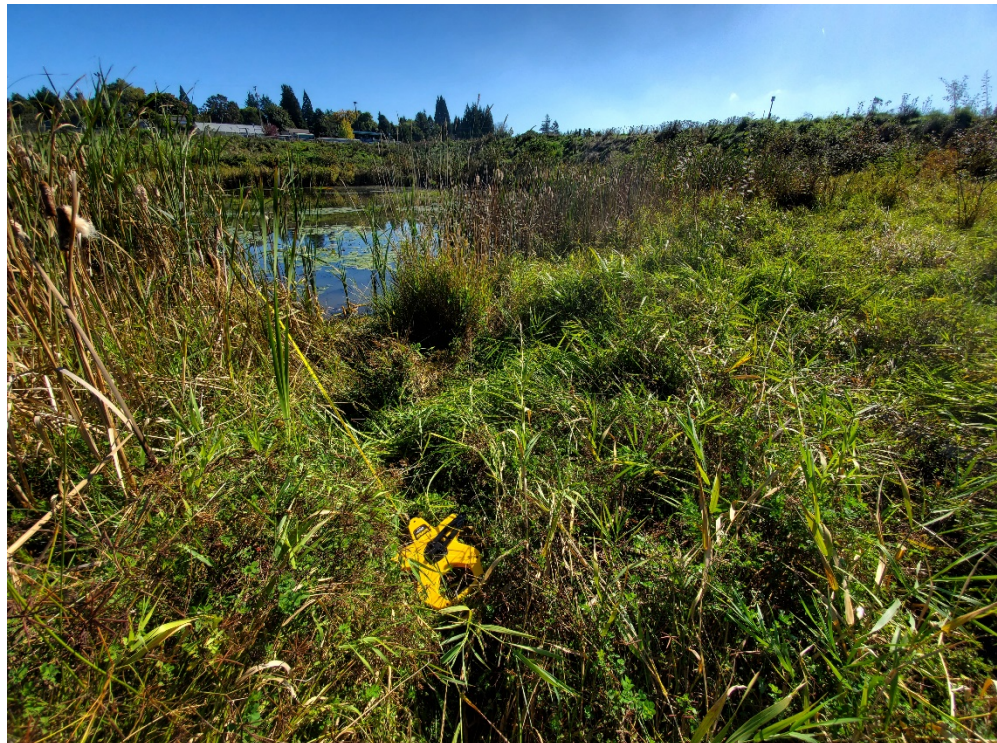
Photo No. 18.

October 2020.
Photo point B1.
Marginal zone. *Juncus* species, cattail, willow species, and reed canary grass observed in vicinity.

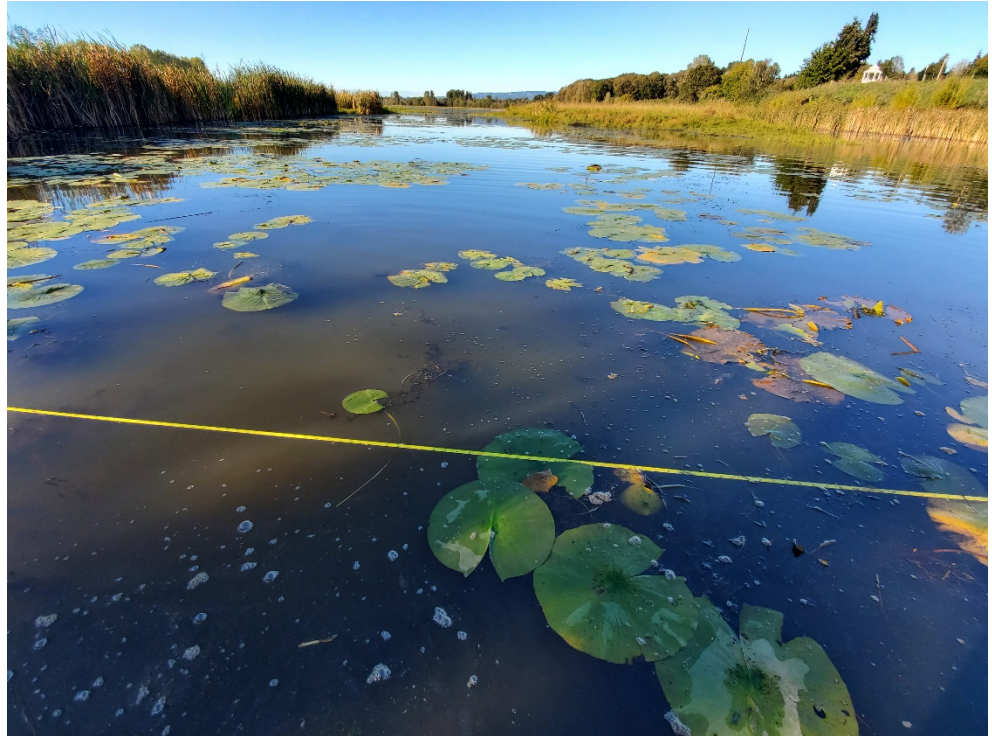
Photo No. 19.

October 2020.
Photo point A5.
Submergent
zone. Water lily,
Canadian
waterweed,
duckweed, and
Eurasian
watermilfoil.
