## TECHNICAL MEMORANDUM

RE: Port of Ridgefield Lake River Remedial Action (NWS-2013-875) Year 5 (2020) Vegetation Monitoring

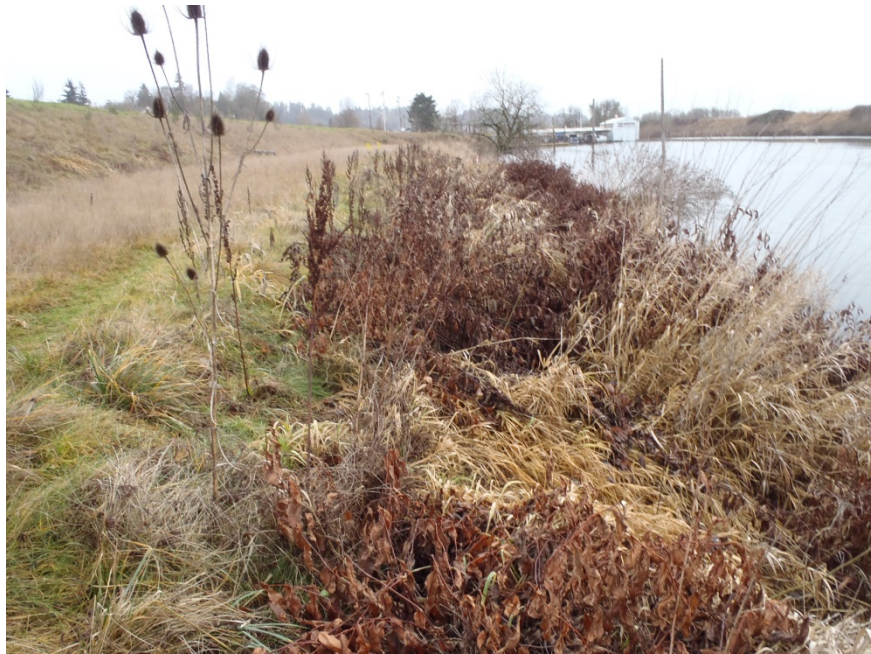
### Photo No. 2.

Winter 2013/4. Cell  
3 shoreline prior to  
remediation.  
Knotweed, reed  
canary grass, and  
thistle. Looking  
south.

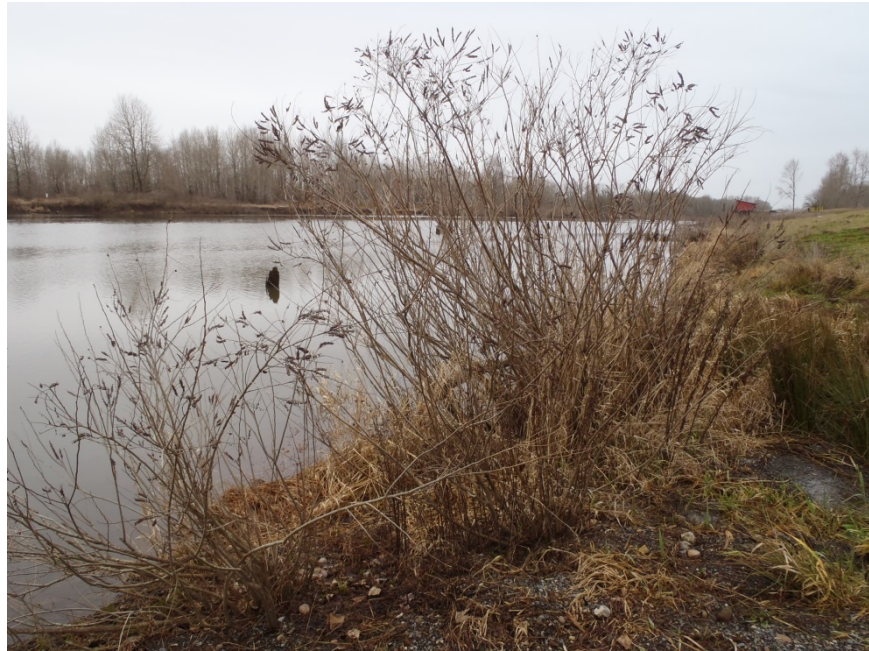
### **Photo No. 3.**

Winter 2013/4. Cell 2 shoreline prior to remediation. False indigo bush and reed canary grass. Looking north.

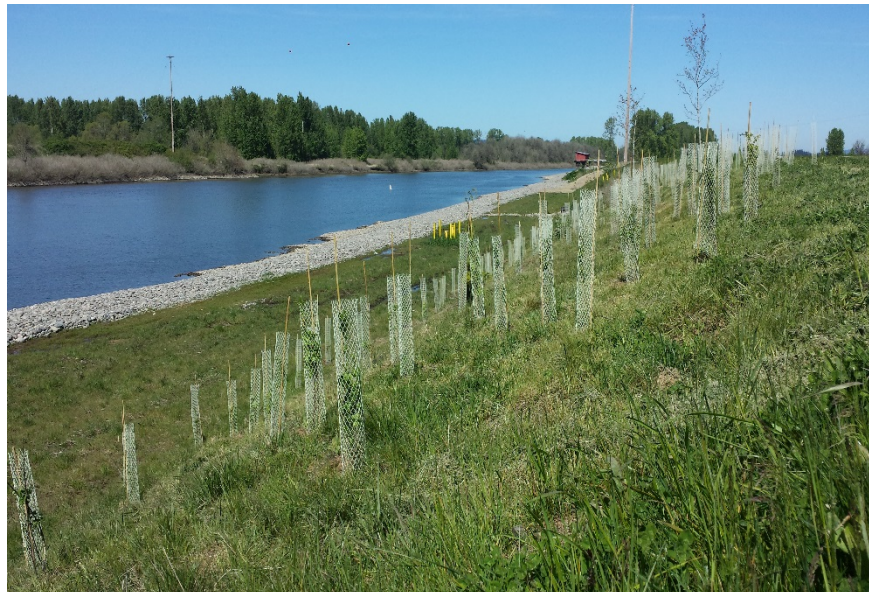
### **Photo No. 4.**

April 2015. Grove 3 (Cell 3) following remediation and plantings. Shoreline debris removed and fish mix rounded rock in place. Looking north.

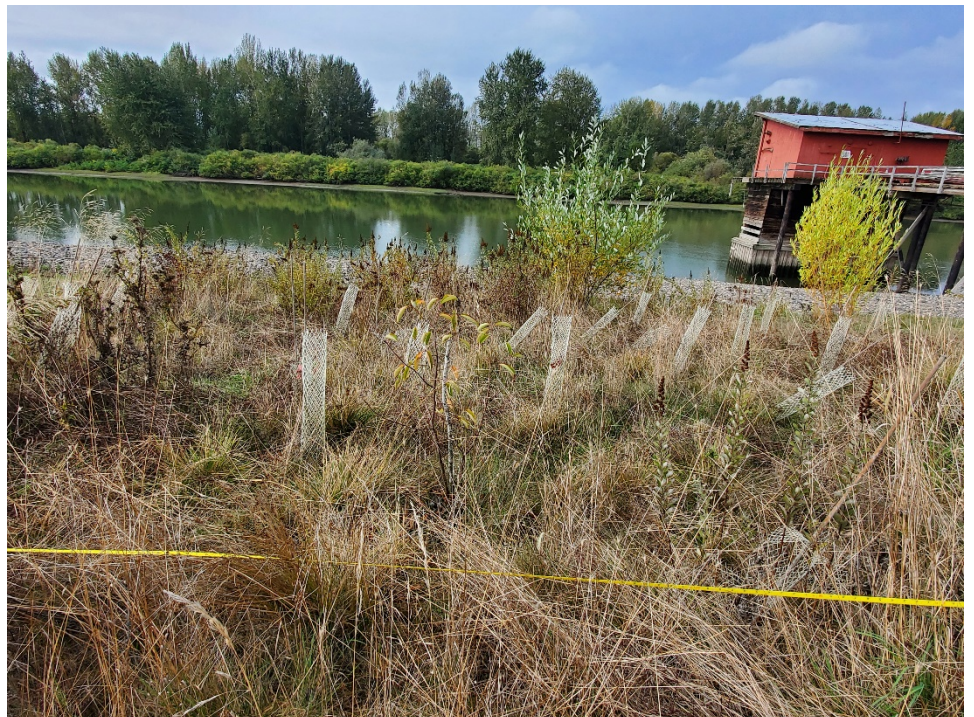
### Photo No. 18.

October 2020.  
Photo point G1-A3.  
Cherry species and  
Juncus.

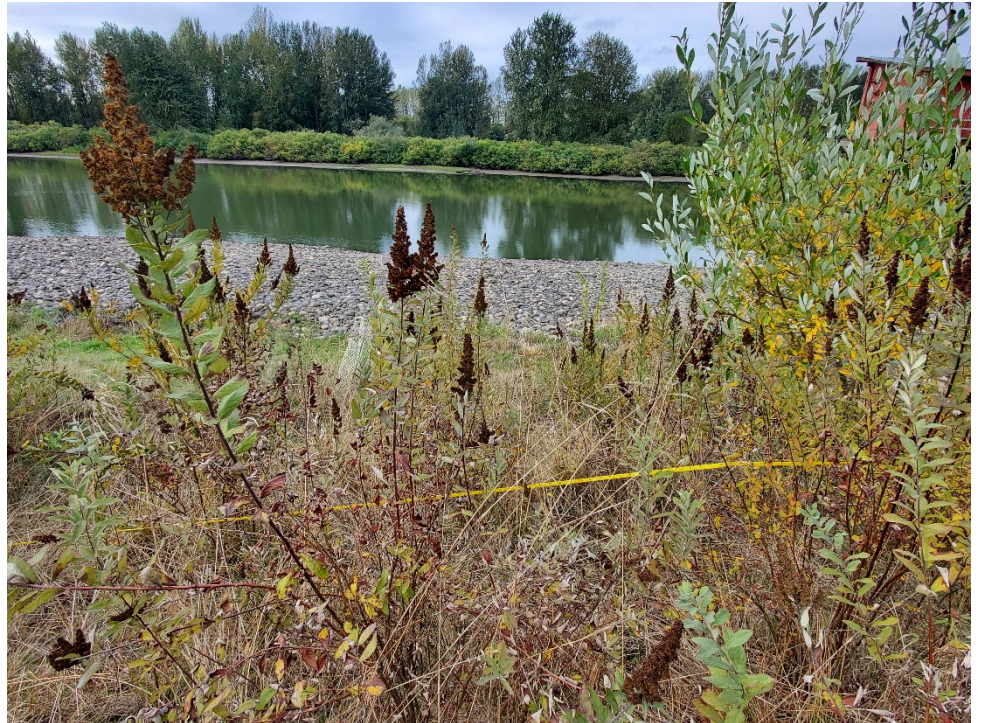
### Photo No. 19.

October 2020.  
Photo point G1-B3.  
Douglas spirea and  
native grasses.

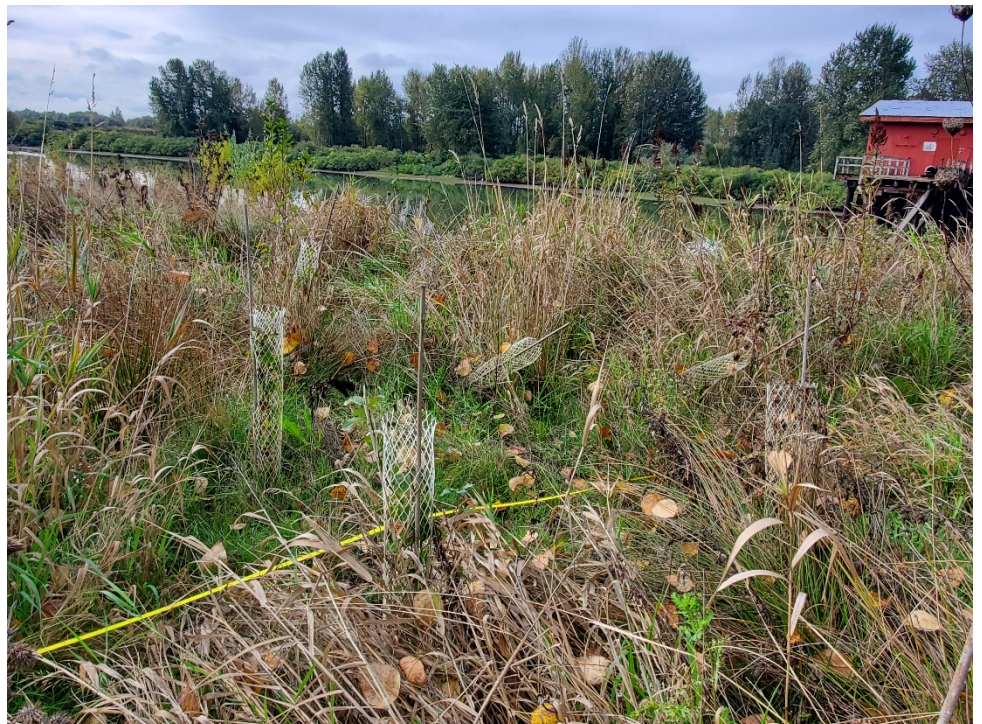
### Photo No. 20.

October 2020.  
Photo point G1-C9.  
Serviceberry, rose,  
Juncus, Douglas  
spirea, reed canary  
grass, thistle, and  
native grasses.

To meet performance standards, reed canary grass and other invasive plant and root mass will be removed from the planting groves as part of the continued vegetation management efforts.

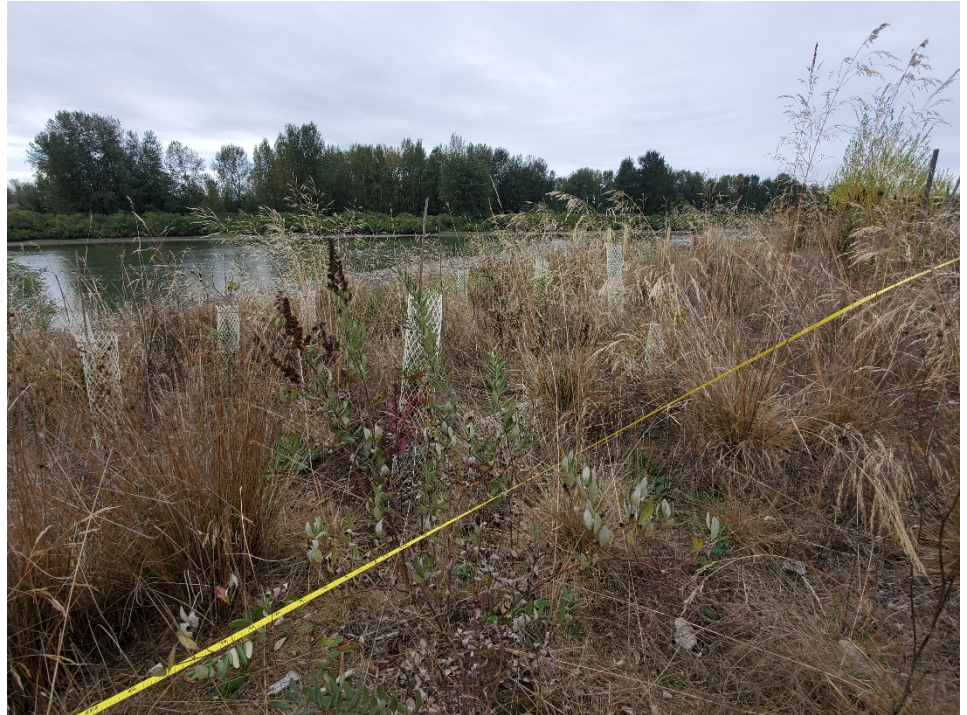
### Photo No. 21.

October 2020.  
Photo point G2-B6.  
Oregon grape,  
Douglas spirea, and  
Juncus.

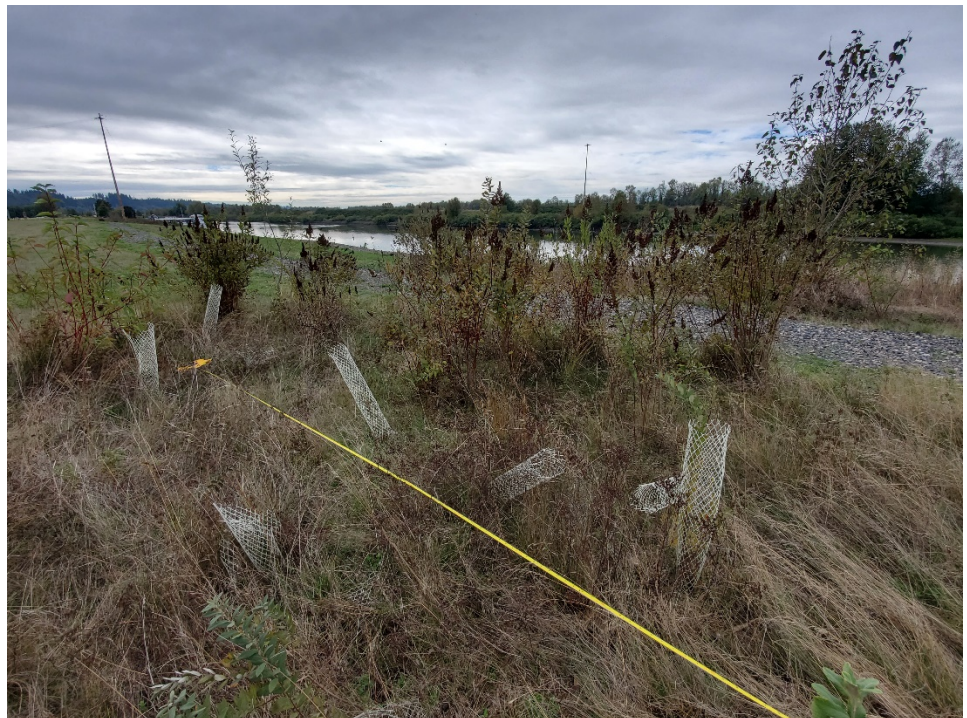
### Photo No. 22.

October 2020.  
Photo point G2-A3.  
Rose species and  
Juncus with native  
grasses.

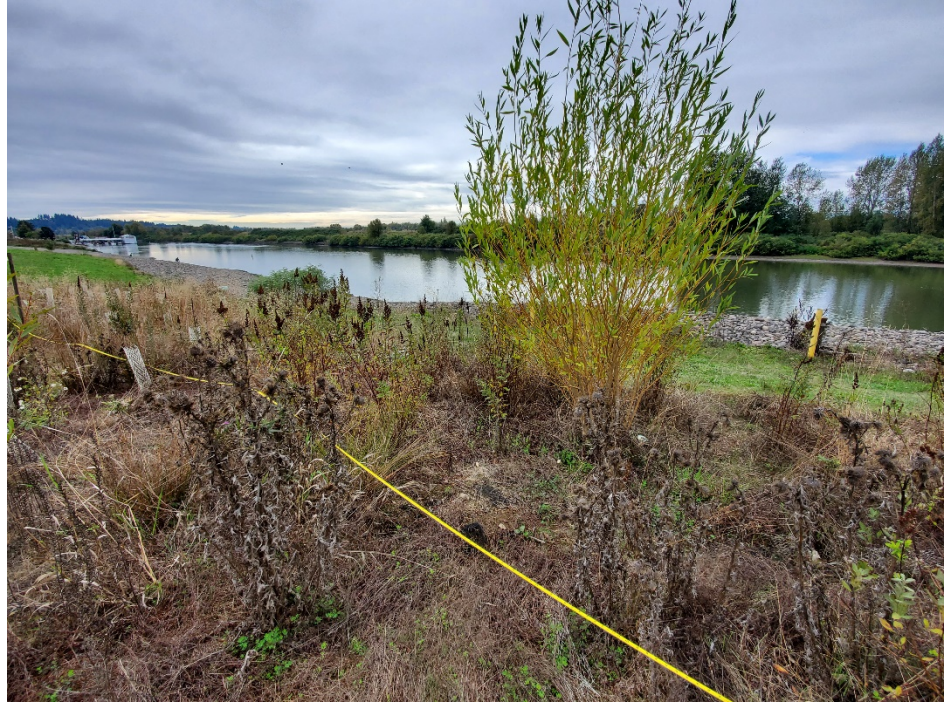
### Photo No. 23.

October 2020.  
Photo point G2-  
B15. Douglas spirea,  
lupine, and Juncus  
with Pacific willow  
nearby.

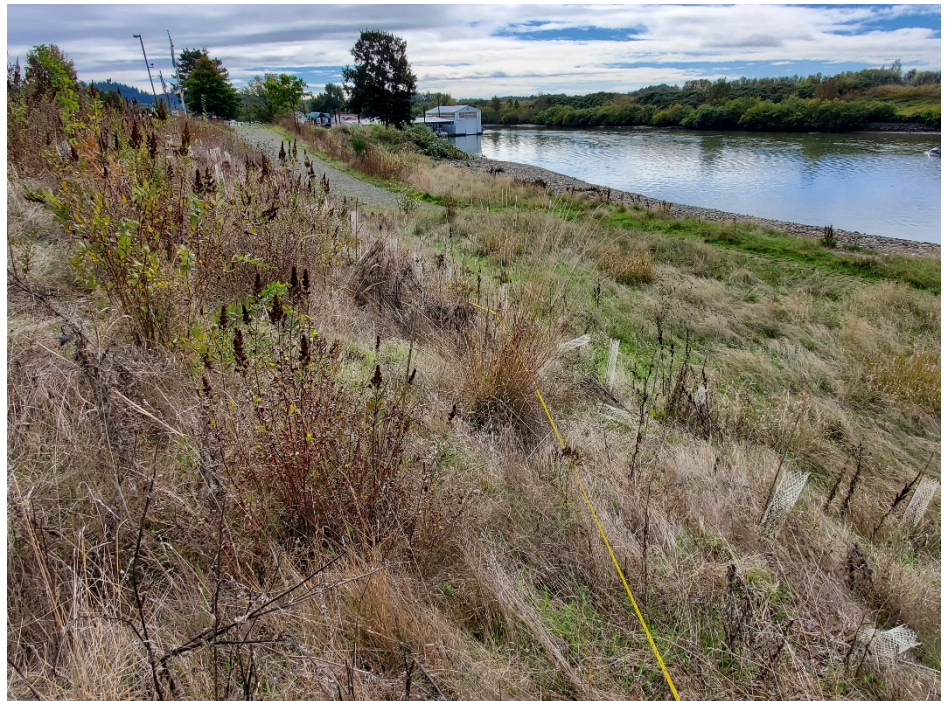
### Photo No. 24.

October 2020.  
Photo point G3-A7.  
Douglas spirea and  
grasses.

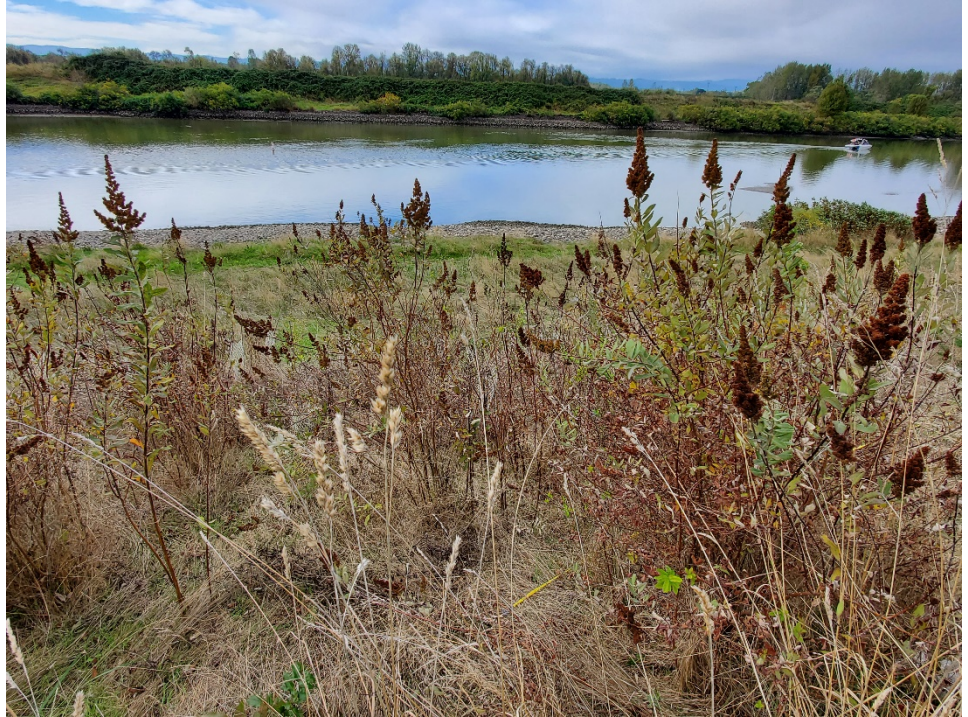
### Photo No. 25.

October 2020.  
Photo point G3-B1.  
Douglas spirea and  
grasses.

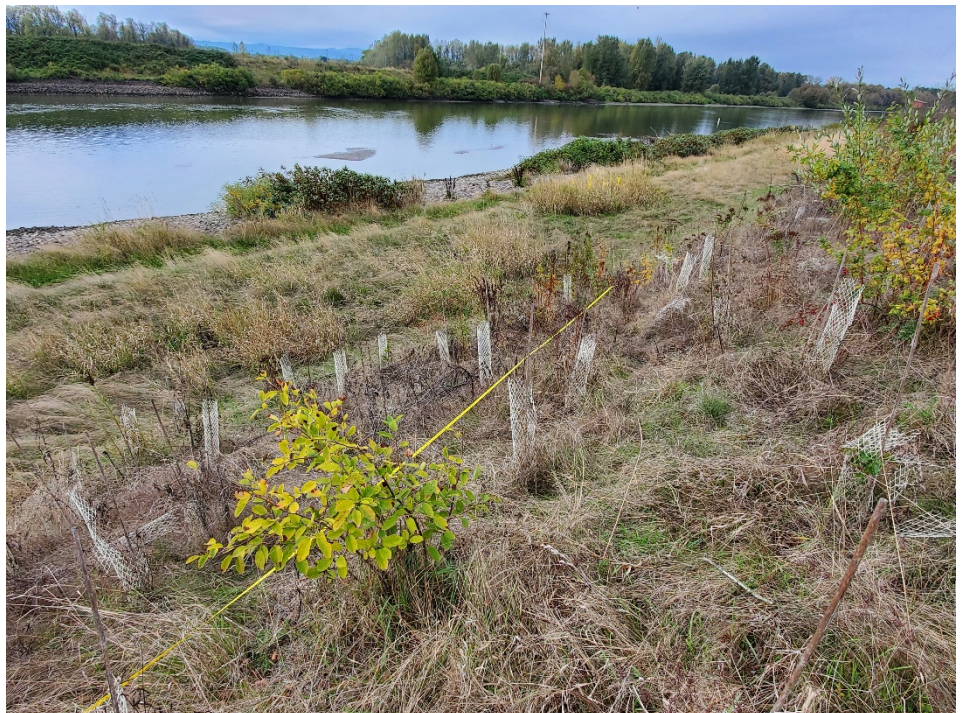
### Photo No. 26.

October 2020.  
Photo point G3-B8.  
Lupine and native  
grasses with cherry  
tree sprouting new  
shoots nearby.
