Lower Duwamish Waterway Early Action Area 2

Summary of Existing Information and Identification of Data Gaps

Toxics Cleanup Program
Northwest Regional Office
Washington State Department of Ecology
Bellevue, Washington

February 2007

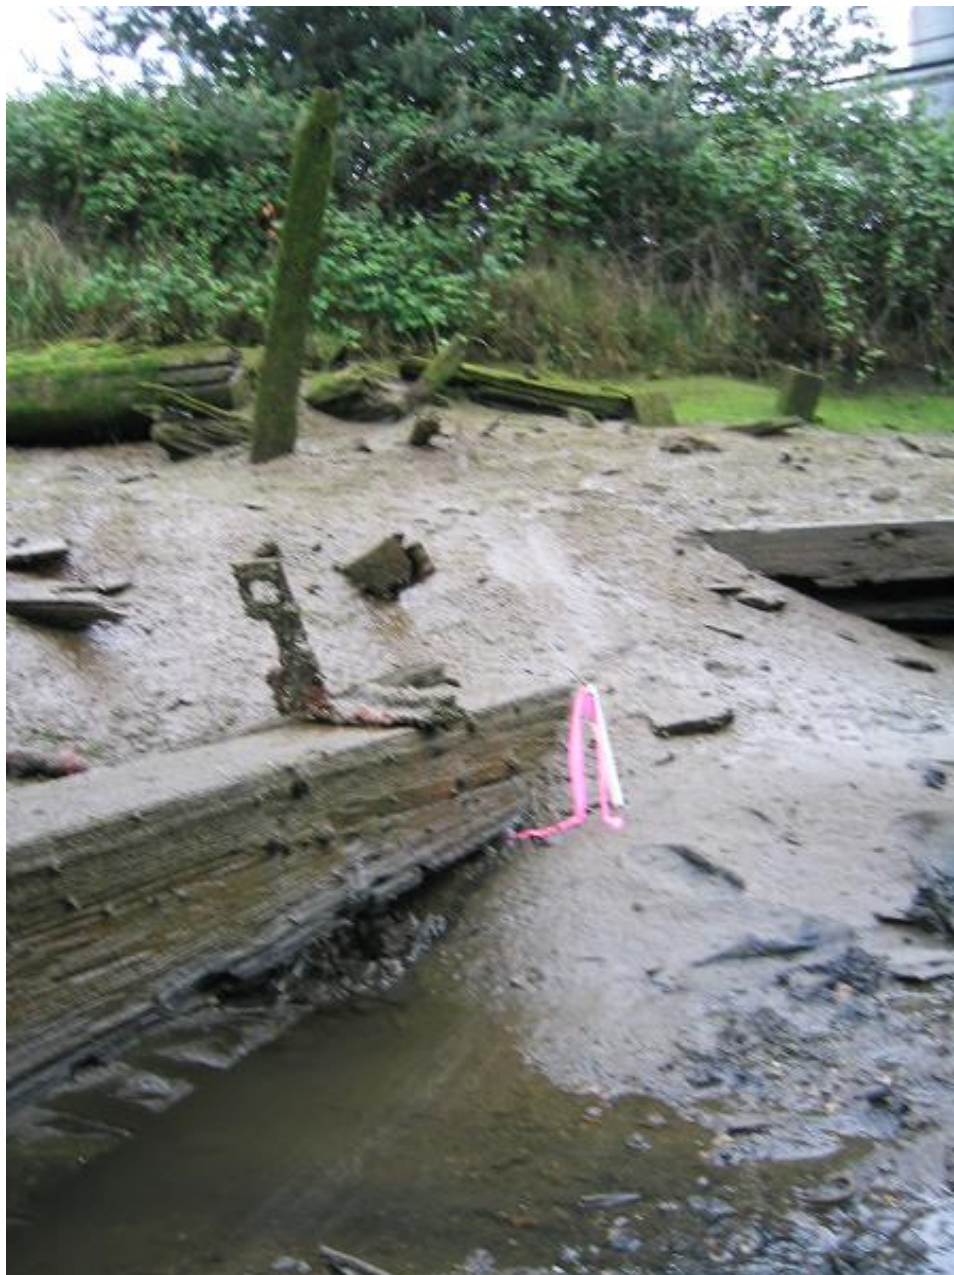
**Early Action Area 2
Seep 53 During Reconnaissance Survey
(LDWG 2004)**

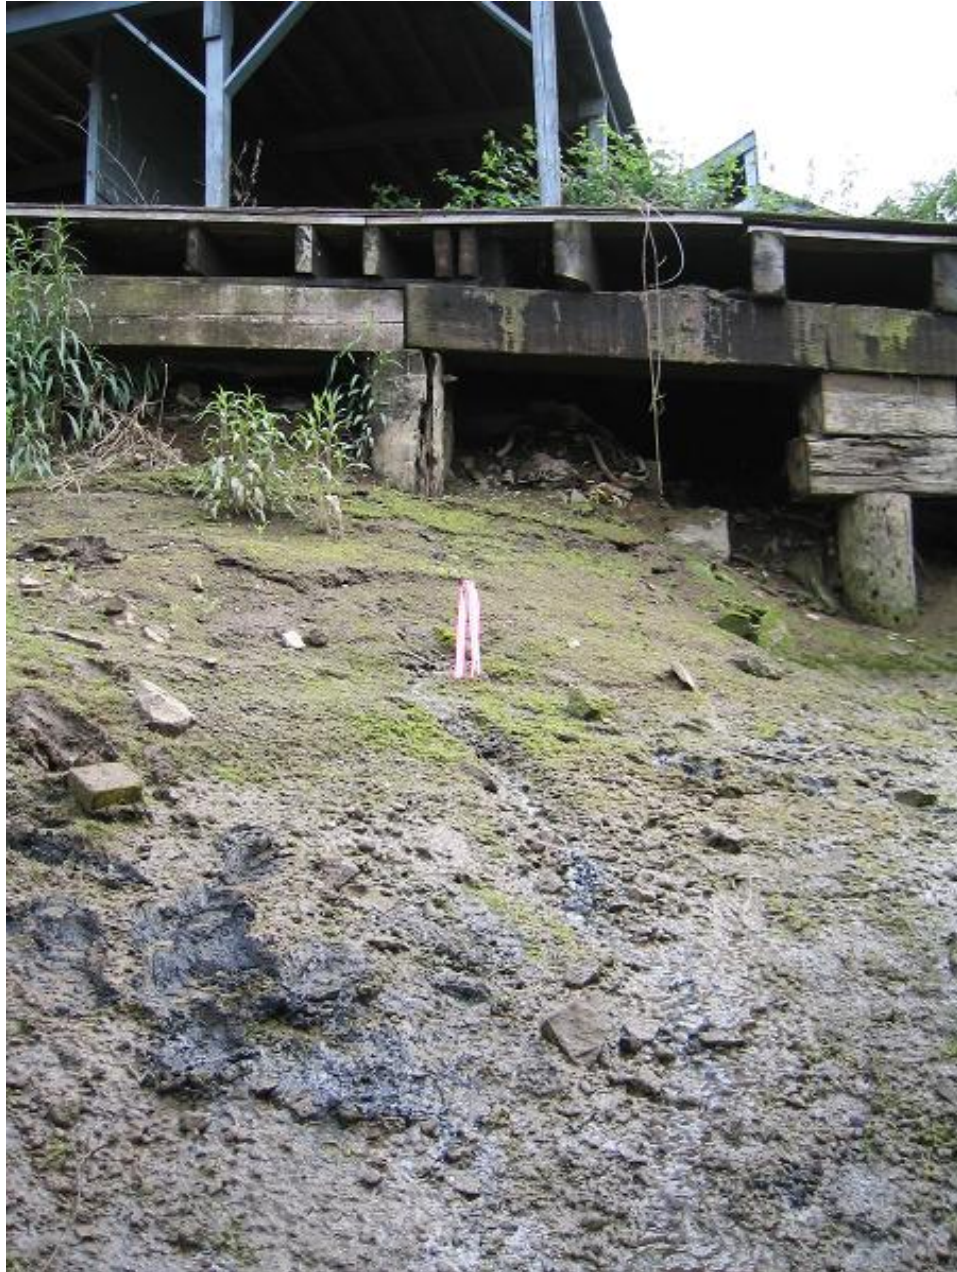
**Early Action Area 2
Seep 54 During Reconnaissance Survey
(LDWG 2004)**

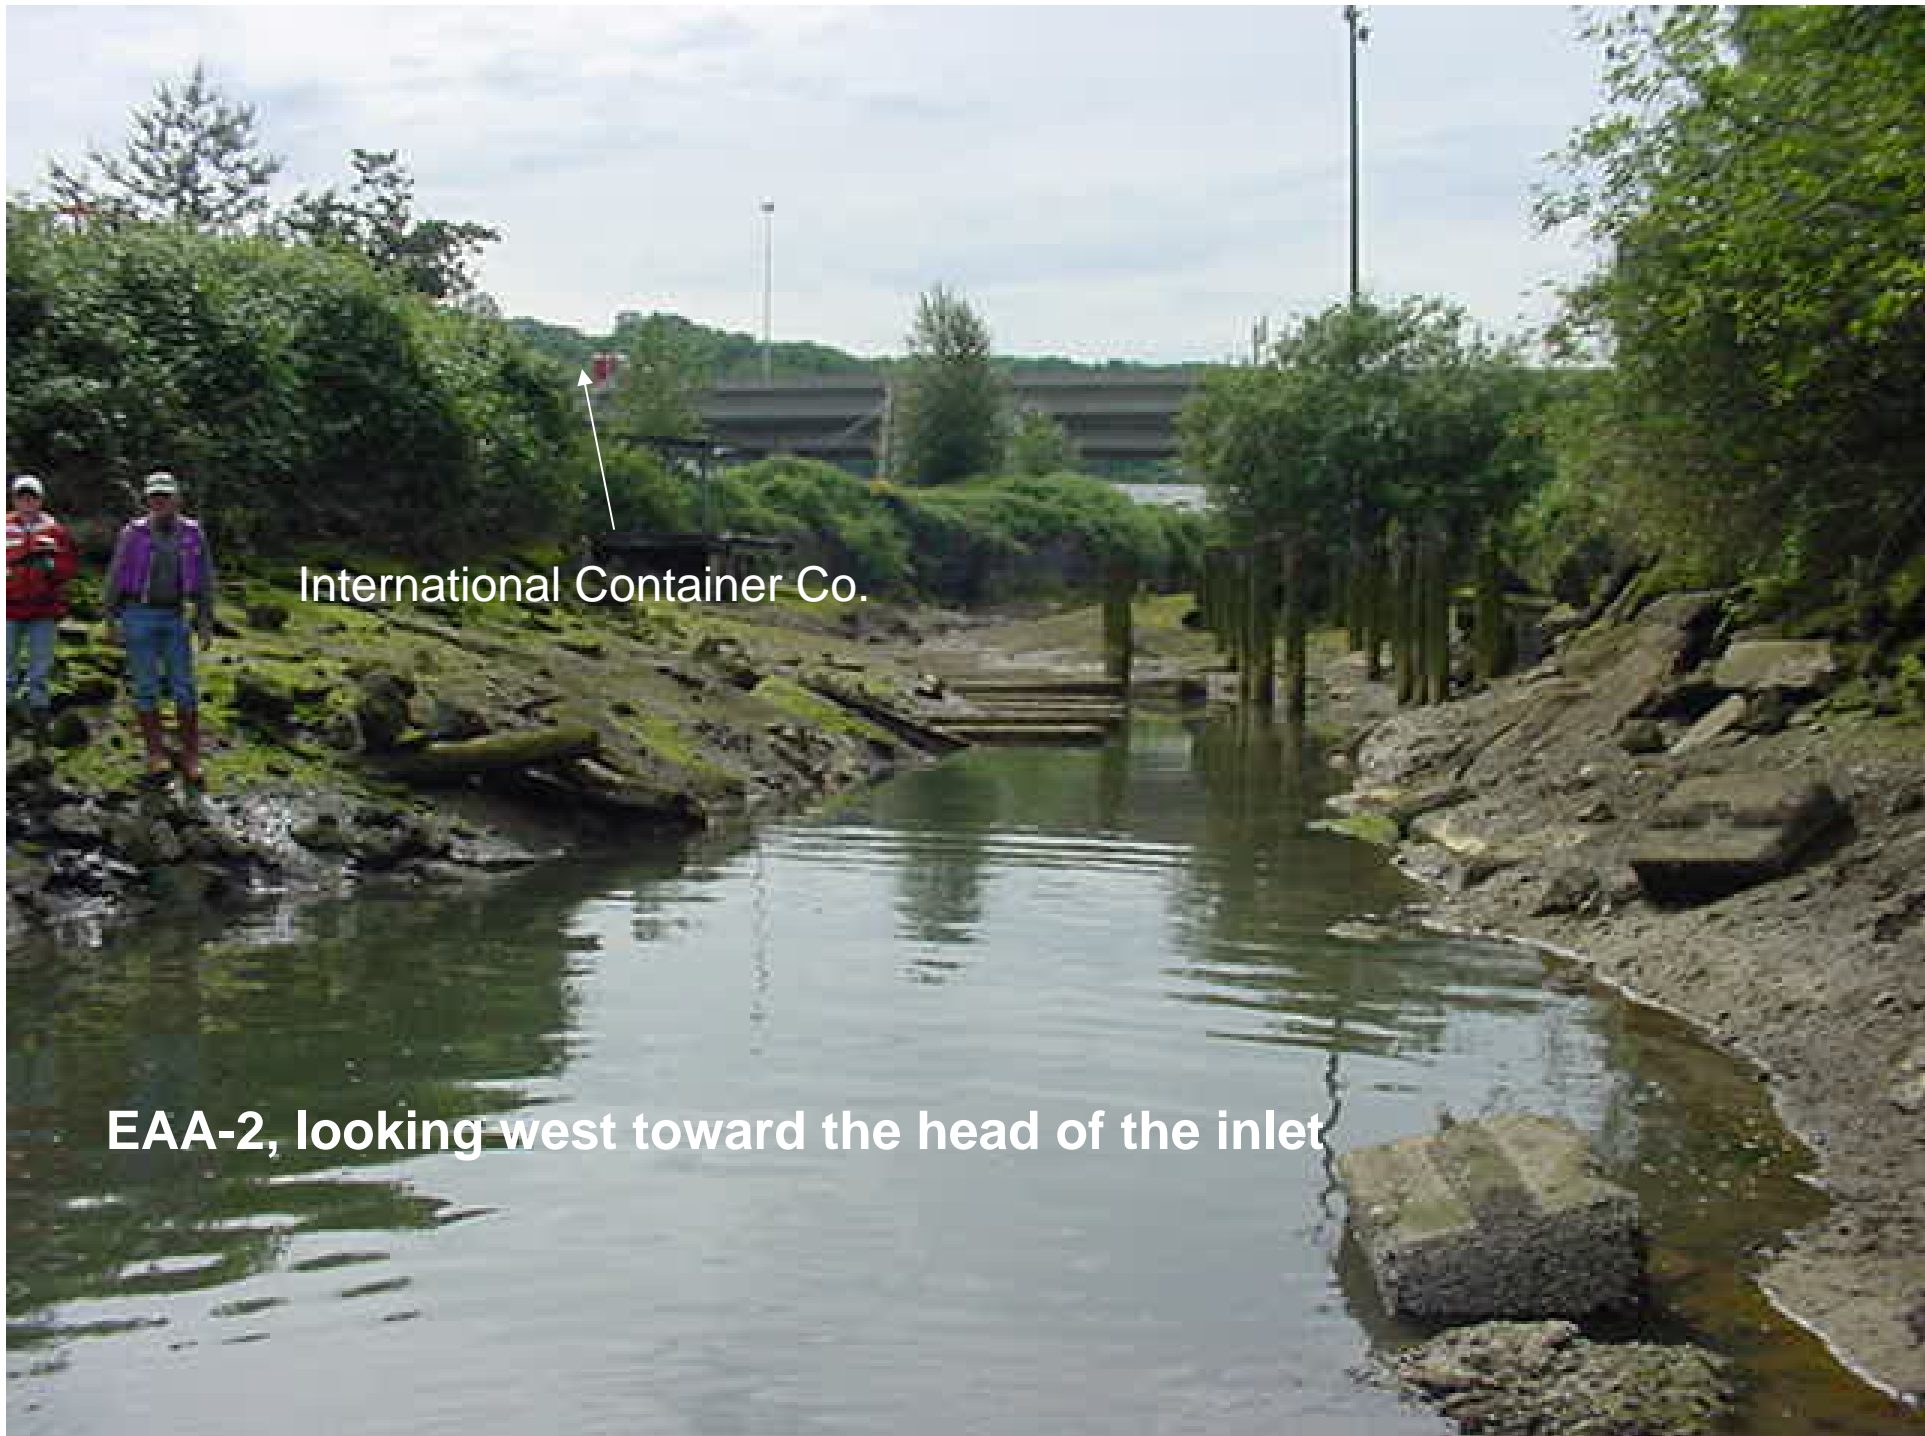
EAA-2, looking west toward the head of the inlet

Storm drain at head of inlet

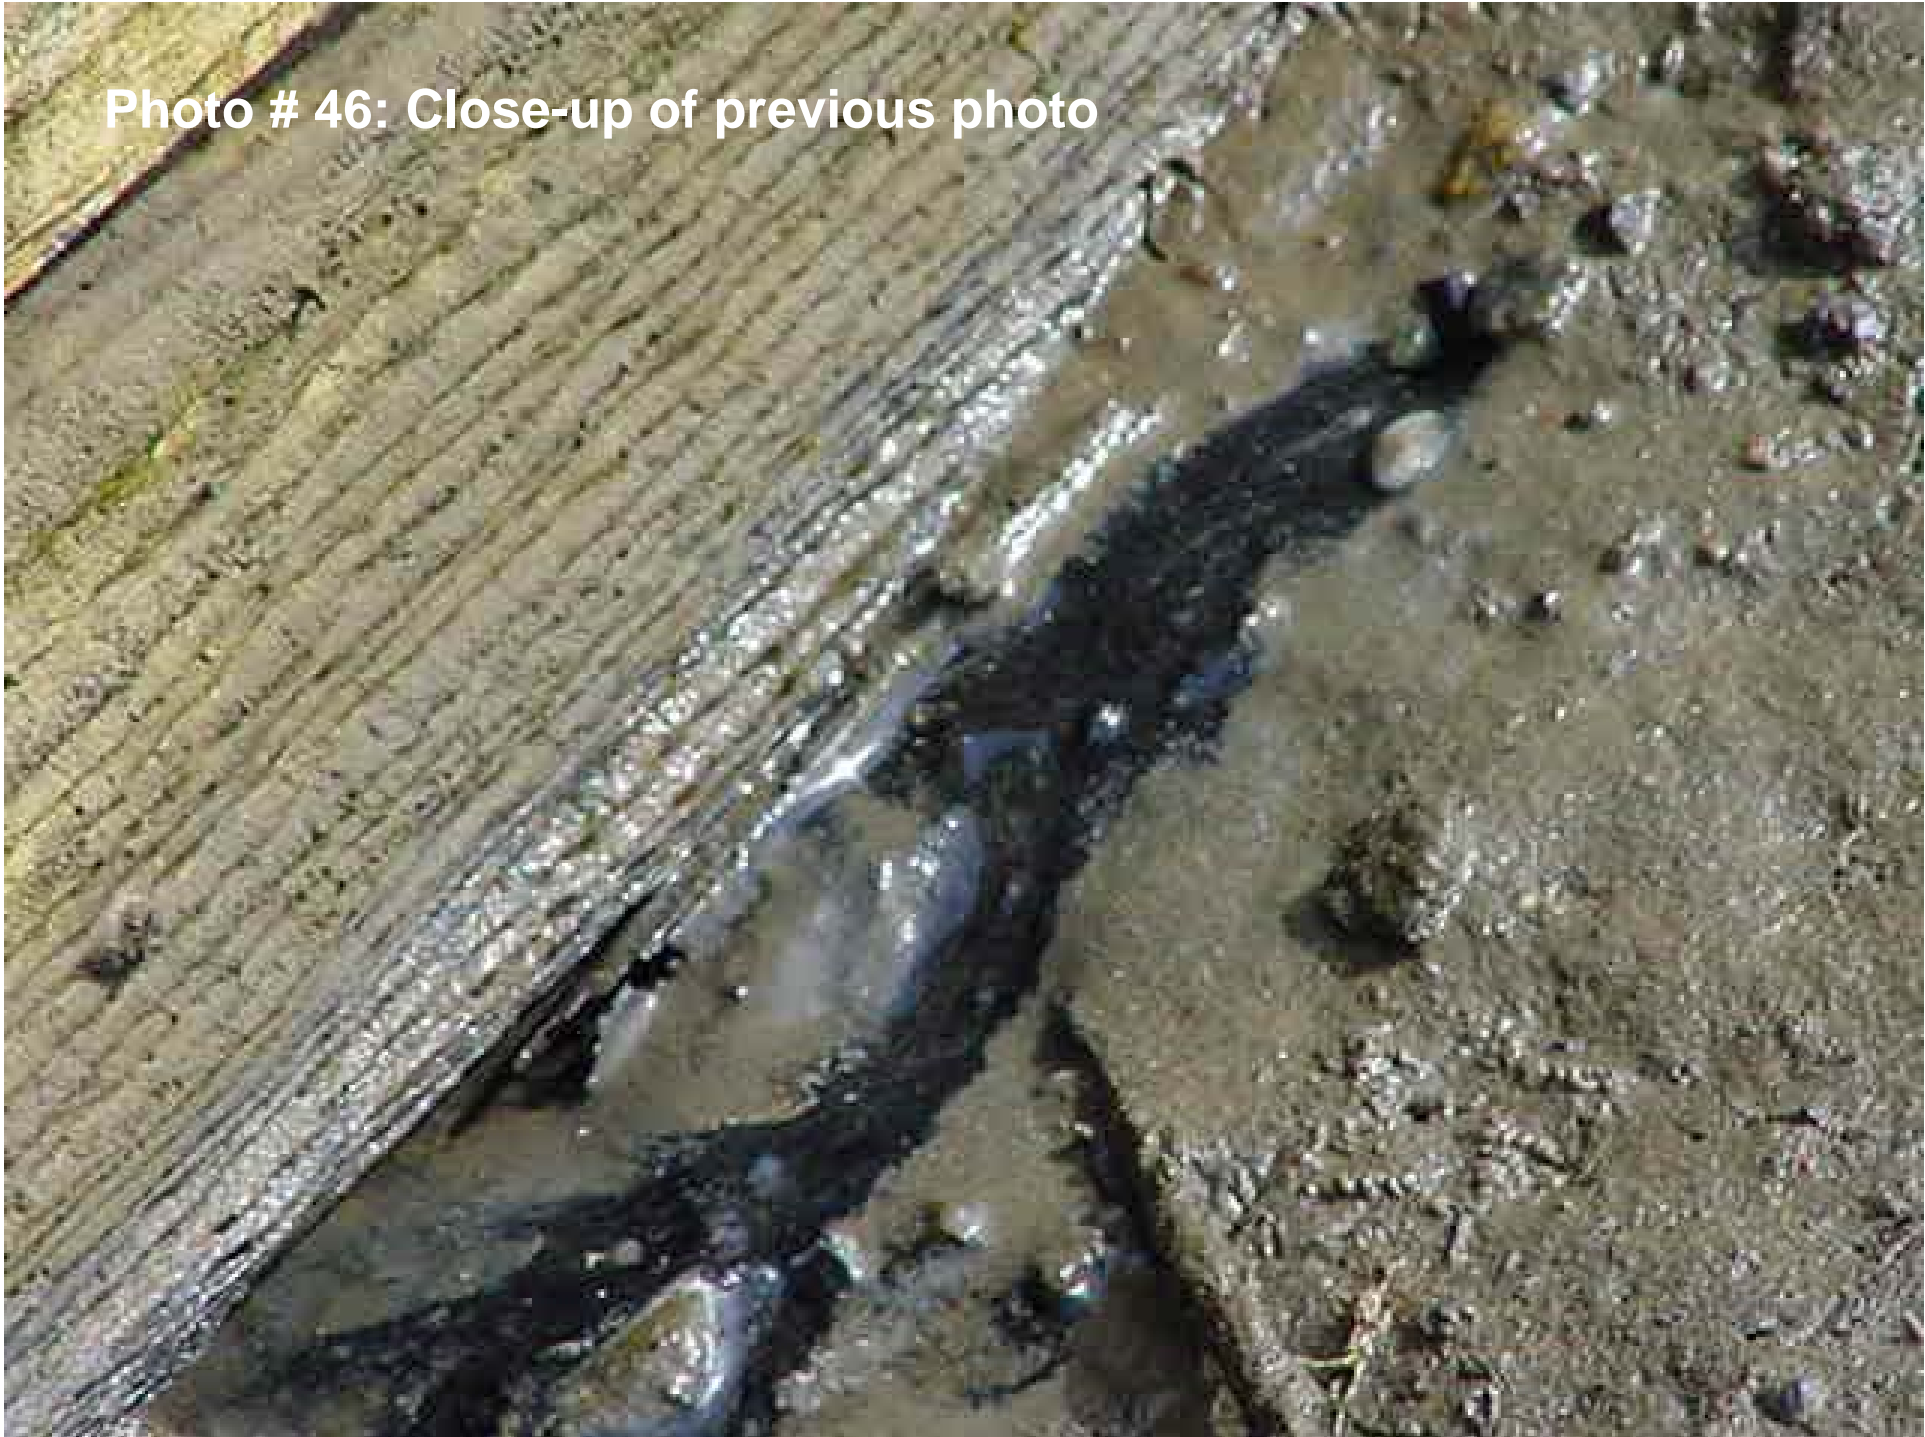
During a site visit by Ecology in May 2004, seeps were observed entering the inlet from the Industrial Container Services site, and a variety of debris including steel drum parts were observed in the south bank and in a waste pile located under a former building near the inlet (Appendix A.3). Bank soil and seeps in the area had a petroleum odor and sheen. In addition, a reconnaissance survey conducted by Windward Environmental in May 2004 identified two seeps entering EAA-2 (LDWG 2004). Although the seep locations are listed as “adjacent to Swan Bay Holdings,” reconnaissance photos of the seeps indicate locations along both the south (Trotsky) and north (Douglas Management Company) sides of the inlet (Appendix A.2).

Photo # 47: Waste drums in sediments at EAA-2

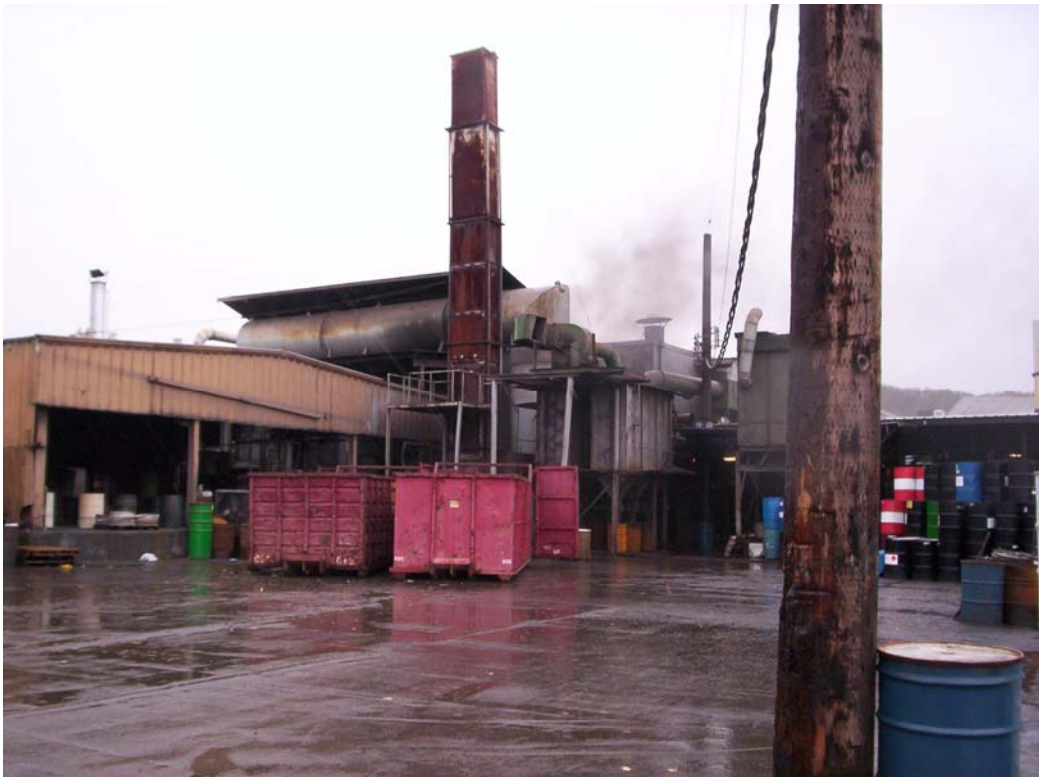
Photo 10: Industrial Container Services – smoke emissions from furnace
