## Germany Creek Photo Points and Channel Stability Evaluation: 1990 – 2000

November 2000 Publication No. 00-10-038

Joanne Schuett-Hames Washington State Department of Ecology Southwest Regional Office Water Quality Program

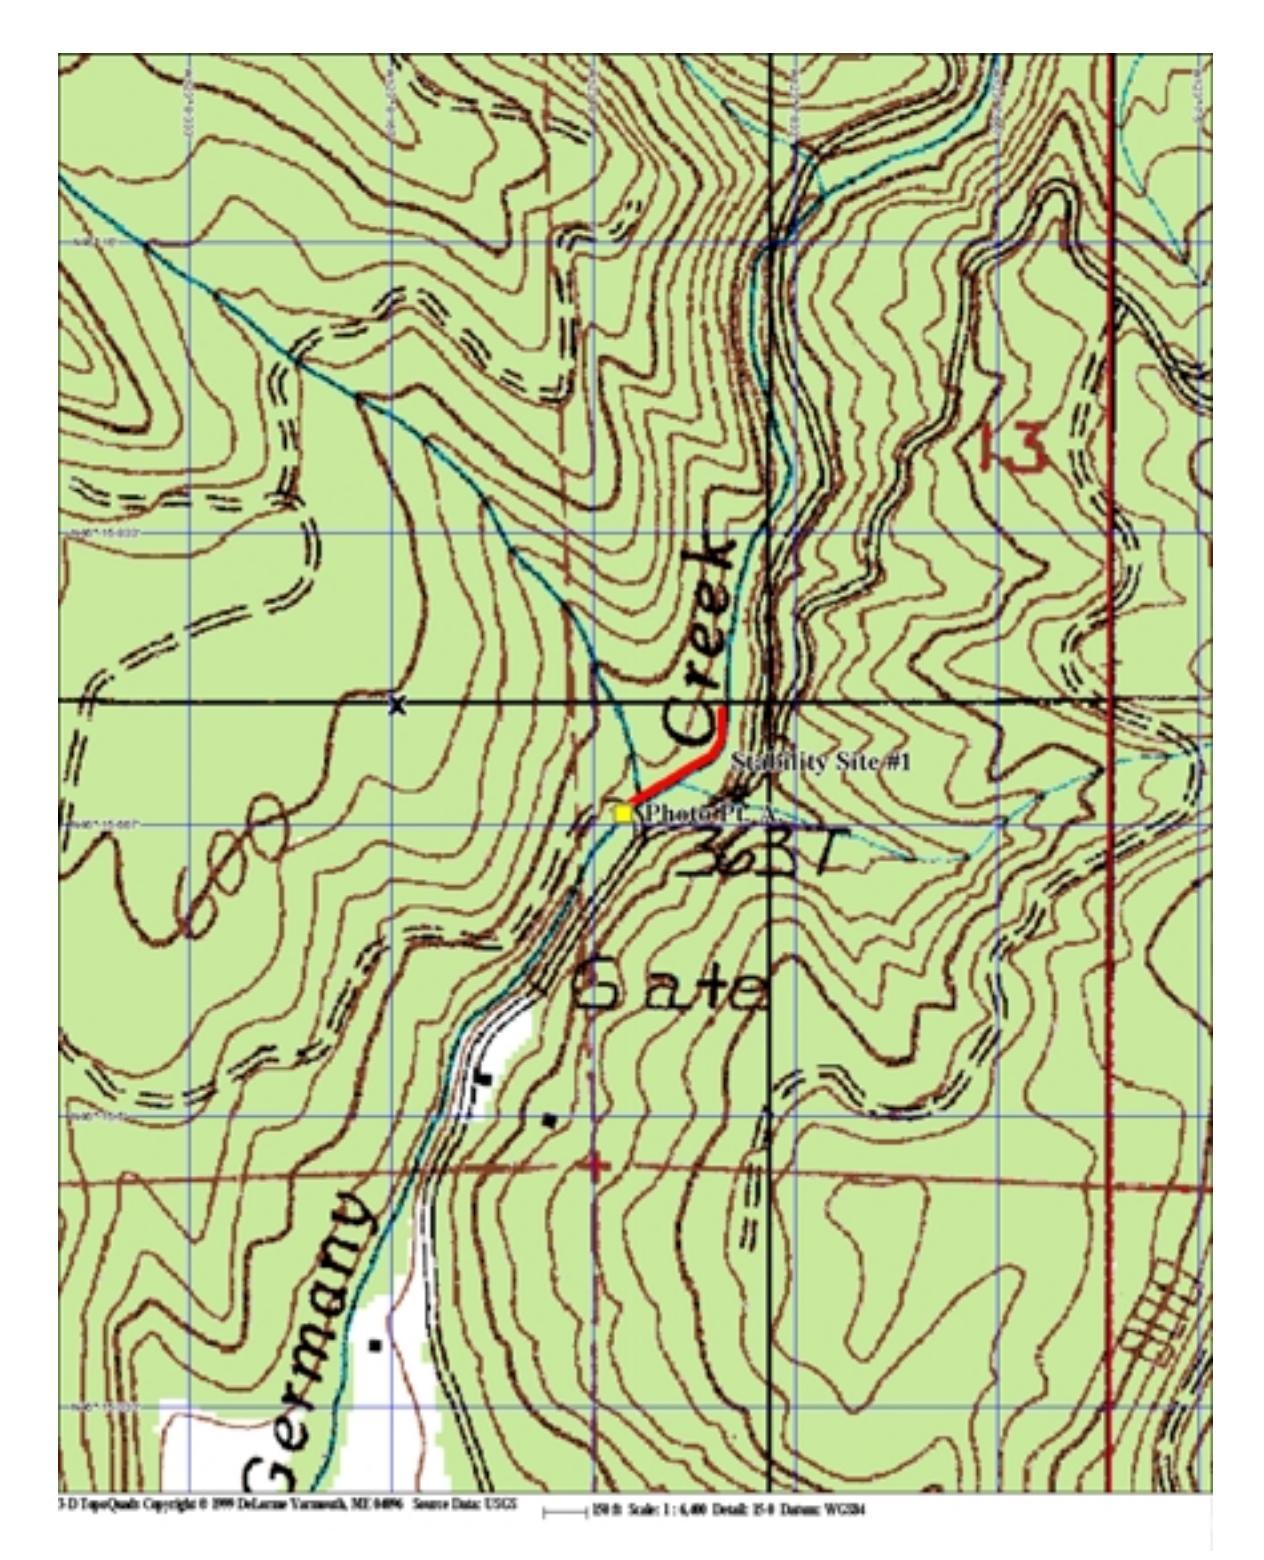
Figure 2. Germany Creek photo point A and channel stability site #1.

| Location | Latitude / | Photo Point | Notes and Comparative Results | | | |
|---|---|--|---|--|--|--|
| Bridge crossing of<br>Germany Creek.<br>Bridge located at mile<br>5.2 from start of<br>Germany Creek Road at<br>Highway, and 0.1 mile<br>from the Hampton Tree<br>Farm gate to the upper<br>watershed. Note that<br>the 500 ft. reach<br>upstream of this bridge<br>is channel stability<br>evaluation site #1. | Latitude<br>N46°15.676'<br>Longitude<br>W123°7.964'<br>Elevation<br>348 ft. | A upstream<br>A downstream<br>Both taken<br>from top of<br>bridge. | Both photos show no large wood in<br>channel. Lower banks look more<br>mossy and vegetated in 2000. It<br>appears in upstream photo that large<br>in-channel gravel bar has downgraded<br>in 2000 photo. Site is a transport<br>reach. | | | |

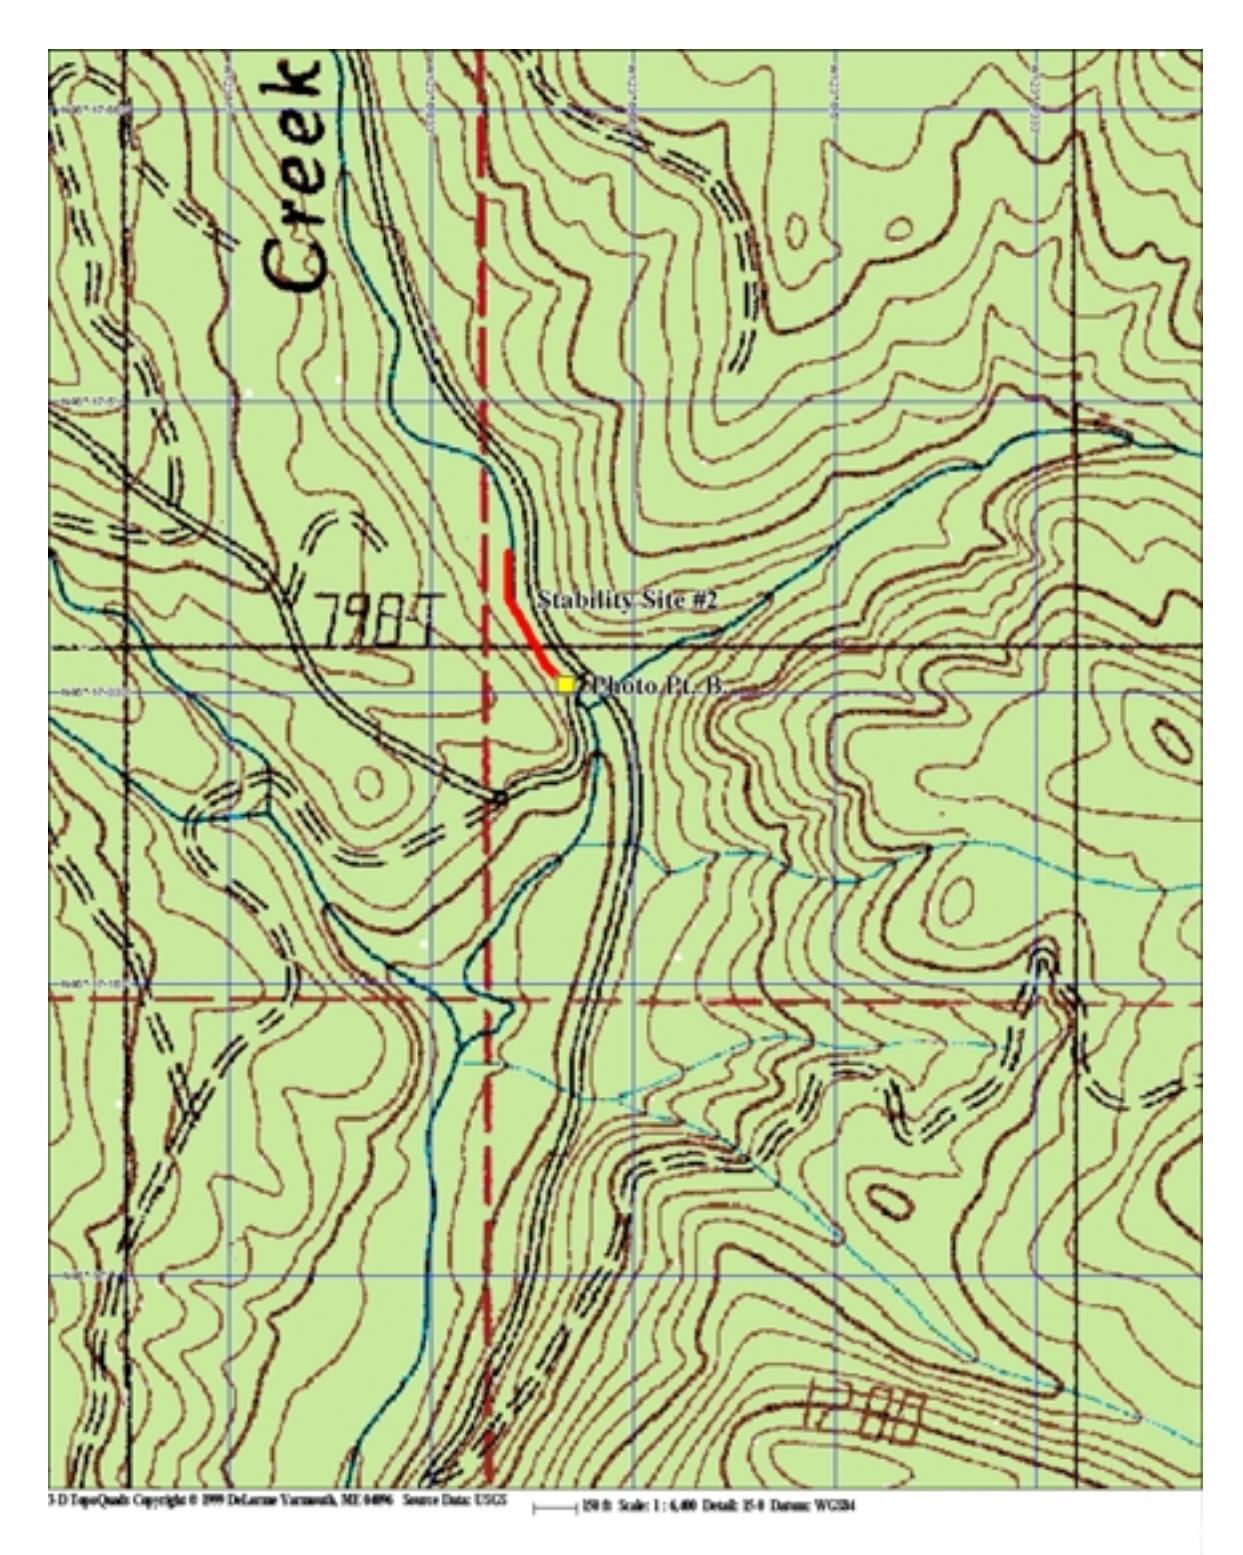
Figure 3. Germany Creek photo point B and channel stability site #2.

| Location | Latitude / | Photo Point | Notes and Comparative Results | | | |
|---|---|--|---|--|--|--|
| Bridge crossing of<br>Germany Creek. This<br>crossing is 3 miles by<br>road from photo point<br>A. Note that the 500 ft.<br>reach upstream of this<br>bridge is channel<br>stability evaluation site<br>#2. | Latitude<br>N46°17.343'<br>Longitude<br>W123°6.725'<br>Elevation<br>604 ft. | B upstream<br>B downstream<br>One set of<br>photos taken<br>from on top of<br>bridge; one<br>set from below<br>bridge. | Mid-channel bar comprised of large<br>rubble-sized particles in 1990 is gone<br>in 2000 photos with channel<br>appearing deepened. Channel now is<br>flanked along right bank with a lateral<br>bar. Nice pool under bridge.<br>Left bank lateral bar is gone in 2000.<br>Steelhead redd on pool tail-out below<br>bridge (2000). | | | |

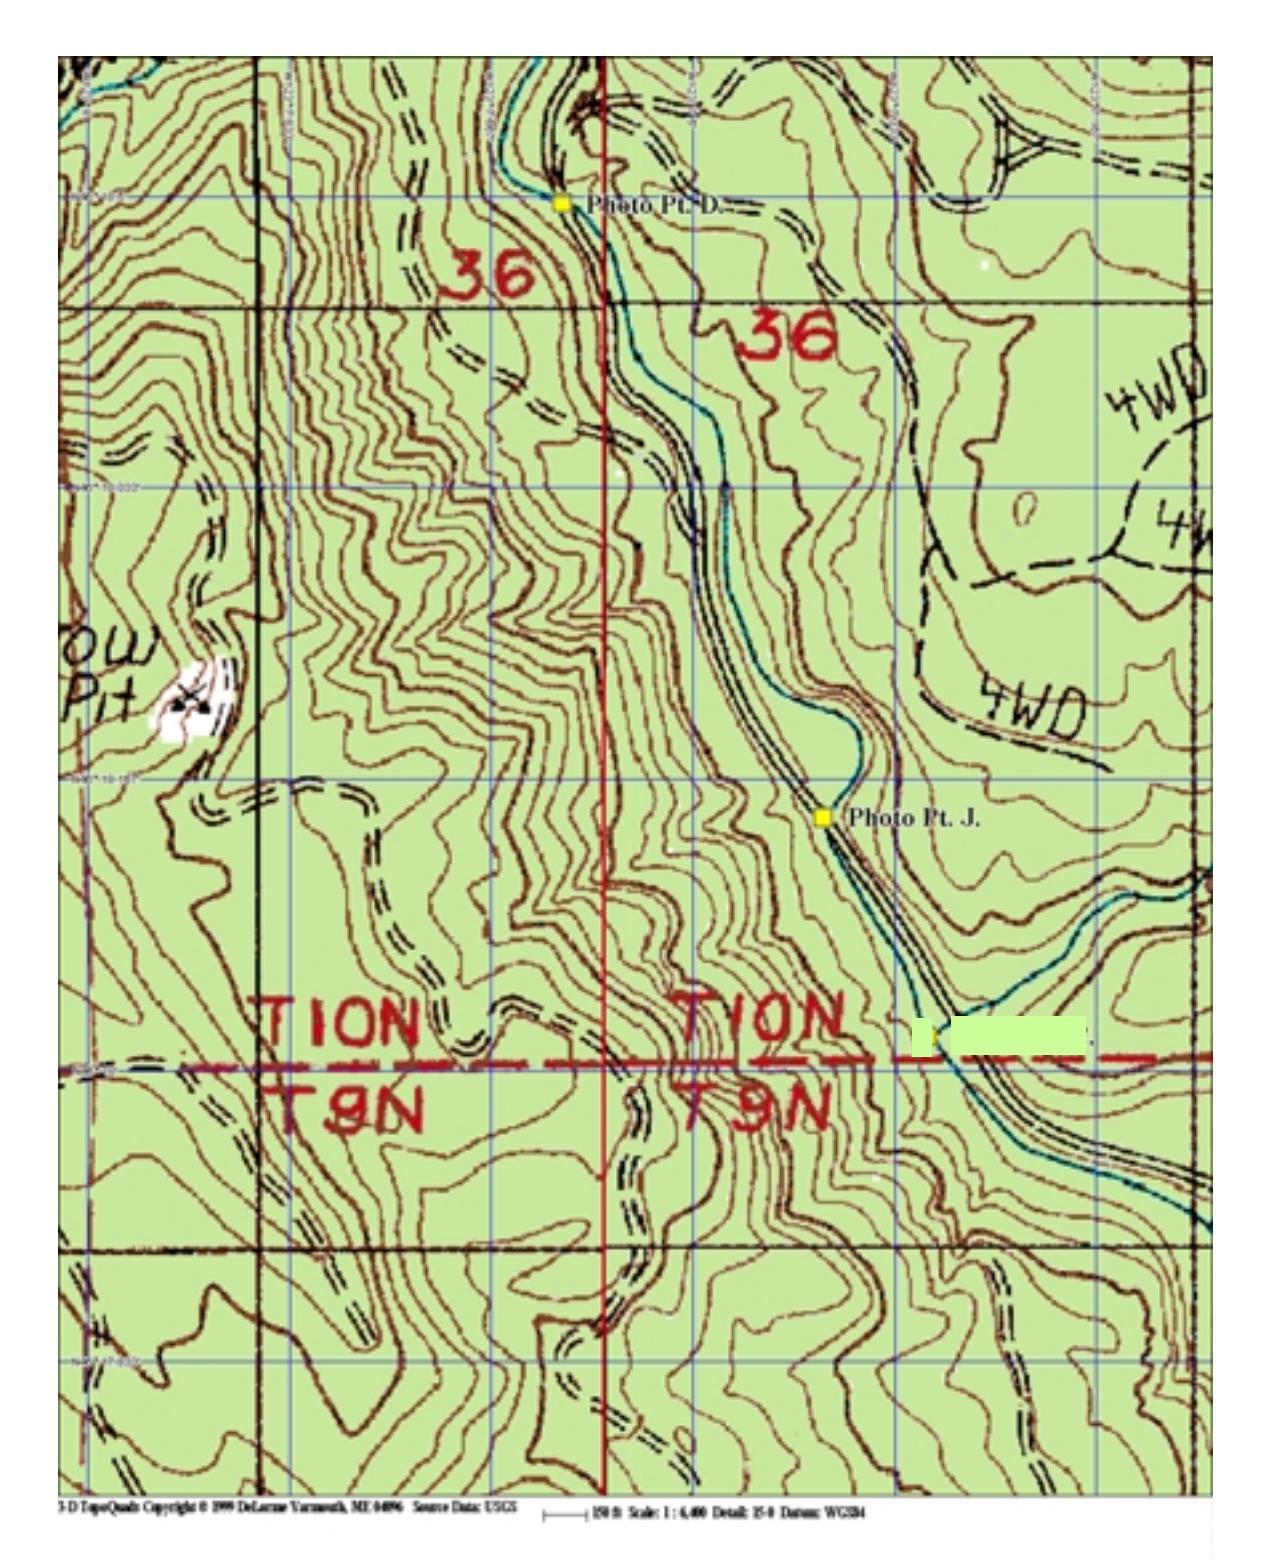
Figure 4. Germany Creek photo points J and D.

| Location | Latitude / | Photo Point | Notes and Comparative Results | | | |
|---|---|--|---|--|--|--|
| Mainline crossing of Germany Creek. | Latitude<br>N46°18.146' | J upstream | Appears that some gravel deposition shown in 1990 has lessened in 2000. | | | |
| | Longitude<br>W123°7.392'<br>Elevation<br>723 ft. | J downstream | Photos look quite similar. | | | |
| Road crossing of<br>mainstem Germany<br>Creek. | Latitude<br>N46°18.498'<br>Longitude<br>W123°7.610'<br>Elevation<br>740 ft. | D upstream<br>D downstream<br>Photos taken<br>from on top of<br>bridge. | 2000 photos: note mid-channel gravel<br>bar with approximately 8 year-old<br>alders. Sediment wedge is being<br>stabilized in-channel at this location.<br>No photos available for 1990. | | | |

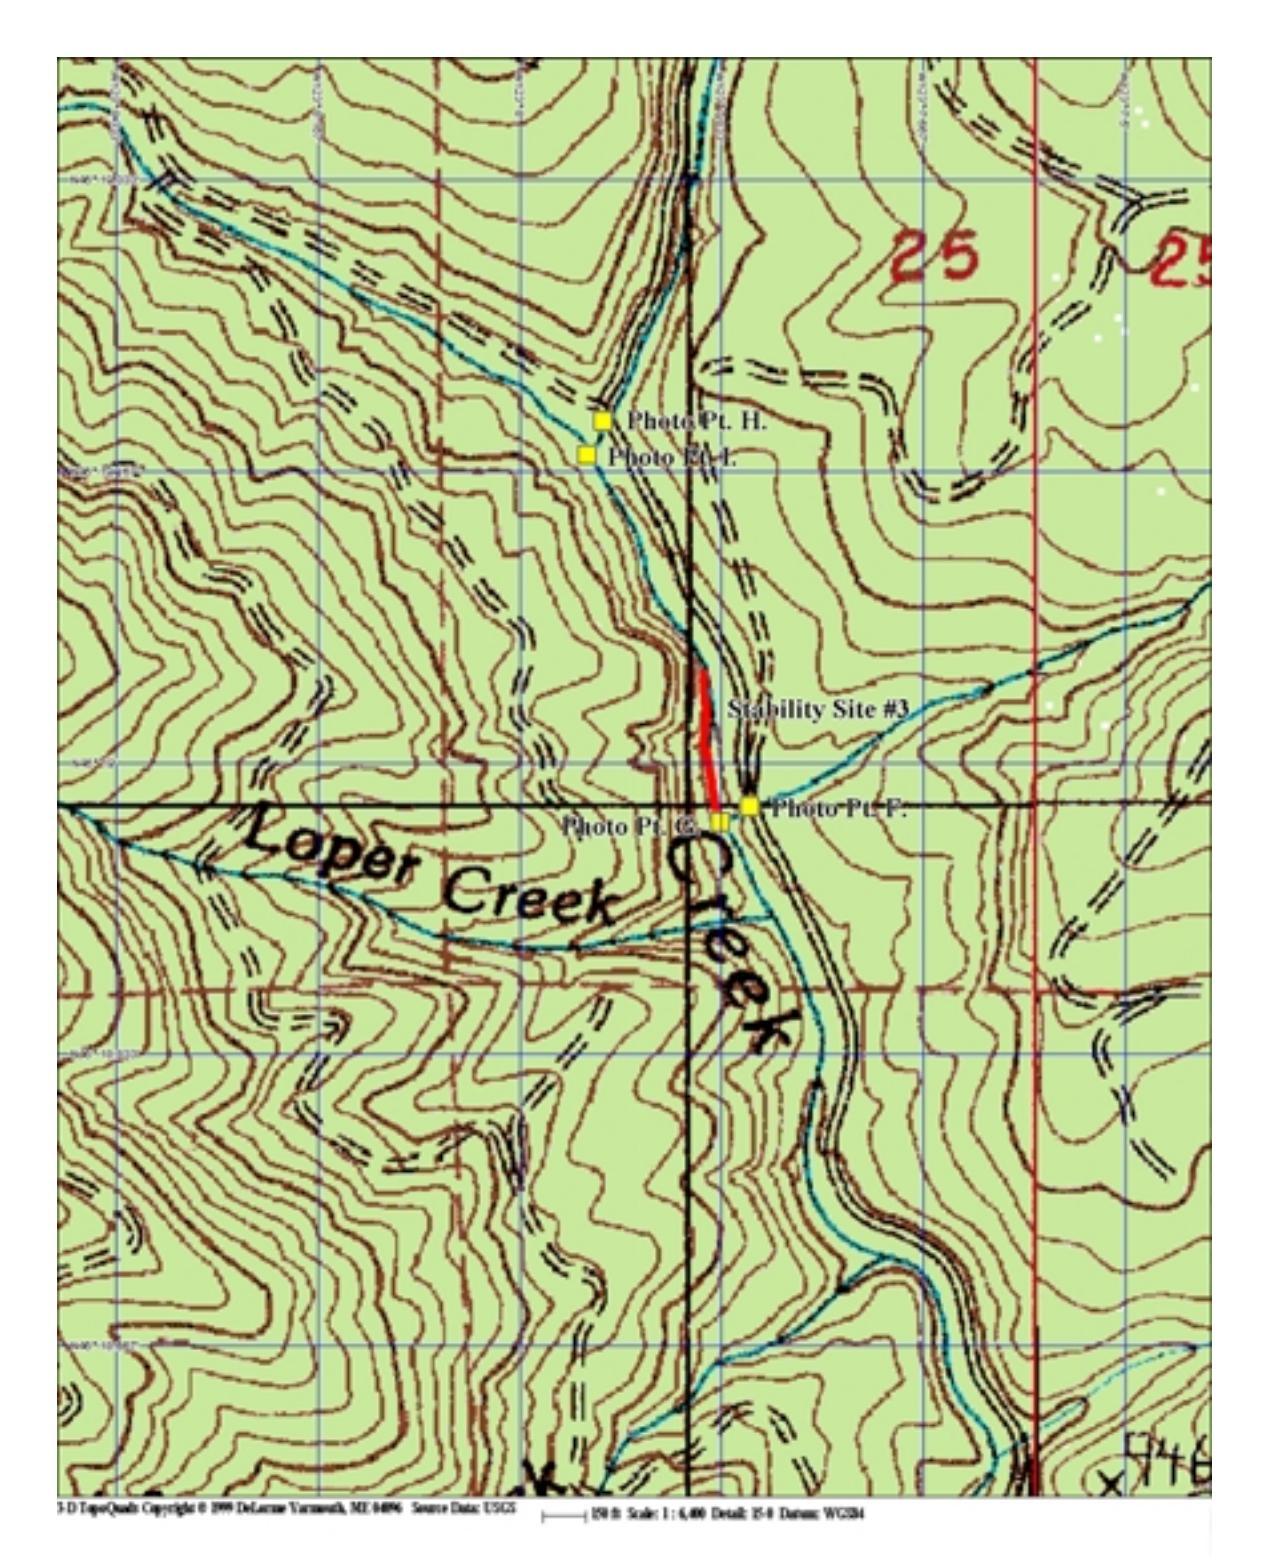
Figure 5. Germany Creek photo points F, G, H, I and channel stability site #3.

| Location | Latitude /<br>Longitude,<br>Elovation | Photo Point | Notes and Comparative Results<br>1990 - 2000 |
|--|---|--|--|
| Road crossing of tributary to Germany | Latitude<br>N46°18.975' | F upstream | 2000: step-pools are forming both upstream and downstream at 20 ft. |
| Creek. | Longitude<br>W123°7.806' | F downstream | intervals. Right bank erosion occurring approximately 75 ft. |
| | Elevation | Photos taken<br>from on top of | upstream. Downstream alluvial fan with alders. Channel mouth now |
| | 860 ft. | bridge. (See<br>also G trib.) | about 30 ft. further upstream from that of 1990. |
| Germany Creek at<br>tributary junction.<br>Also note G tributary is<br>same tributary as in | Latitude<br>N46°18.968'<br>Longitude<br>W123°7 836' | G upstream | 2000: viewing upstream primary<br>change at site appears to be change in<br>tributary location. Riparian has<br>remained stable |
| photo point F but the<br>view is from its mouth | Elevation | G downstream | 2000: lateral bar has shifted from<br>right side of channel to left side. |
| with Germany Creek.<br>Note that the 500 ft.<br>reach upstream of the<br>mouth of the creek is<br>channel stability<br>evaluation site #3. | 863 ft. | G tributary<br>All views are<br>from in<br>channel near<br>mouth of<br>tributary | The change shown in the tributary<br>characteristics is distinctive. 1990<br>shows an unsorted large rubble<br>morphology. 2000 shows distinctive<br>sorting and start of step-pool<br>morphology |
| Road crossing of<br>tributary to Germany<br>Creek. | Latitude<br>N46°19.198'<br>Longitude<br>W123°7.929'<br>Elevation<br>914 ft. | H upstream<br>H downstream | 1990 notes describe this tributary as<br>having been sluiced to bedrock with<br>loose sediment on top.<br>2000 photos (especially upstream)<br>and site visit show the extensive<br>golden colored sand deposition from<br>the new, year 1999 or 2000 landslide<br>that is about 100 to 300 ft. upstream,<br>right side. |
| Germany Creek at<br>tributary junction.<br>Also note I tributary is | Latitude<br>N46°19.176'<br>Longitude<br>W123°7.944'<br>Elevation | I upstream | Boulders and rubble seen in right side<br>of channel in 1990 photos are gone in<br>2000 with exposed bedrock showing. |
| same tributary as in photo point H. | | I downstream | Lateral bar on left side of channel in<br>1990 photo is gone in year 2000<br>photos. |
| | 910 ft. | I tributary | Year 2000 photo shows extensive sediment deposition. |
