REPORT OF FIELD STUDIES ON THE WILLAPA RIVER
August 29-31, 1972 and September 19-20, 1972Introduction

STATE OF WASHINGTON
 LOWER WILLAPA RIVER
 SAMPLING POINT LOCATIONS
 SURVEY OF AUG. - SEPT. 1972

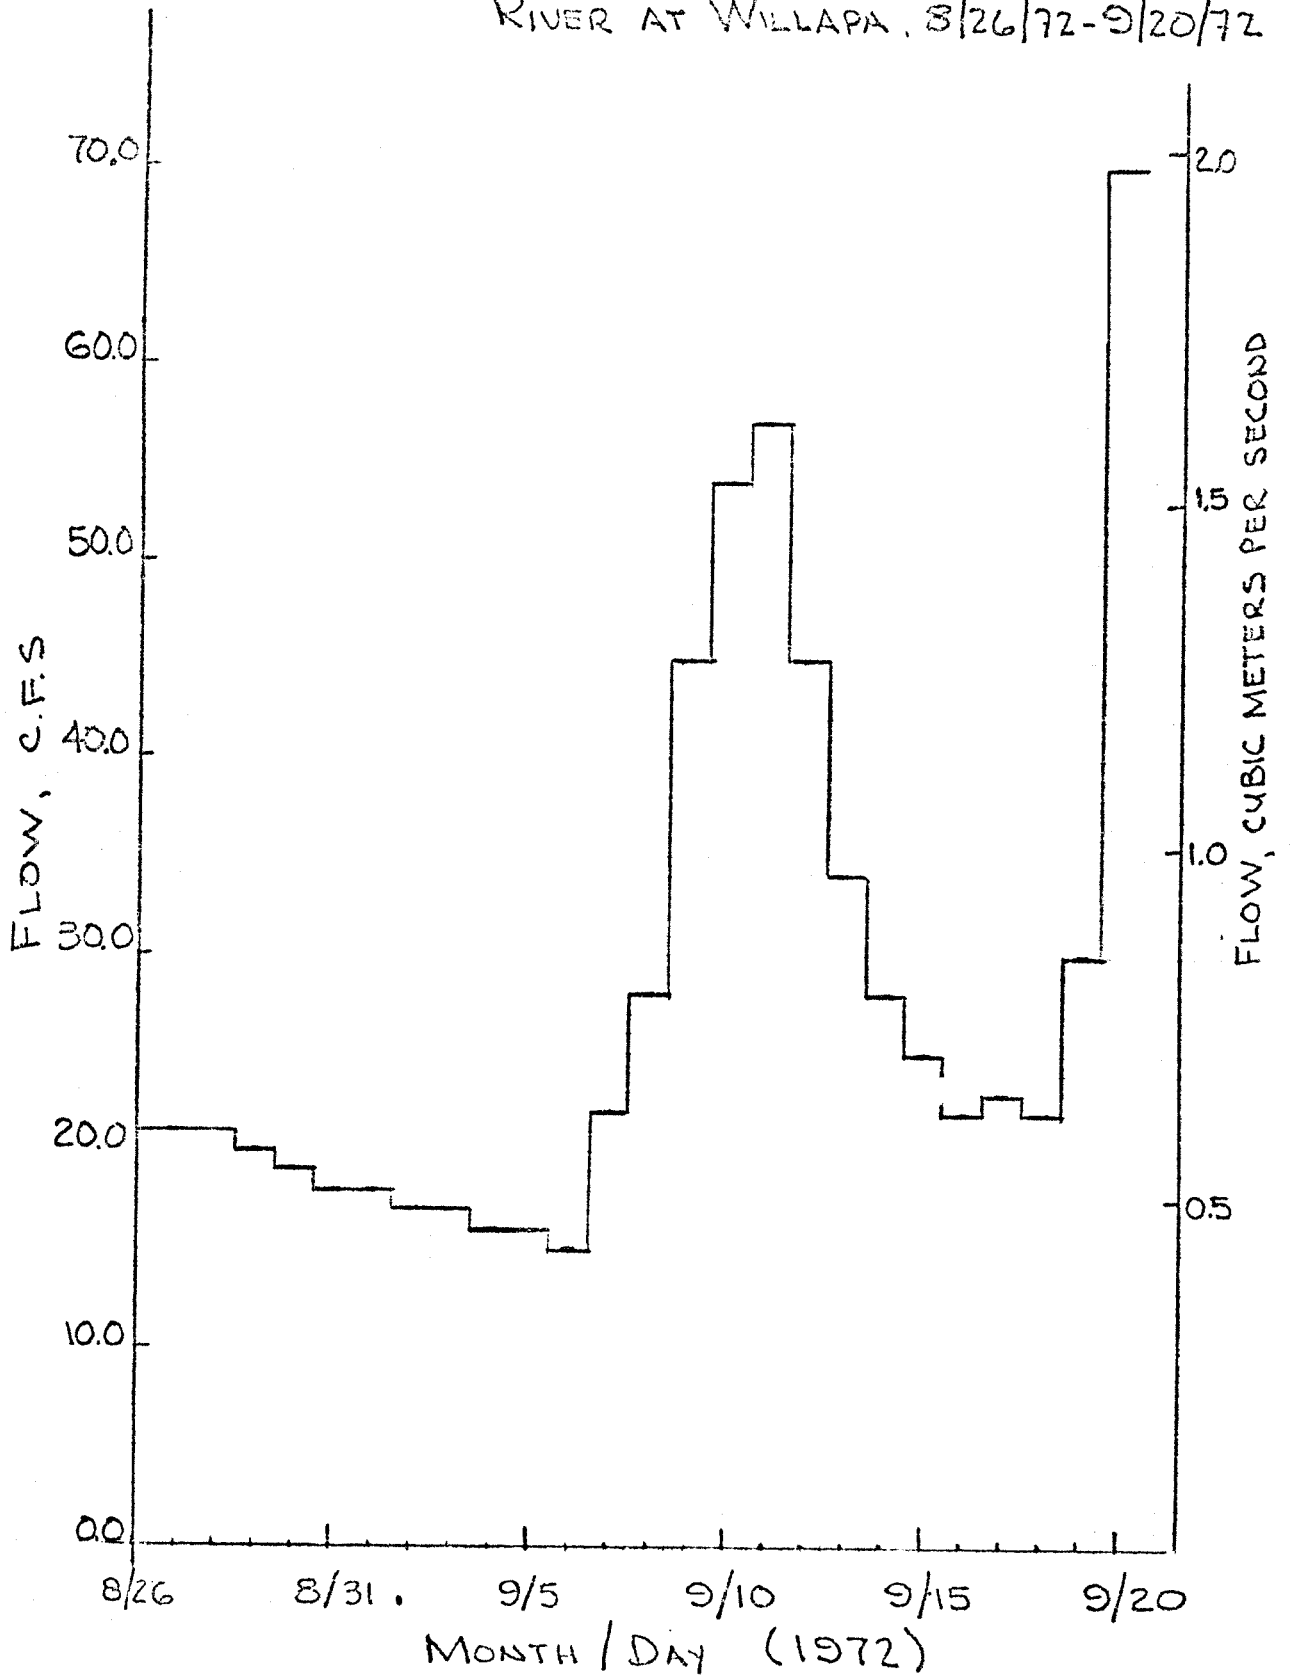
FIGURE 2. DISCHARGE OF THE WILLAPA RIVER AT WILLAPA, 8/26/72-9/20/72

The USGS discontinued the stream gauge on the South Fork of the Willapa in September of 1971. The USGS still maintains a gauge on the main stem at Willapa, upstream from Raymond. The gauge was not functioning properly during the survey period, but estimates of the discharge were made from rainfall records and water shed characteristics. The discharge estimates made by the USGS are shown in Figure 2.

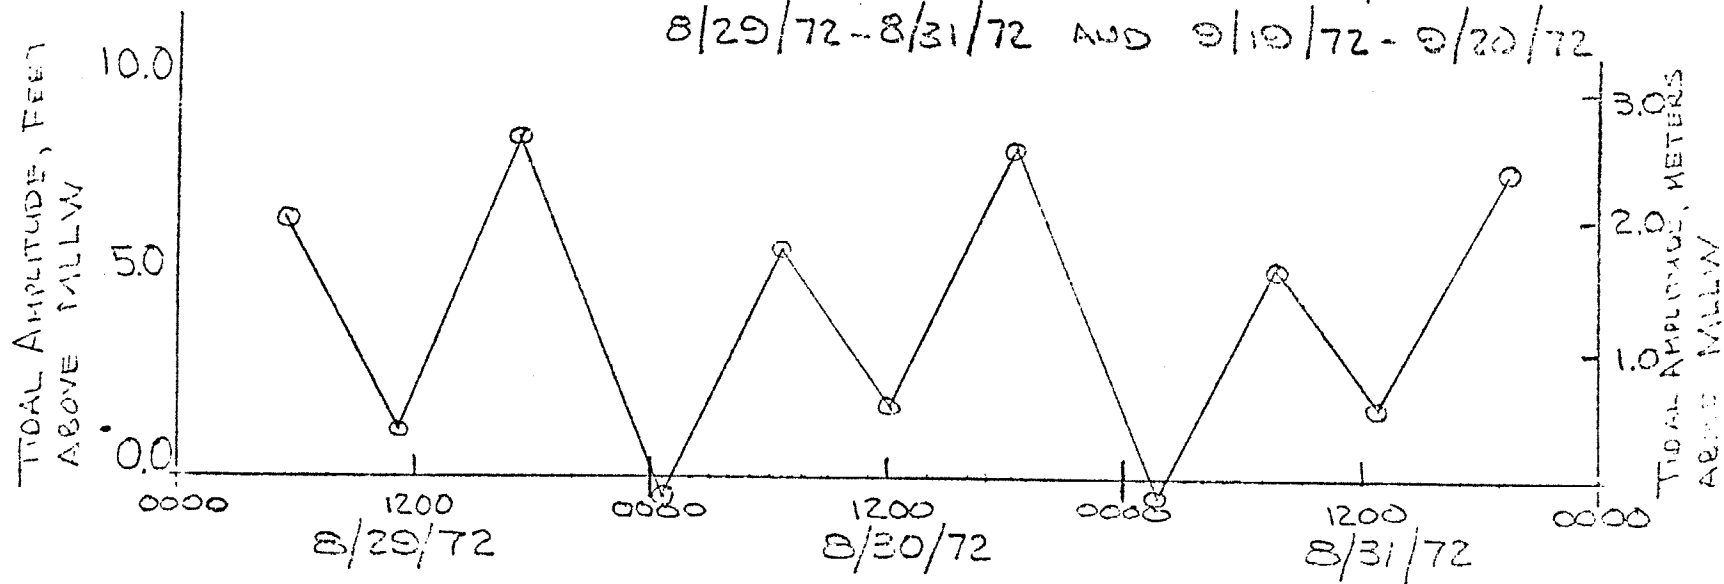
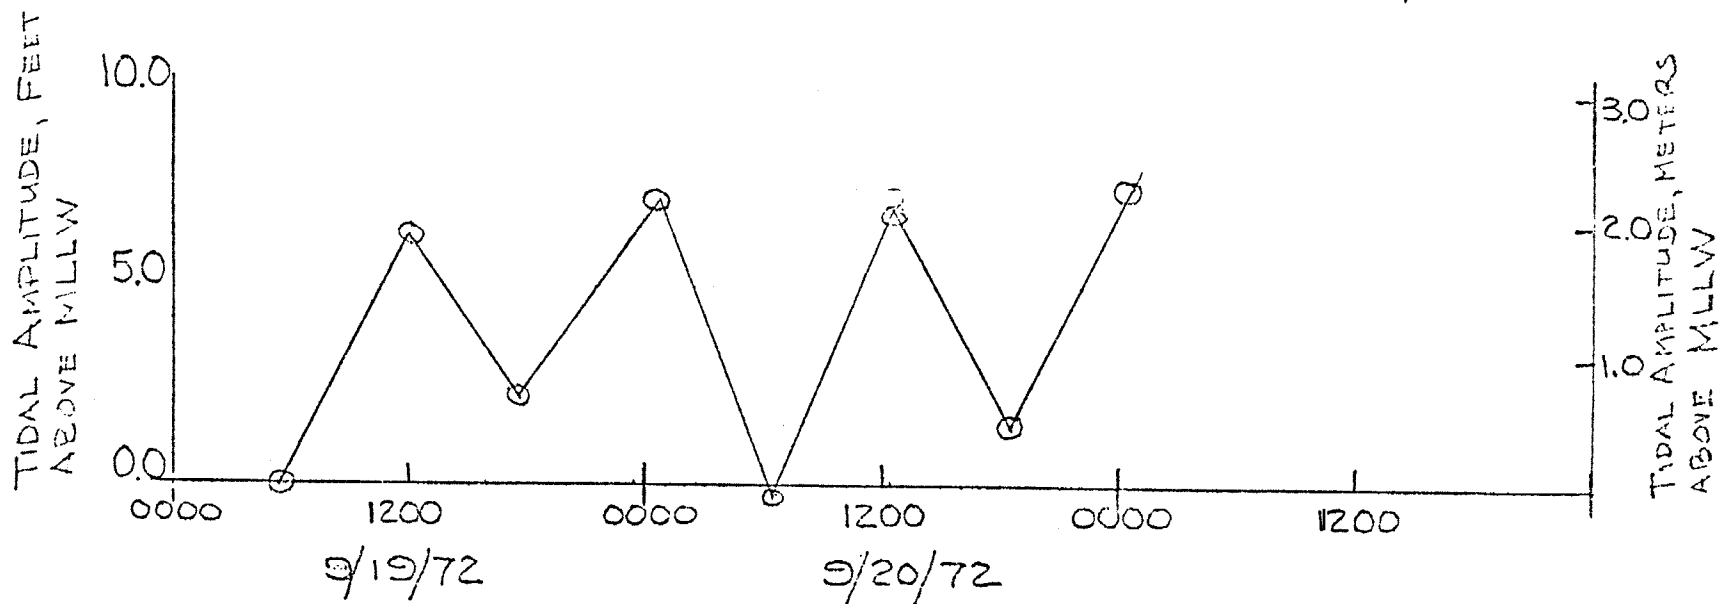
FIGURE 3 TIDAL AMPLITUDE AT RAYMOND, WASHINGTON
8/29/72-8/31/72 AND 9/19/72-9/20/72

The main stem of the Willapa River and the South Fork are influenced by the tide up to River Miles 15.6 and 12, respectively. Tidal heights at Raymond during the two surveys are shown in Figure 3.

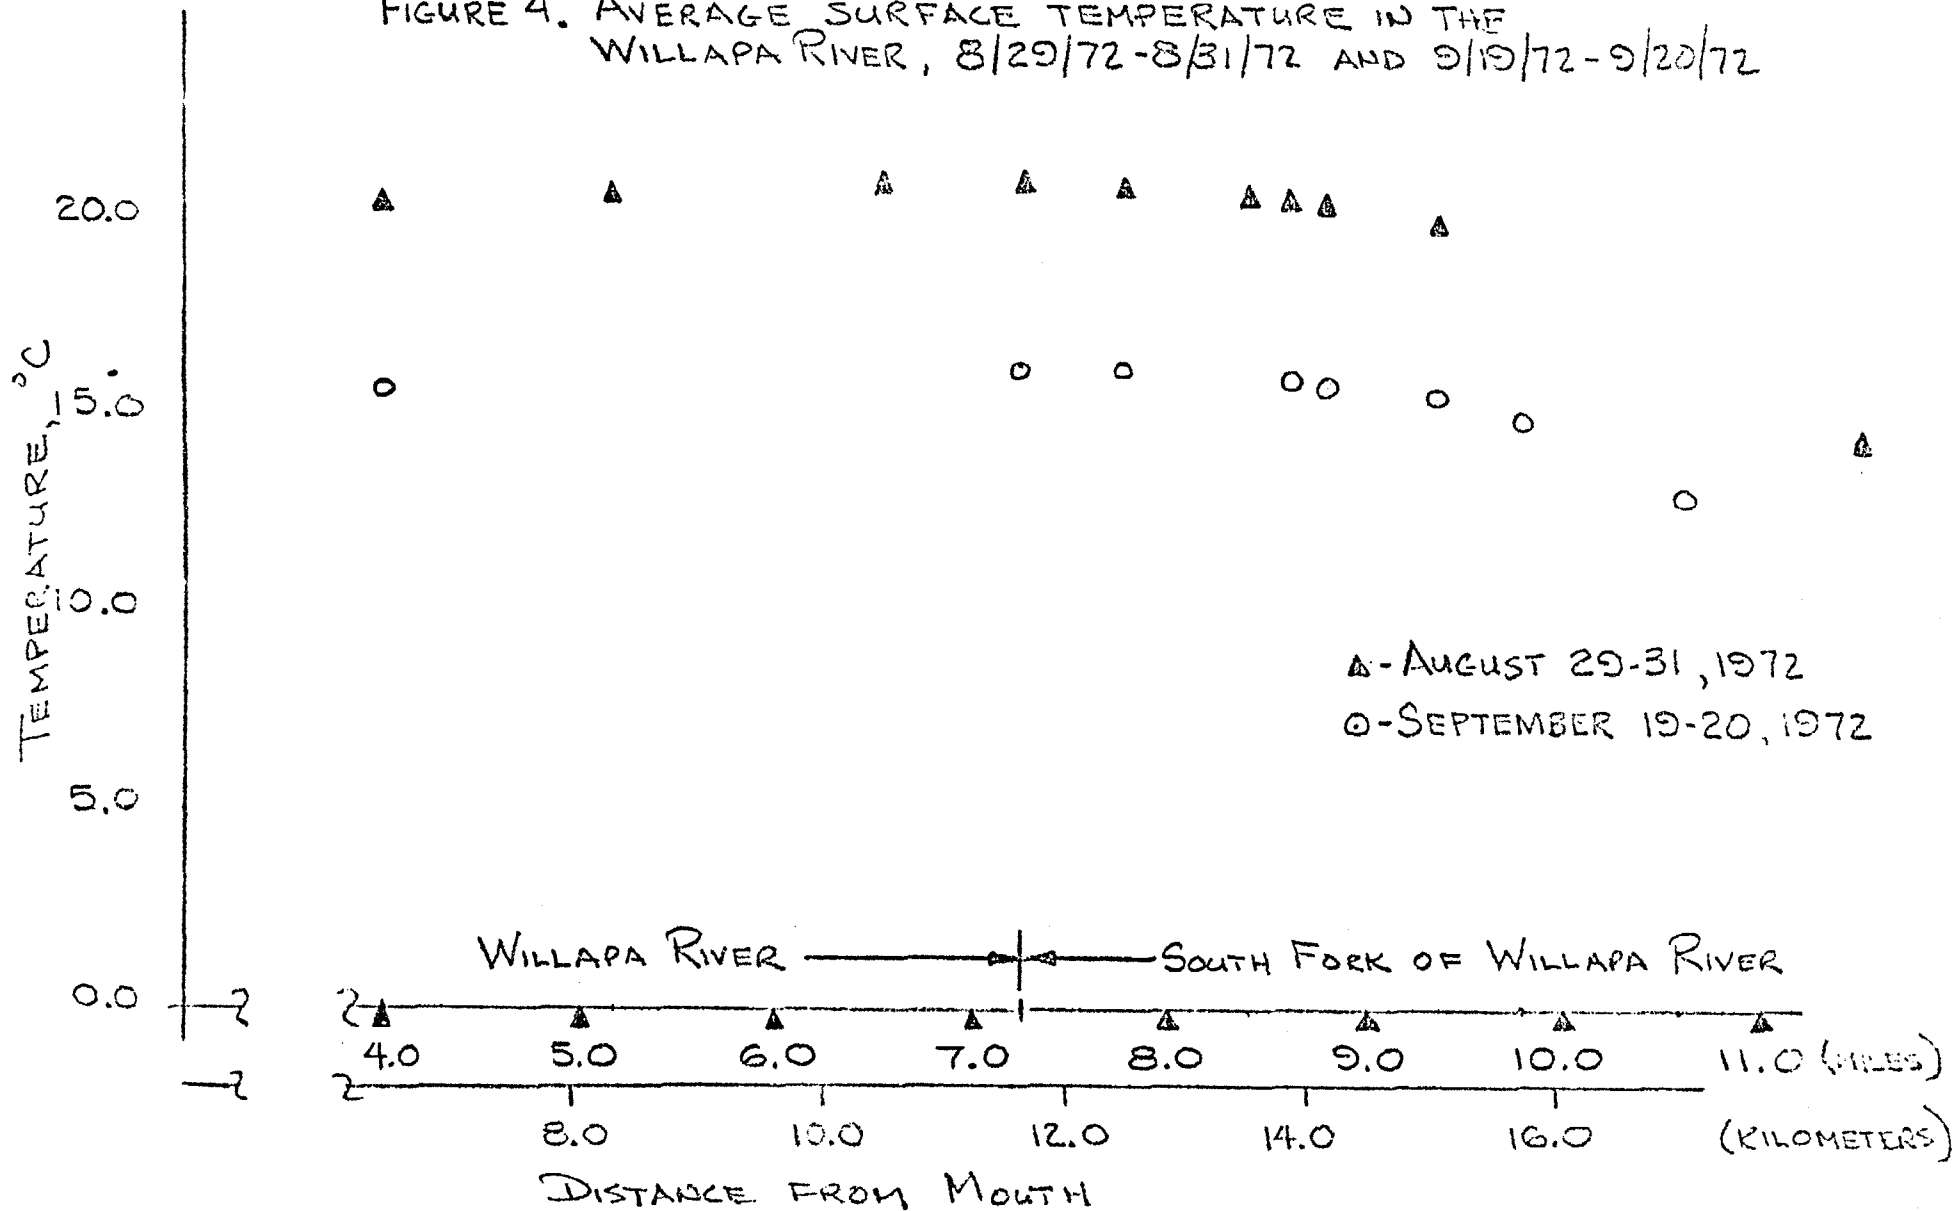
FIGURE 4. AVERAGE SURFACE TEMPERATURE IN THE
WILLAPA RIVER, 8/29/72-8/31/72 AND 9/19/72-9/20/72

Average surface temperatures during each of the surveys are plotted in Figure 4. The plotted data is for the main stem of the Willapa River from South Bend to the confluence of the South Fork and up the South Fork from the confluence to the head of tidewater.

During both surveys average surface temperatures were nearly constant from South Bend (River Mile 4.0) to River Mile 9.0 on the South Fork the cooling influence of the South Fork is noticeable. The South Fork is well shaded and the travel time from the source in the surrounding hills is short. During the August 29-31 survey, the temperature in the freely flowing portion of the South Fork was 6°C lower than typical temperatures in the lower reaches of the river.

The average temperature at each station decreased approximately 5°C between the August 29-31 survey and the September 19-20 survey.

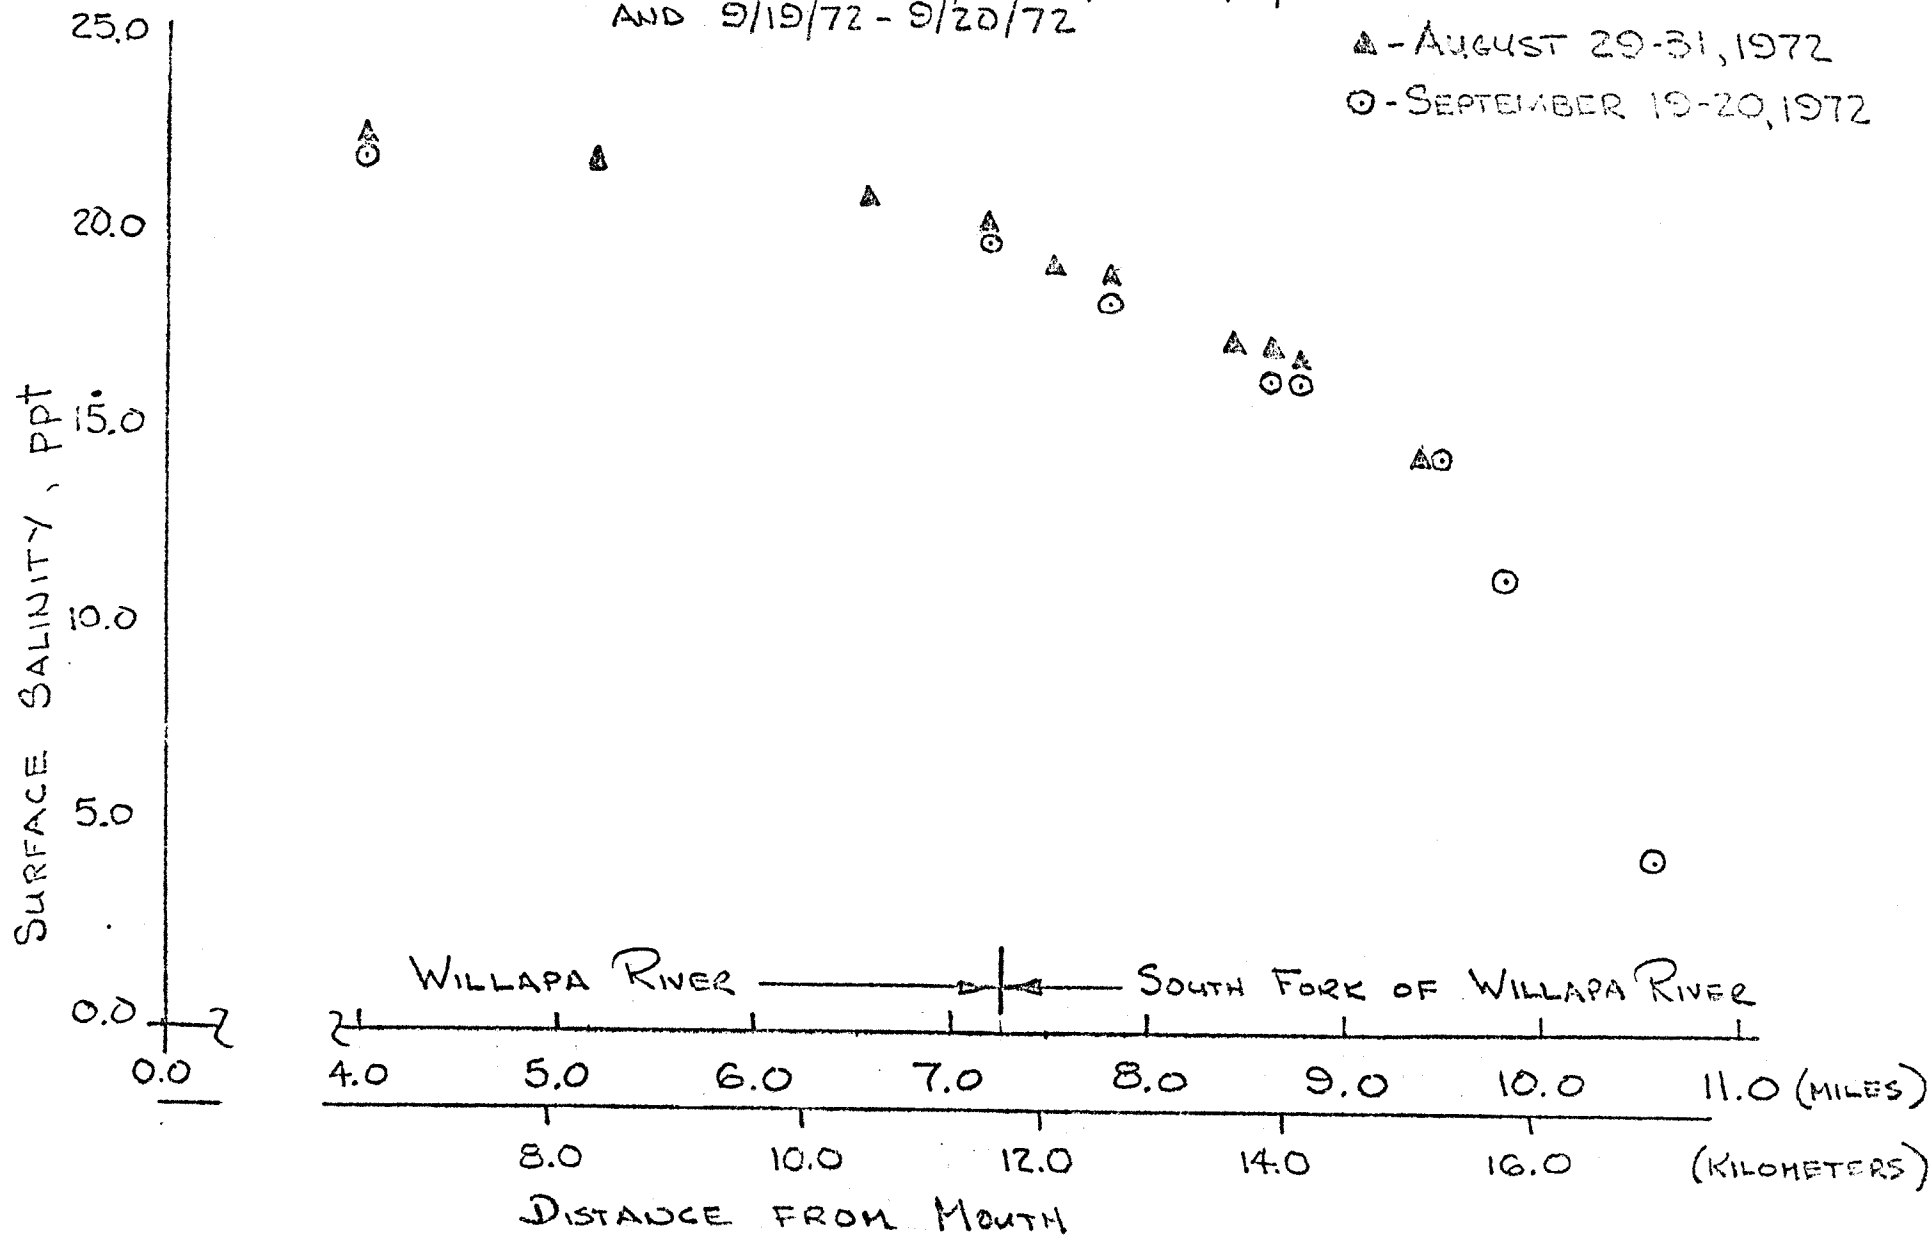
FIGURE 5. AVERAGE SURFACE SALINITY IN THE
WILLAPA RIVER, 8/29/72 - 8/31/72
AND 9/19/72 - 9/20/72

Average surface salinities during each of the surveys are plotted in Figure 5. Surface salinity was slightly lower during the September 19-20 survey because of the increase in river discharge.

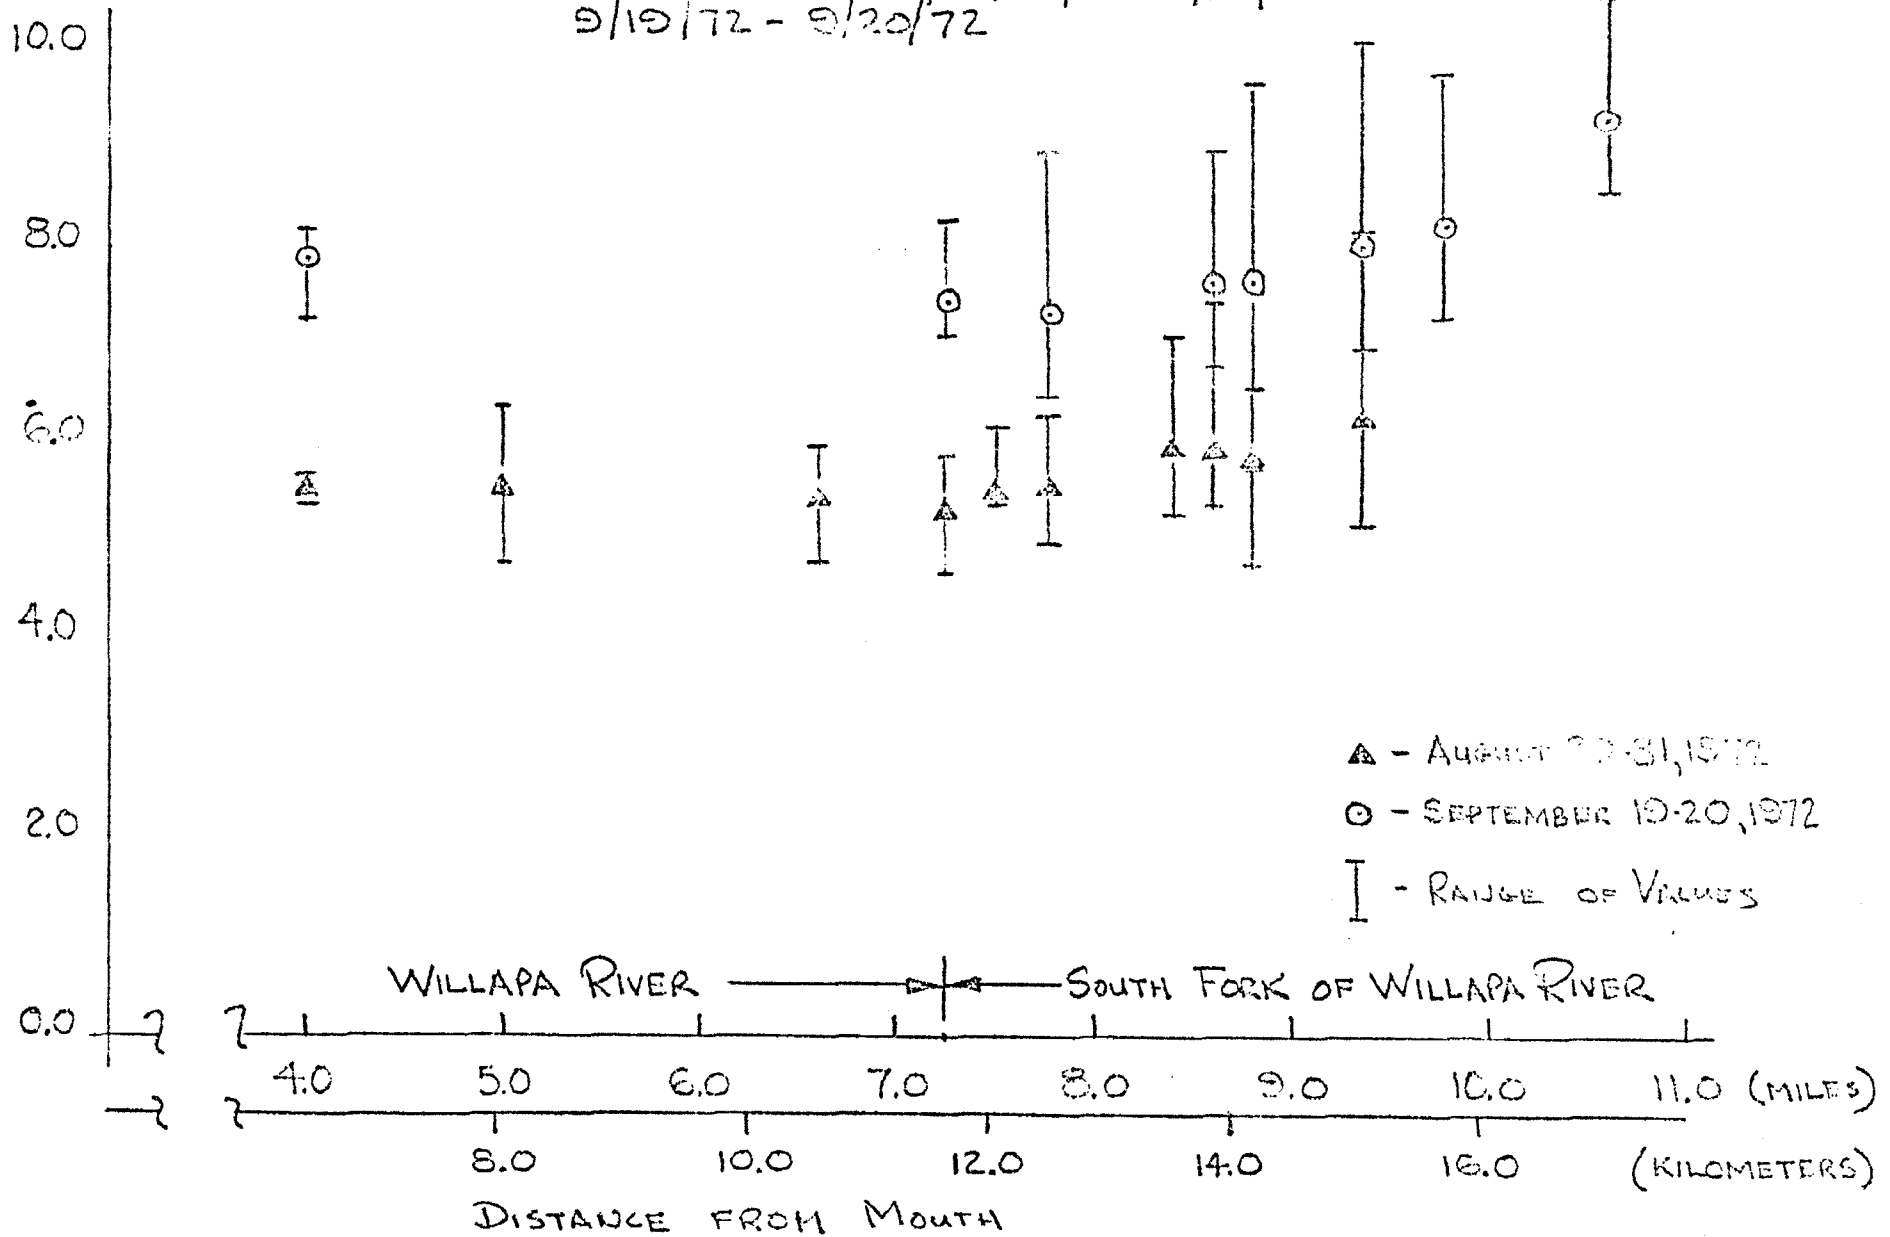
FIGURE 6. AVERAGE DISSOLVED OXYGEN IN THE WILLAPA RIVER, 8/29/72-8/31/72 AND 9/19/72 - 9/20/72

Average dissolved oxygen during each of the surveys are plotted in Figure 6. At individual stations the average dissolved oxygen values during the September 19-20 survey were from 1.7 to 2.2 mg/l greater than corresponding values from the August 29-31 survey. In addition, the ratio of the instream dissolved oxygen to the saturation value of dissolved oxygen (percent saturation) (Figure 1) increased between 10% and 20% from August 29-31 and September 19-20. Dissolved oxygen deficit (Figure 8) decreased between 0.8 mg/l and 1.4 mg/l.

Lower river temperatures, resulting in higher saturation levels for dissolved oxygen, were the cause of part of the increase in dissolved oxygen. However, the significant change in deficit implies that a large amount of dissolved oxygen was added to the river during the period of higher discharge (September 9-12) and/or a large demand on the oxygen resource was removal. A possible source of this demand is the low dissolved oxygen appears along the Washington coast in late summer due to upwelling. However, there is no data from the Willapa Bay area which indicates that upwelling was a major factor during the survey period.
