Publication No. 73-e65

SUBJECT: Investigation of Seepage to a Grant County Watercourse

Adjacent to U & I Sugar Co., Moses Lake

April 10, 1973

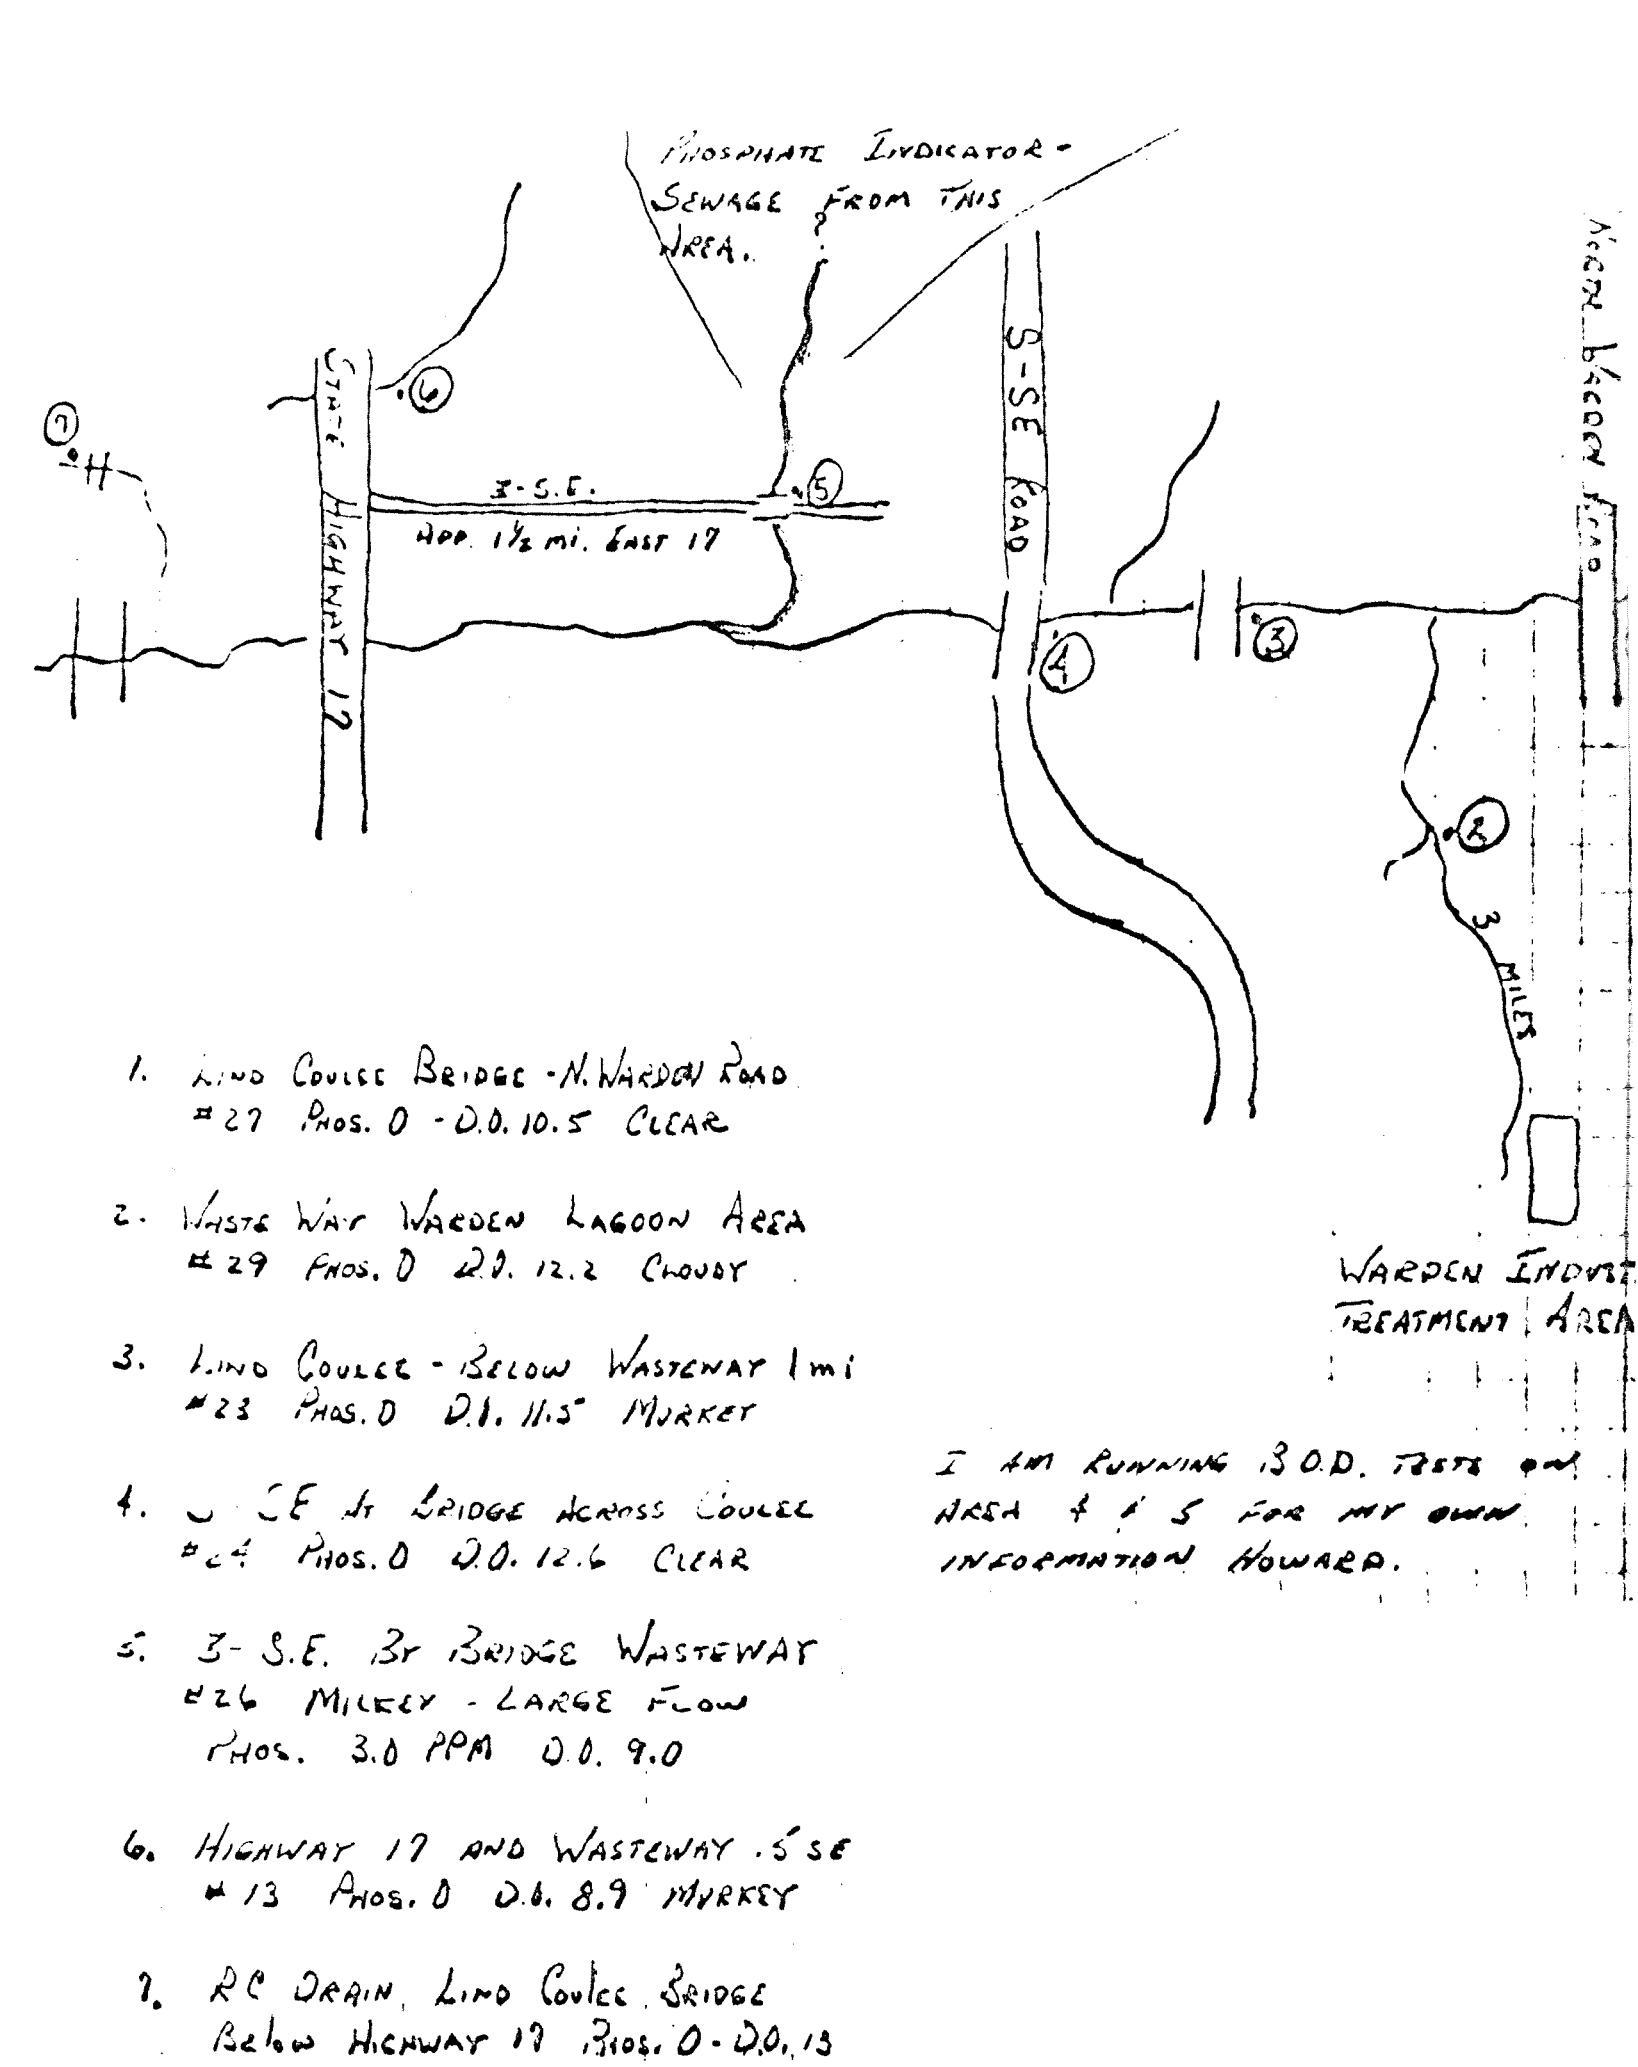
Howard Bunten and I met on March 2, 1973, and reviewed the area to be sampled. The following morning I collected samples from 3 watercourse stations and a lagoon station (see Figure 1).
