# CAMERON YAKIMA CONTAMINATED SOIL REMOVAL PROJECT REMEDIAL ACTION REPORT

PROJECT NAME: Cameron Yakima Contaminated Soil Removal Project

**LOCATION:** Site of former Cameron Yakima, Inc. facility

1414 S. First Street, Yakima, Washington

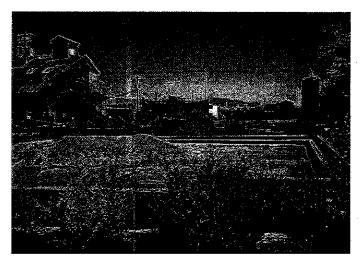
Subject PropertyFacingWest-PriorToExcavation

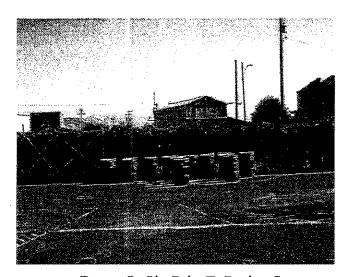
SubjectPropertyFacingEast - Prior ToExcavation

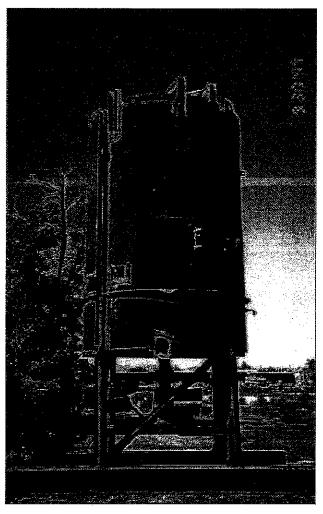
Kiln-FacingWest

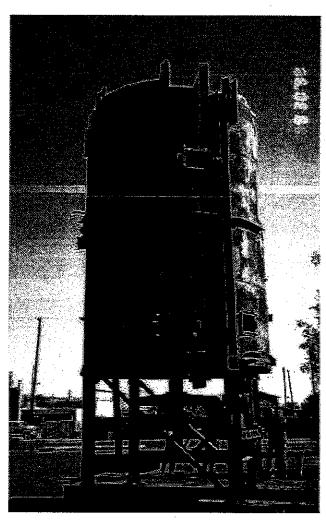
Kiln-FacingEast

Before any excavation activities the kiln location on the eastern half of the property was prepared for disposal. All openings in the kiln were welded shut and the kiln was painted with a latex paint to seal the kiln surface area. Once the kiln was sealed, a crane was used to lower the kiln onto a flatbed trailer. The kiln was then encapsulated with plastic and transported to Waste Management's disposal facility in Arlington, Oregon.

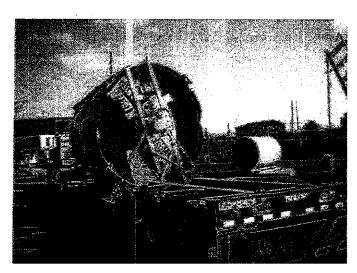
Kiln-onboardtrailerfortransportoffsite

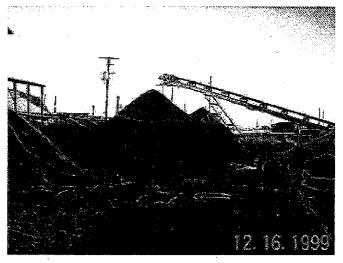
ScreenedStockpile

The excavated soil was screened to separate rocks greater than 2 inches in diameter, and stockpiled on a lined surface. Soil samples were obtained following the excavation of 4 to 5 feet of soil, based on a 40-by-60-foot grid pattern, to determine the extent of excavation needed and the degree of contamination of excavated fine and coarse soils. Verification sampling was completed following clean preliminary sample results to confirm that residual contaminant levels in the floor and sides of the excavation did not exceed the specified project cleanup levels.

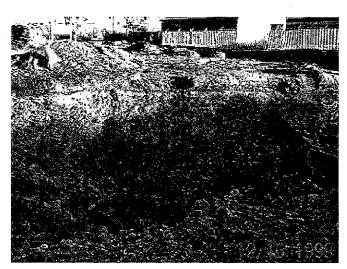
Excavationof gridC1

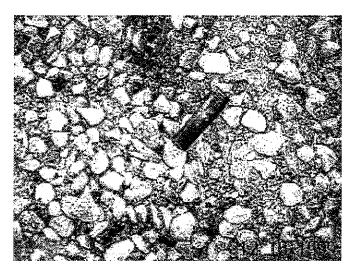
Debris

Other buried debris such as concrete was observed throughout the western excavation area. Several areas had large concrete footings and other concrete debris. Most of the subsurface debris was located in grids D5-6', E5-6'. This area had a very large amount of concrete footings and other buried concrete material. All of the material excavated was covered with carbon.

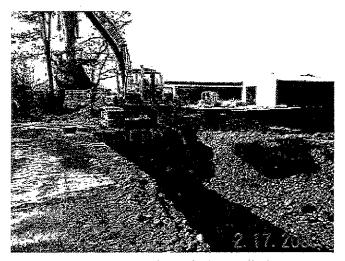
Excavation of Shano ditch

Following the excavation and backfilling of the western half of the property, the Shano ditch was excavated, the existing galvanized and concrete ditch structure was removed, and the underlying soil sampled. During the excavation of the Shano ditch contamination, was observed along the northern end in grids B6 and C6, however contamination did not exceed 6 feet bgs.

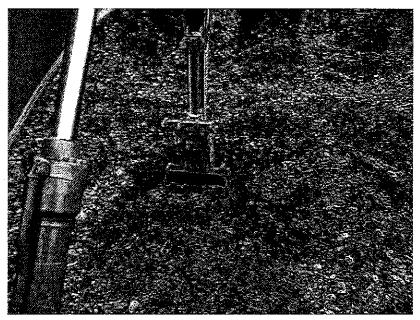
Test pit grid D4

During the excavation of grids D4 and E4 unexpected contamination was observed at 10 to 12 feet bgs, 5 to 7 feet above groundwater soil interface. This contamination was different from the contamination outlined in the Scope of Work based on field observations and analytical results. Two soil samples were collected of this material and sent to North Creek's Portland laboratory for analysis. Analysis of this material indicated that the contamination consisted of gasoline, diesel, heavier petroleum hydrocarbon analytes along with benzene, toluene, ethylbenzene, and xylene. The material was excavated, trucked and disposed of at the Rabanco facility. Along with this unexpected contamination, a vertical, 10 inch steel pipe was located just east of the new contamination area. The pipe went from 2 feet bgs to 25 feet bgs and possibly deeper. During its removal it was broken two feet below the water table. It is unknown if the pipe was associated with the additional contamination.

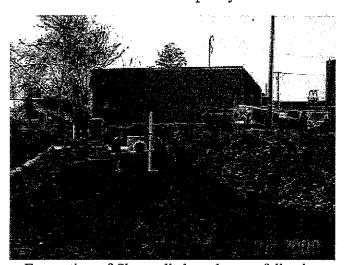
Excavation of Shano ditch underway following installation of temporary ditch

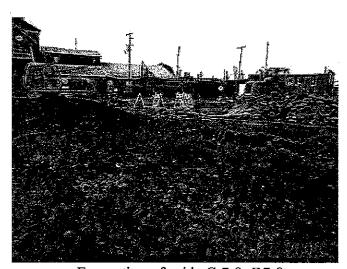
Excavation of grids C-7-8, D7-8

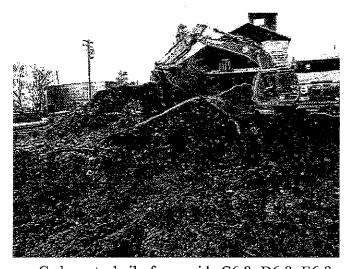
Carbon stockpile from grids C6-8, D6-8, E6-8

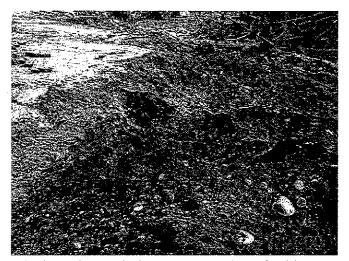
Carbon observed along eastern edge of grids E7, D6

The soils directly below the asphalt appeared heavily laden with carbon throughout the eastern half of the property. Soil from 5 to 7 feet bgs was removed from the eastern half of the property encompassing grids B, C, D and E7, B, C, D, and E8, B, C, D, and E9. Carbon was observed in all of these grids with a thicker more defined layer along the eastern property boundary . This layer of carbon on the eastern boundary of the property through grids B7, B8 and parts of B9 had a depth of up to 8 feet bgs.

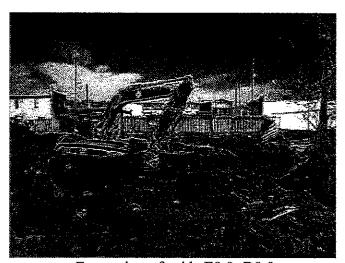
Excavation of grids E8-9, D8-9

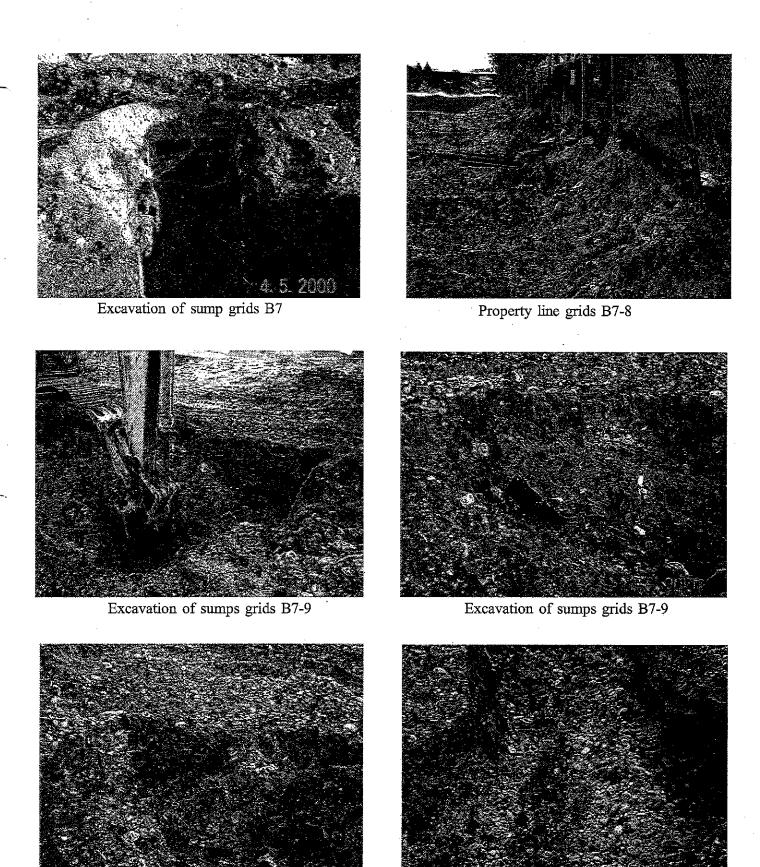
Excavation of sumps grids B7-9

During the excavation of the first lift of soil, three sump systems as well as three septic systems were encountered along the northern boundary of the property in grids B6, B7, B8 and B9. Three of them along the northern boundary in grids B7, B8 and B9 were connected by a 4 to 6 inch pipe. Each system was removed on site with an excavator and samples were collected from directly below the location of the removed system. Also, during the excavation along the northern boundary of grids B6, B, a 10 to 12 inch pipe was observed directly below one of the storage/septic devices located in this grid. This pipe ran into the ground approximately 10-12 feet bgs. When investigated the pipe appeared to be full of sand and dirt at 12 feet bgs. Further excavation could not be completed due to sloping from the northern property boundary. Sampling collected from the pipe location were free of target SSC's. Following the removal of the septic drainage systems from the northern property boundary and the removal of 5 to 8 feet of soil throughout the entire eastern half of the property, preliminary and verification sampling was completed in each grid with no indication of contamination.
