Stream Discharge Technical Notes

Station ID: 05A105

Station Name: South Fork Stillaguamish River at Jordan Road bridge

Water Year: 2023

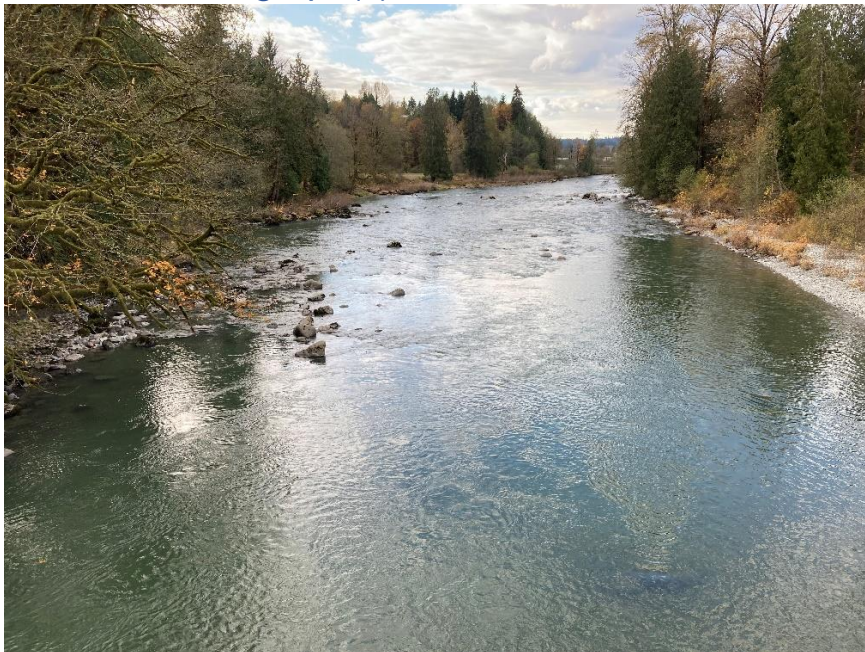
Figure 1: South Fork Stillaguamish River looking downstream toward the boulder control structure.
