Washington State Department of Ecology

Stream Discharge Technical Notes

Station ID: 05B090

Station Name: North Fork Stillaguamish River at Oso

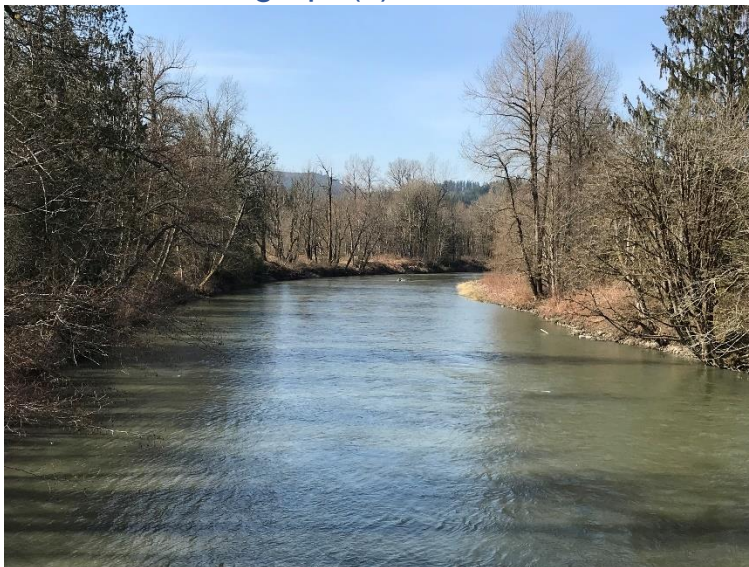
Figure 1: Downstream view of the North Fork Stillaguamish River at Oso during winter flows.

The gage is located on the right bank of the North Fork Stillaguamish River at the north end of Whitman Road bridge. The gage house is at the same elevation as the roadway; and the slant-pipe drops about 25 feet along the side of an old bridge abutment into the river. The terminal end of the pipe extends into a deep portion of the channel a few feet offshore.
