**REVISED DRAFT CLASS 3 PERMIT MODIFICATION FOR  
SITE 1 CAMU  
TESORO REFINING AND MARKETING COMPANY  
ANACORTES REFINERY**

**DECEMBER 15, 2020**

**Gregg Stiglic  
Tesoro Refining and Marketing Company,  
Anacortes Refinery  
10200 March's Point Rd  
Anacortes, WA 98221**

**Pacific Groundwater Group  
2377 Eastlake Avenue East, Suite 200  
Seattle, Washington 98102  
206.329.0141  
[www.pgwg.com](http://www.pgwg.com)**

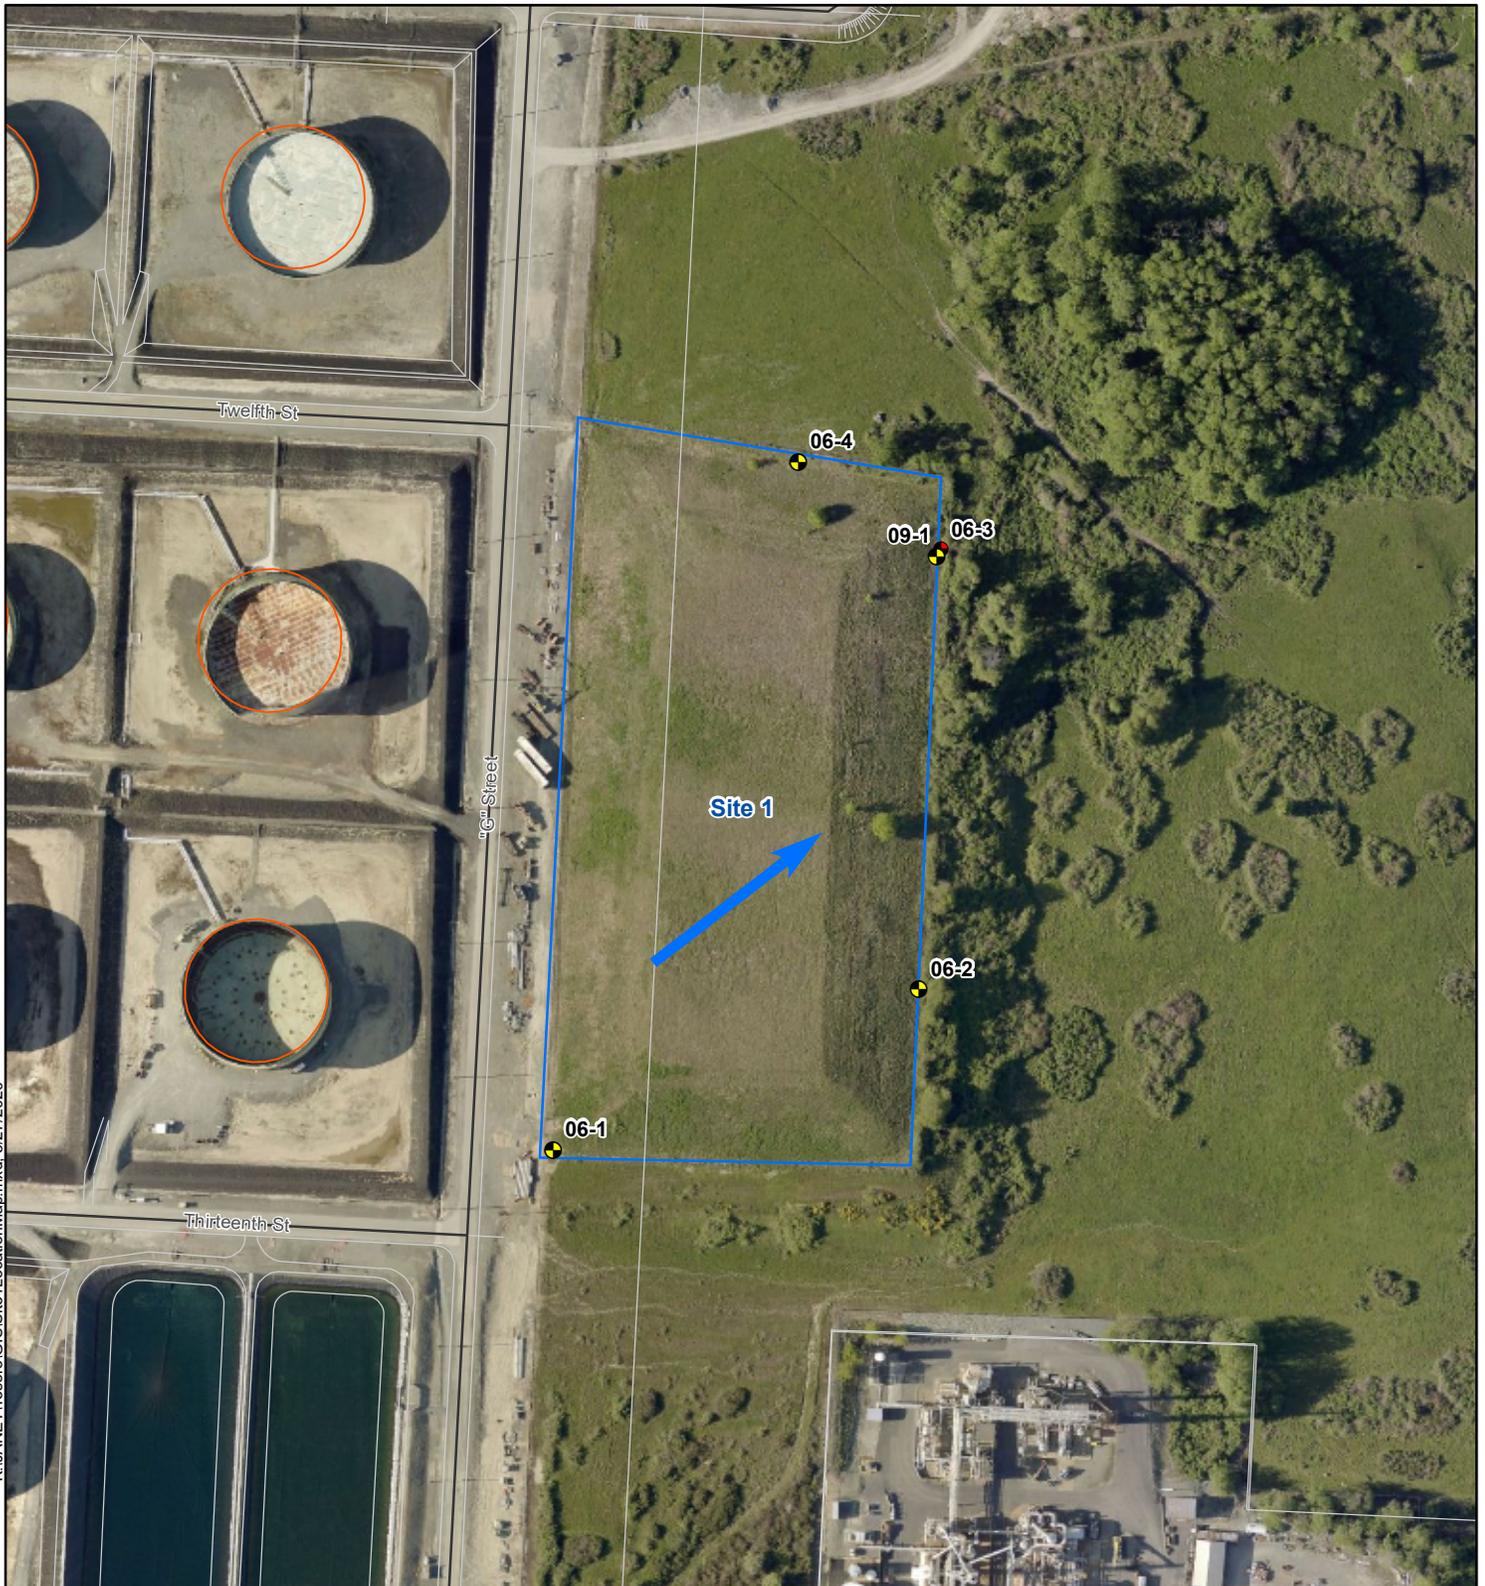
Figure 1  
Site 1 Monitoring  
Well Locations

Aerial Photo: 2019

The Tesoro Anacortes Refinery (Tesoro), which is located on the northern half of March Point peninsula on Fidalgo Island (Figure 1), is submitting this Class 3 Permit Modification to request early termination of the post-closure care period for Tesoro's Site 1 Corrective Action Management Unit (CAMU). The Washington Department of Ecology (Ecology) approved Site 1 CAMU for closure in 2006 and post-closure groundwater monitoring has taken place since that time. As detailed in Section 4.4, post-closure groundwater monitoring data supports early termination of the post-closure care period and is the basis of this Class 3 Permit Modification.

The inactive Land Treatment Unit (LTU) and now CAMU referred to as Site 1 is located in the southeastern part of the Anacortes refinery (Figure 1). It was used from 1971 through 1974 for land treatment of refinery wastes.

Site 1 CAMU (SWMU 18) is an inactive land farm located in the southeastern part of the refinery (Figure 1), covering an area of approximately 7 acres. Site 1 CAMU is covered by a vegetated cap and was used from 1971 through 1974 for land treatment of refinery wastes. Per the approved 2006 Permit Modification, Site 3 soils that did not contain principal dangerous constituents substantially above MTCA Method C levels were transferred from Site 3 to Site 1 and soil sampling confirmed that levels did not exceed Method C levels.

Four Site 1 CAMU groundwater wells were installed in 2006 following placement of Site 3 soils, clean fill cap, grading, and seeding. The wells include upgradient well 06-1 and downgradient wells 06-2, 06-3, and 06-4. In 2009, a replacement well (09-1) for 06-3 was installed due to seasonal low water that did not allow consistent sampling at 06-3. The well logs for all five wells are included in Appendix A. All wells were installed by a Washington licensed driller in accordance with WAC 173-160 with soil types and hydrogeology documented by a PGG geologist.
