Remedial Investigation / Feasibility Study Report

Lacey Urban Center
7131-7269 Martin Way East
Olympia, Washington 98516

AEG Project #: 17-126
Date of Report: April 1, 2021

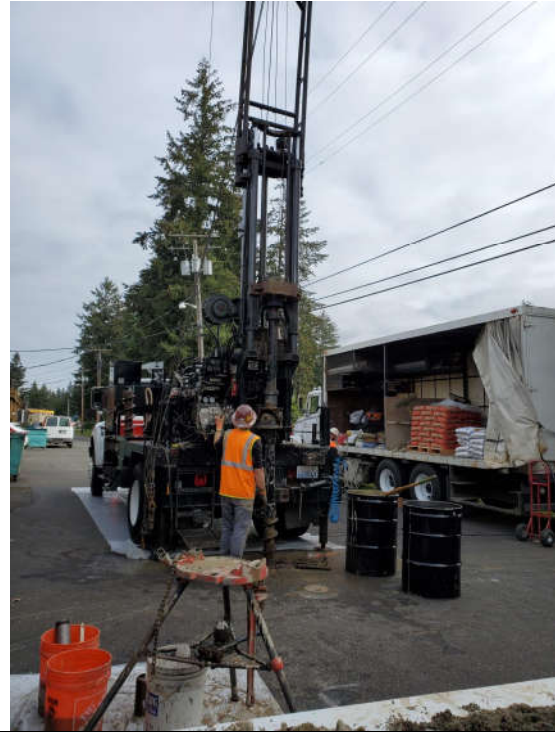
Photo #2: *Installation of monitoring well MW-4 facing north.*

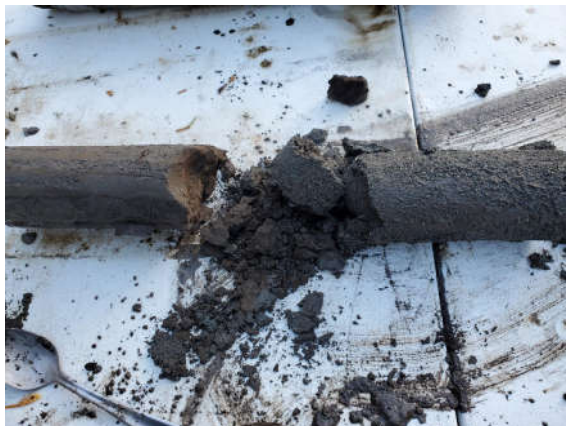
Photo #3: *Typical soil profile from location B-19 sand/silts.*

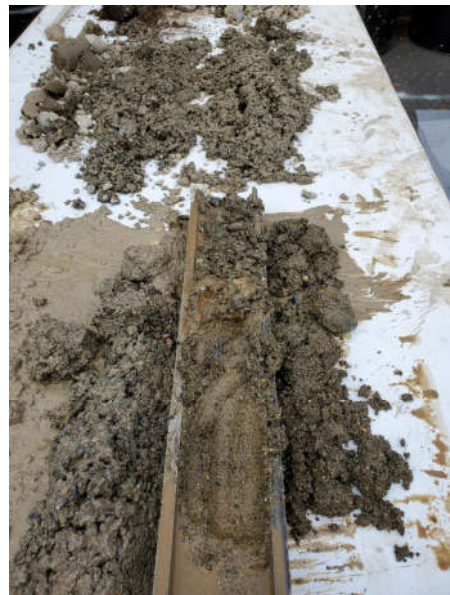
Photo #4: *Deep soil profile from location MW-4 silts/sands with gravels.*
