Focused Subsurface Investigation Report

23418 Pacific Highway South Kent, Washington

Stephen M. Spencer ECI Project No.: 0673-01-01
Principal Environmethal Scientist

File: FSI-23418 Pacific Highway S.-121817 ECI Project No.: 0673-01-01

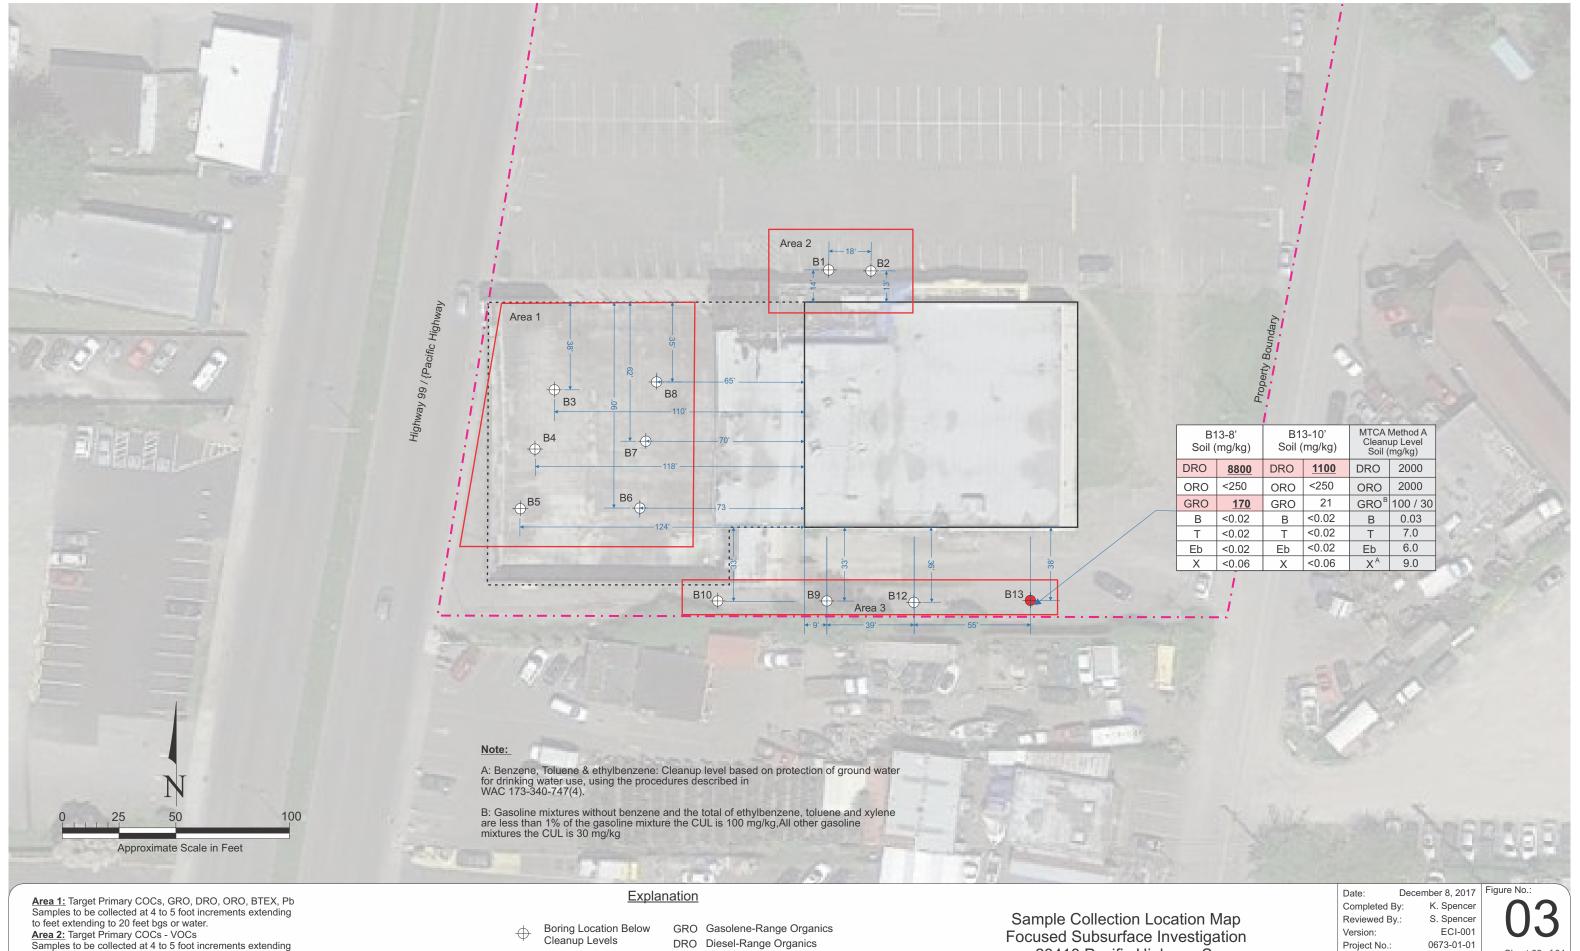
Figure 3: Boring Location Map

Area 3: Target Primary COCs - GRO, DRO, ORO, VOCs

Samples to be collected at 4 to 5 foot increments extending to feet extending to 20 feet bgs or water.

Boring Location Above Cleanup Levels

Standard Environmental Probe of Tumwater, Washington advanced twelve (12) borings at the Site (Borings B1 through B10 and Borings B12 and B13) using a Geoprobe® drill rig and direct push drilling techniques under the supervision of an ECI environmental professional. The locations of the borings are

presented on Figure 3 in Appendix A. Six (6) borings were installed in Area 1, two (2) borings were installed in Area 2 and four (4) borings were installed in Area 3.

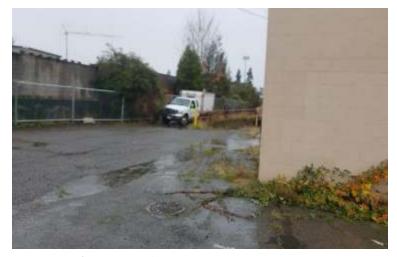
Photograph One: Boring B13

In Boring B13, DRO was detected at a depth of 8 feet bgs (Sample B13-8') at a level of 8,800 mg/kg which is above the MTCA Method A cleanup level of 2,000 mg/kg. The laboratory also reported GRO at a level of 170 mg/kg, which is above the MTCA Method A cleanup level of 100 mg/kg. However, according to the laboratory, the GRO reported is not actually GRO but DRO. It is a result of an overlap of the DRO hydrocarbon range with the GRO hydrocarbon range.

Boring B13 is located along the southern property boundary approximately 38 feet south of the building and approximately 240 feet east of the corner of the former building footing (100 feet west of the centerline of 30th Avenue South) (Figure 3, Appendix A). The analytical results are presented in Table 1, Appendix B and the laboratory datasheets are presented in Appendix D.

Based on the location of the boring and the depth of the sample, it is believed that the DRO reported maybe from the adjacent property to the south, which has had a cleanup of DRO in 2002.

ECI recommends that further investigation be performed to delineate the extent of the soil contamination on the Subject Property in the area of Boring B13. In addition, it is recommended that the owner of the adjacent property be notified.
