Technical Memorandum

RE: **Big Hanaford Closure Summary**
Emerald Kalama Chemical/Fire Mountain Farms
Fire Mountain Farms Storage Units
Lewis County, Washington
Project No. 0066045.110.113

This technical memorandum provides a summary of closure activities for Big Hanaford storage facility (Big Hanaford) operated by FMF. From January 4, 2021 through February 5, 2021, FMF completed the facility's closure in accordance with the Final Closure Plan (LAI 2020), which was prepared for all three facilities as stipulated in the Agreement. Closure activities are described in the following sections and consisted of removal and disposal of mixed material stored in Big Hanaford, investigation of the structure and prior mixed-material releases outside of Big Hanaford, decontamination of mixed-material residues, and collection of confirmation samples.

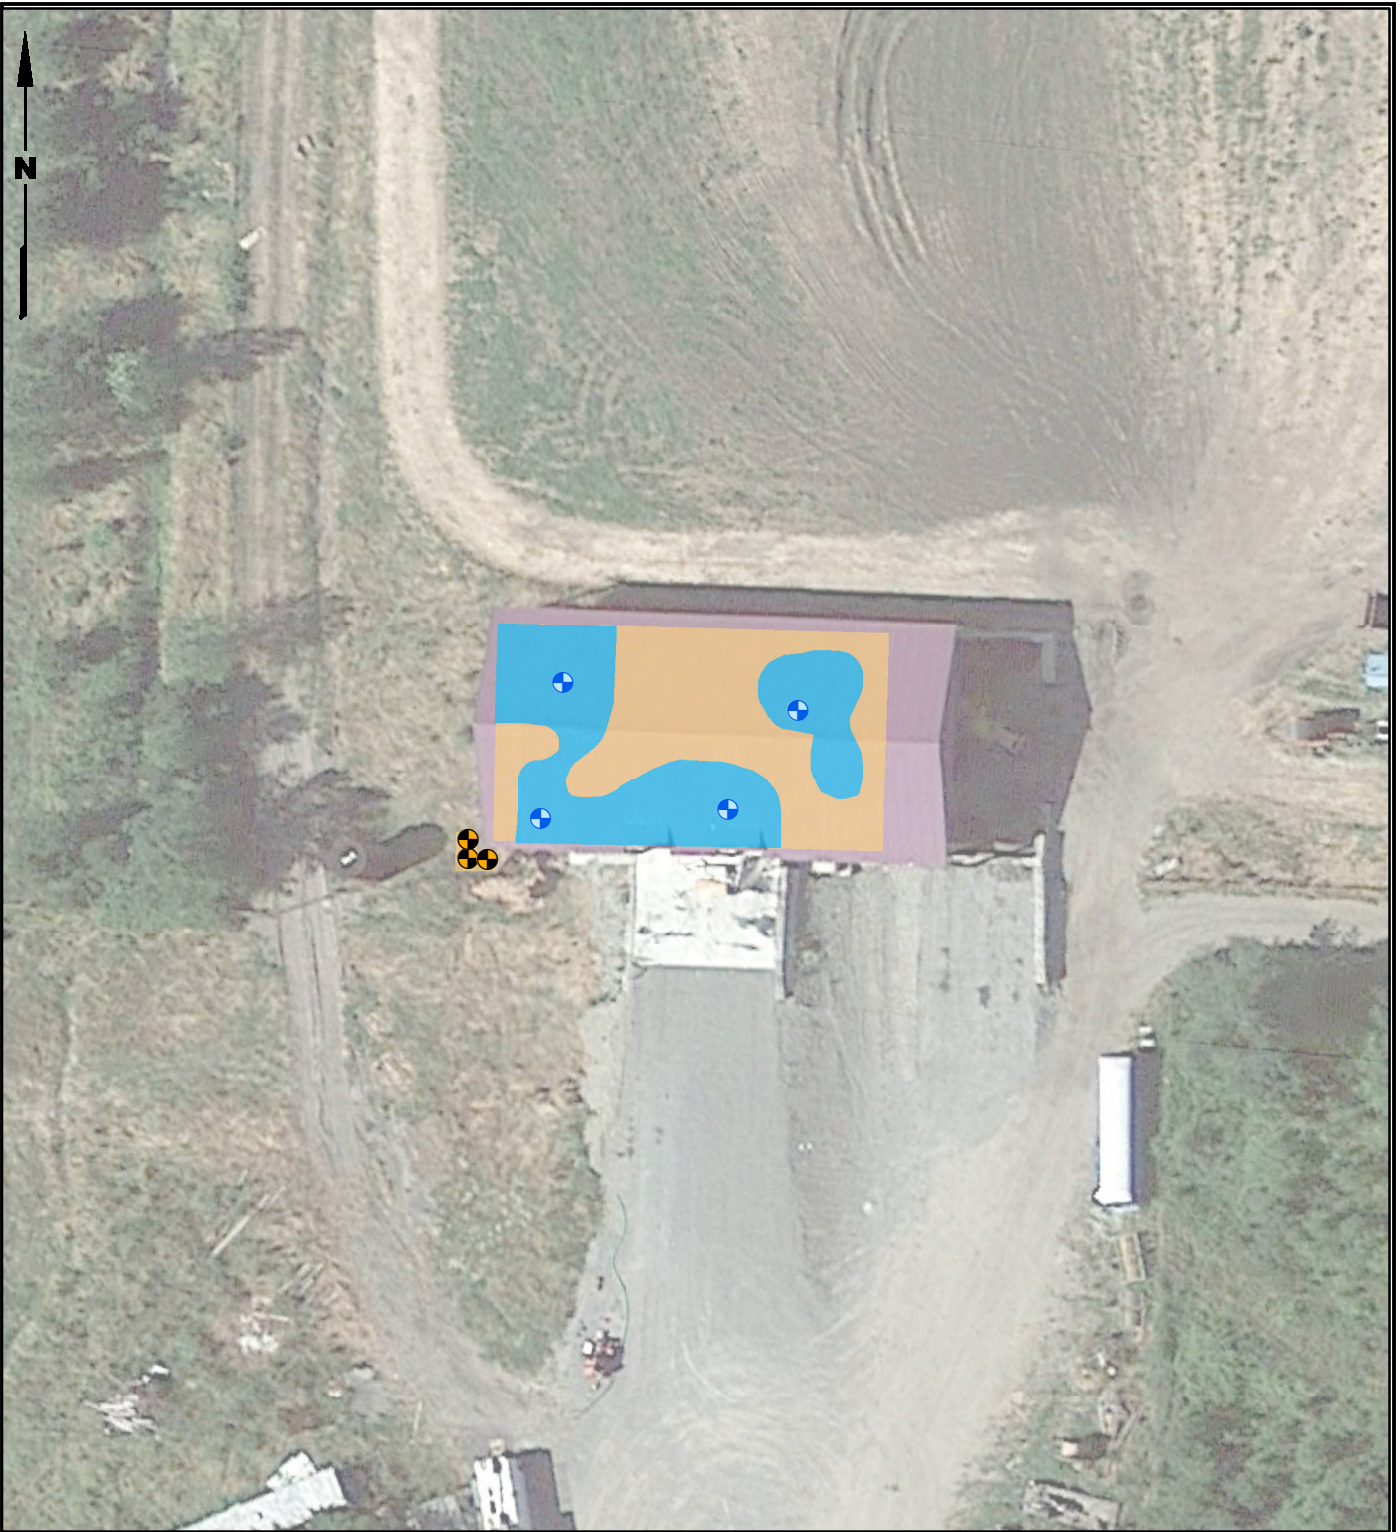
Figure
2

Soil Sample Aliquot Location for Sample BH-SOIL1-020521
-

Water Sample Aliquot Location for Sample BH-RINSE1-020521
-

**Big Hanaford Storage Unit
Sampling Locations**

On February 5, 2021, LAI collected confirmation samples related to storage unit decontamination and the historical leak outside the southwest corner of the storage unit. Sampling locations are shown on Figure 2.

After pressure-washing to remove the mixed material adhered to the concrete walls and slab, FMF applied rinse water to the clean sides of the storage unit and allowed water to pool on the concrete floor for sample collection. LAI collected and composited four aliquots of pooled water into a 1-liter container and then collected a sample, BH-RINSE1-020521, from that composited rinse water.

A composite soil sample, BH-SOIL1-020521, was collected outside of and immediately adjacent to the southwest corner of the storage unit from three aliquots within a 10-ft by 10-ft area centered around the historical leak. The soil from the aliquots was gently homogenized and the sample was collected using EPA field collection Method 5035A.

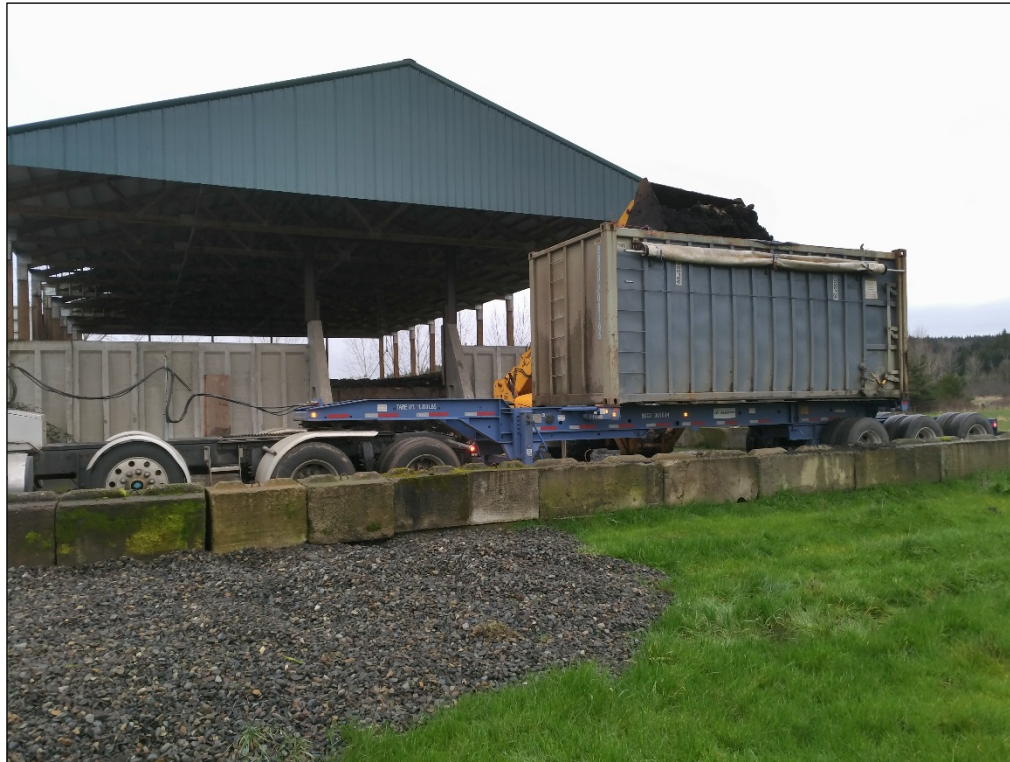
1. Loading mixed material into intermodal container (01/05/2021).

Mixed material, along with a small amount of soil as discussed in the next section, was removed by FMF personnel between January 4 and January 25, 2021. Using a front-end loader, the mixed material was loaded into plastic-lined shipping containers on truck trailers that were provided and transported by LeMay Enterprises, Inc. (LeMay), which is Lewis County's designated waste hauler. FMF cleaned any spilled mixed material from the sides and top of each container and each container was then covered before leaving the site. On behalf of Emerald, LAI personnel conducted periodic inspections to monitor the cleanup progress. After removal of the bulk of the mixed material with the front-end loader, hand tools (shovels) were used to remove what the front-end loader could not. Hand-removed mixed material was placed in bags and then disposed of in the final container. LeMay hauled 56 containers to the Centralia Rail Yard where containers were transferred onto rail cars and transported to the Roosevelt Landfill in Roosevelt, Washington for final disposal. Based on the bills of lading, the total weight of the disposed material was 1,450 tons.

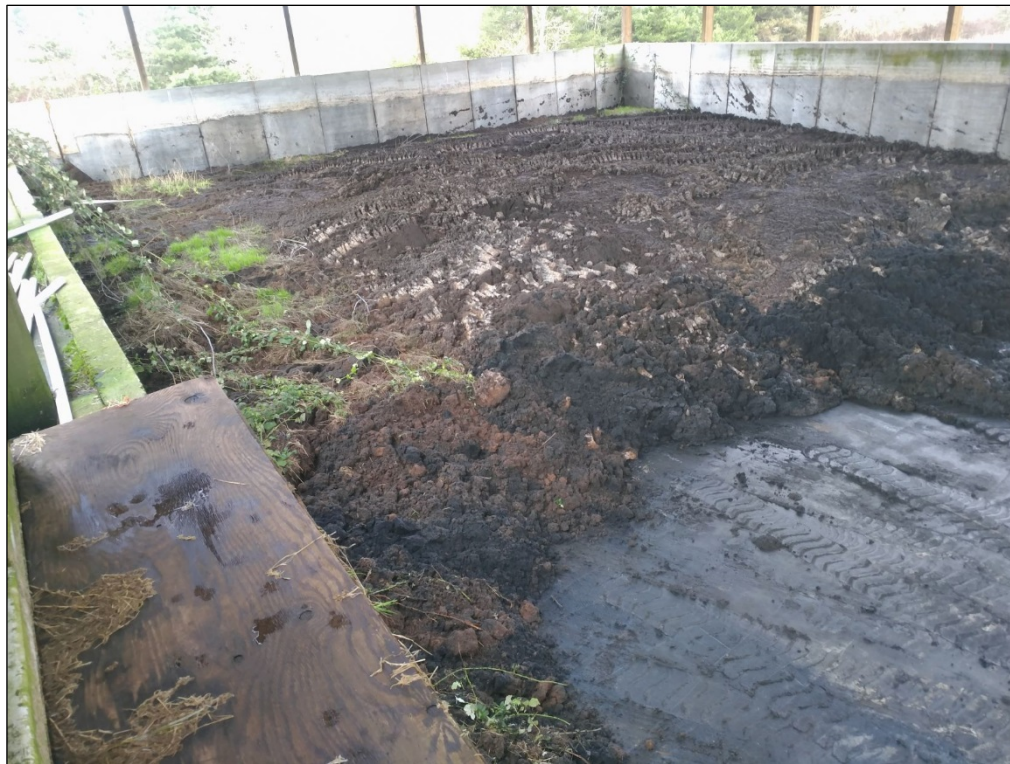
2. Storage unit being emptied (01/18/2021).

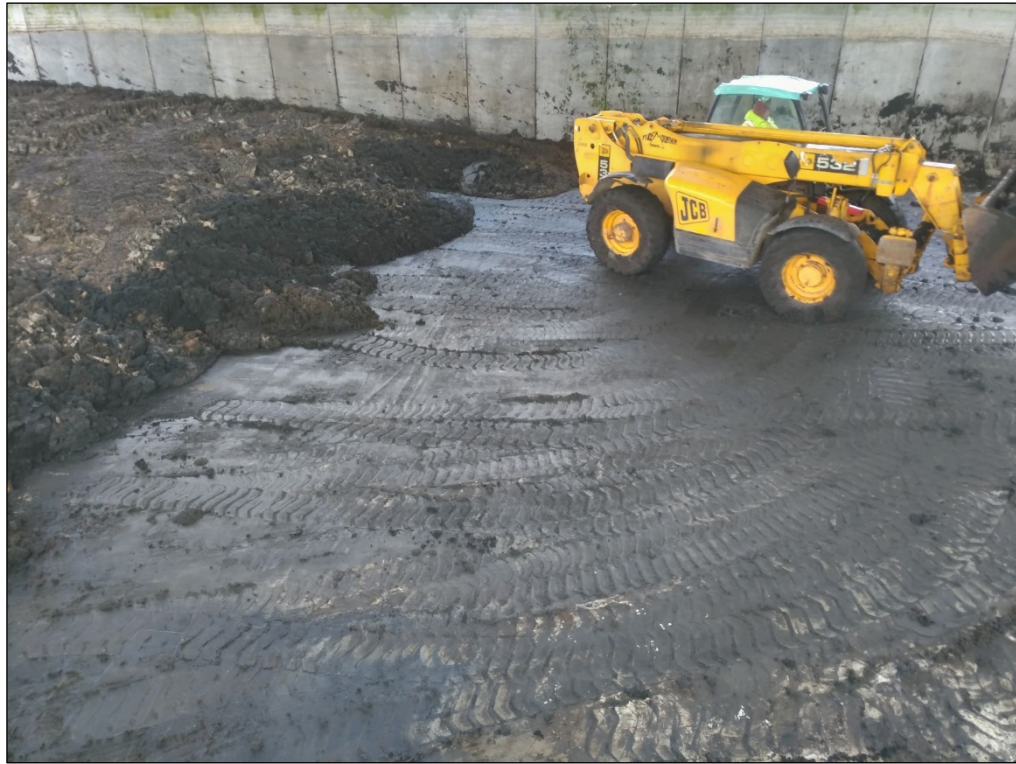
3. Storage unit being emptied (01/18/2021).

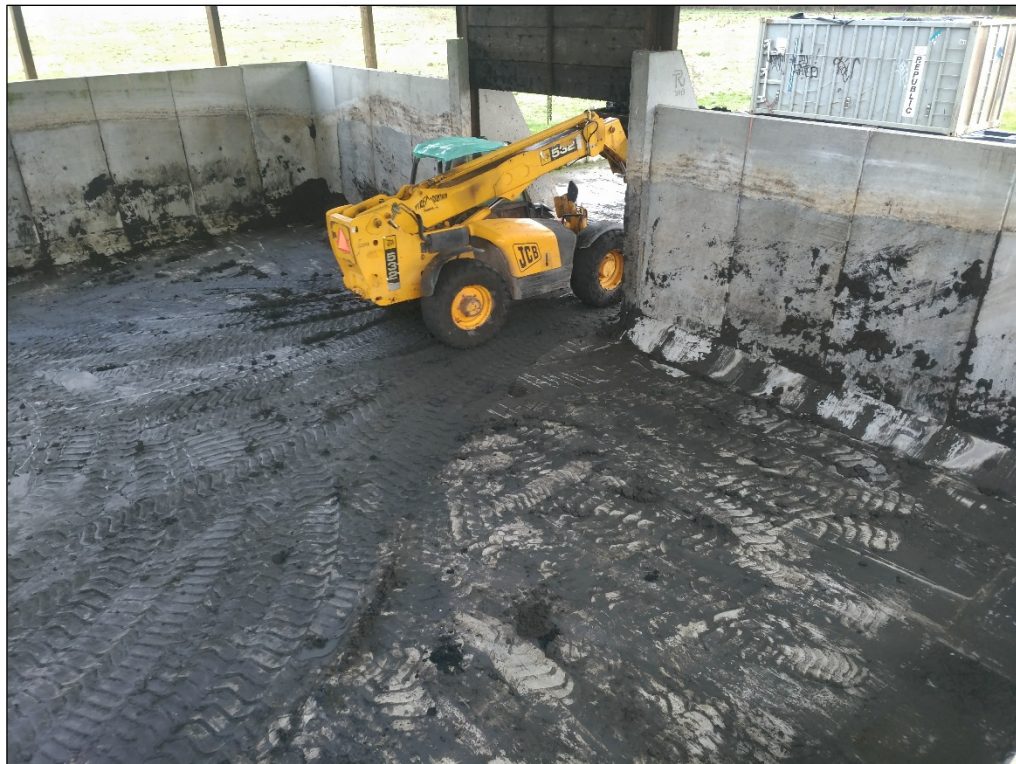
4. Removing mixed material from Big Hanaford (01/18/2021).

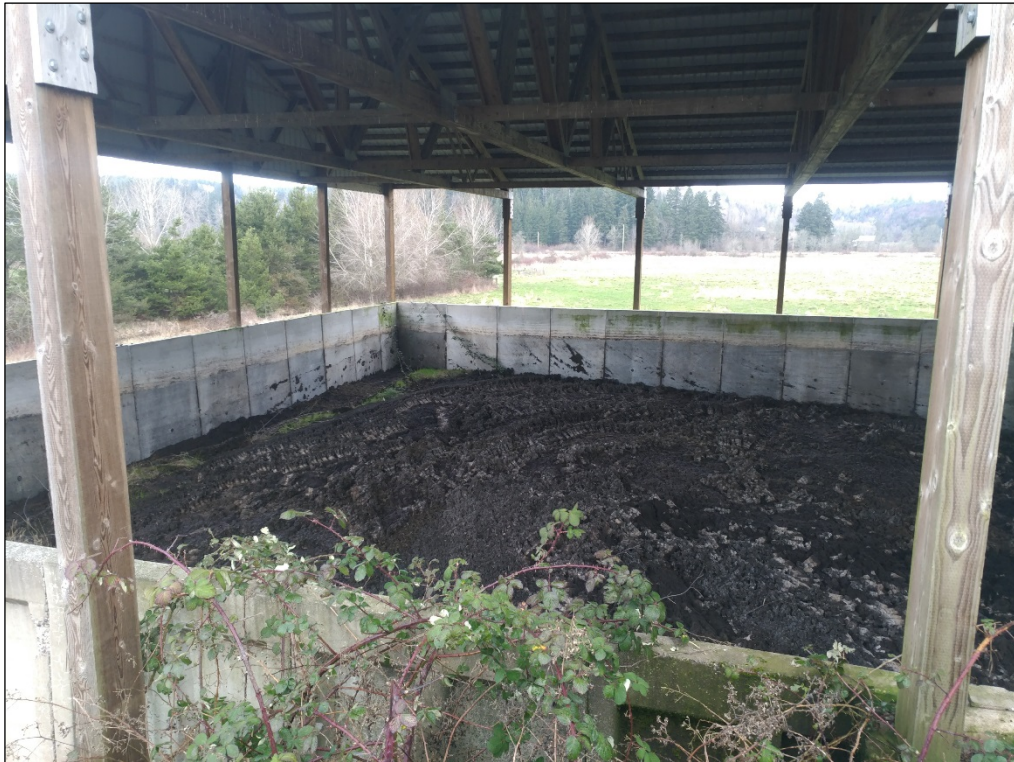
5. Storage unit being emptied (01/18/2021).

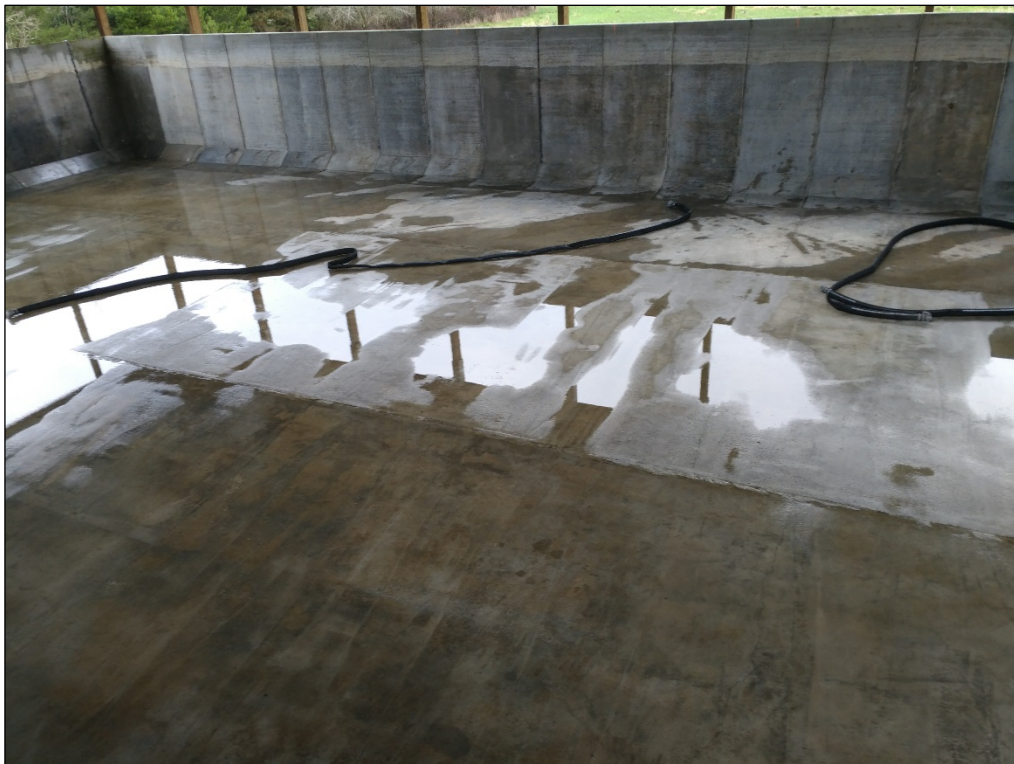
6. Mixed-material removal and decontamination complete (02/05/2021).

Big Hanaford was decontaminated by FMF on February 4 and 5, 2021. The concrete base and internal walls of the storage unit were cleaned and decontaminated using scrub brushes, brooms, and pressure washers. The approximately 1,300 gallons of decontamination water generated by pressure-washing was collected and pumped into a holding tank for transport to the Emerald Kalama plant on February 17, 2021.

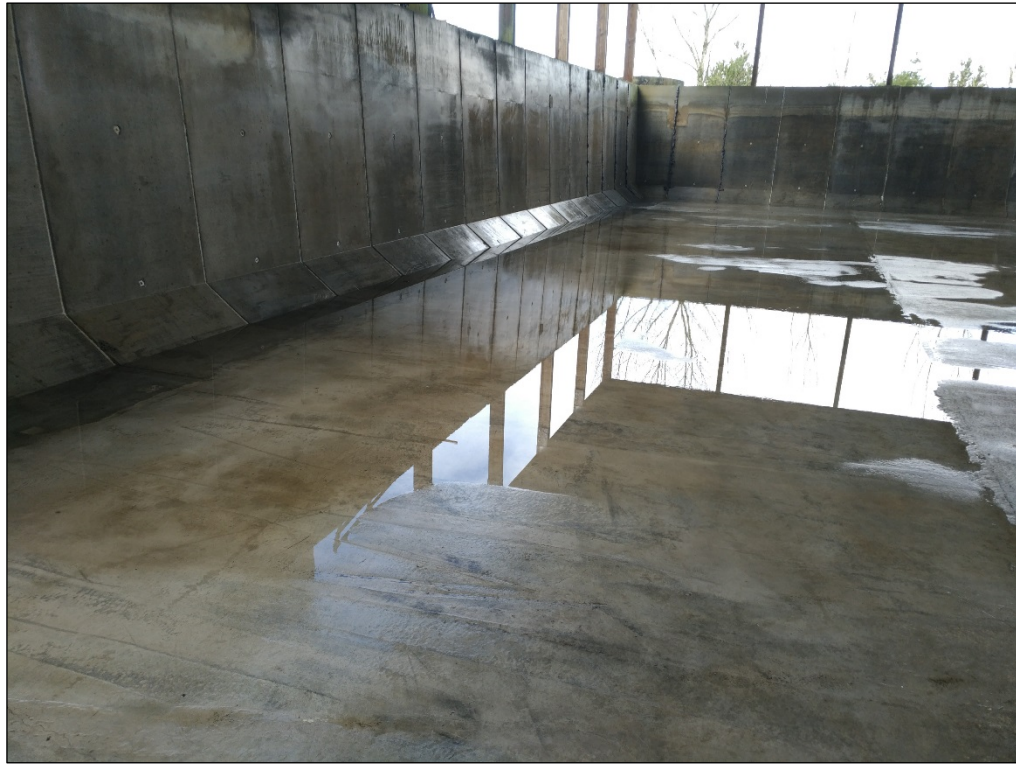
7. Mixed-material removal and decontamination complete (02/5/2021).

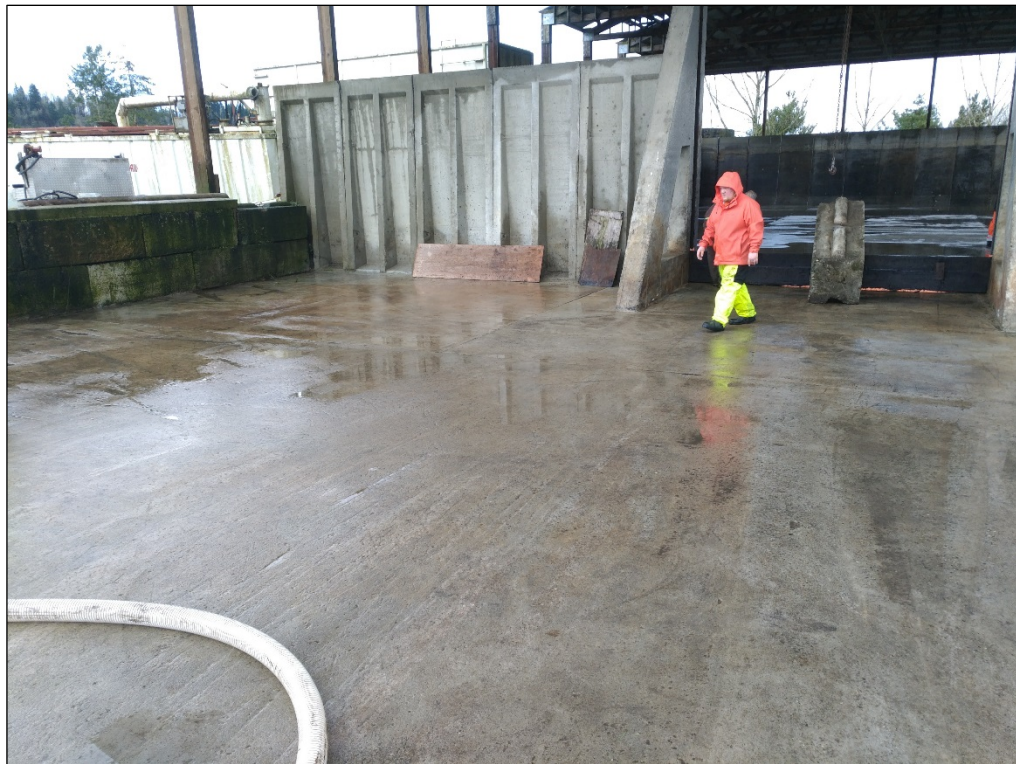
8. Mixed-material removal and decontamination complete (02/5/2021).
