**SAHLBERG EQUIPMENT, INC.  
PROPERTY**

**W-7497**

**April, 1991**

**Level I Environmental Site Assessment  
Sahlberg Equipment, Inc. Property  
5950 4th Avenue South  
Seattle, Washington**

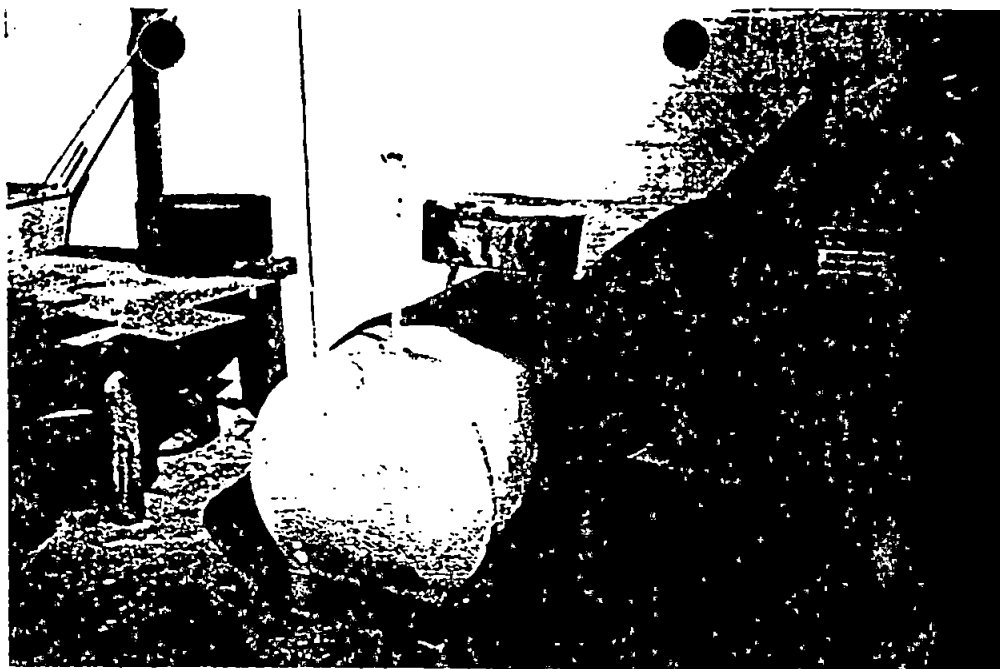
We also observed the presence of an approximately 200 gallon above ground storage tank, situated upon concrete pavement, adjacent to the southwest portion of Building 3, which Mr. Sahlberg informed us contains waste oil. Mr. Sahlberg further informed us that the above ground tank is pumped out, when necessary, by Northwest Enviroservice, Inc. Although the top side of the tank exhibited some oil residue, no apparent indication of product leakage in the form of stained ground surface areas was observed in the vicinity of the tank. See Figure 2, the Site Plan, for above ground storage tank location. See also Appendix for color photograph.

**ABOVE GROUND WASTE OIL TANK**

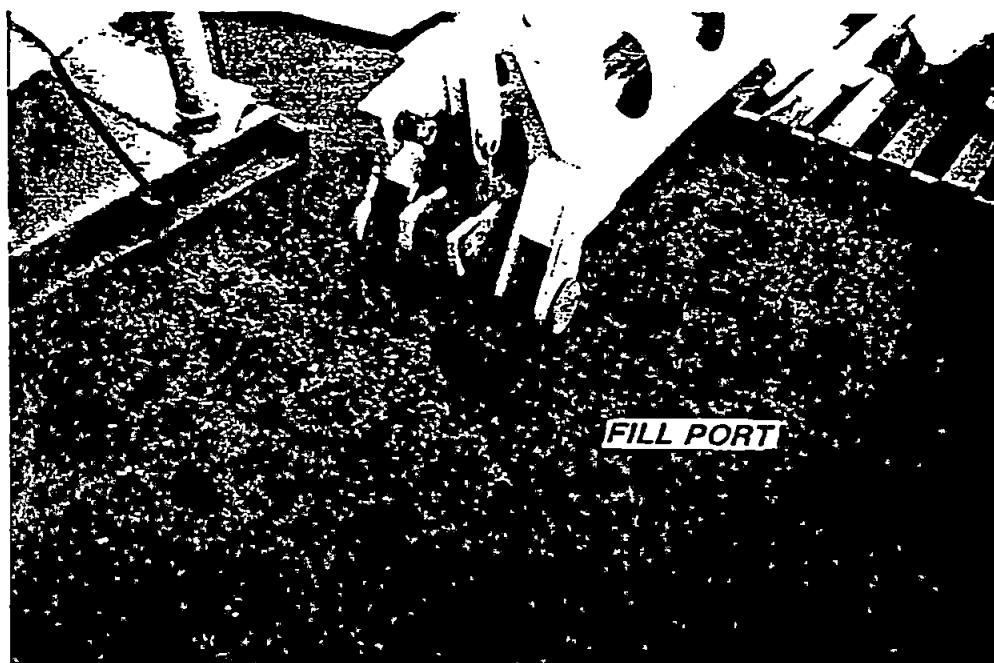
An underground heating oil storage tank (UST) presently exists in the northwest portion of the property, beneath asphalt pavement. According to Mr. Sahlberg, this UST, apparently 300 gallons in capacity, was associated with a former oil furnace which heated Building 1 from 1956 up until sometime around 1970, at which time the building's oil heating system was converted over to natural gas. Upon investigation, we found that an undetermined amount of heating oil still remains present within the UST. See Figure

**FILL PORT UNDERGROUND HEATING OIL TANK**

We recommend, however, that the UST be pumped empty of product, and appropriately decommissioned, by way of either in-place abandonment or removal. If the UST is removed, surrounding soils may be observed at that time for petroleum impact, and remediated, if necessary.

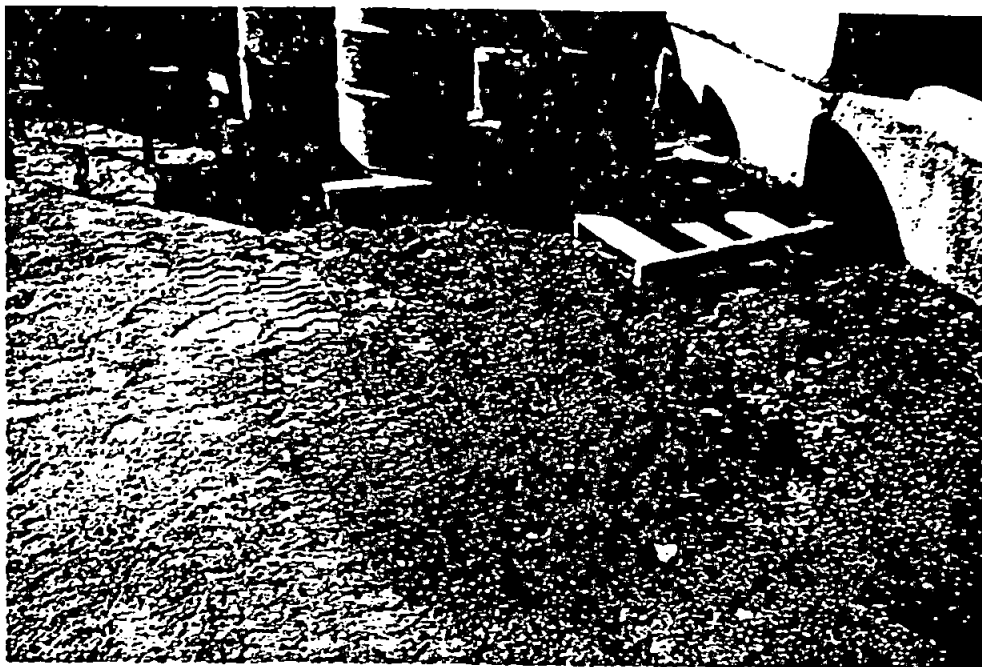
During our site visit, we encountered visible evidence of petroleum product leakage or spillage, in the form of stained soil surface, in the vicinity of a group of 55 gallon drums which were stored on the southeast portion of the property upon exposed soil. We also observed the presence of a no longer utilized heating oil UST near the northwest corner of the property, which we found upon further investigation, to still contain a significant amount of petroleum product. While we were unable to determine whether the UST is leaking, the quantity of still-remaining product, even after the passage of approximately twenty years of non-use, tends to suggest that the UST may be structurally sound, and not leaking. If product leakage has occurred, however, it is conceivable that there may be locally confined zones of petroleum contamination of the soils immediately surrounding the UST.

**STAINED SOILS NEAR STORED DRUMS**

We also feel that it would be prudent to perform a limited program of sampling and chemical analysis of near-surface soils in the vicinity of the drums which are stored upon exposed soil. We further recommend that storage drums, empty or otherwise, no longer be stored on that portion of the site, but only upon concrete or asphalt-paved surfaces.
