STATE OF WASHINGTON  
DEPARTMENT OF ECOLOGY

**Re: Opinion pursuant to WAC 173-340-515(5) on Remedial Action for the following  
Hazardous Waste Site:**

- **Site Name:** Montlake Texaco
- **Site Address:** 2625 E Montlake Pl E, Seattle WA 98112
- **Facility/Site No.:** 47724816
- **Cleanup Site ID No.:** 14857
- **VCP Project No.:** NW3242

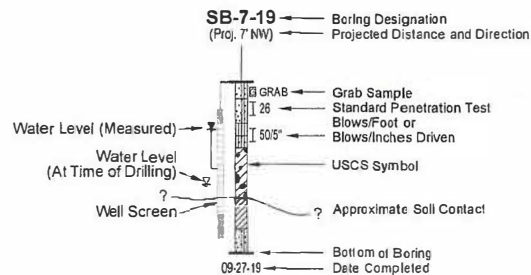
Enclosure A, Figure 3

**Geology:** Borings drilled on the Site encountered the following geologic strata (**Figure 3**):

- Sandy silt to silty sand (including pavement base course, fill, and native materials), approximately 18 feet thick;
- Sand to silty sand with gravel, discontinuous, encountered from 20 to 25 below ground surface (bgs); and
- Very dense silty sand to sandy silt (glacial till). The glacial till surface elevation is variable beneath the Site and forms a trough that extends southeast to northwest, varying in elevation from 45 feet to 31 feet amsl (Figure 4). The till extends to at least 60 feet bgs, the maximum depth explored.

Montlake Gas Station VCP Remedial Investigation Report 2625 E Montlake Place E Seattle, WA	
<b>CONCEPTUAL SUBSURFACE CONTAMINANT PROFILE B-B'</b>	
March 2020	21-1-22242-104
<b>SHANNON &amp; WILSON, INC.</b>	<b>EXHIBIT 4</b>

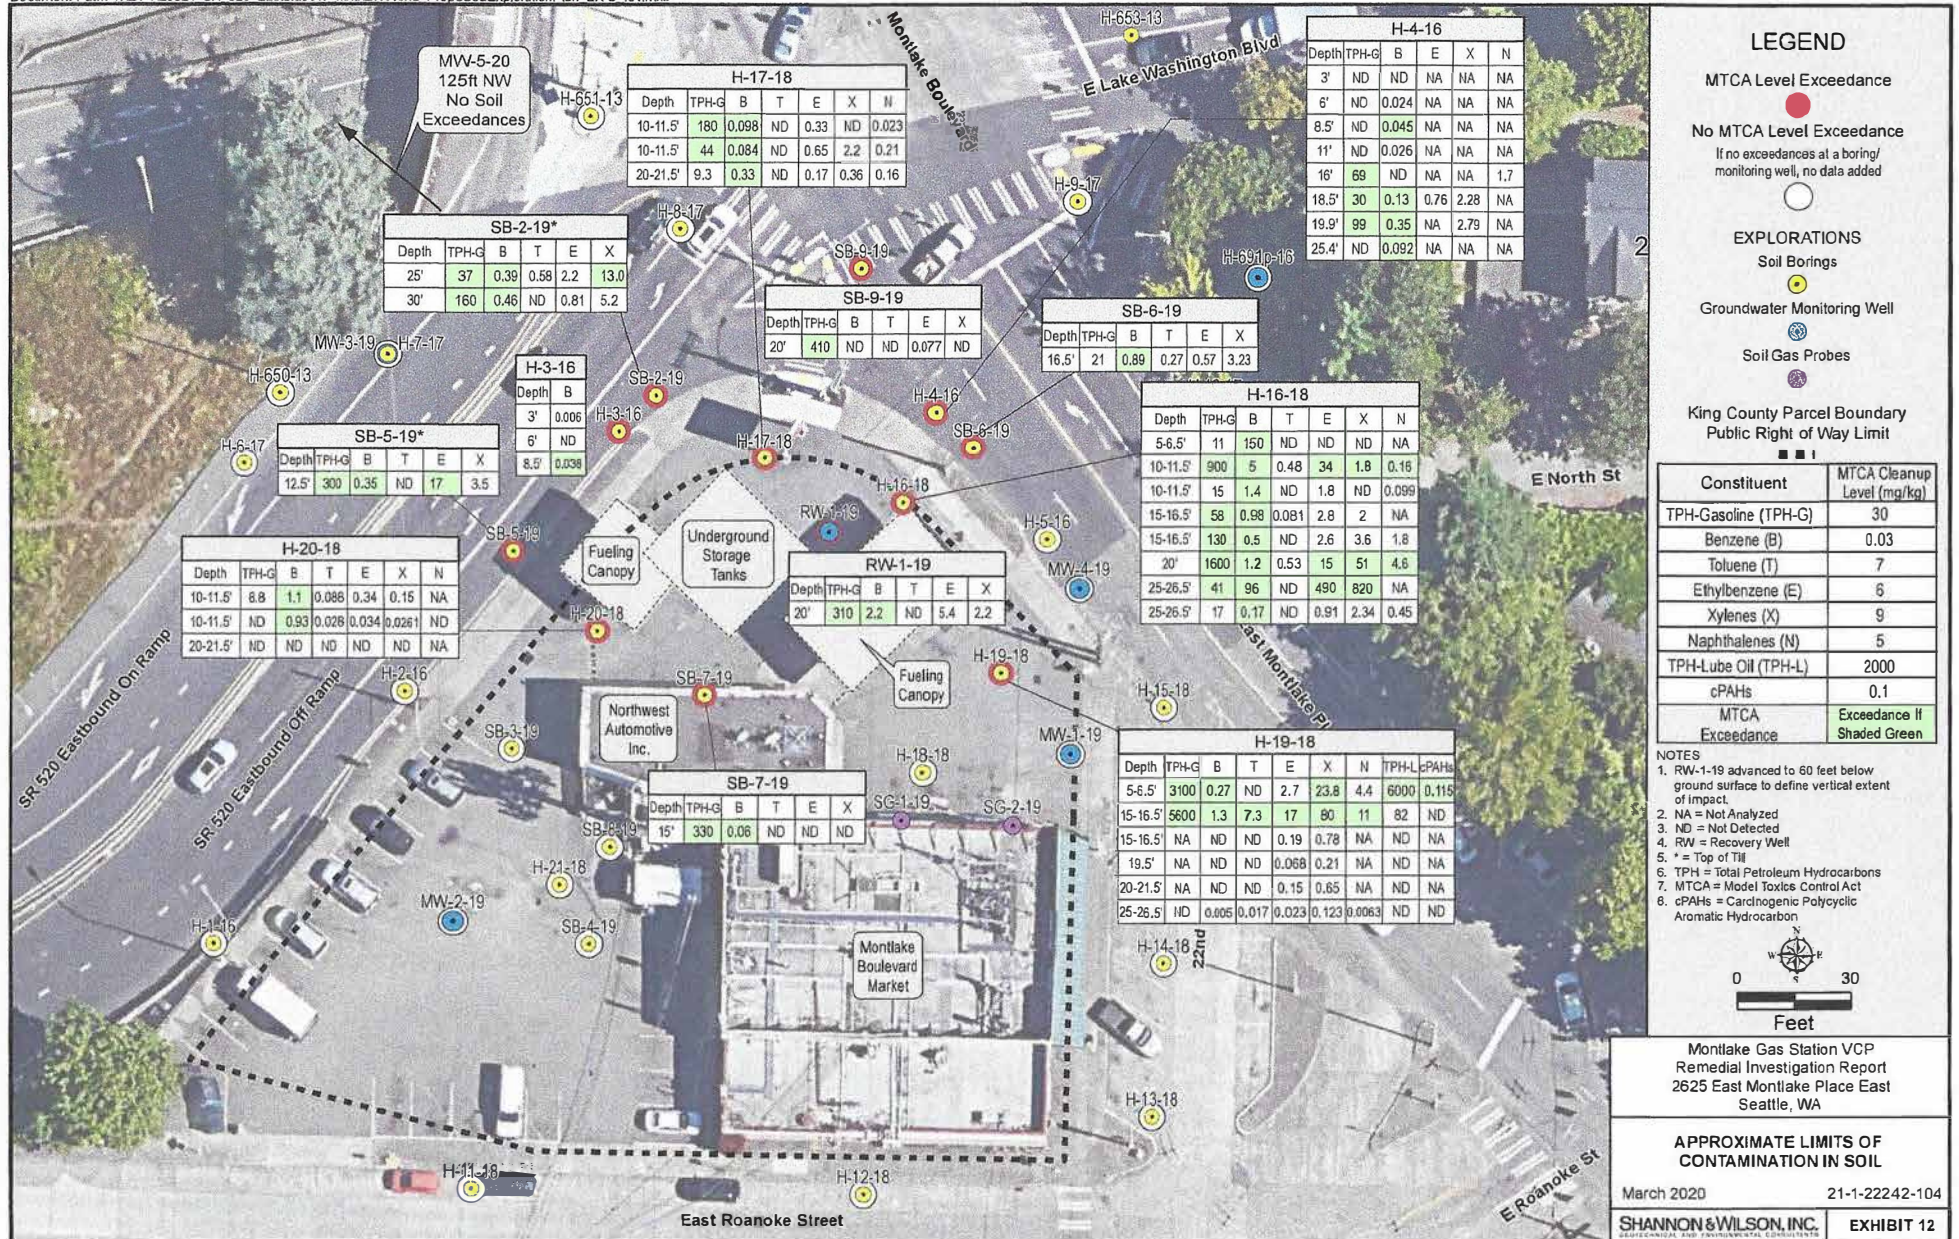
Enclosure A, Figure 6

The distribution of contaminants of concern (COCs) in soil is shown in **Figure 6** and in groundwater in **Figures 7 and 8**. Contamination in soil and groundwater was observed in the area within and surrounding the pump islands, and extends into the adjacent E Montlake Place E and SR 520 rights-of-way. Contamination in groundwater also appears to extend to the north and northwest, within the backfill of the combined sewer line.
