UST CLOSURE SITE ASSESSMENT AND INTERIM REMEDIAL ACTION REPORT

**DeBock's Main Street Texaco
Grandview, WA**

**Prepared For:
Mr. Gary Christensen
Powell Christensen, Inc.
501 East Main Street
Grandview, WA 98930**

MAY, 1995

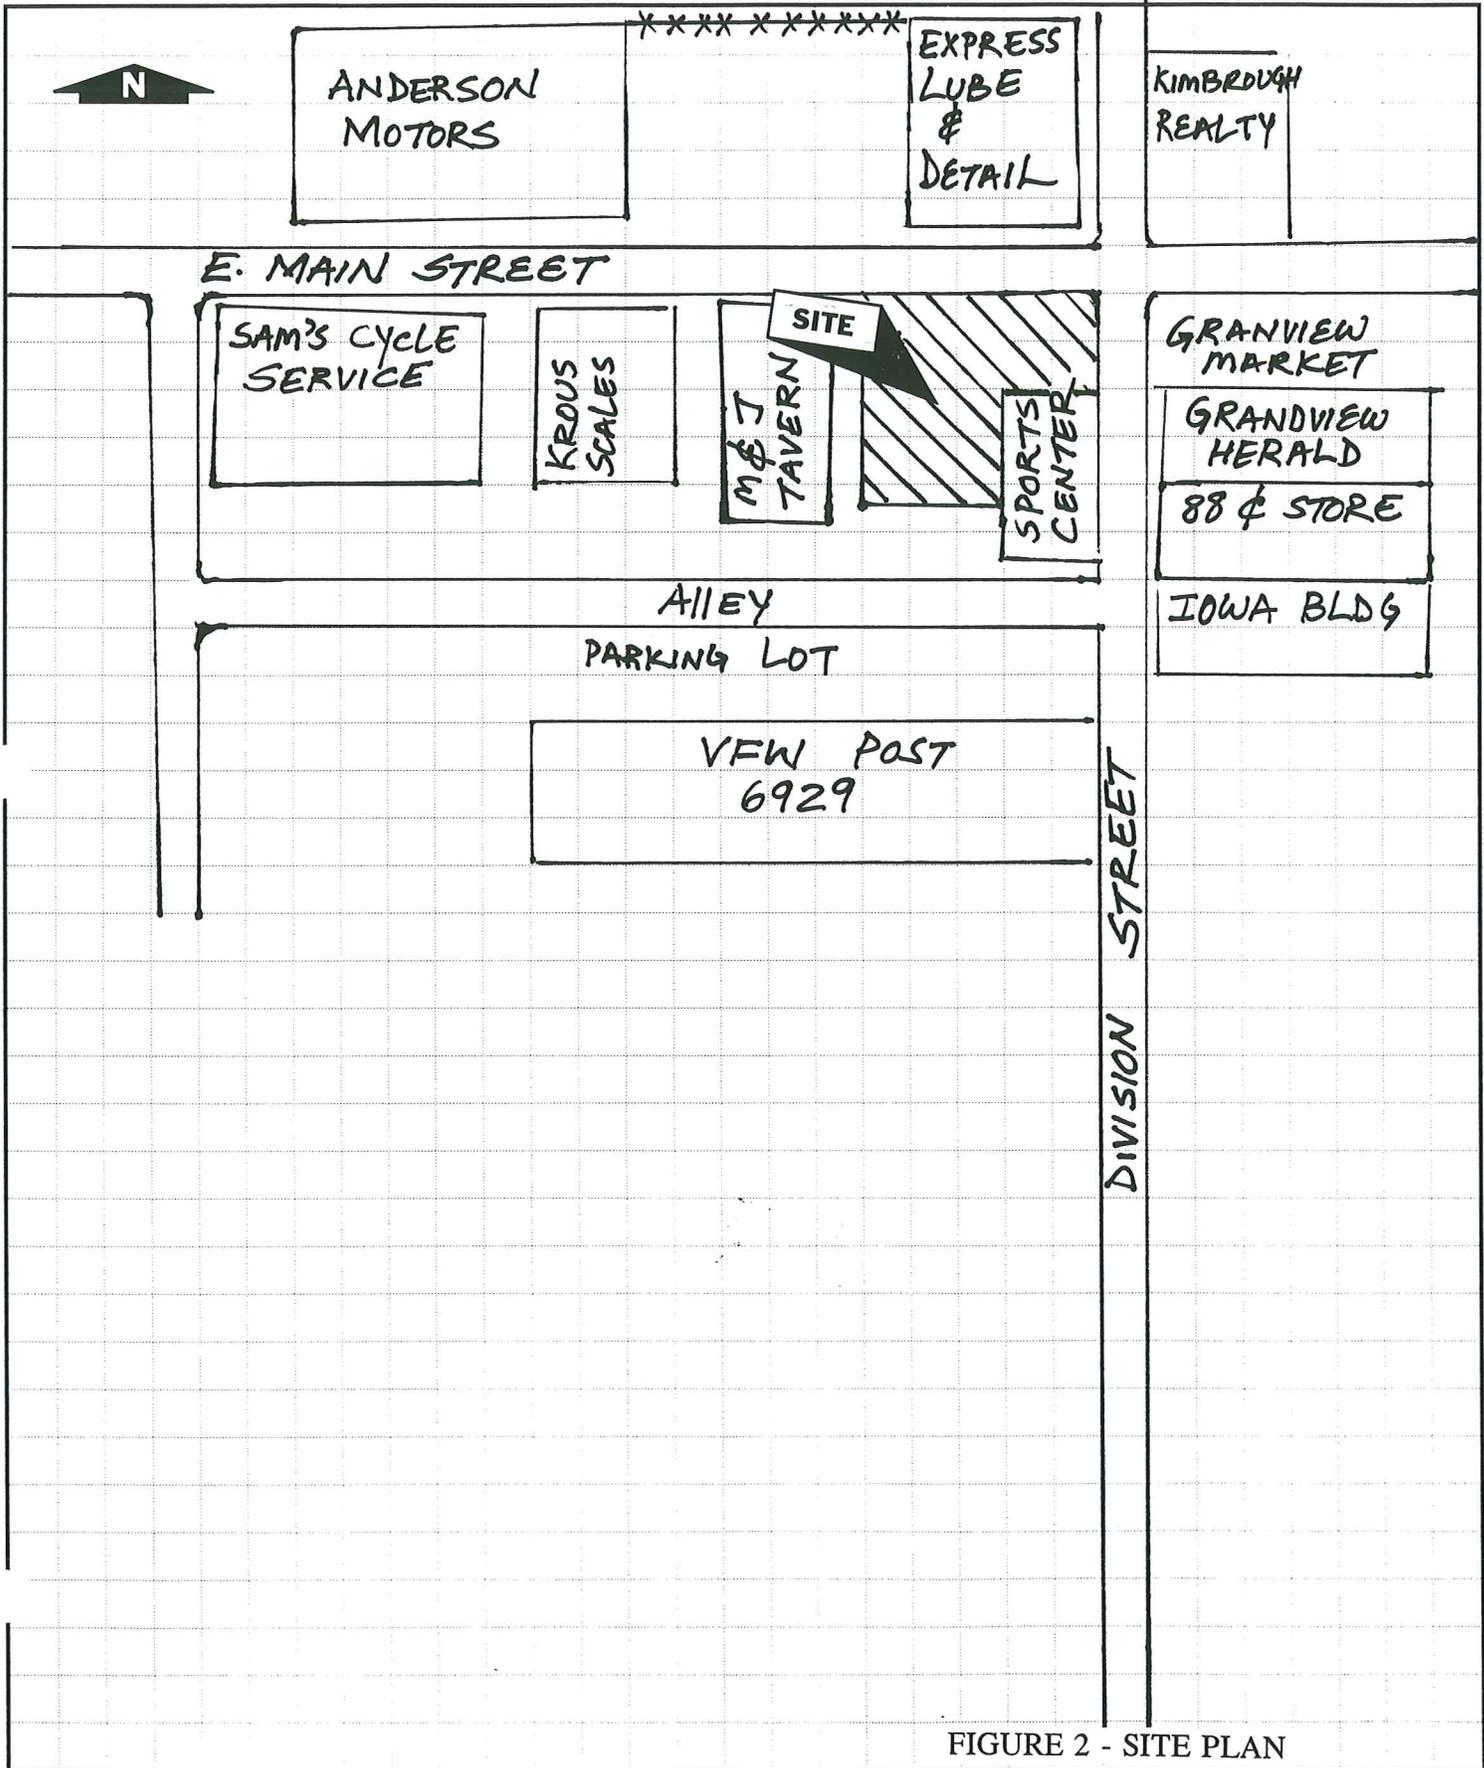
FIGURE 2 - SITE PLAN

De Bocks Main Street Texaco is located at the southwest corner of West Main Street and Division Street. The offices of Kimbrough Realty and Bleyhl Farm Services are located in the northeast quadrant of E. Main Street and Division Street. Express Lube and Detail and Anderson Motors' car lot are located across E. Main Street to the north. The Sports Center Bar and M & J Tavern are to the east and west of the subject site respectively. The Grandview Market, Grandview Herald, and 88 ¢ Store are located to the east across Division Street. VFW Post 6929 is located across an alley and a parking lot to the south of the subject site. Refer to Figure 2, Site Plan.

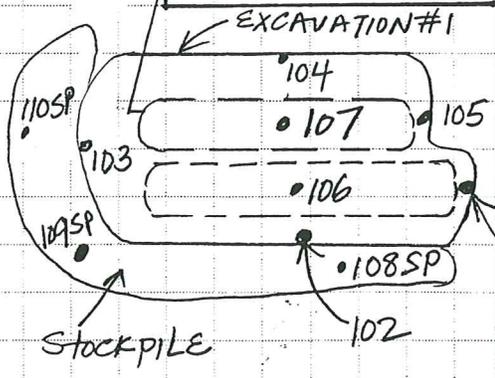
FIGURE 3- SAMPLING PLAN

One 1000 gallon UST was located at the northwest corner of The Service Station Building. One 5000 gallon UST and one 8000 gallon UST were located to the south of the building. Refer to Figure 3, Sampling Plan. The tanks were approximately 22 years old.

The main UST excavation, hereafter referred to as excavation #1, was located to the south of the building. One 5000 gallon tank and one 8000 gallon tank were removed from excavation #1. The excavation measured approximately 30' x 30' x 11' in depth.

The excavation for the removal of 1000 gallon tank, hereafter referred to as excavation #2, measured approximately 15 feet x 10 feet x 10 feet deep. It was located at the northwest corner of the building. The soil in the excavation appeared clean and had no smell of petroleum. The stockpiled soil that was taken from the top of the tank exhibited signs of limited petroleum contamination.

The Sampling Plan (refer to Figure 3) and the attached Field Sampling Log (Appendix A) show the location, depth and types of samples taken. In general, sample collection and control followed the following protocol:

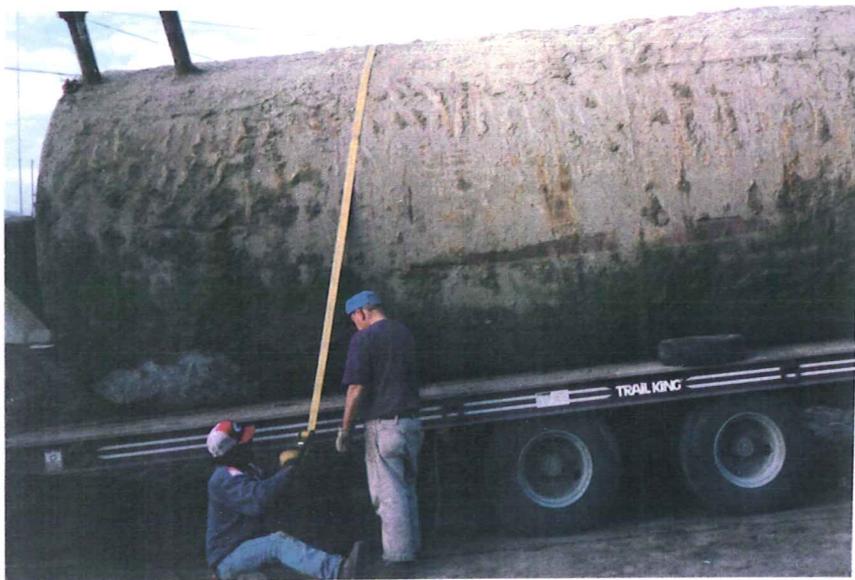
Photograph 5: 5,000 gallon tank

The 5000 gallon tank had minor corrosion on the bottom, but the rest still had the original paint. The tank was 7'10" in diameter and 14'4" long. Refer to Photograph 5, Condition of 5000 gallon tank.

TANK HAS MINOR CORROSION ON THE BOTTOM. NO HOLES WERE NOTICED.

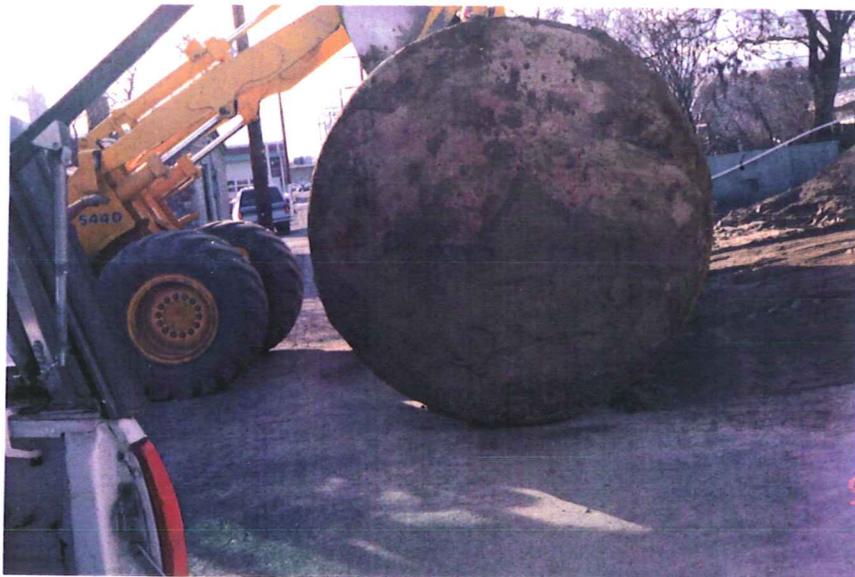
Photograph 6: 8,000 gallon tank.

The 8000 gallon tank was in good condition with little evidence of corrosion or pitting. The tank measured 7'10" in diameter and 22' in length. Refer to Photograph 6, for the condition of the 8,000 gallon tank.
