**PHASE II ENVIRONMENTAL  
SITE ASSESSMENT  
REPORT  
JULY 26, 2004**

**FORMER HARDEL MUTUAL  
PLYWOOD WATERFRONT PROPERTY  
1210 N.W. WEST BAY DRIVE  
OLYMPIA, WASHINGTON  
TAX PARCEL #72600200100**

**Stemen Environmental, Inc.**

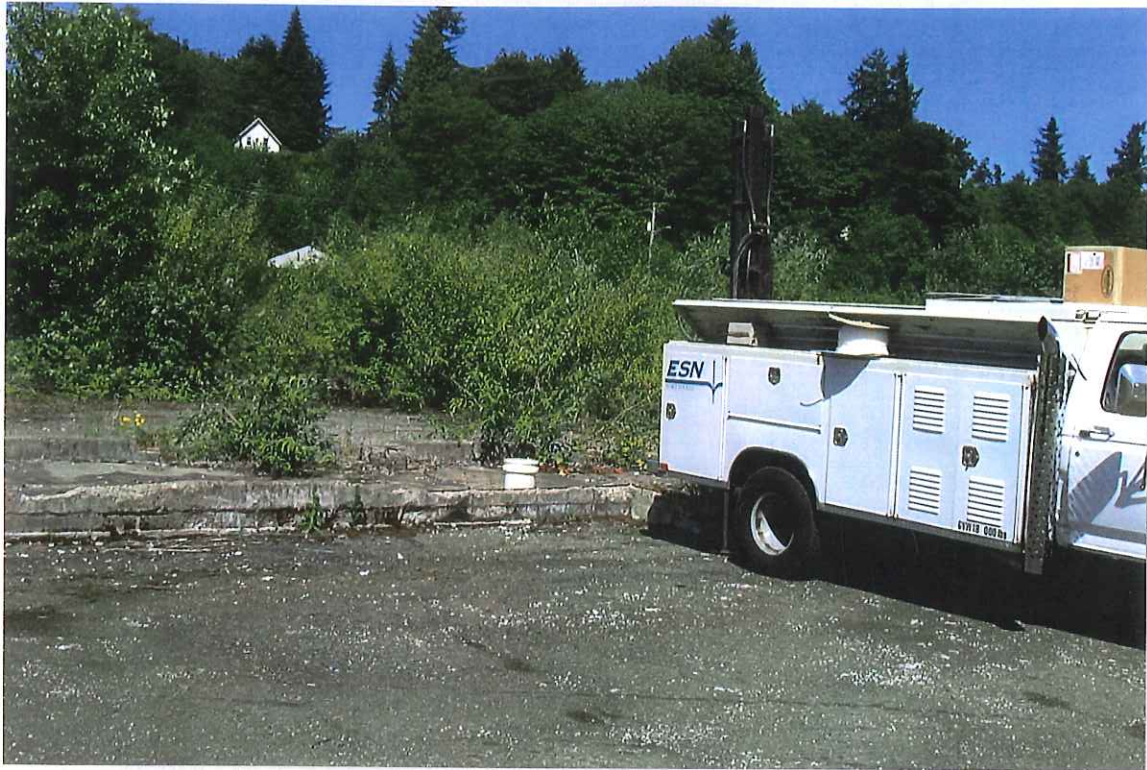
DIRECT PUSH SAMPLING SYSTEM  
AT SAMPLING LOCATION S-1

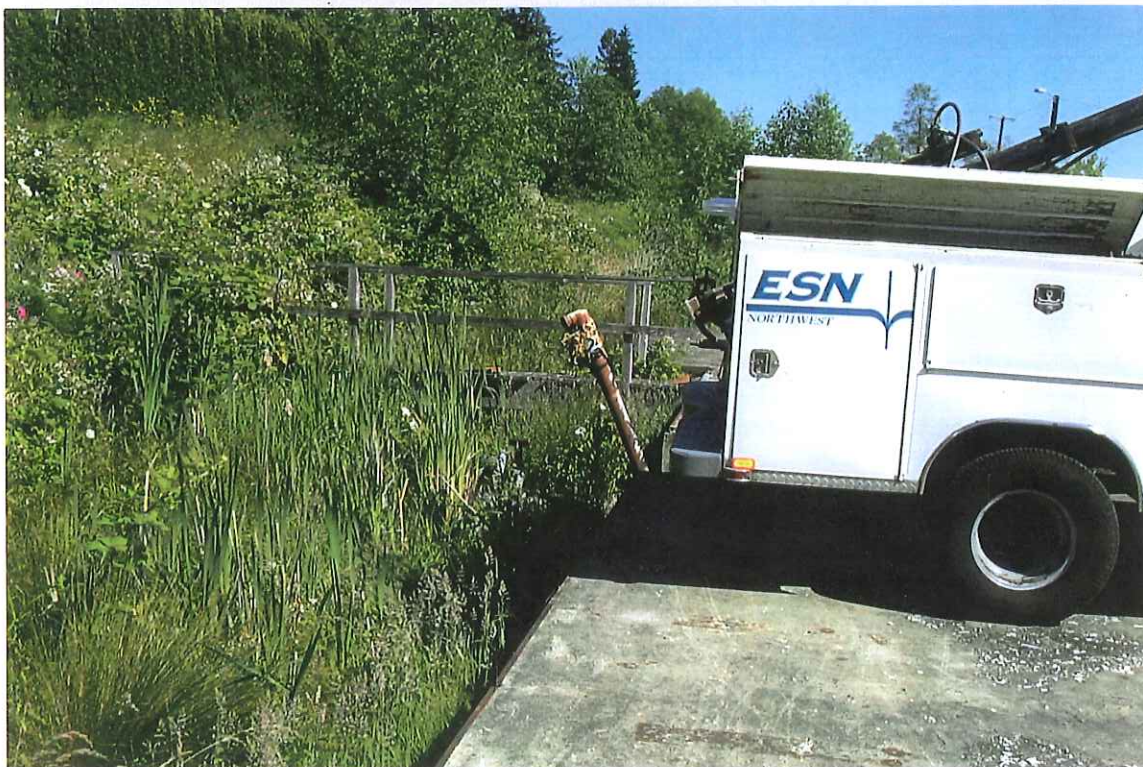
DIRECT PUSH SAMPLING SYSTEM  
AT SAMPLING LOCATION S-10

Water samples obtained from investigative sampling locations S-10 and S-15 were oily in appearance and possessed a noticeable musky heavy oil type odor. An inspection of the sampling tube used to obtain water samples at these two (2) sampling locations indicated the presence of a layer of Free Product floating on the water table.

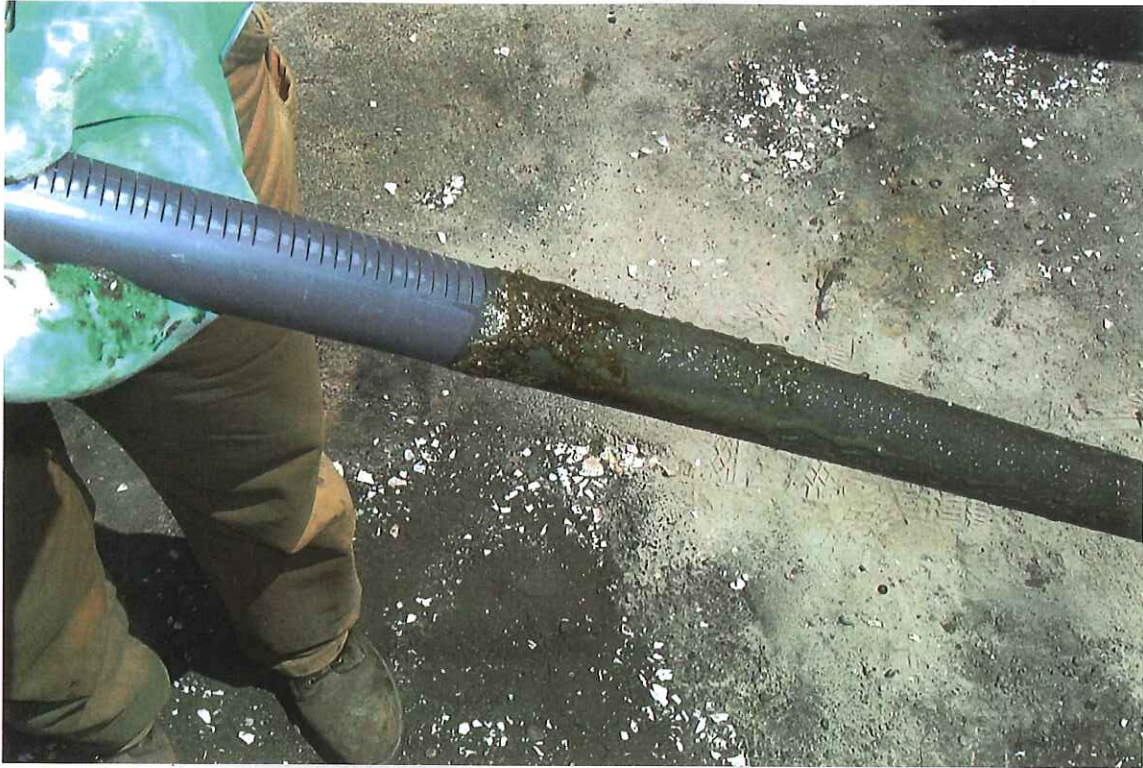
“FREE PRODUCT” ON WATER SAMPLING  
TUBE FROM SAMPLING LOCATION S-10

Laboratory analyses results for investigative water samples S-10-W, S-10-2-W, S-12-W, and S-15-W confirmed the presence of heavy oil range T.P.H. at levels that exceed Ecology's Method "A" Clean Up Levels at their respective sampling locations.
