SITEWIDE RI/FS WORK PLAN

Morell's Dry Cleaners

D.E. Wickham, Successor to Walker Chevrolet

Project No. 080190 • June 4, 2021

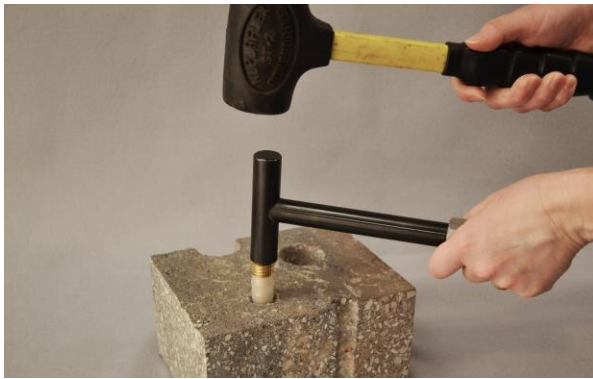
- 5) Remove the drill bit, brush the hole with the bottle brush, and remove the loose cuttings with the vacuum.
- 6) Place the lower end of VAPOR PIN® assembly into the drilled hole. Place the small hole located in the handle of the installation/extraction tool over the vapor pin to protect the barb fitting, and tap the vapor pin into place using a dead blow hammer (Figure 2). Make sure the installation/extraction tool is aligned parallel to the vapor pin to avoid damaging the barb fitting.

Figure 2. Installing the VAPOR PIN®

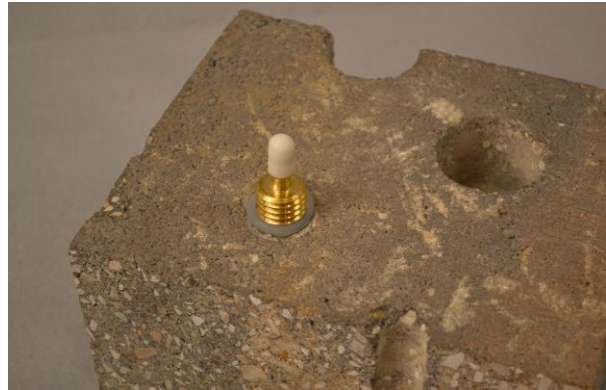
During installation, the silicone sleeve will form a slight bulge between the slab and the VAPOR PIN® shoulder. Place the protective cap on VAPOR PIN® to prevent vapor loss prior to sampling (Figure 3).

Figure 3. Installed VAPOR PIN®

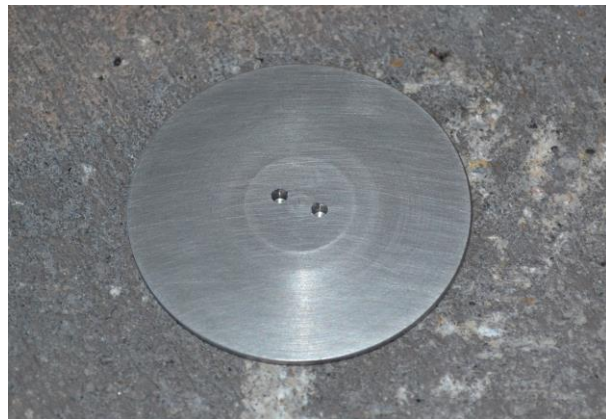
- 7) For flush mount installations, cover the vapor pin with a flush mount cover, using either the plastic cover or the optional stainless-steel Secure Cover (Figure 4).

Figure 4. Secure Cover Installed

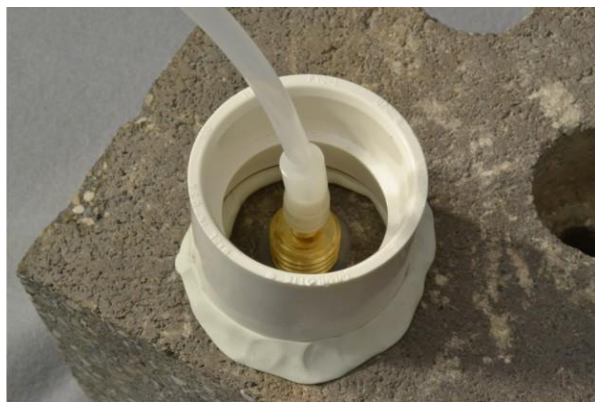
10) Conduct leak tests in accordance with applicable guidance. If the method of leak testing is not specified, an alternative can be the use of a water dam and vacuum pump, as described in SOP Leak Testing the VAPOR PIN® via Mechanical Means (Figure 6). For flush-mount installations, distilled water can be poured directly into the 1 1/2 inch (38mm) hole.

Figure 6. Water dam used for leak detection

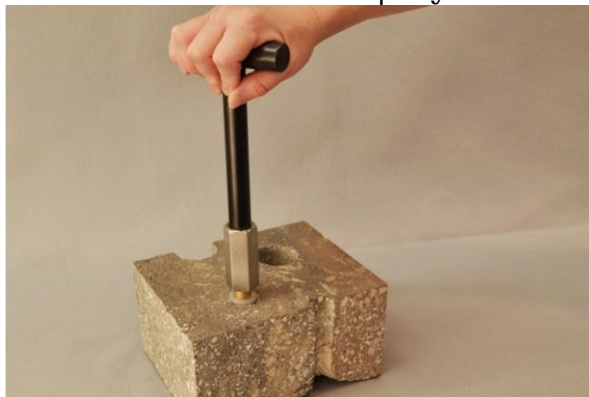
- 1) Remove the protective cap, and thread the installation/extraction tool onto the barrel of the VAPOR PIN® (Figure 7). Turn the tool clockwise continuously, don't stop turning, the VAPOR PIN® will feed into the bottom of the installation/extraction tool and will extract from the hole like a wine cork, DO NOT PULL.
- 2) Fill the void with hydraulic cement and smooth with a trowel or putty knife.

Figure 7. Removing the VAPOR PIN®
