STATE OF WASHINGTON
DEPARTMENT OF ECOLOGY

Re: Opinion pursuant to WAC 173-340-515(5) on Remedial Action for the following Hazardous Waste Site:

- **Site Name:** Cascade Laundry
- **Site Address:** 205 Prospect St., Bellingham WA 98225
- **Facility/Site No.:** 21786898
- **Cleanup Site ID No.:** 11853
- **VCP Project No.:** NW3076

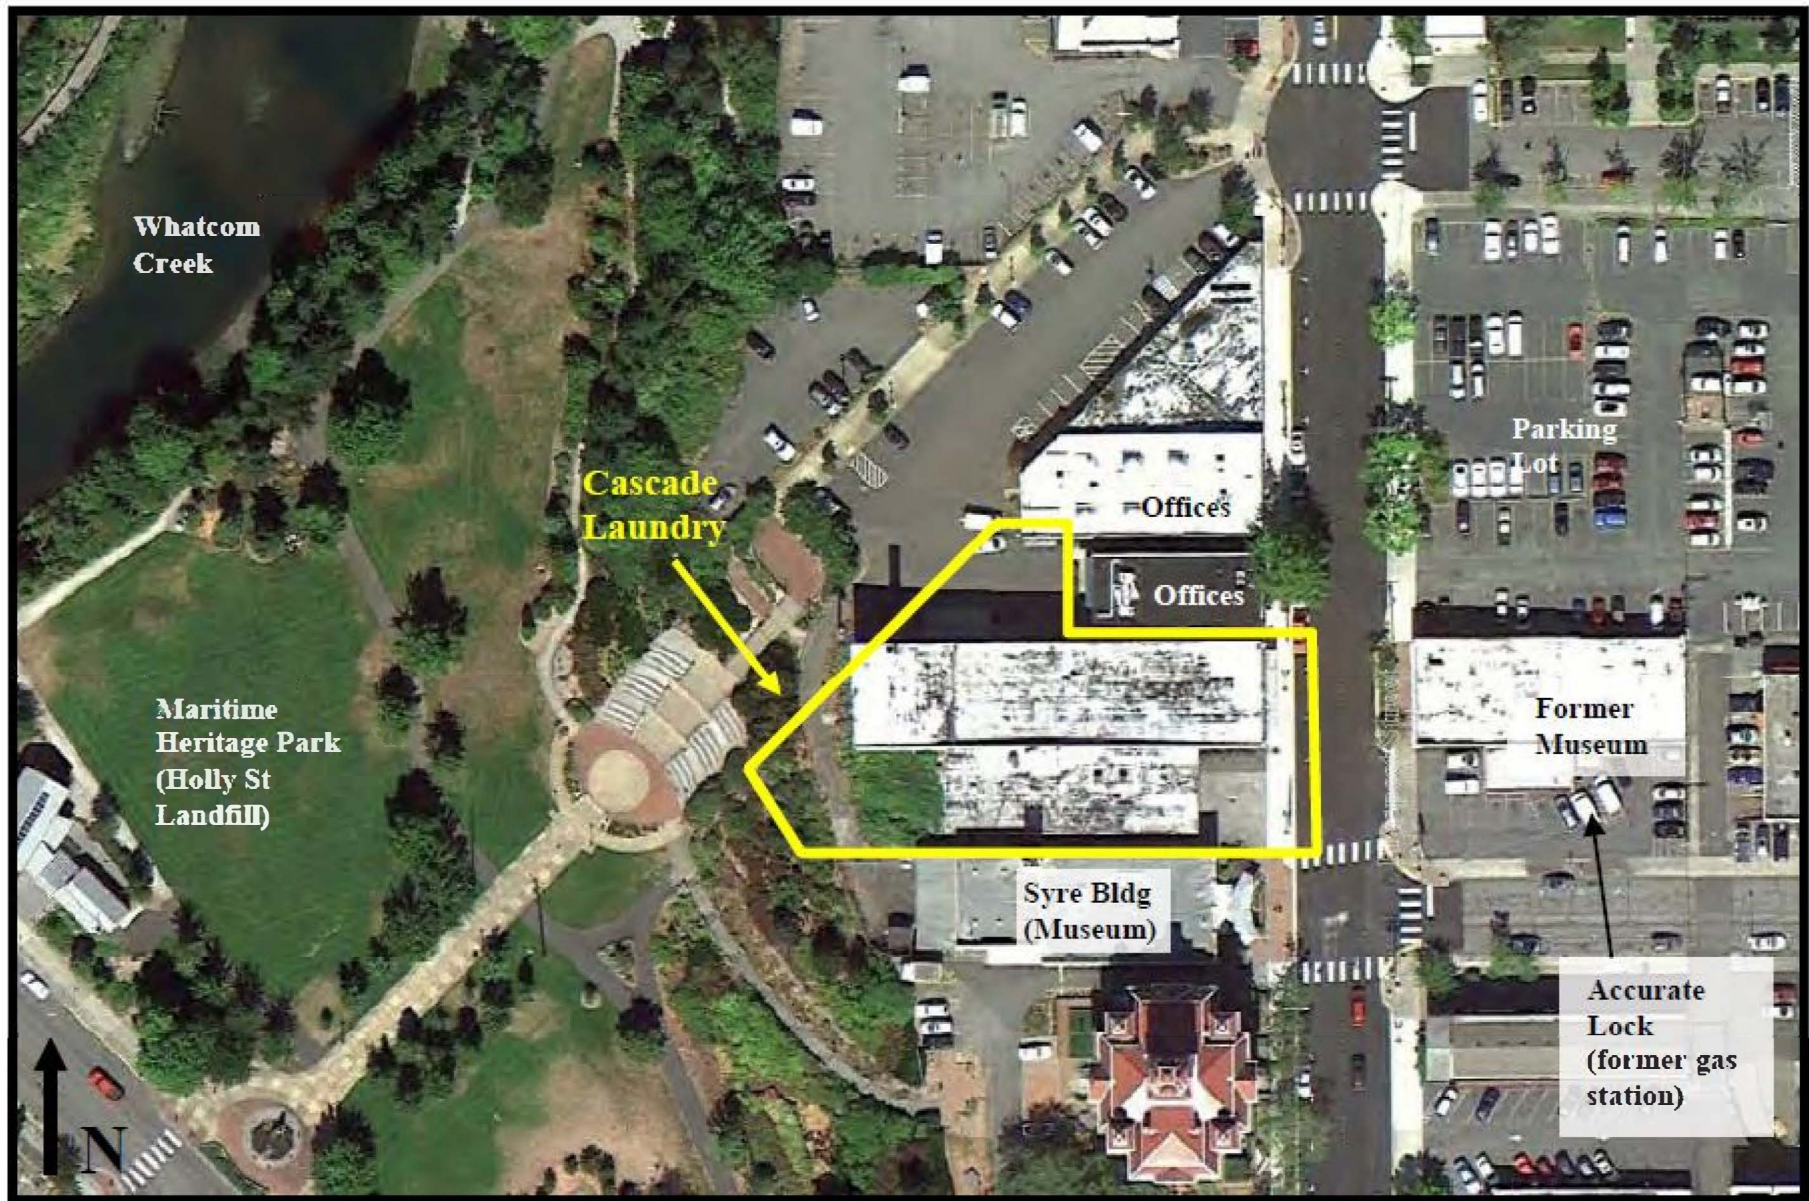
Enclosure A, Figure 2

Figure 2. Aerial photograph of site and vicinity (GoogleEarth, 2018)

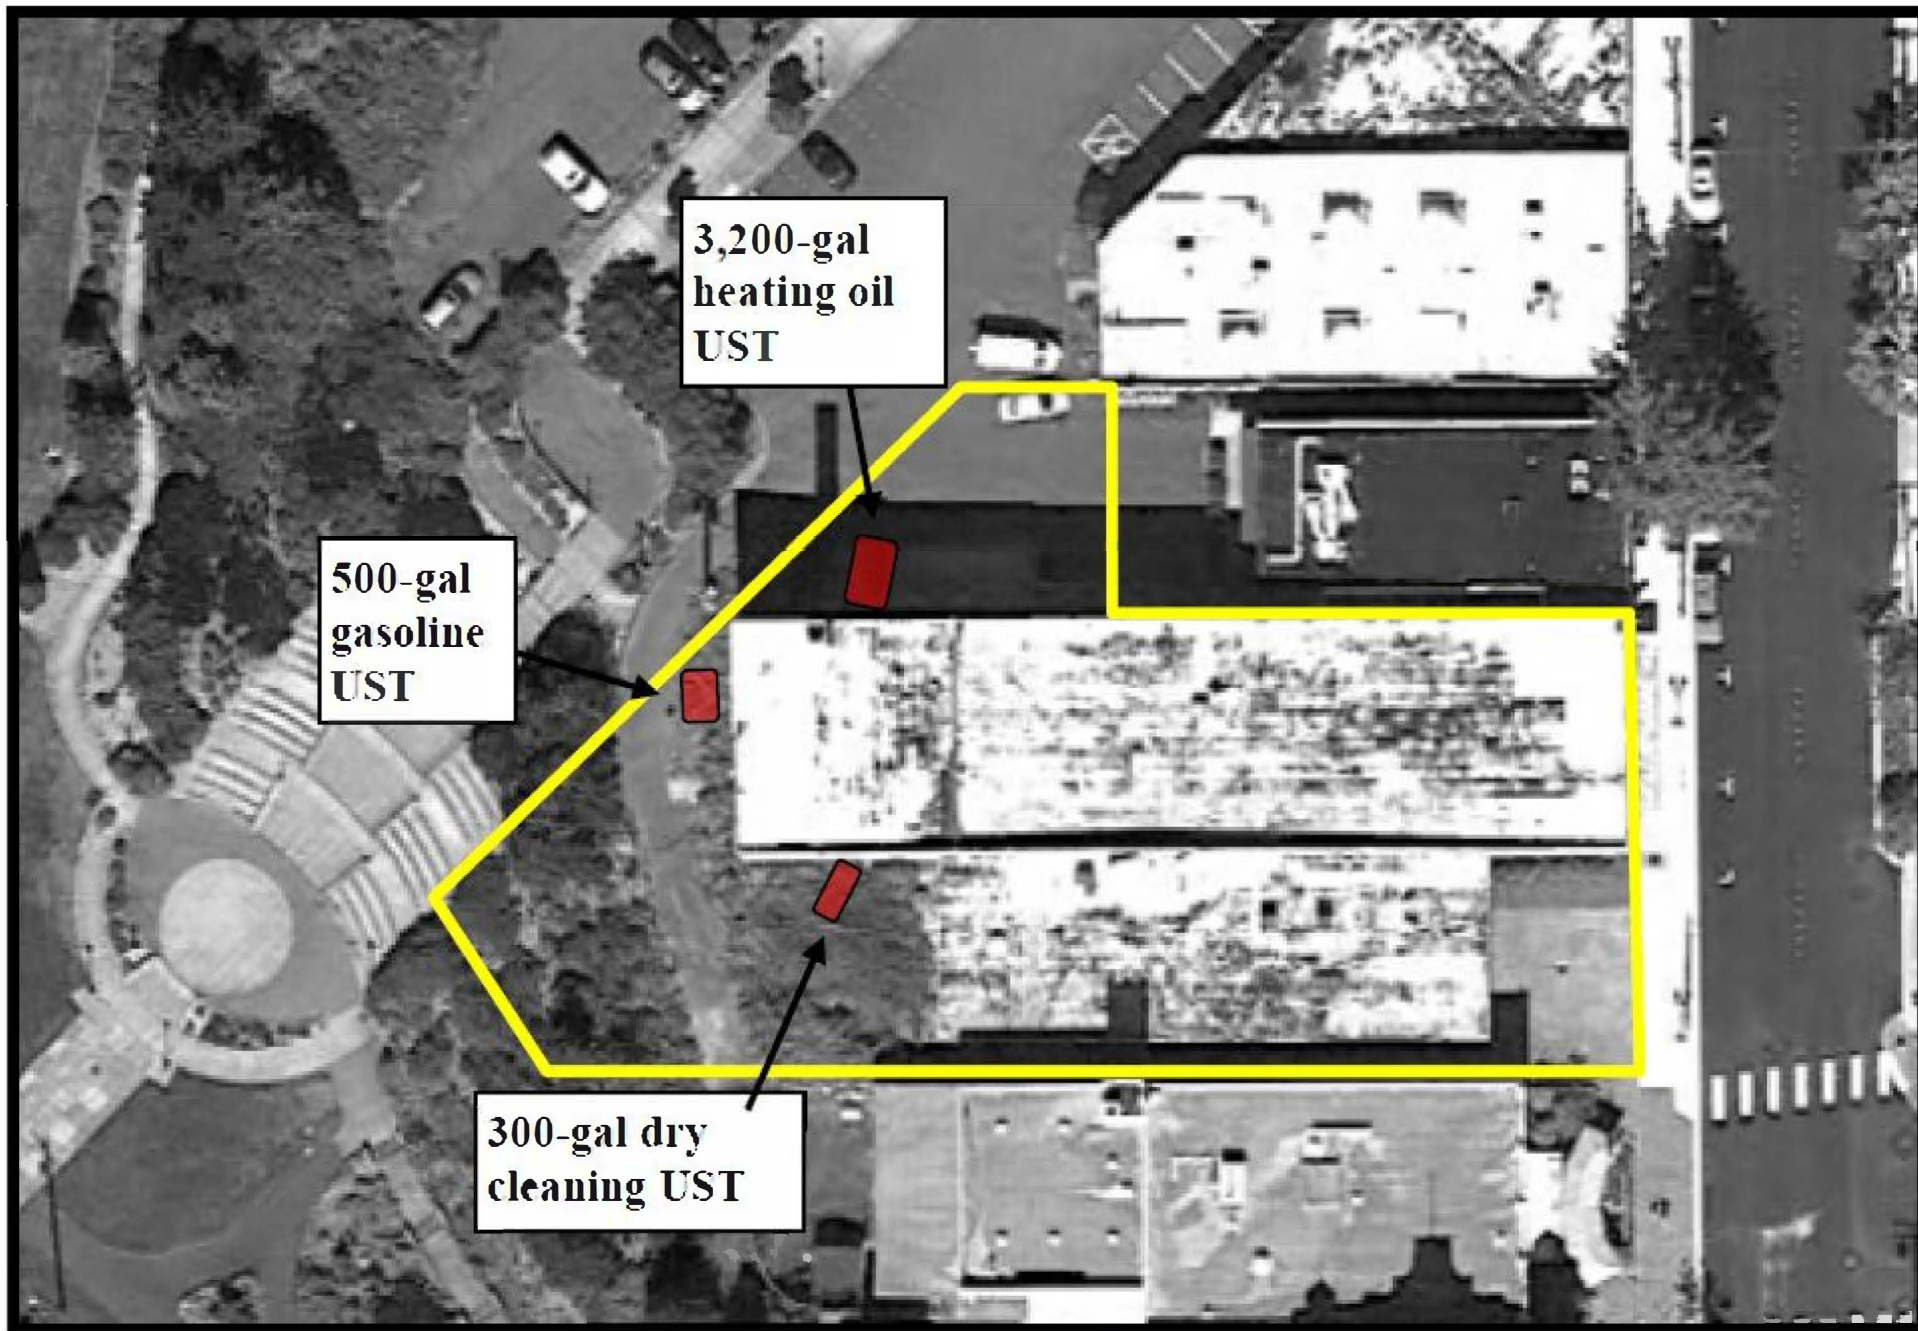
Figure 4. Onsite tank locations
Enclosure A, Figure 3

Contaminant Sources and History: Three underground storage tanks (USTs) were previously located on the Property, for storage of Bunker C fuel oil (3,200 gallons) used to power the boilers, gasoline (500 gallons), and dry cleaning solvent (300 gallons); see **Figure 3**. The gasoline UST was installed in 1978 and closed-in-place in 1992. The installation dates of the other two USTs are unknown but they were both removed in 2010.

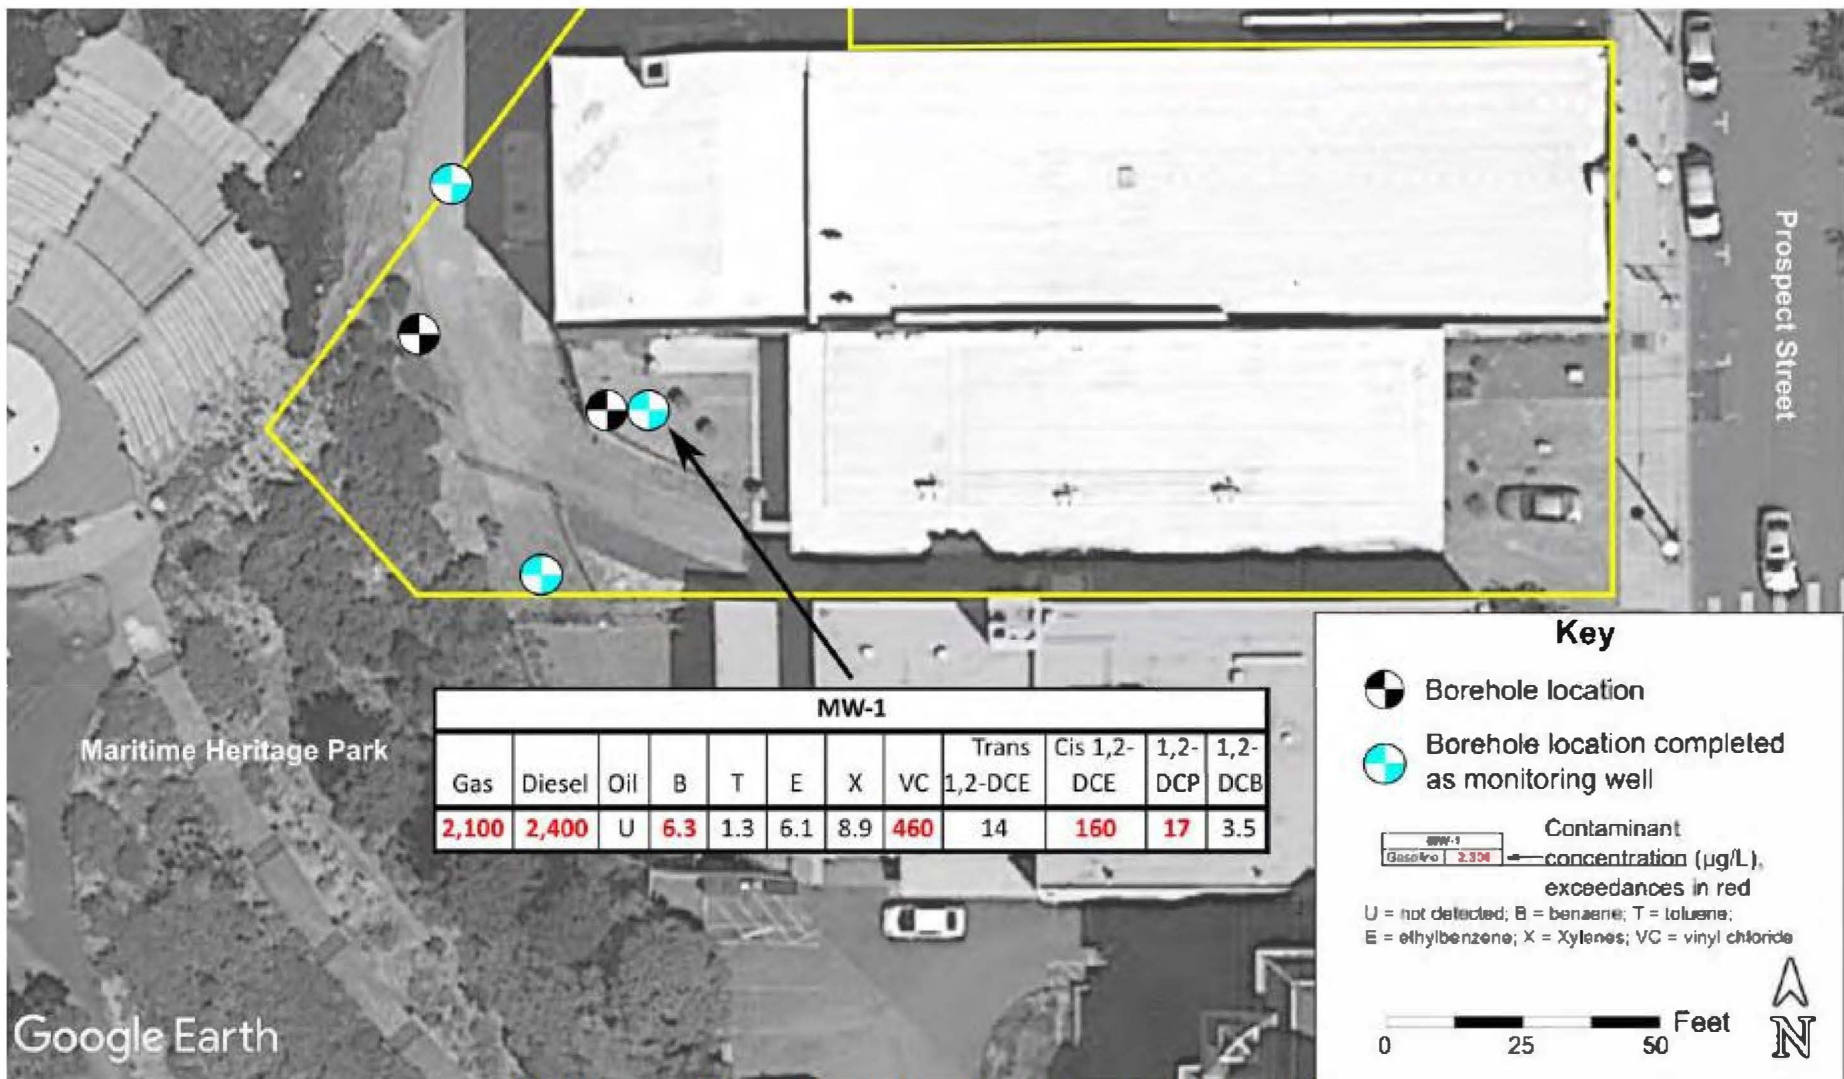
Enclosure A, Figure 8

Figure 5. Map of groundwater sample results.

TPH-G, benzene, PCE, and vinyl chloride have been detected in groundwater at concentrations exceeding their MTCA Method A cleanup levels (**Figures 7 and 8**). Groundwater contamination was identified beneath the building footprint and adjacent to the southwest and west sides of the building. The horizontal and vertical extent of groundwater contamination has not been delineated.
