RE: Final Report
2012 Annual Performance Monitoring
Black Sand Beach Project
Stevens County, Washington
URS Job No. 36310154

Presented in this letter report is a summary of the second annual performance monitoring event conducted at Black Sand Beach in Stevens County, Washington on October 8, 2012. The purpose of this report is to document sediment erosion and/or re-deposition changes in the Black Sand Beach that have occurred following completion of the Black Sand Beach project in October 2010. The 2012 annual performance monitoring event was performed in accordance with a Washington Department of Ecology (Ecology) – approved Performance Monitoring Plan dated March 2010. Similar to the 2011 annual performance monitoring event, the 2012 annual performance monitoring event included obtaining photographs, making visual observations, and performing a topographical survey.

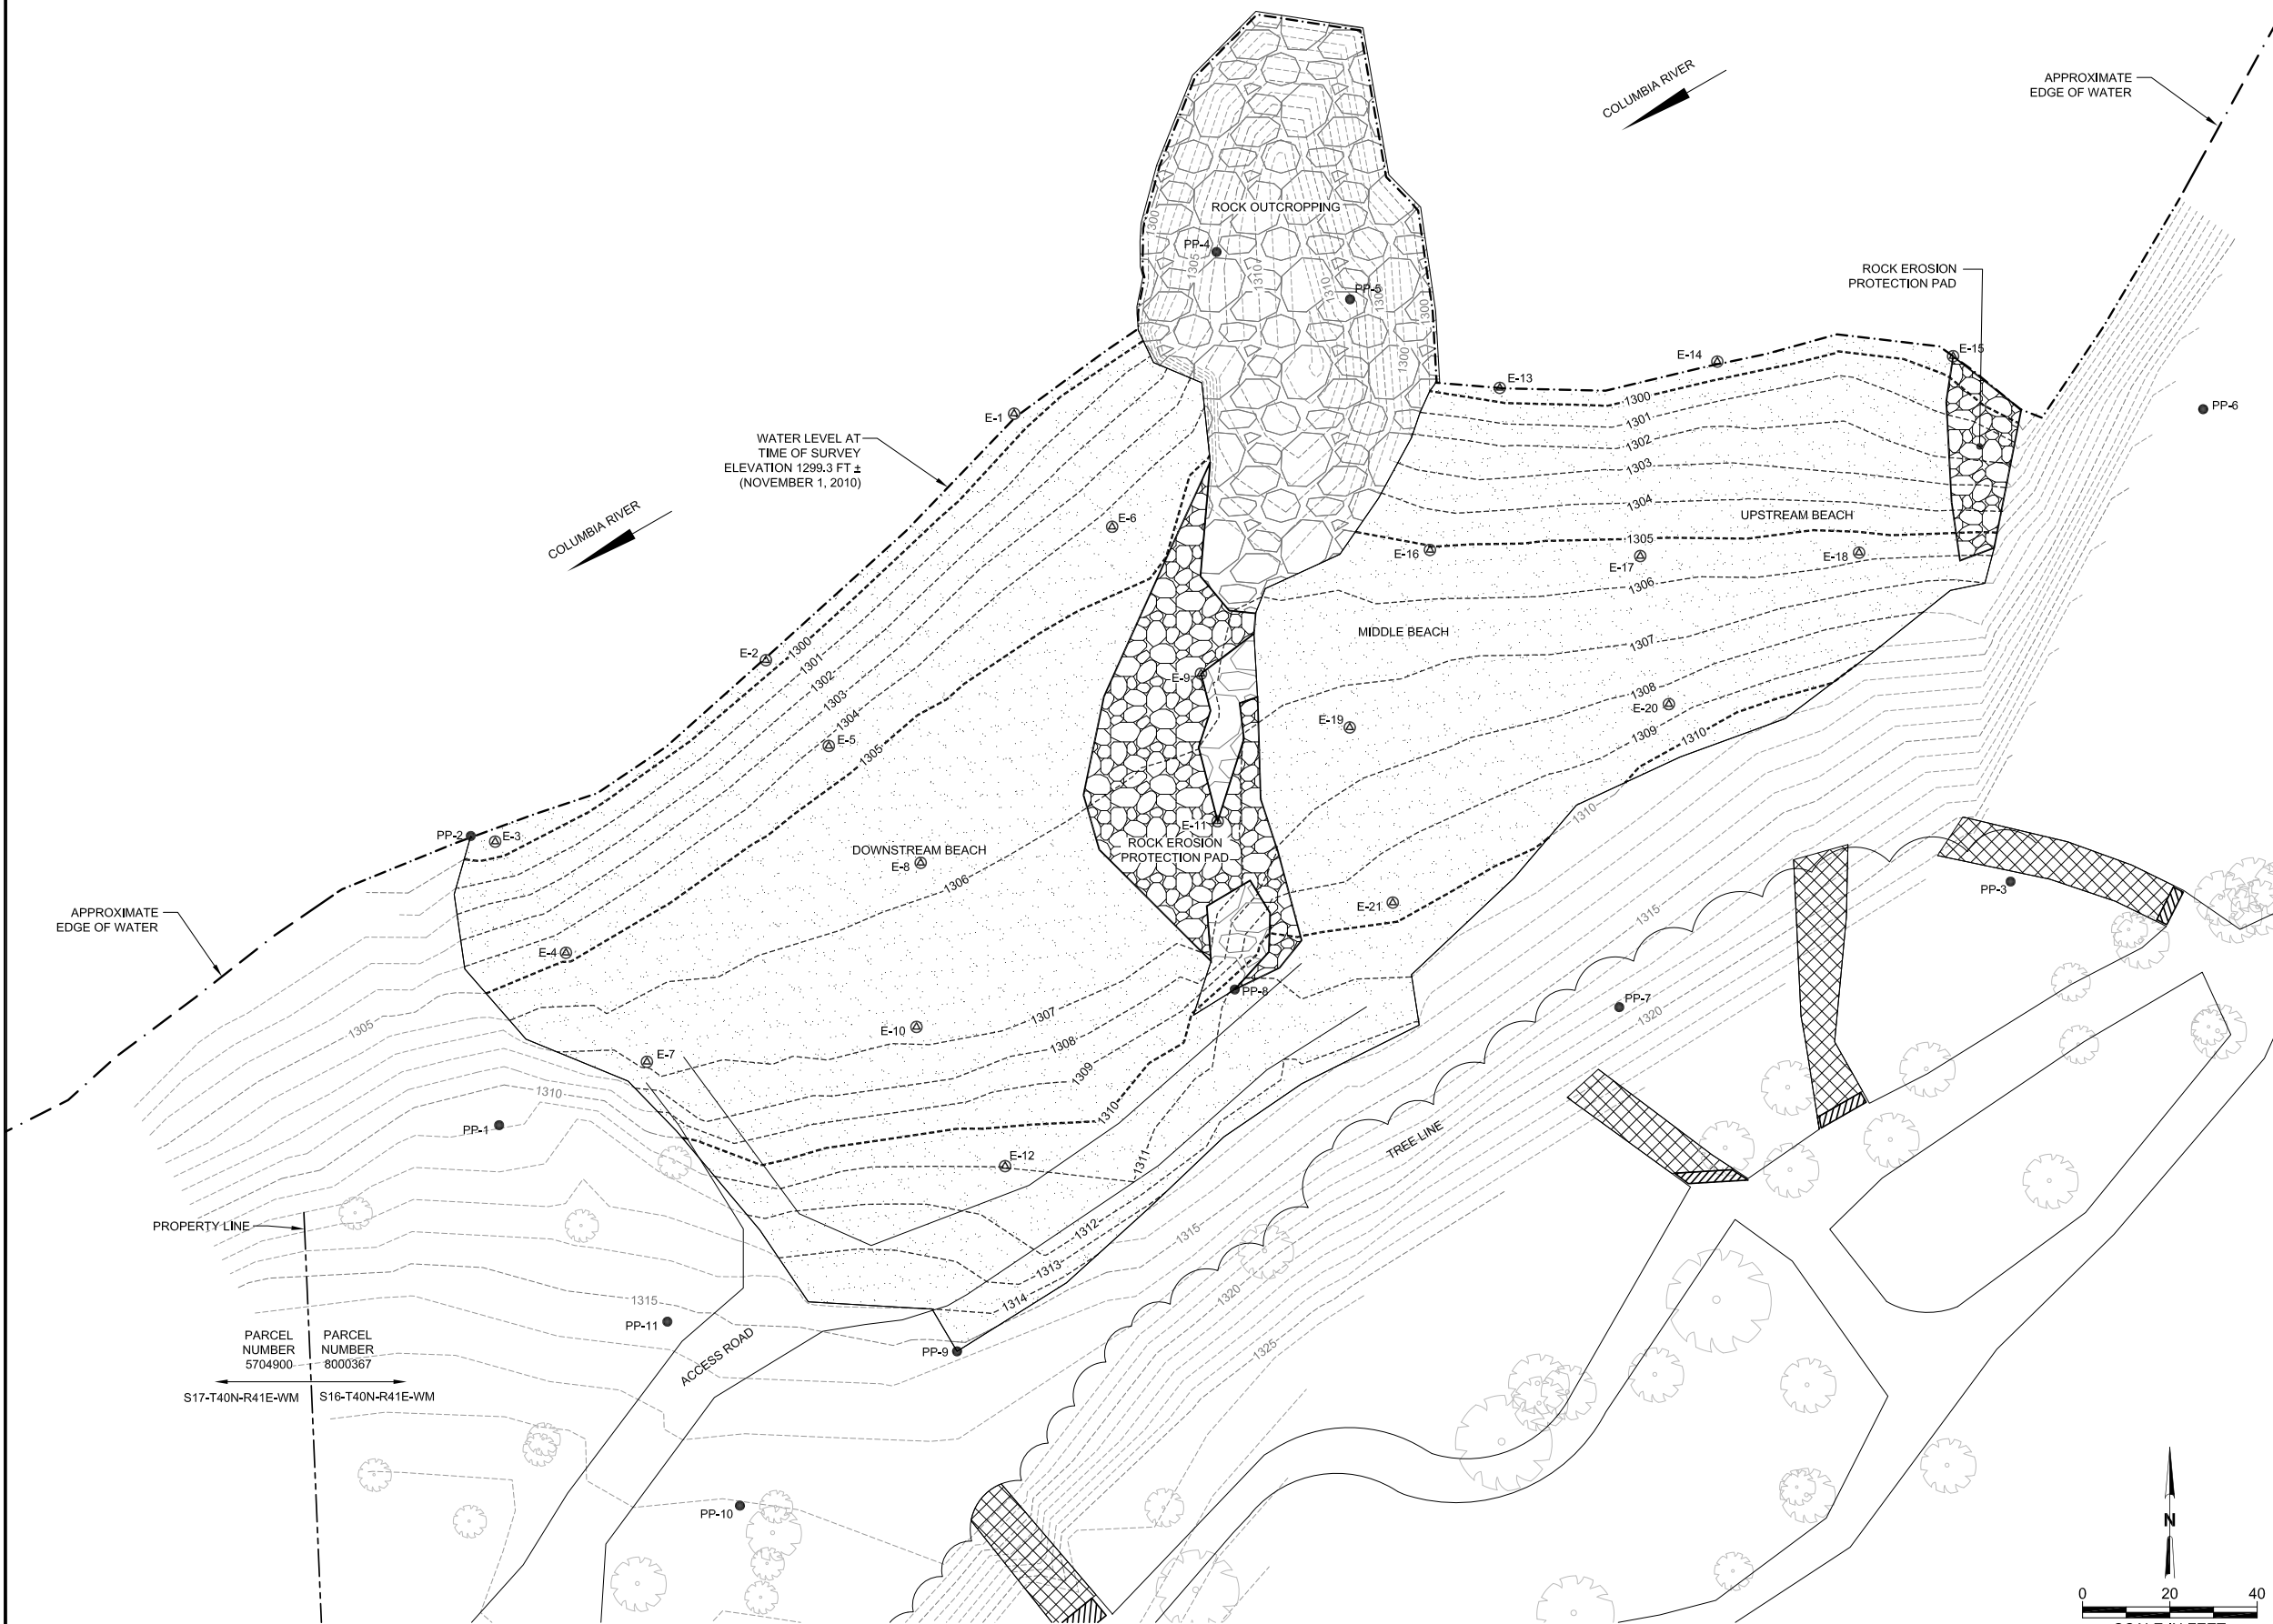
**FIGURE 1
 2010 TOPOGRAPHIC
 SURVEY MAP**

- **Figure 1 – 2010 Topographic Survey Map:** Figure 1 illustrates 1-foot (ft) topographic elevation contours at time of As-Built Survey following completion of the Black Sand Beach project. The topographic survey was performed by a licensed land surveyor (Survey Solutions) on November 1, 2010.

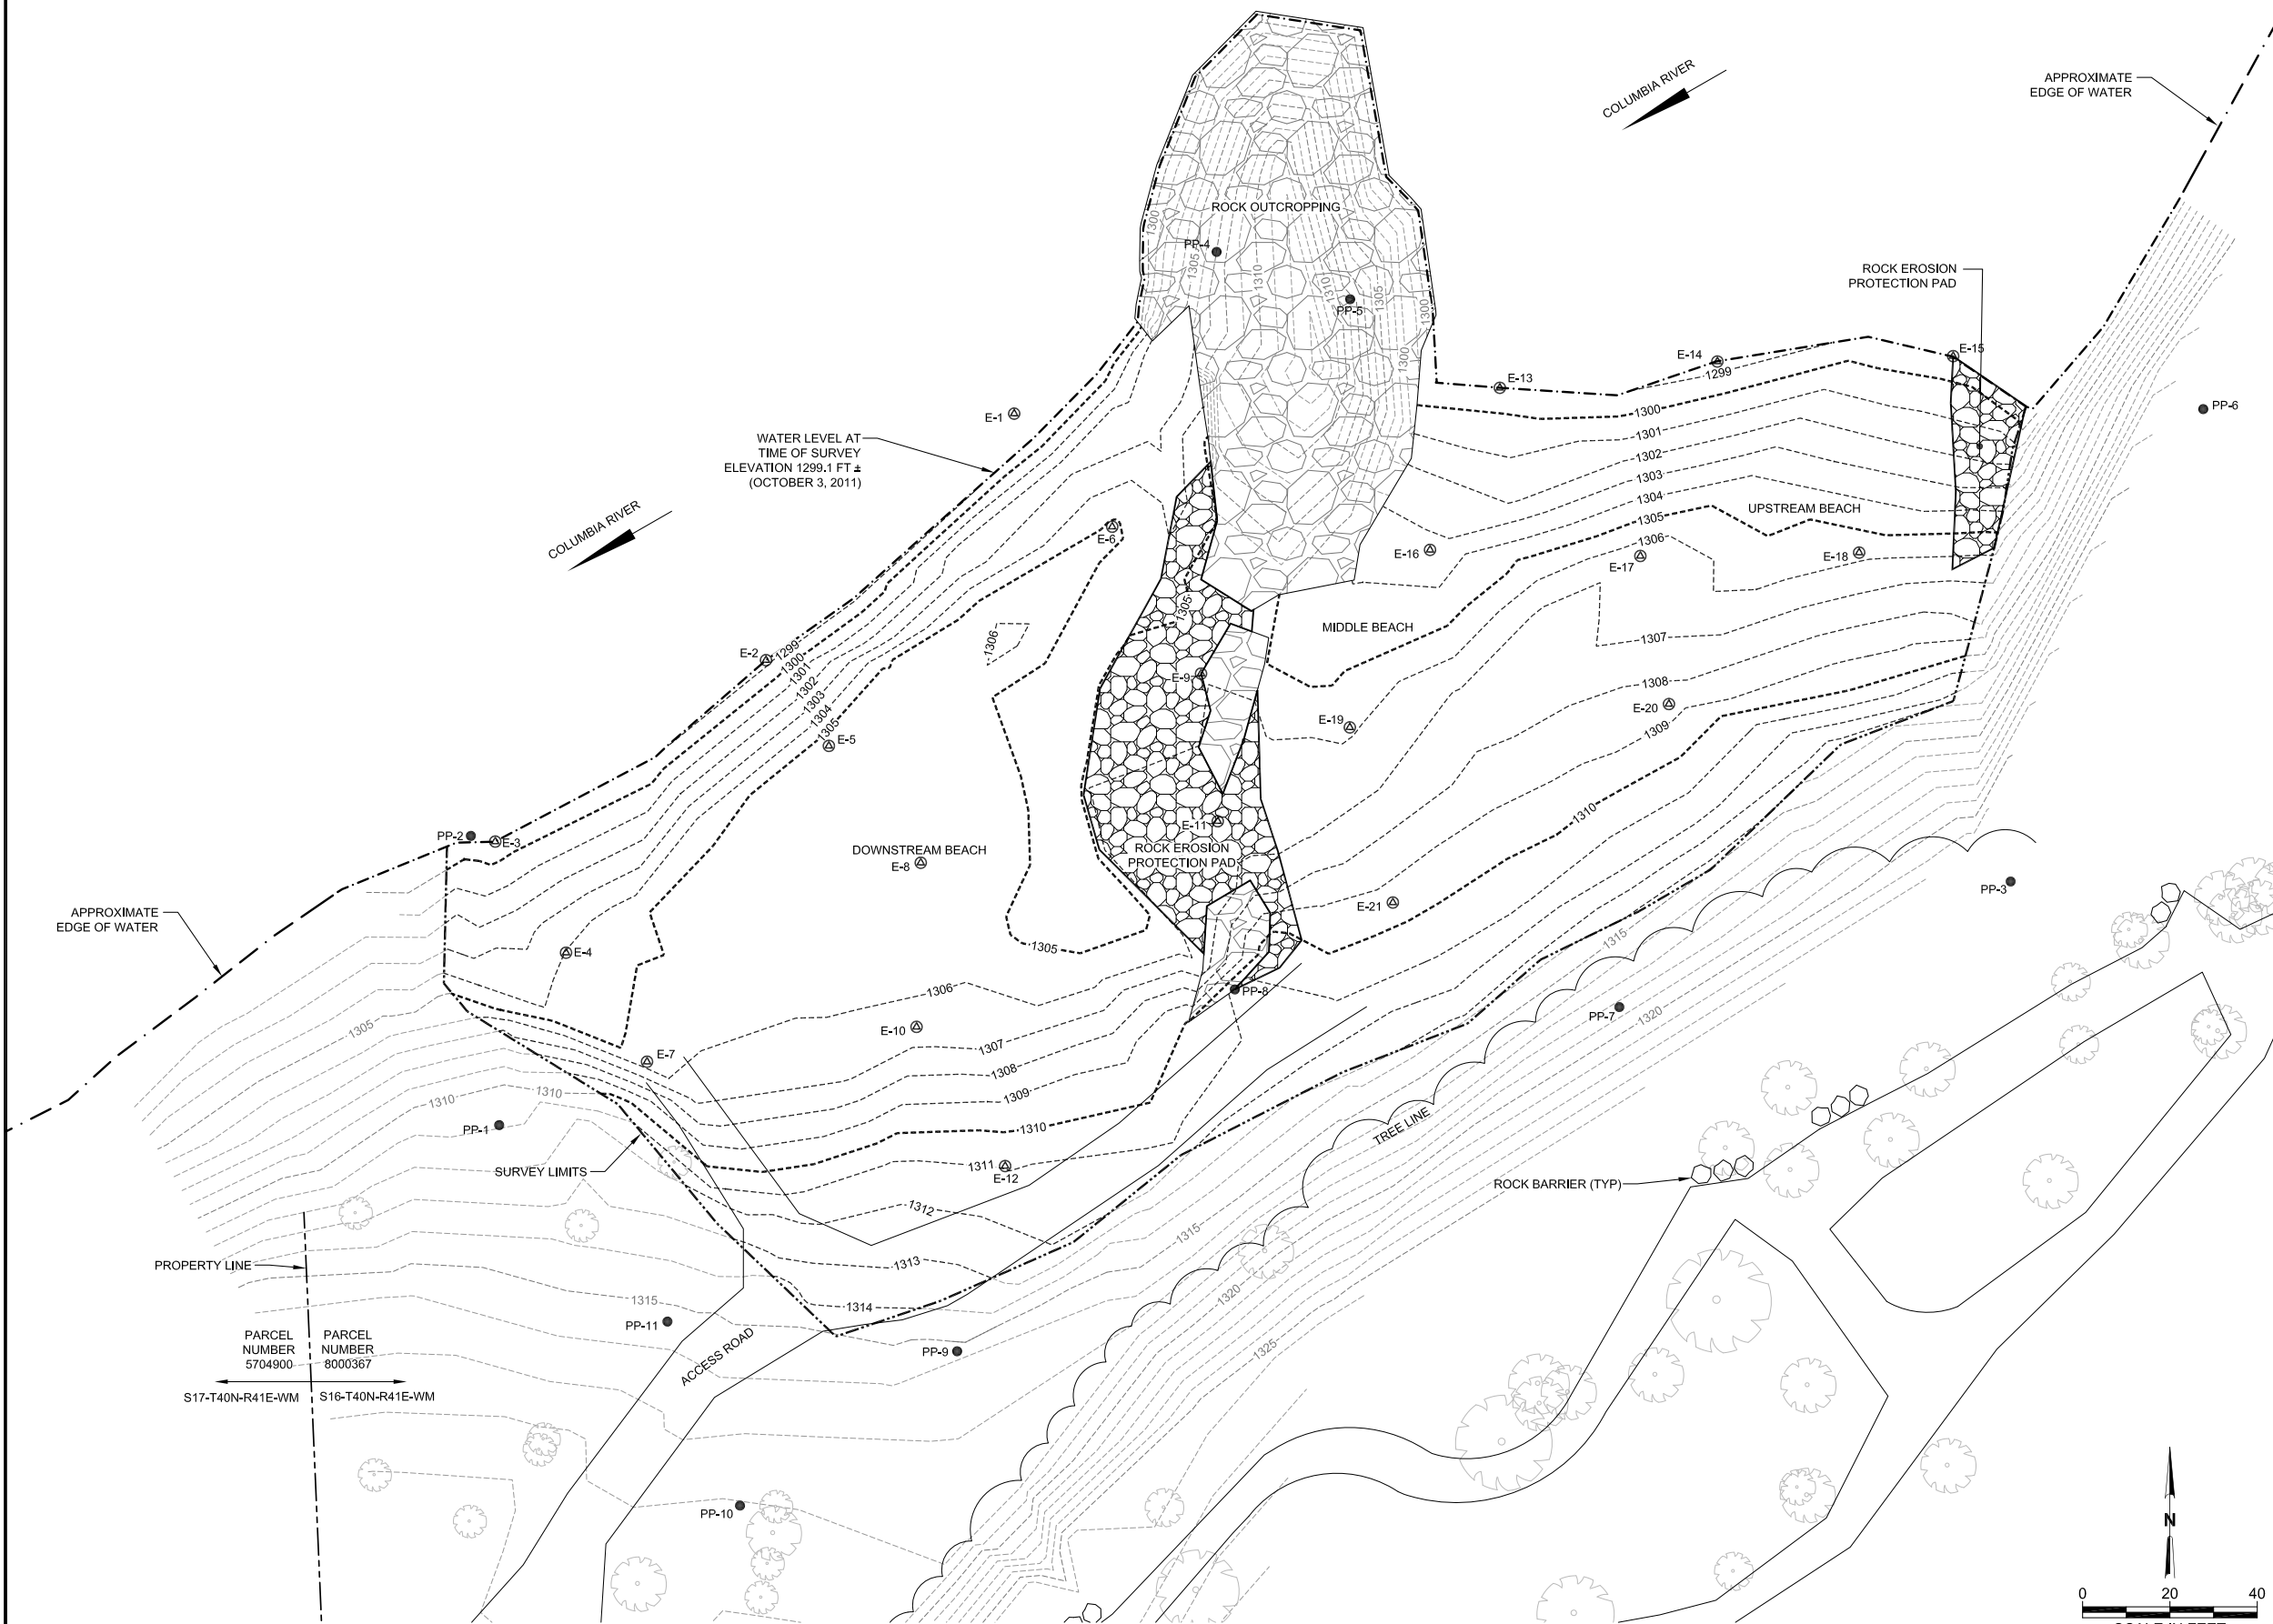
**FIGURE 2
 2011 TOPOGRAPHIC
 SURVEY MAP**

- **Figure 2 – 2011 Topographic Survey Map:** Figure 2 illustrates 1-ft topographic elevation contours at the time of the 2011 Annual Performance Monitoring (October 3, 2011). This topographic survey was performed by Survey Solutions.

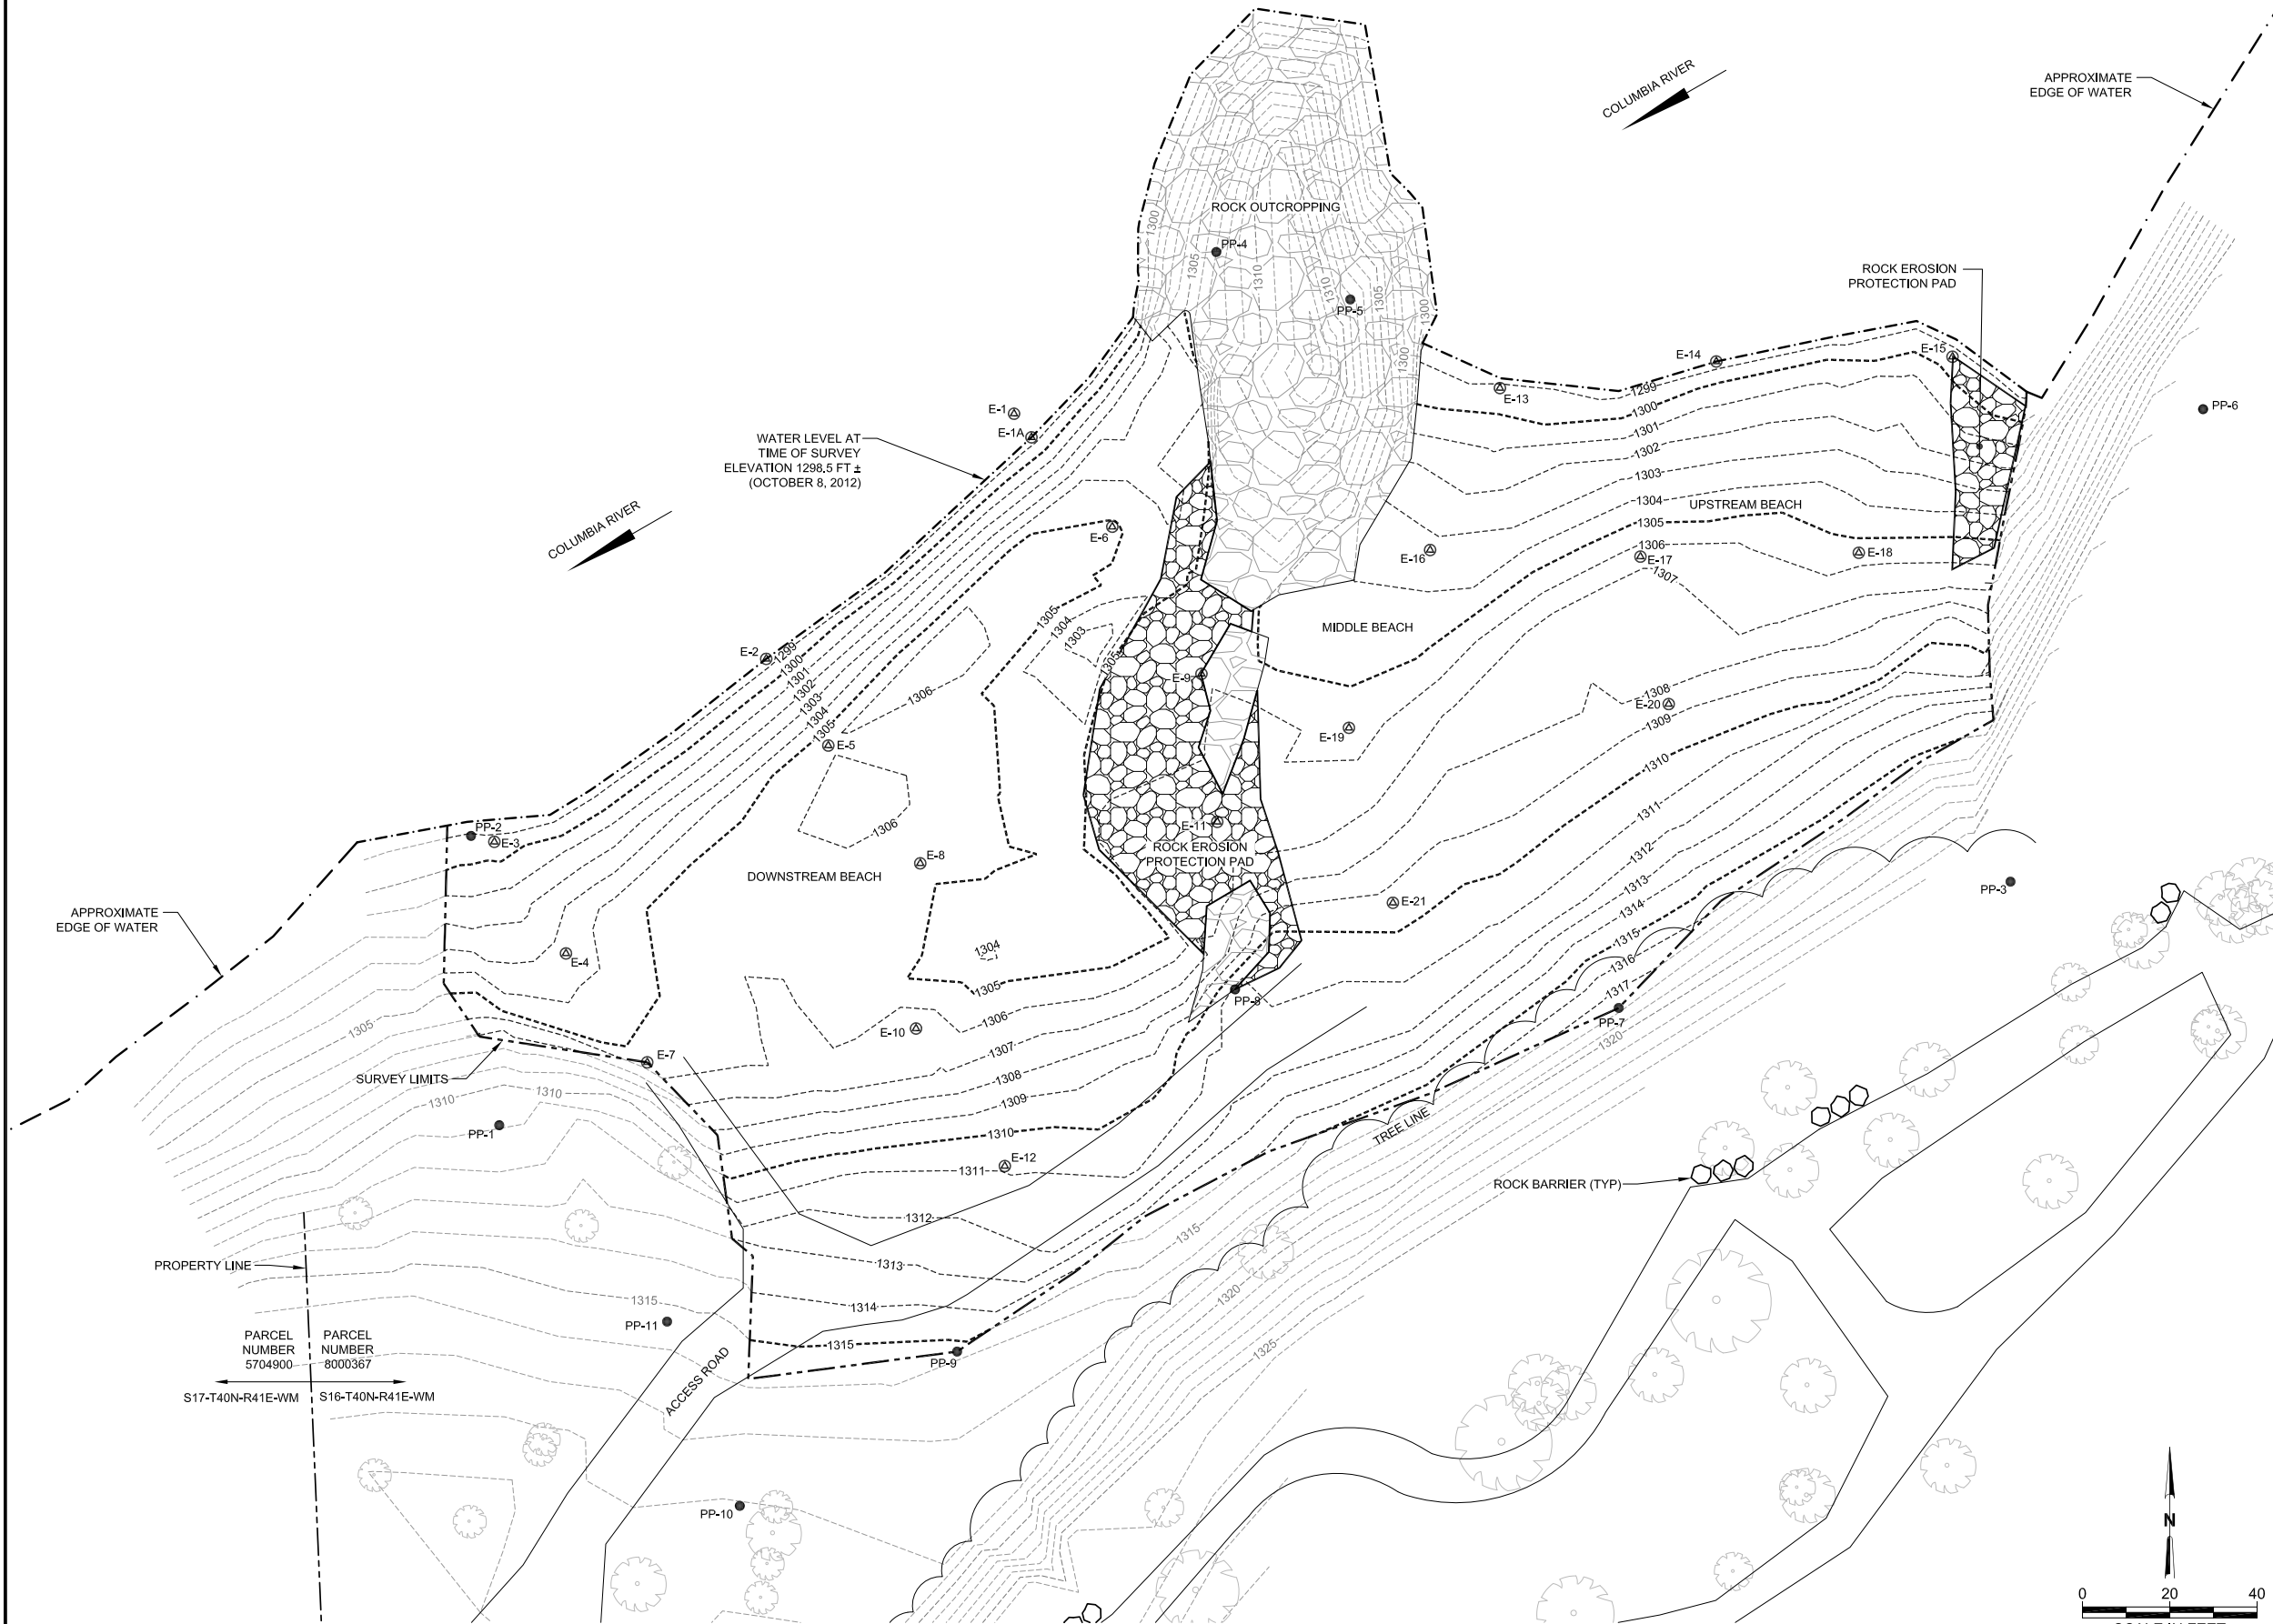
**FIGURE 3
 2012 TOPOGRAPHIC
 SURVEY MAP**

- **Figure 3 – 2012 Topographic Survey Map:** Figure 3 illustrates 1-ft topographic elevation contours at the time of the 2012 Annual Performance Monitoring (October 8, 2011). This topographic survey was performed by Survey Solutions.

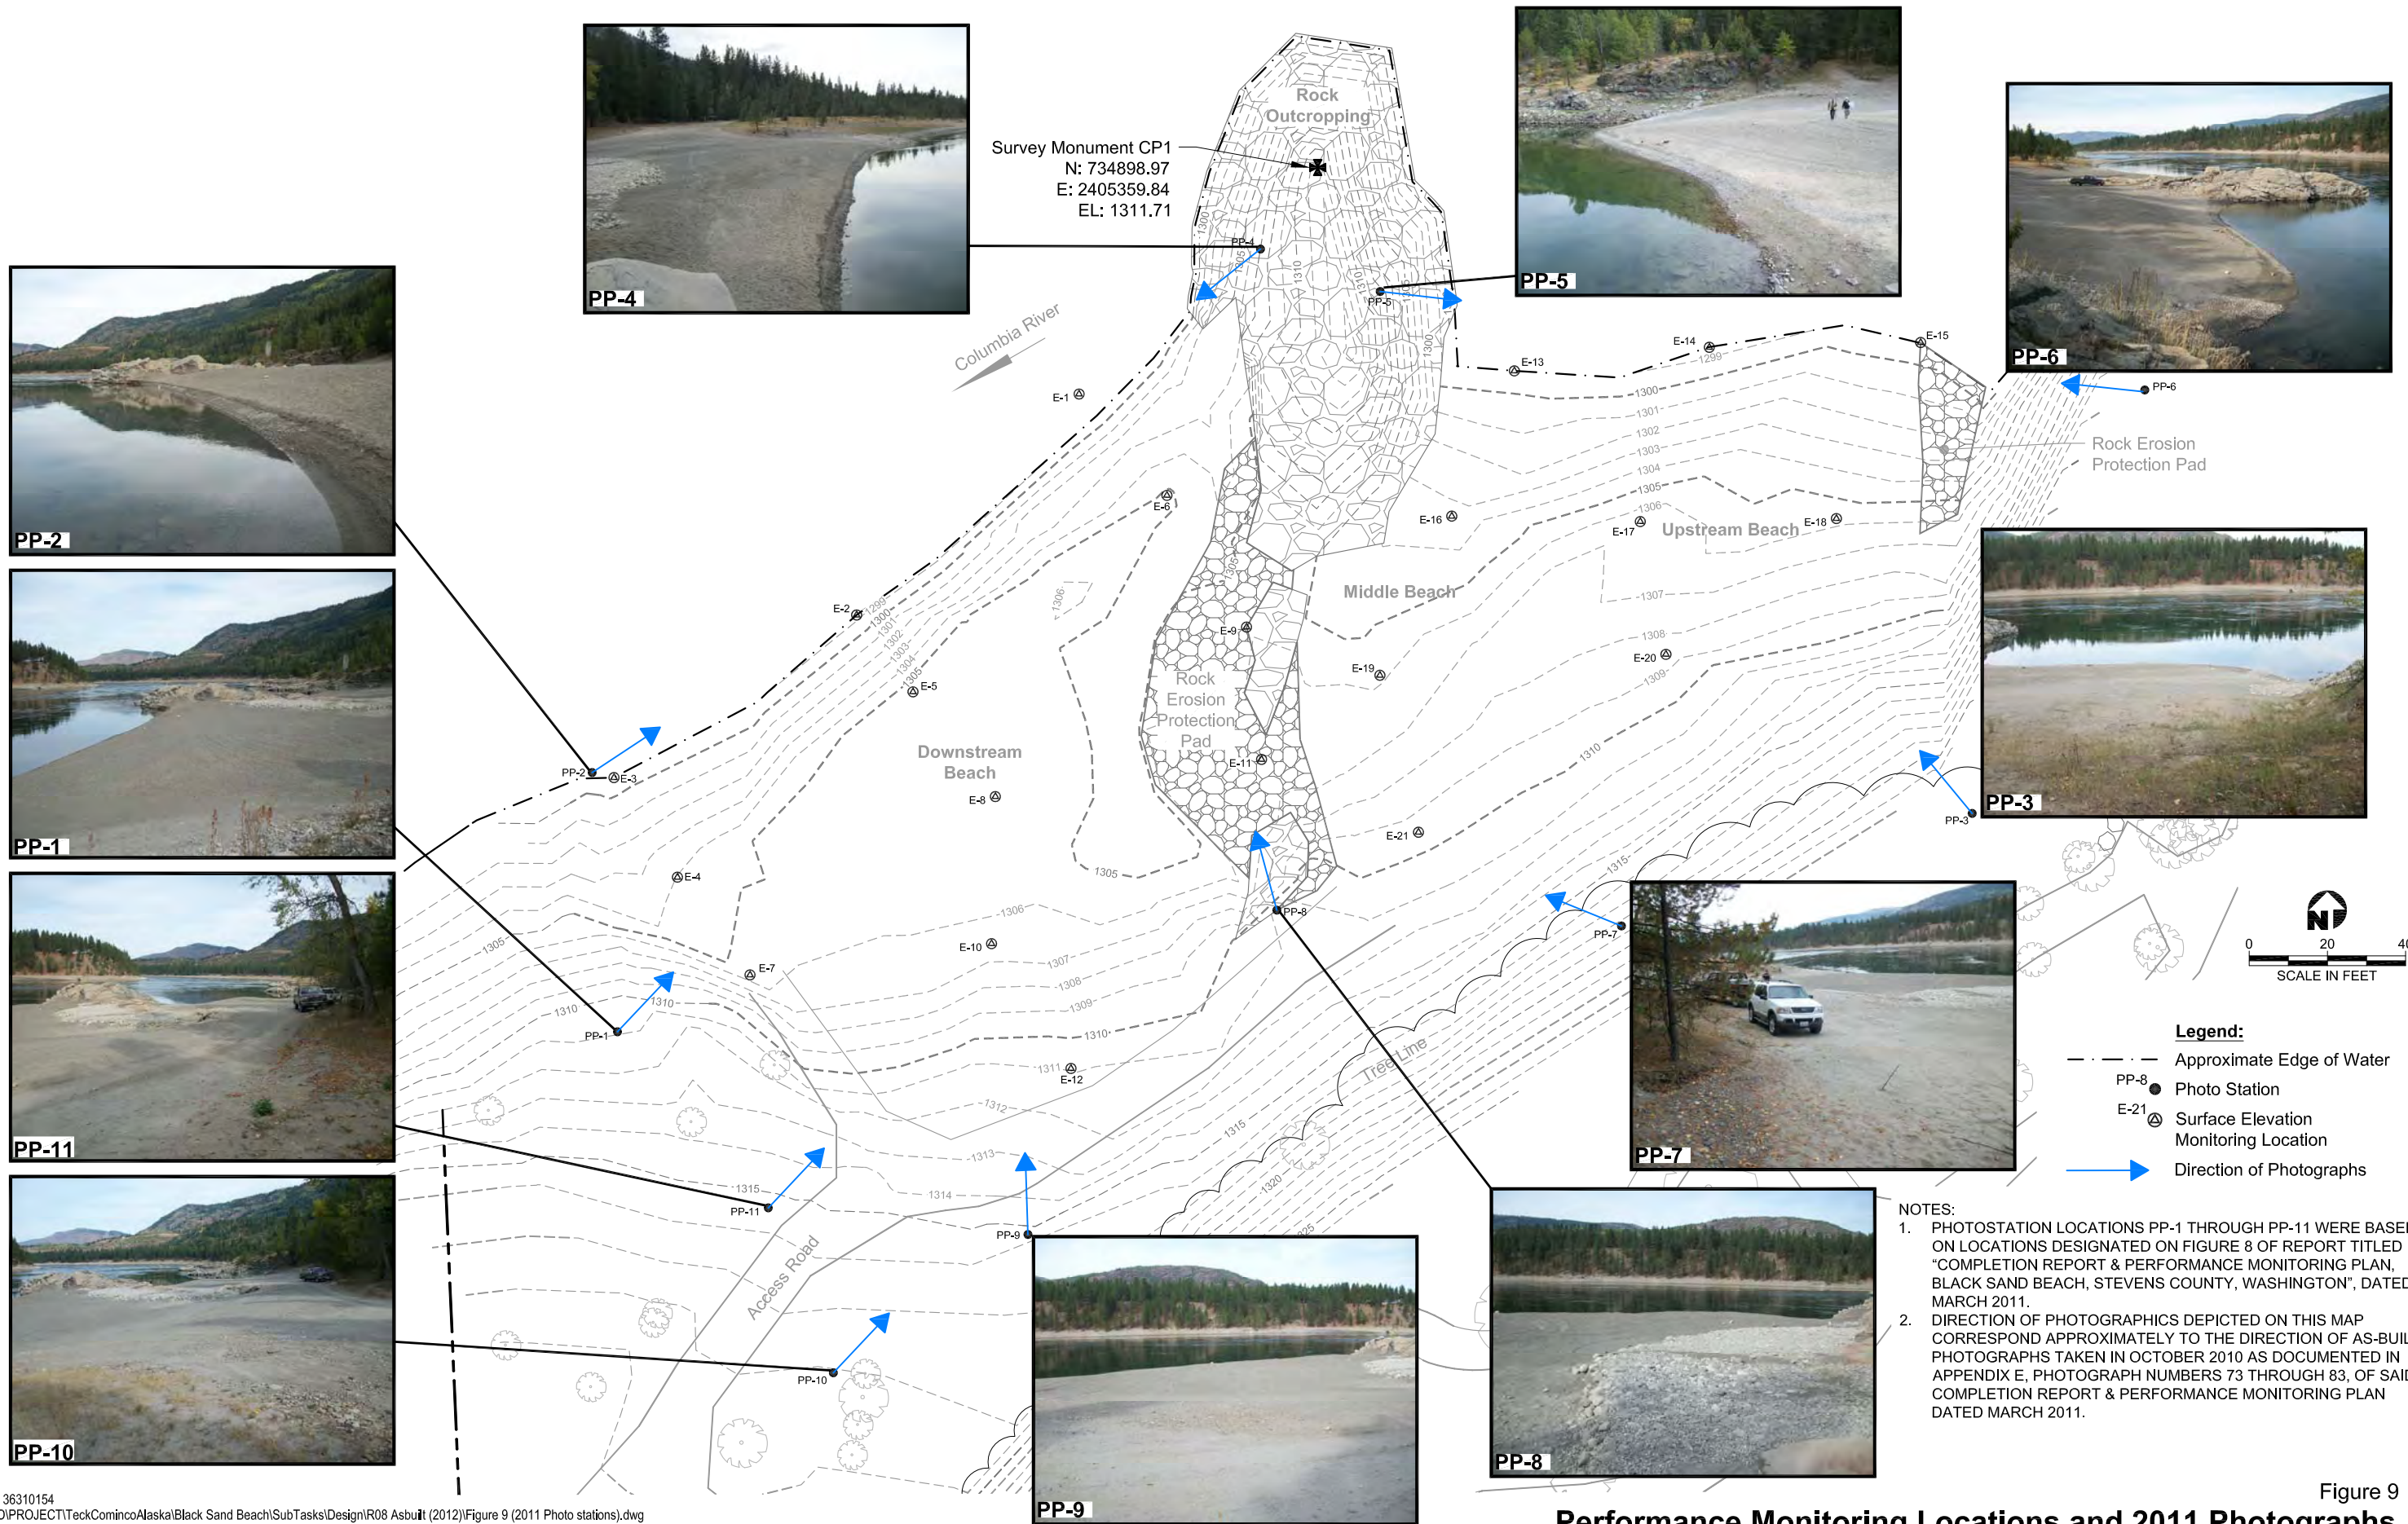
Figure 9
Performance Monitoring Locations and 2011 Photographs
 Black Sand Beach
 Northport, Washington

- **Figure 9 – Performance Monitoring Locations and 2011 Photographs:** Figure 9 illustrates surface elevations and photographs recorded during the October 3, 2011 Annual Performance Monitoring event.

- NOTES:**
1. PHOTOSTATION LOCATIONS PP-1 THROUGH PP-11 WERE BASED ON LOCATIONS DESIGNATED ON FIGURE 8 OF REPORT TITLED "COMPLETION REPORT & PERFORMANCE MONITORING PLAN, BLACK SAND BEACH, STEVENS COUNTY, WASHINGTON", DATED MARCH 2011.
 2. DIRECTION OF PHOTOGRAPHICS DEPICTED ON THIS MAP CORRESPOND APPROXIMATELY TO THE DIRECTION OF AS-BUILT PHOTOGRAPHS TAKEN IN OCTOBER 2010 AS DOCUMENTED IN APPENDIX E, PHOTOGRAPH NUMBERS 73 THROUGH 83, OF SAID COMPLETION REPORT & PERFORMANCE MONITORING PLAN DATED MARCH 2011.
