SUBJECT: SUMMARY OF FINDINGS—SUBSURFACE INVESTIGATION
Former Mastermark Printing
6545 Fifth Avenue South
Seattle, Washington 98108
SES Project Number: 0761-001-02

Sound Environmental Strategies (SES) has prepared this letter report to document the subsurface investigation activities conducted by SES at Former Mastermark Printing, located at 6545 Fifth Avenue South in Seattle, Washington (hereafter referred to as the Property), as shown on Figure 1.

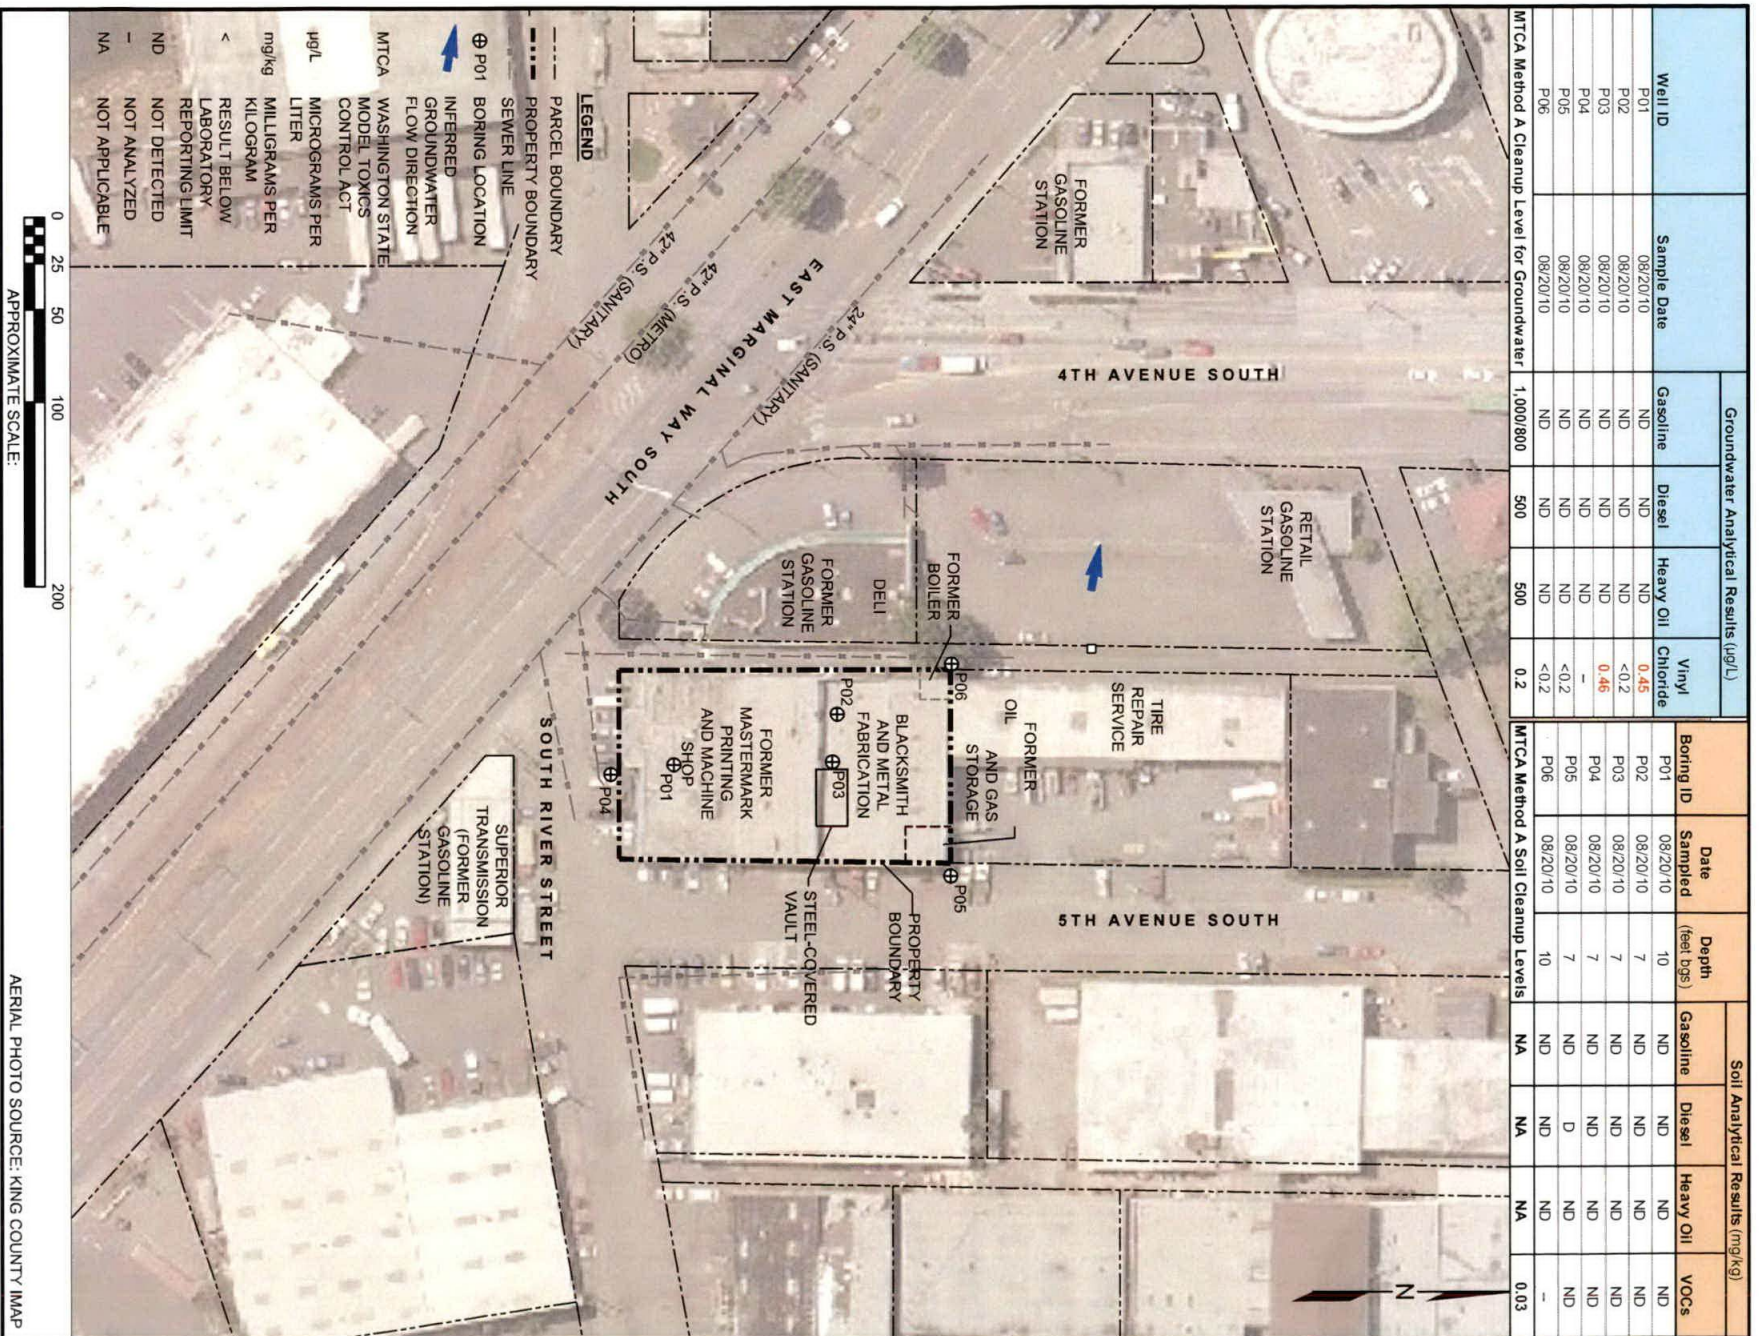
FIGURE 2
 SUMMARY OF
 GROUNDWATER AND SOIL
 ANALYTICAL RESULTS

The subsurface investigation was conducted on August 20, 2010, and included collection of soil and groundwater samples from push-probe borings P01 through P06. The borings were advanced using a limited access direct-push drill rig. Borings were sampled continuously from ground surface to depths of 10 to 12 feet below ground surface (bgs). The samples were described in accordance with the Unified Soil Classification System (USCS) and were screened in the field for potential evidence of contamination using visual observations and notations of odor. The USCS symbol and visual and olfactory notations for the samples were recorded on boring log forms, which are provided in Appendix A. The borings were placed at the following locations (Figure 2):

- Boring P01 was advanced to 10 feet bgs within the south end of the building, in the center of the former Mastermark Printing and Machine Shop.
- Borings P02 and P03 were advanced to 12 and 10 feet bgs, respectively, within the north end of the building, in the former blacksmith and metal fabrication area.
- Boring P04 was advanced to 11 feet bgs outside of the building, on the south of the Property in the vicinity of the side sewer connection.
- Boring P05 was advanced to 12 feet bgs outside of the northeast corner of the building, in the adjoining right-of-way.

- Boring P06 was advanced to 12 feet bgs outside of the northwest corner of the building, in the vicinity of the former boiler location.

Soil analytical results indicated the following (Figure 2, Table 1):

- Diesel was detected at a concentration of 2,900 mg/kg in the soil sample collected from boring P05 at 7 feet bgs.
- Concentrations of gasoline, diesel, and heavy oil were reported as not detected from the soil samples collected from all remaining borings.
- Concentrations of chlorinated solvents were below their respective laboratory reporting limits and/or MTCA Method A cleanup levels in the soil samples collected from P01 through P05.
- Concentrations of MTCA 5 metals were below their respective laboratory reporting limits and/or MTCA Method A cleanup levels in the soil sample collected from P06.

Groundwater analytical results indicated the following (Figure 3, Table 2):

- Concentrations of gasoline, diesel, and heavy oil were reported as not detected from the groundwater samples collected from borings P01 through P06.
- Concentrations of vinyl chloride above the applicable MTCA Method A cleanup level were detected in the groundwater samples collected from P01 and P03.
- Concentrations of chlorinated solvents were below their respective laboratory reporting limits and/or cleanup levels in the groundwater samples collected from P02, P05, and P06.

The results of the limited subsurface investigation at the Property confirm the presence of shallow diesel contamination in the soil beyond the northeast corner of the Property, as well as the presence of vinyl chloride in groundwater beneath the center of the Property. Due to the nature of push-probe sampling techniques, the concentrations of vinyl chloride observed in groundwater collected from borings P01 and P03 may be biased high; the installation of monitoring wells on the Property will provide a more quantitative evaluation of the contaminant concentrations.

The elevated concentration of diesel in soil indicates an area of contamination that is likely limited in extent; the area in which it was encountered is beneath to the right-of-way, and the contamination may have resulted from a leaking drum or a spill.

Additional investigation would be required in order to confirm the presence of elevated vinyl chloride in groundwater.

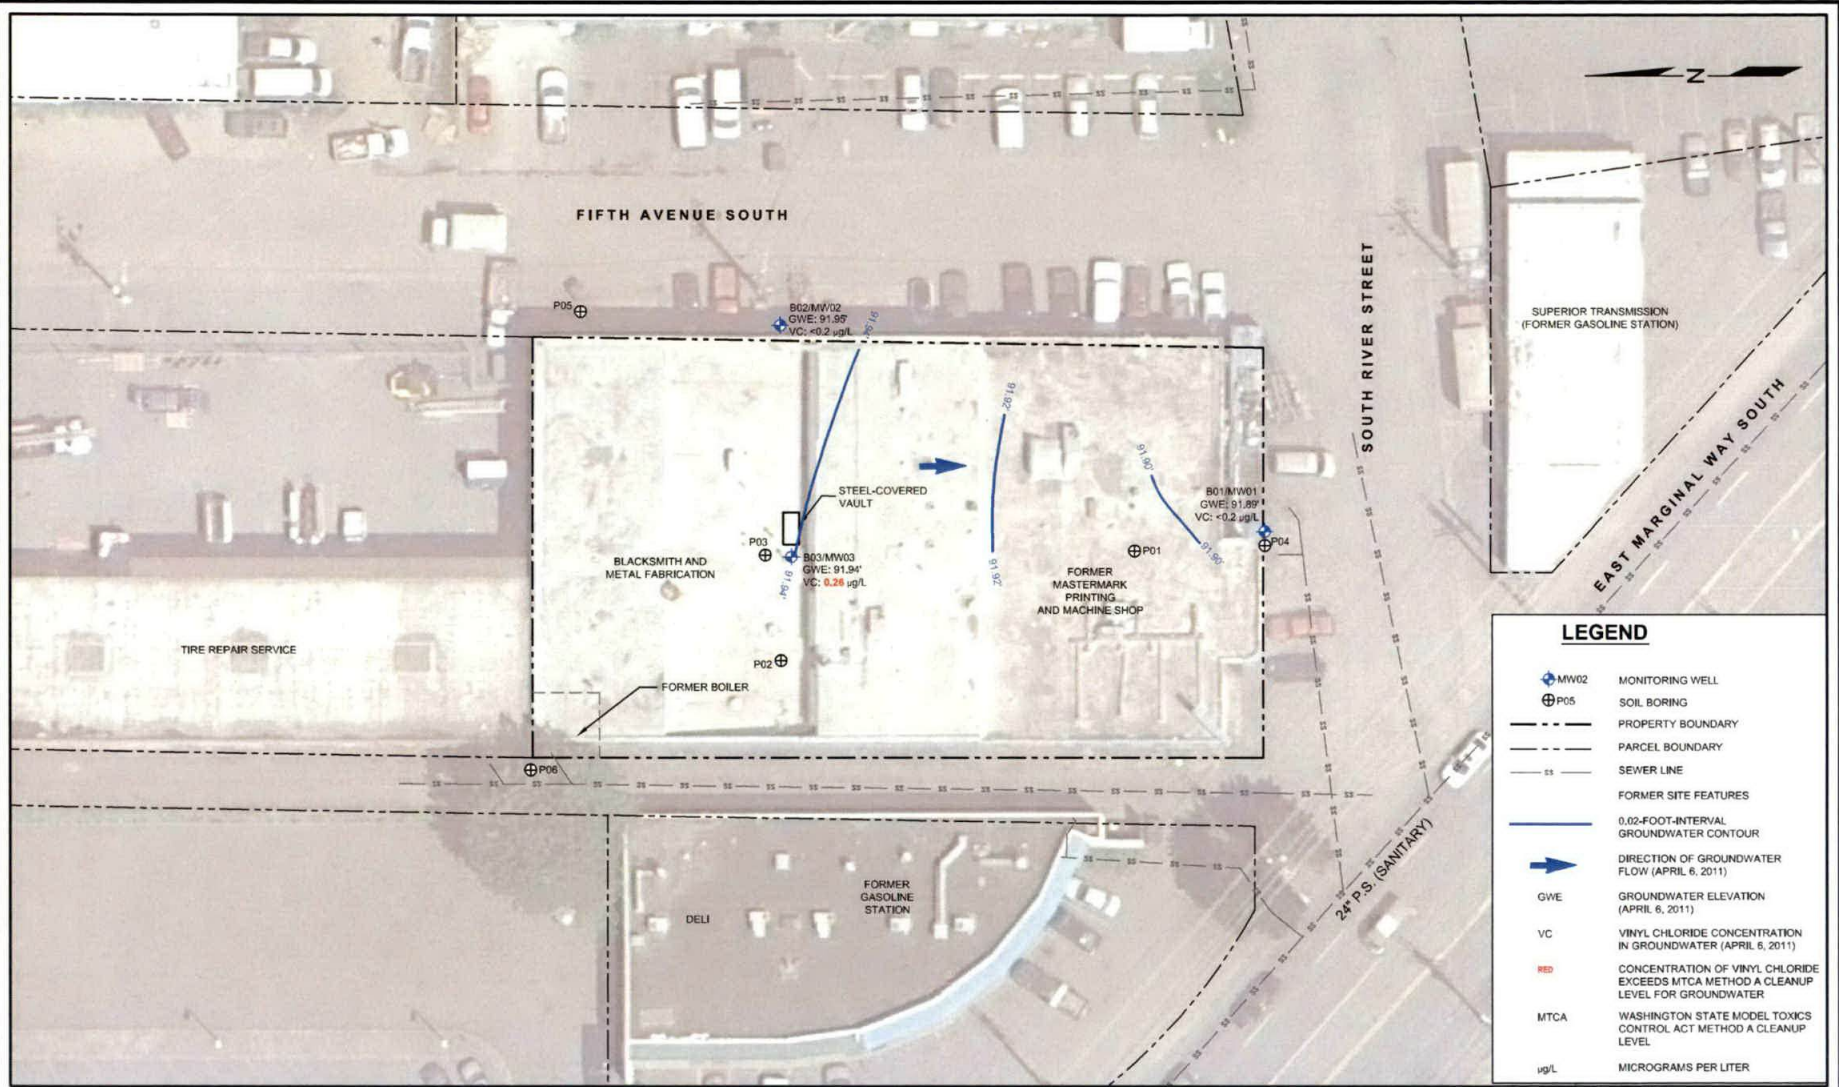
Soil encountered during drilling activities for boring B02 consisted of silty sand or fine sandy silt within the maximum explored depth of 16.5 feet bgs. No hydrocarbon odors or elevated PID readings were observed for the soil samples recovered from boring B02.

Sand or silty sand was observed in drill cuttings or reported by the driller during the advancement of borings B01 and B03. Bentonite was observed in drill cuttings from boring B01 and is interpreted to be from the adjacent abandoned previous soil boring P04.

With respect to the presence of vinyl chloride slightly above the MTCA cleanup level in groundwater sampled from monitoring well MW03, SoundEarth considers the value to be potentially anomalous. Therefore, we recommend sampling all wells, MW01 through MW03, for an additional quarter to assess whether vinyl chloride concentrations may still be biased high for MW03 due to the relatively short time span between the well installation, and the sampling of the new well. In the event that chlorinated solvent concentrations are below MTCA cleanup levels for all three wells during the additional quarter of groundwater sampling, SoundEarth would then recommend continued quarterly groundwater monitoring in an effort to achieve four consecutive quarters of groundwater quality compliance. However, if chlorinated solvent concentrations remain above MTCA cleanup levels in groundwater, then additional remediation technologies may be recommended followed by continued quarterly groundwater monitoring in an effort to achieve regulatory compliance. At the time that four consecutive quarters of groundwater monitoring results demonstrate compliance with MTCA cleanup levels for chlorinated solvents, a determination of No Further Action will be requested from the Washington State Department of Ecology.
