**From:** Janet Knox <[janet@PGWG.COM](mailto:janet@PGWG.COM)>  
**Sent:** Tuesday, July 14, 2020 1:18 PM  
**To:** Maurer, Christopher (ECY) <[cmou461@ECY.WA.GOV](mailto:cmou461@ECY.WA.GOV)>  
**Subject:** Scougal Rubber VCP NW1707 Vapor Samples

## Table 1. Sampling Results Summary

Scougal Rubber Corporation, Seattle, Washington

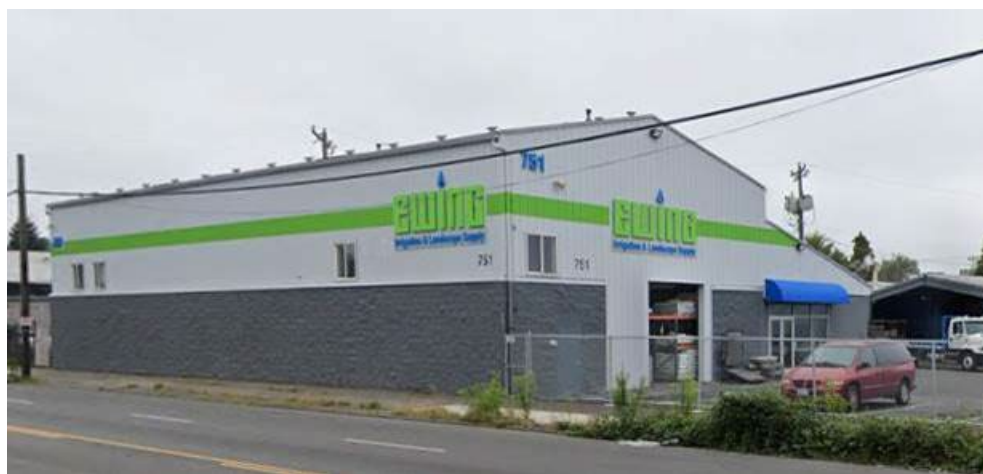
We received the vapor samples from subslab sampling near the Ewing building. As shown in the attached tables, the results exceed the Method C sub-slab cleanup level. However, the Ewing building is an open, warehouse-style retail store like a Home Depot with big garage doors that are often open for loading. It is built on a concrete slab that extends from 2 to 10 feet beyond the building on all sides, surrounded by asphalt parking lot.

The attached picture shows the transition between the concrete and asphalt. The white marked area is where SV-2 was collected. The concrete is unreinforced, according to the private locator.
