**RE: Underground Storage Tank (UST) Site Assessment Report
University Volkswagen Audi
4700 Roosevelt Way Northeast
Seattle, Washington 98105
RGI Project No. 2014-068J**

The Riley Group, Inc. (RGI) is pleased to present this *Underground Storage Tank (UST) Site Assessment Report* for an abandoned UST system located on the University Volkswagen Audi property at 4700 Roosevelt Way Northeast, Seattle, King County, Washington (hereafter referred to as the Site, Figure 1).

Site Photographs

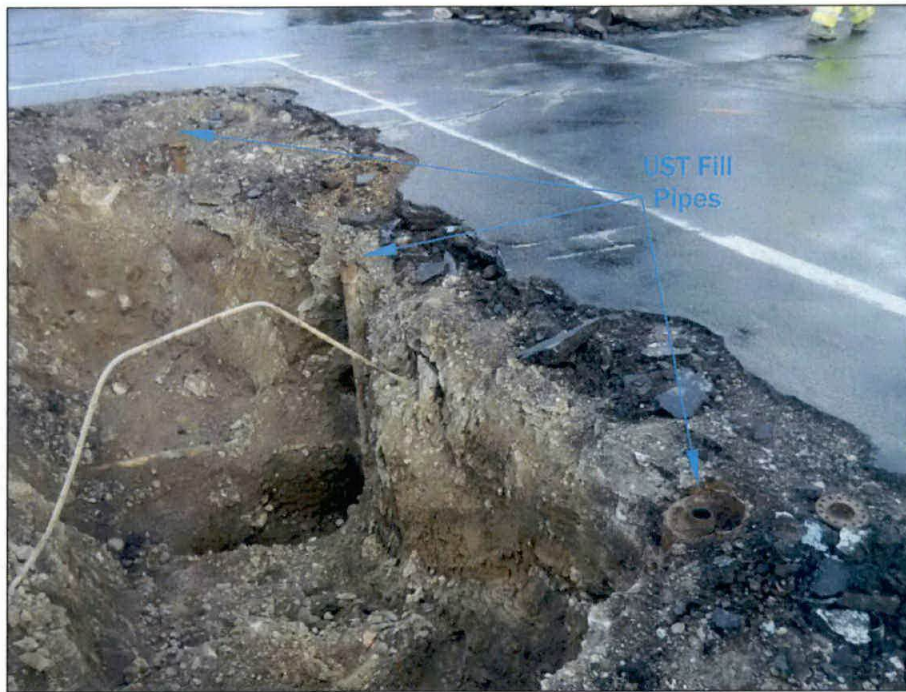
Photograph 1: The three uncovered UST fill pipes.

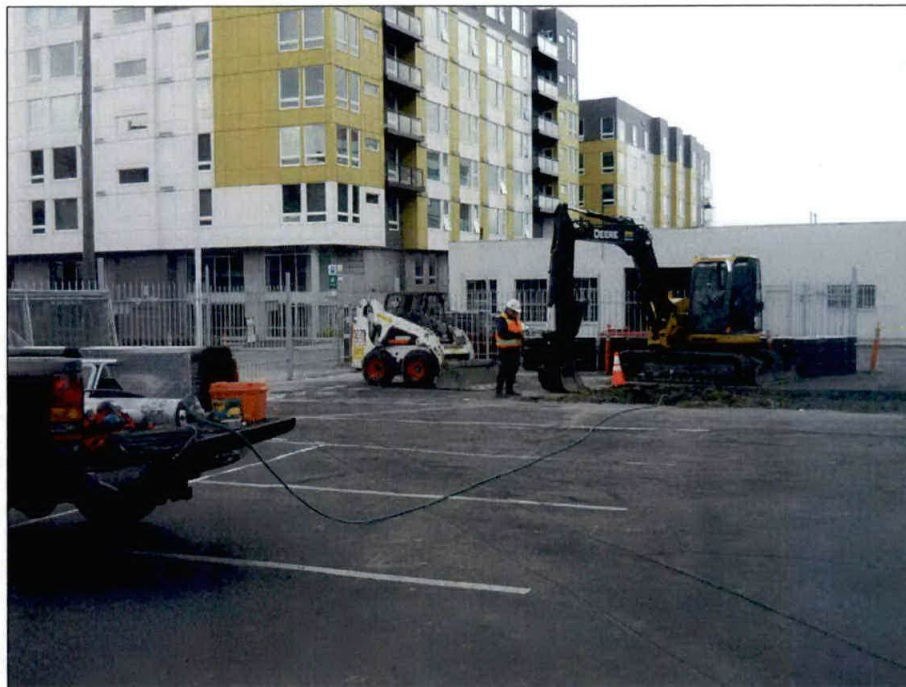
A marine chemist with Northwest Marine Chemist, Inc. used a combustible gas/LEL meter to monitor the oxygen and LEL concentrations in each UST, and inerted the USTs. Two City of Seattle Fire Department representatives inspected the work in association with a UST decommissioning/removal permit. Marine Vacuum Services, Inc. (Mar-Vac) triple-rinsed and pumped sludge and rinse water out of the USTs.

Photograph 2: Marine chemist inserting the USTs.

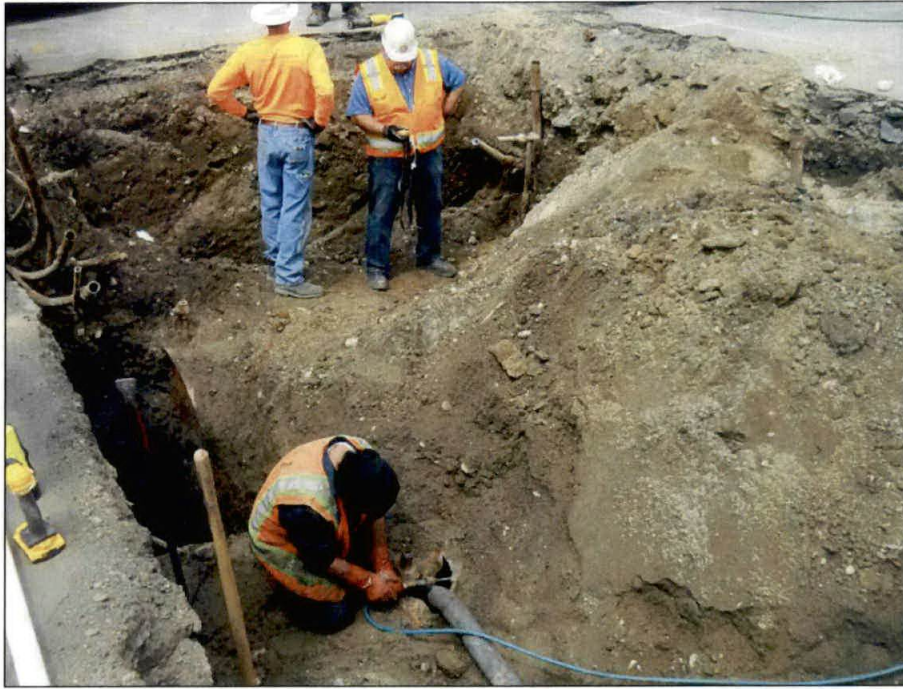
Photograph 3: Mar-Vac pumping and rinsing the USTs.

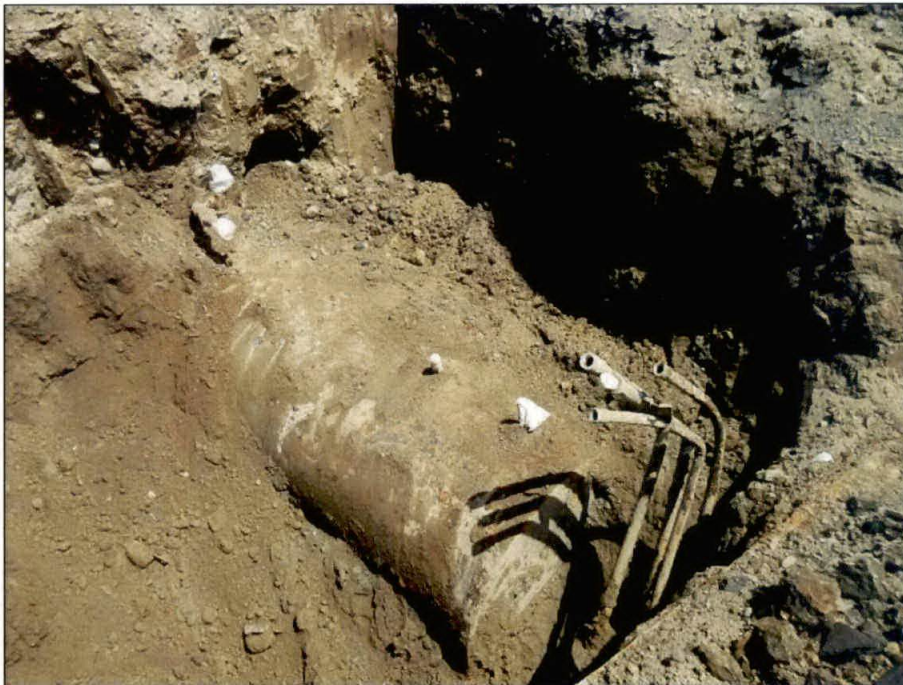
UST1 and UST2 were approximately 10 feet long and 3 feet in diameter (approximately 600 gallon capacities). UST1 was empty and had been inadvertently punctured during RGI's 2014 subsurface investigation, but did not appear to have any other holes. UST2 contained approximately 8 inches of old gasoline, and had small holes on the top and sides. UST3 was approximately 8 feet long and 3 feet in diameter (approximately 500 gallon capacity). UST3 contained approximately 6 inches of a mixture of old gasoline and water, and had numerous small holes in the top and bottom. UST3 appeared less rusty than the others and may have been newer steel. The three USTs were single-walled and appeared structurally intact.

Photograph 4: One of the uncovered USTs.

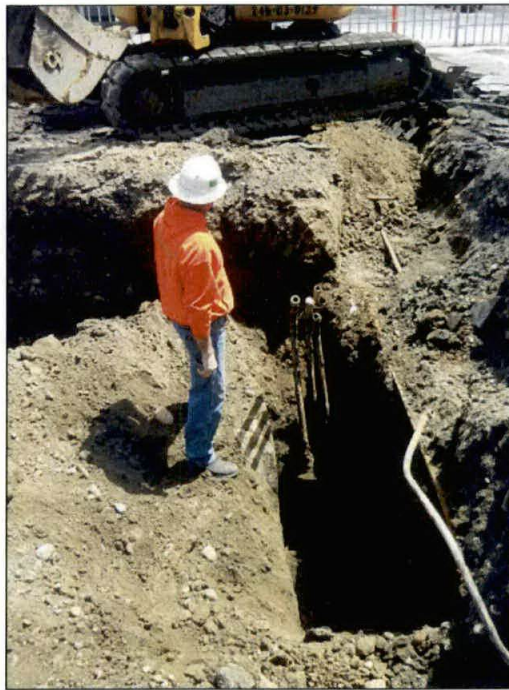
Numerous pipes were observed, of which many were determined to be associated with three pressure vessels (one for each of the USTs). These pressure vessels were approximately 20 gallons in size. The pressure vessels were historically used to store/pump fuel to the fuel

Photograph 5: One of the uncovered pressure vessels.

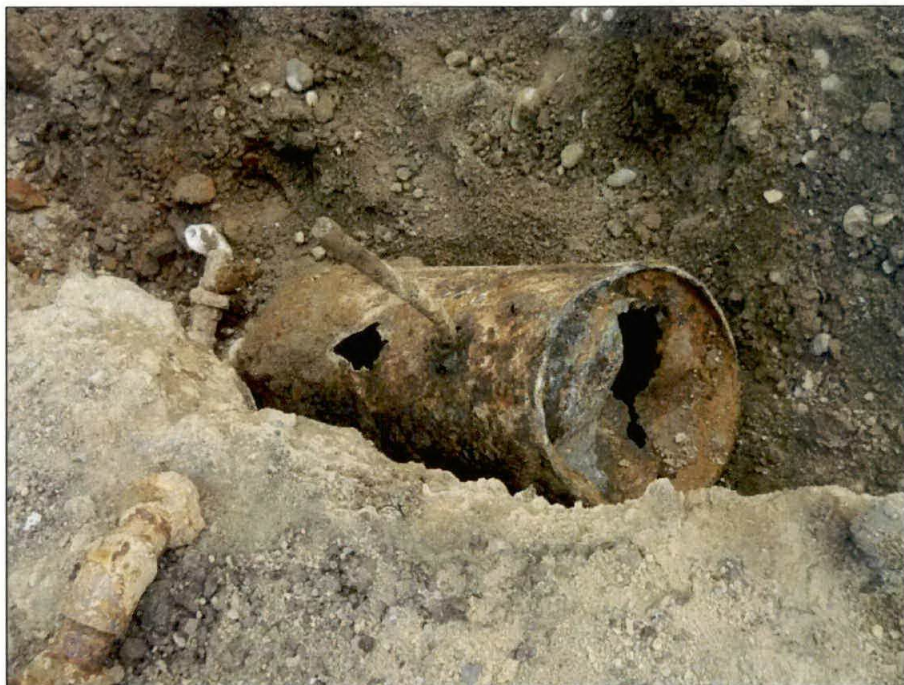
dispensers. The pressure vessel associated with UST1 had a small hole in the side and contained some residual product. The pressure vessel associated with UST2 had large holes all over it and did not contain any product. The pressure vessel associated with UST3 did not have any holes and contained some residual product.

Photograph 6: The pressure vessel associated with UST2 with large holes.

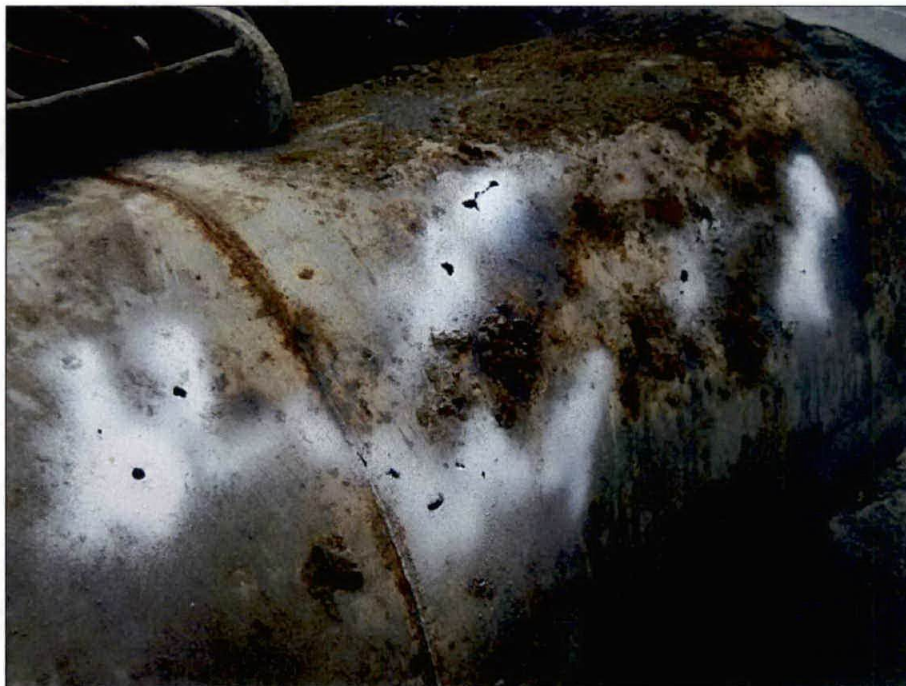
Petroleum odors and elevated PID readings were noted beneath UST3, on the east side wall of the excavation, and on the western end of the south sidewall of the excavation. The contaminated soil appeared to range between approximately 7 and 9 feet bgs at maximum, and was primarily within the UST backfill (brown gravelly silty sand). More contaminated soils appeared grey in color. Field indications of contamination reduced within the native soil (brown medium sand), which transitioned around 9 feet bgs. Contaminated soils were also observed beneath some areas of piping in the southwest corner of the excavation, as previously mentioned.

Photograph 8: UST3 with numerous small holes marked in white paint.

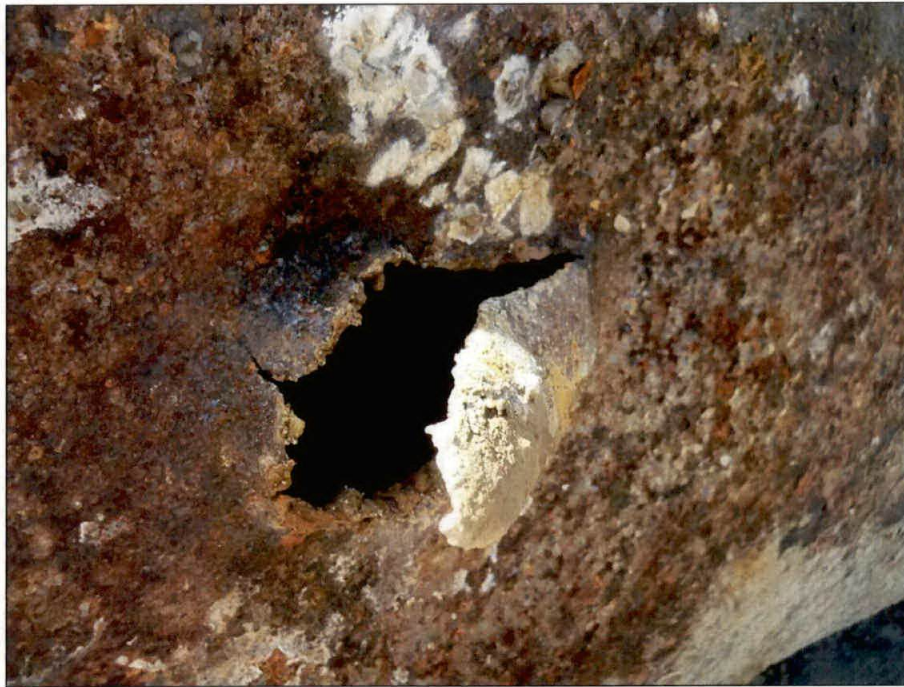
Photograph 9: Borehole in UST1.

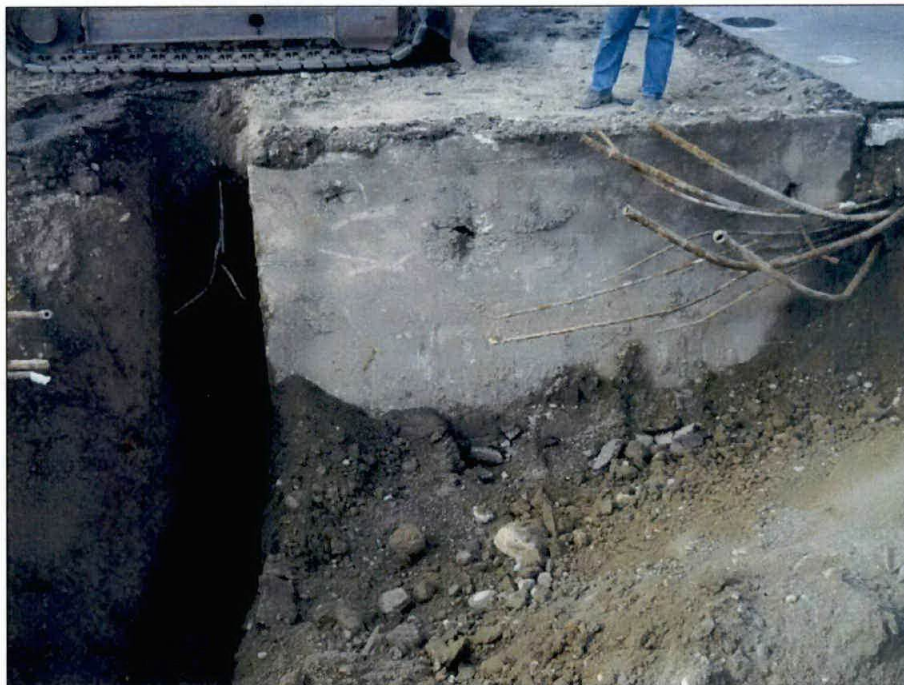
A relatively large concrete vault was identified immediately south of the USTs. The former use of the vault is unknown, but may have been an old septic system or stormwater vault. The rectangular-shaped vault was approximately 7 feet tall, 11 feet wide, and 13 feet deep. Two round openings, likely for former piping, were observed on the north side of the vault (which was the side exposed by the UST excavation). The vault had a solid concrete lid with no openings on top. Additional excavation was completed around the northeastern and northwestern corners of the vault to depths of approximately 10 feet bgs in an attempt to identify its former use and any potential contamination sources. While petroleum odors and elevated PID readings were noted beneath the exposed northwestern portion of the vault, the nature and extent of contamination (especially depth and thickness) appeared consistent with other areas of the excavation (further discussed below). The vault did not appear to be a source of contamination.

Photograph 10: Excavation around the corner of the discovered concrete vault. Piping visible includes product piping from UST to former pump islands.

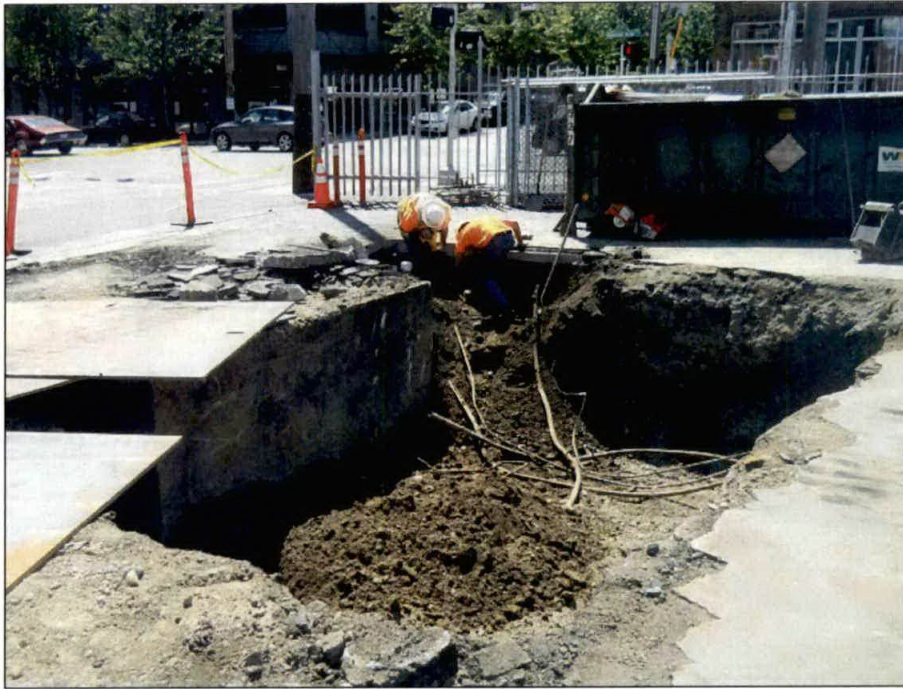
Vent pipes appeared to continue out of the southeast corner of the excavation. Other piping continued out of the southwest corner of the excavation and was suspected to lead to the former pump island(s). The southwest corner was further excavated in order to collect soil samples beneath the product piping. No cracked piping or bad piping connections were observed in the sections of piping found in the UST excavation. However, petroleum odors and elevated PID readings were noted beneath some areas of the piping in the southwest corner of the excavation at a depth of approximately 2 feet bgs, which suggests historical leaks from the piping. All product/vent piping was removed to their point of termination.

Photograph 11: Excavation in the southwestern corner where product piping was located.

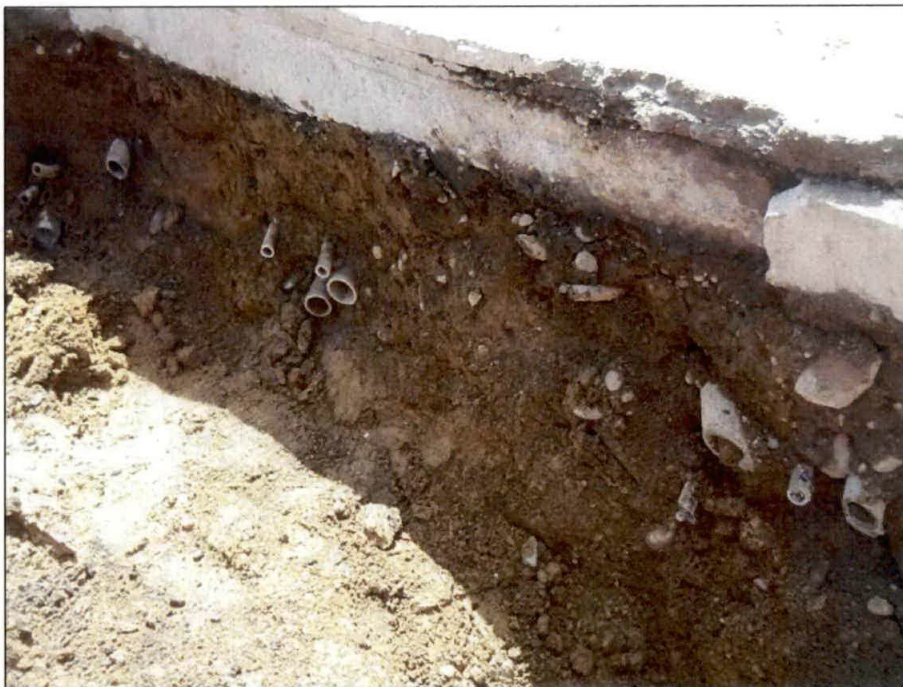
Photograph 12: Piping in the southwestern corner of the UST excavation.
