Reference: Terminal 115 Site Inspection,

Preliminary Assessment Screening--Follow-up Inspection

Terminal 115

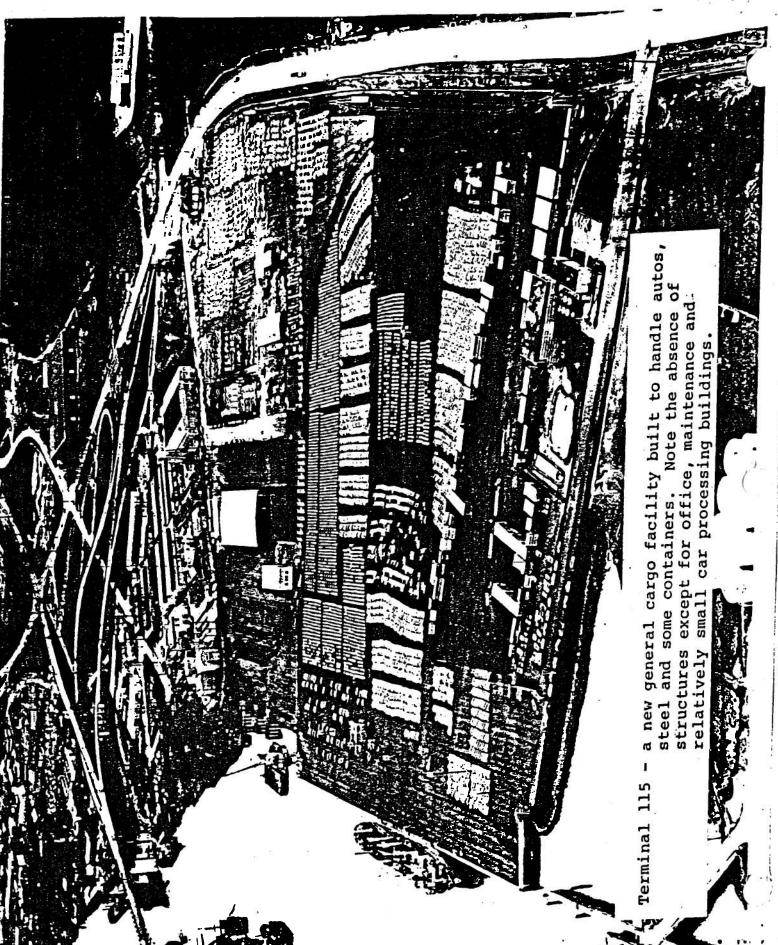
Item 7: 1966 photograph (oriented southeast) showing a containment dike under construction at Terminal 115. The area between the dike and the existing west shoreline was elevated with select fill. Note that dredged material (two dredged material disposal pond cells) is being used to elevate a parcel of shoreline area west of M and T Chemicals. The Boeing plant is still in place, bordered on the north by the remaining aquatic area of McLaughlin's Slough.

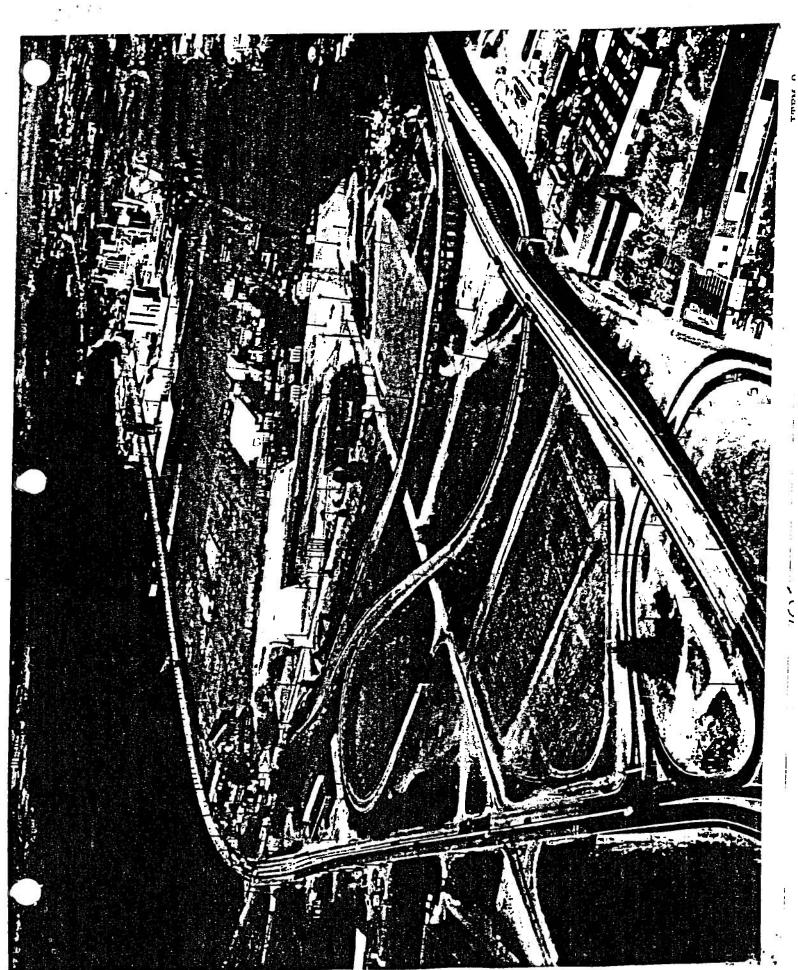
Item 8: 1972 photograph (oriented south) indicating the finished fill area at Terminal 115. Note that the ready-mix cement plant and the lumber yard have been removed in order to construct the terminal area. The Boeing facility remains in operation and fill has been placed southeast of the Boeing area in order to expand upland area for development use.

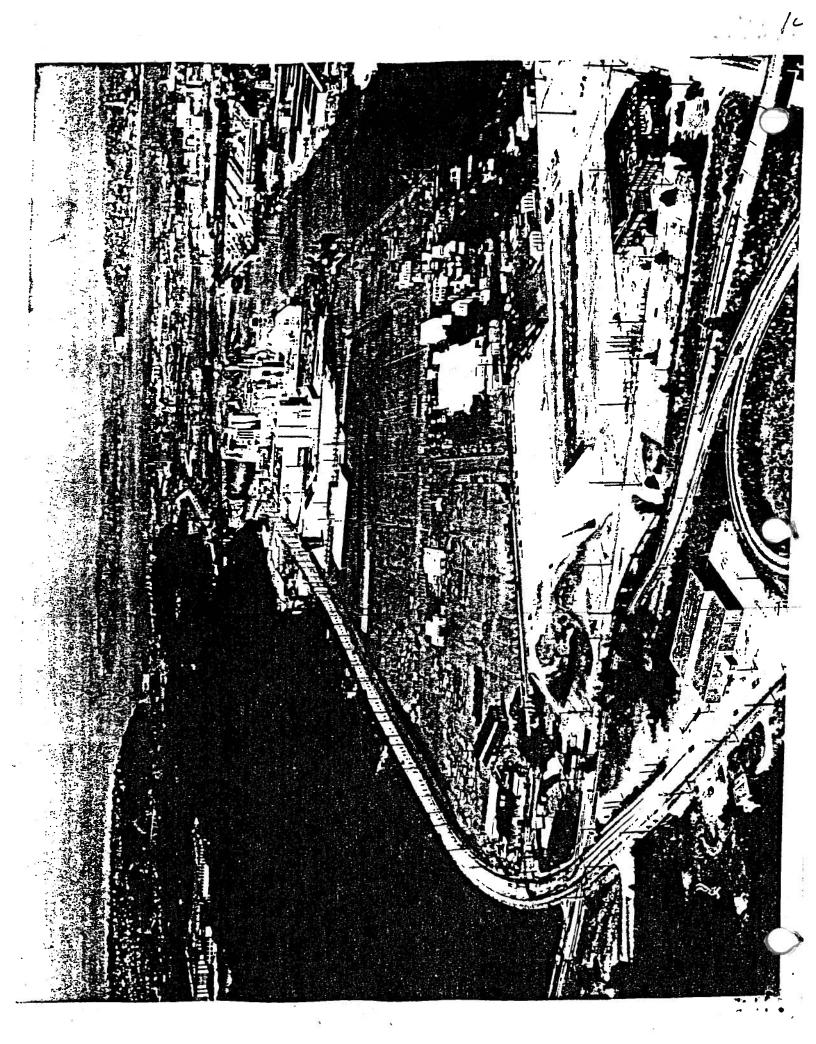
Item 9: Photograph from 1975 (oriented north) indicating new warehouse construction at Terminal 115. Note the Boeing plant has been demolished, excepting the administration building (constructed in 1929).
