**PHASE I ENVIRONMENTAL SITE ASSESSMENT
& PRELIMINARY PHASE-II**

Card-Lock Commercial Fueling Facility
Port of Seattle Lease - Terminal 115
6760 West Marginal Way
Seattle, Washington

ASSOCIATED PETROLEUM PRODUCTS

JN-31026

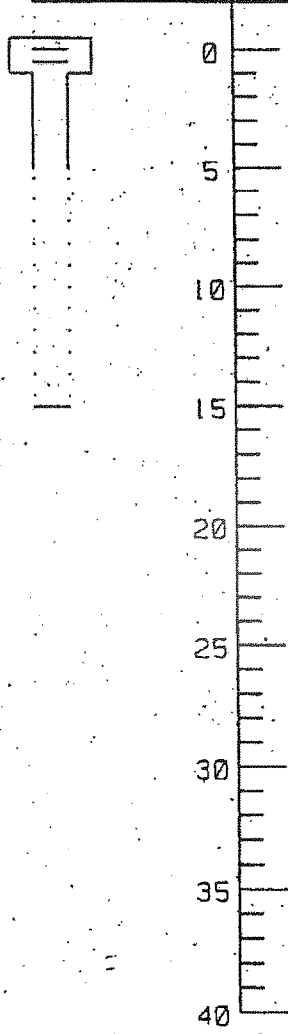
MONITORING WELL MW22

0				CONCRETE SURFACE	
	5	1	6	▽	FILL LIGHT BROWN, GRAVELLY SAND FILL: AO1ST. LOOSE	HS - NO
	10	2	11		AH GRAY PLASTIC SILT, AO1ST TO SATURATED, SOFT TO STIFF - BECOMES BROWN WITH WOOD FIBERS AT 11 FEET	HS - NO
15	3	7			- DRILLED TO 17' PER POS REQUEST, 15' TO 17' - FILLED W/ BENTONITE	HS - NO
20						
25						
30						
35						
40

NOTES: - Sample numbering includes prefix indicating monitoring well or boring (e.g.: sample MW1-1 is sample 1 from monitoring well MW1).
 - Some silt soils encountered may be fill material native to general area.
 - HS = results of head space screening. Results in parts per million (ppm). ND denotes none detected.
