# FINAL CLEANUP REPORT

PACIFIC PRIDE FUELING FACILITY  
HALF-ACRE PORTION OF KITTITAS COUNTY PARCEL # 263835  
903 W. 1<sup>ST</sup> STREET  
CLE ELUM, WASHINGTON 98922

DLH ENVIRONMENTAL CONSULTING  
2400 NW 80<sup>TH</sup> STREET  
PMB 114  
SEATTLE, WASHINGTON 98117

JULY 29, 2010

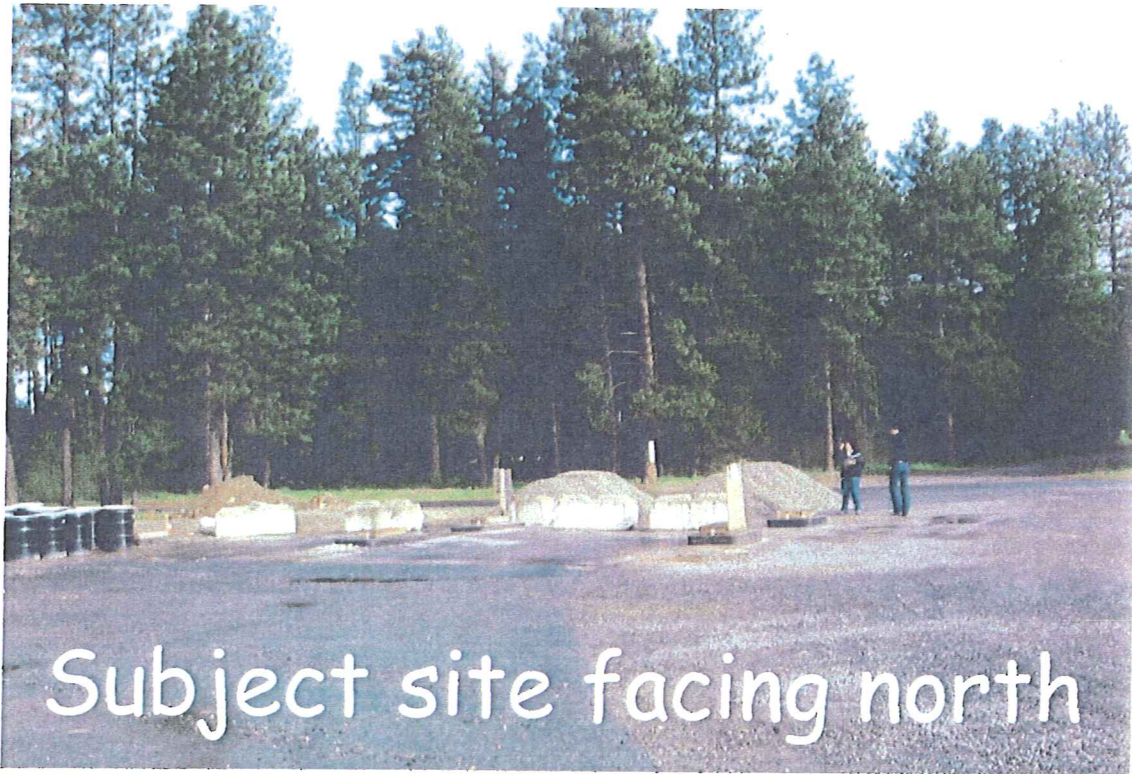
Subject site facing north

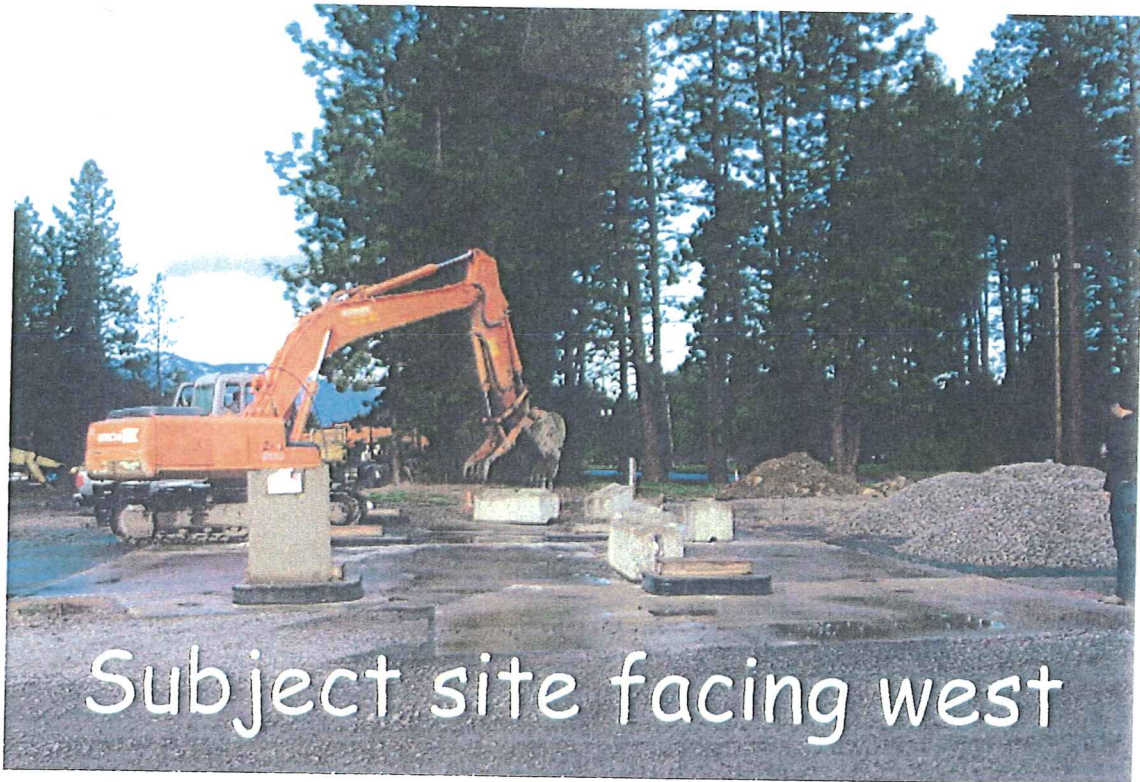
Subject site facing west

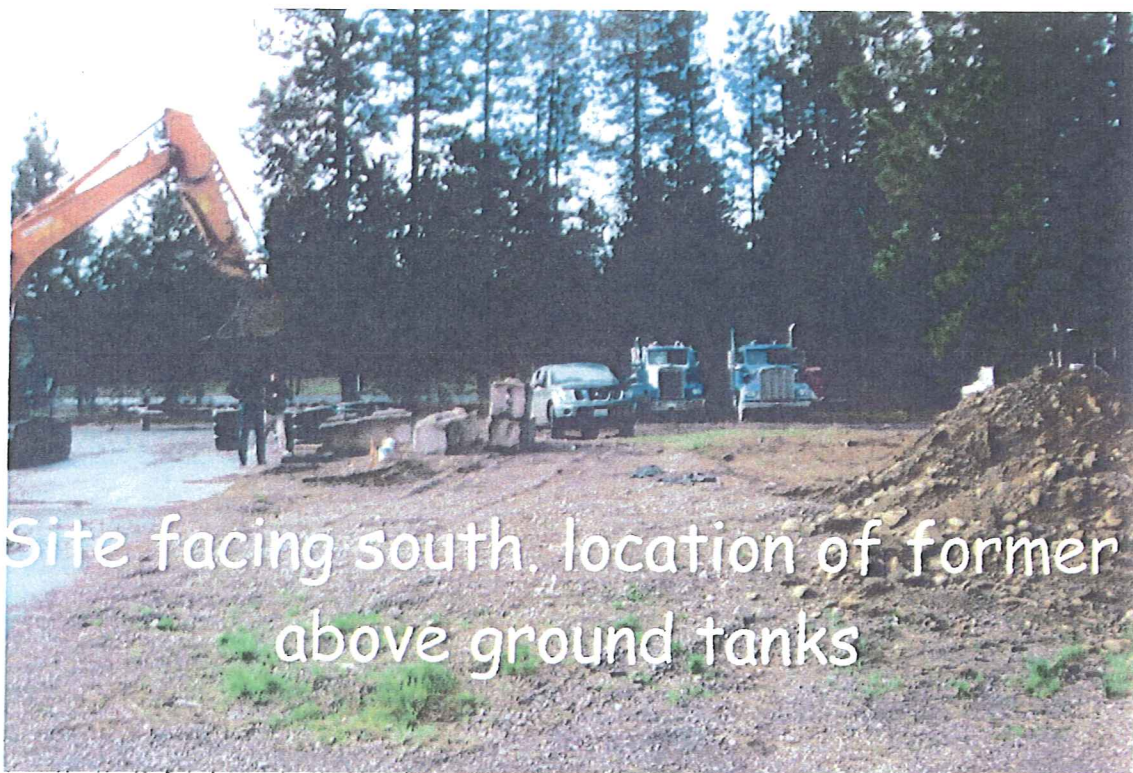
Site facing south, location of former  
above ground tanks

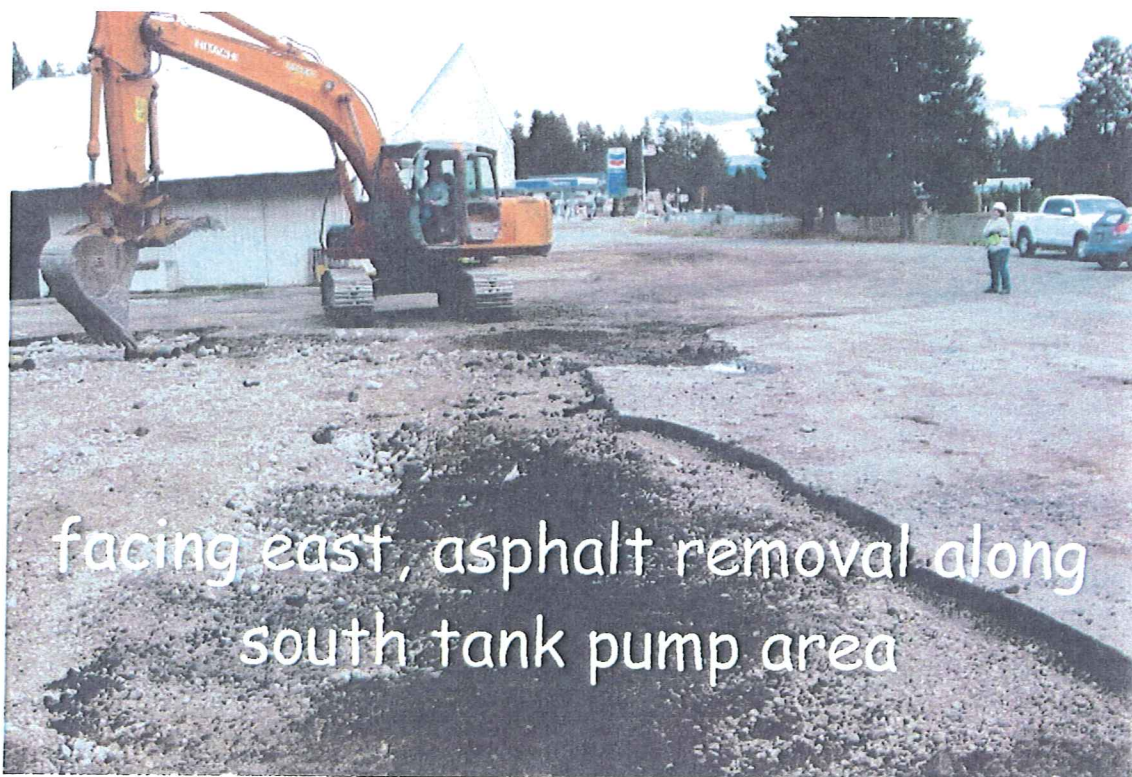
facing east, asphalt removal along  
south tank pump area

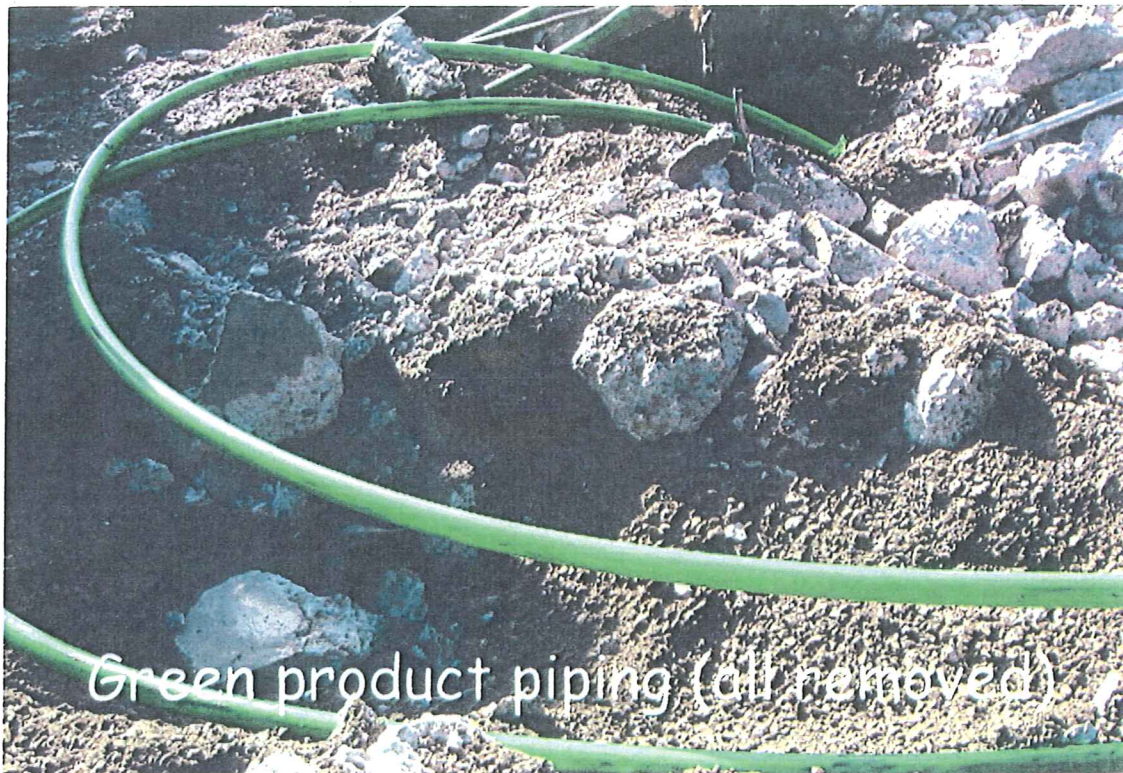
Green product piping (all removed)

Green "Environ" flexible product piping was found under the concrete pad area still attached to the remaining fuel dispenser system. This is a double-walled product and was found to contain small amounts of free product (diesel). The free product was found contained in the secondary (interstitial) containment, which could possibly indicate that the product lines had failed. This free product, approximately 2-3 gallons, was disposed of in 55-gallon drums located onsite that had been formerly used for soil cuttings during drilling activities. Also at this time, all of the soil in the 55-gallon drums was emptied into a dump truck along with other excavated materials for disposal.

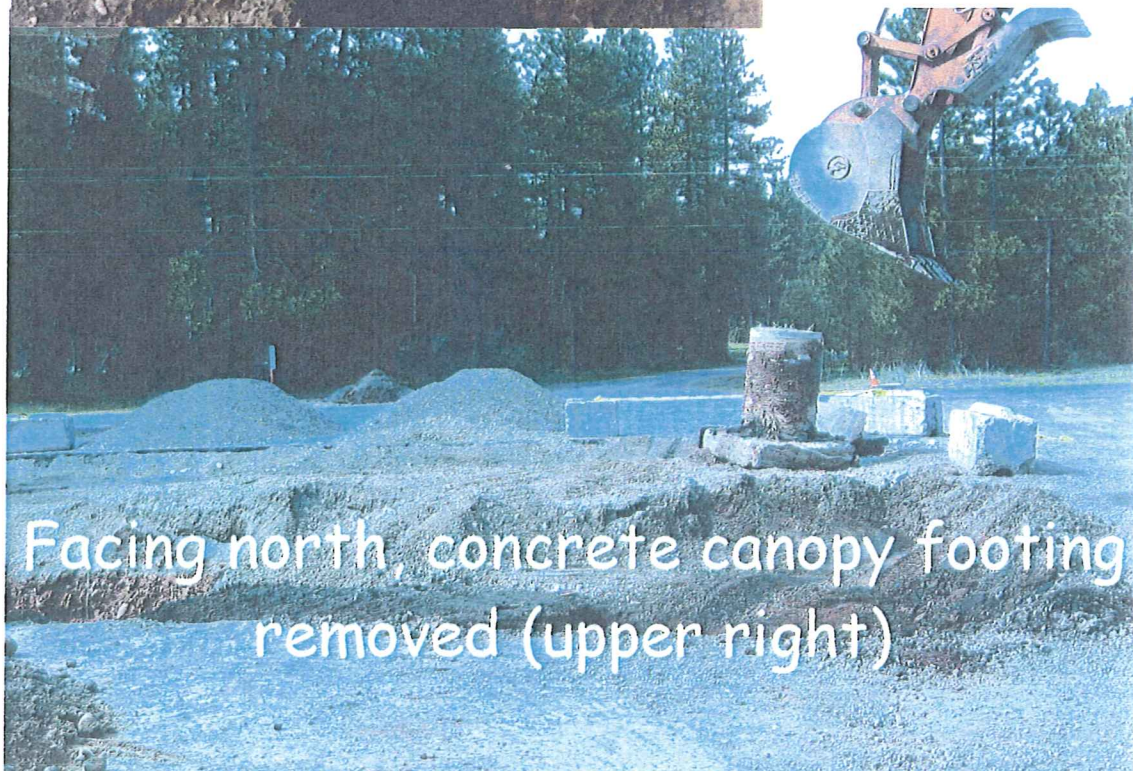
Facing north, concrete canopy footing  
removed (upper right)

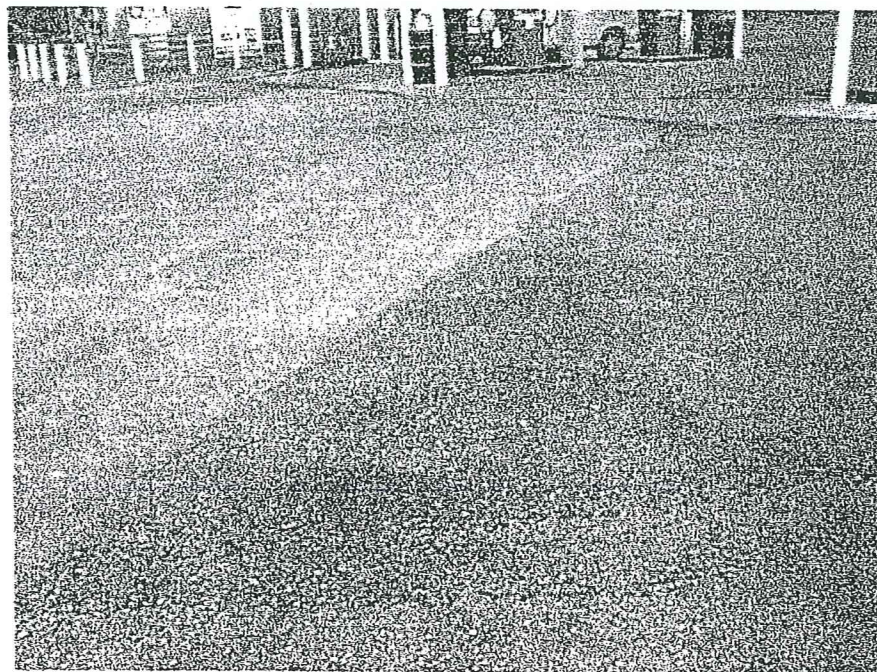
Photograph 2 – Staining in Soil Southeast of Fueling Pad, November 5, 2007  
(South of Boring Location B-5)

- **Clean Up the Contaminated Soil in the Vicinity of Boring B-5**  
White Shield recommends that the soil in the vicinity of Boring B-5 that is above the MTCA Cleanup Levels be excavated and disposed of. It is not anticipated that the volume of soils to be removed would be very large. Upon excavation the remaining soils on the sidewalls and base of the excavation should be re-sampled and analyzed for diesel range and gasoline range organics.

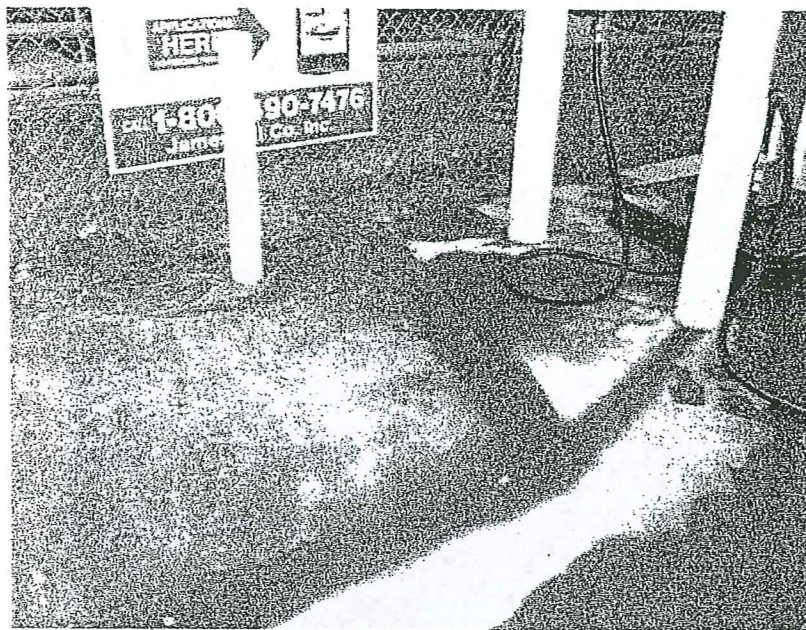
**Photograph 3 – Staining and Spillage on Soil and Concrete, November 5, 2007 (Near Boring Location B-3)**

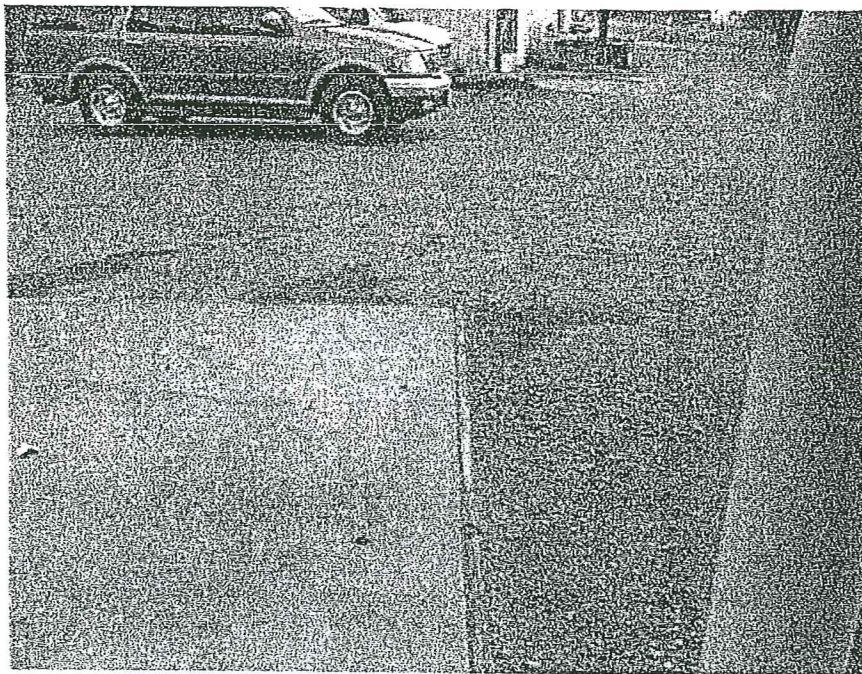
Photograph 5 – Staining in Soil, November 5, 2007 (Boring location B-5)

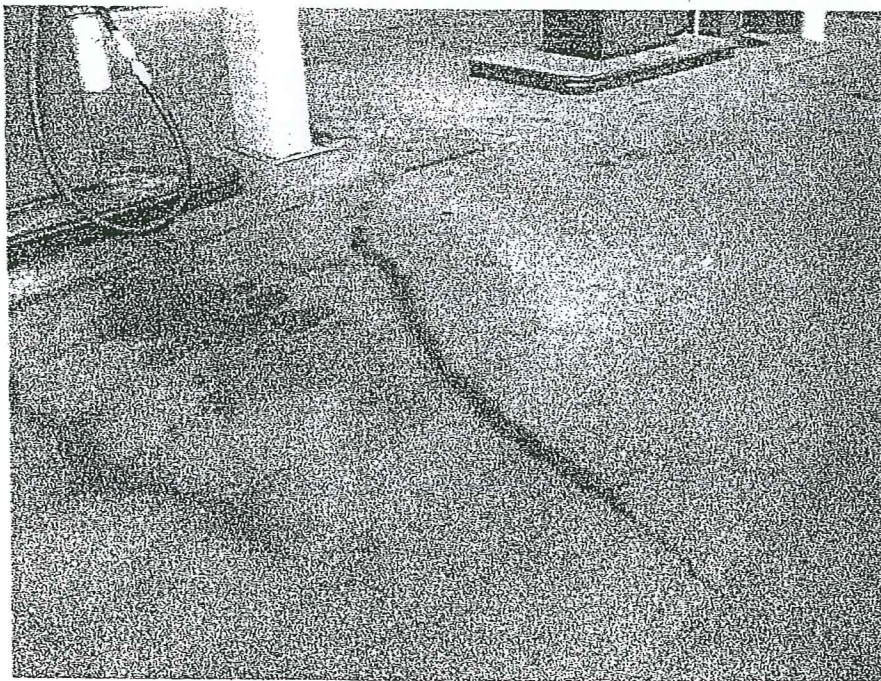
Photograph 6 – Staining and Cracking in Concrete, November 5, 2007 on East Side of the Pump Islands
