SITE ASSESSMENT AND MONITORING REPORT T-115 SOUTHWEST TANK AREA

T-115 Southwest Tank Area
6730 West Marginal Way Southwest
Seattle, Washington

June 12, 2012

Project No.: 0675-002-04

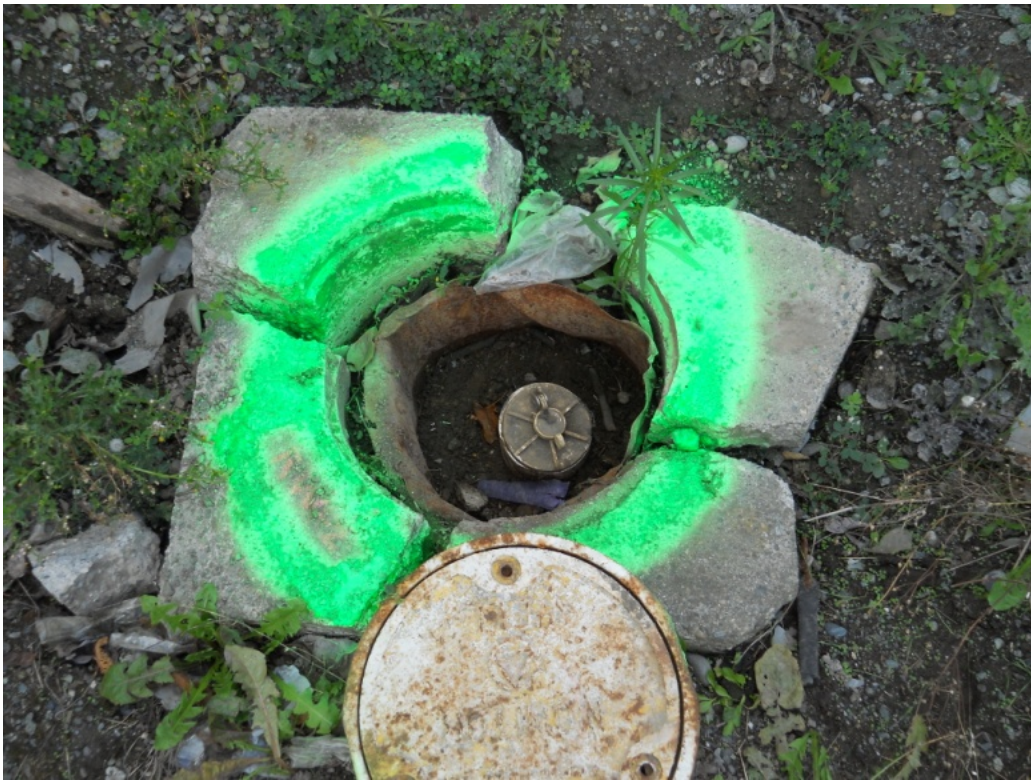
The surface monument for recovery well RW-2 had been severely damaged sometime before beginning groundwater monitoring activities in May 2011. On October 12, 2011, Cascade Drilling, L.P. removed the damaged RW-2 well monument and installed a new flush-grade surface monument. Photographs documenting the damaged and repaired well monument are included as Appendix A.

Photograph 1. Condition of well RW-2 prior to repair.

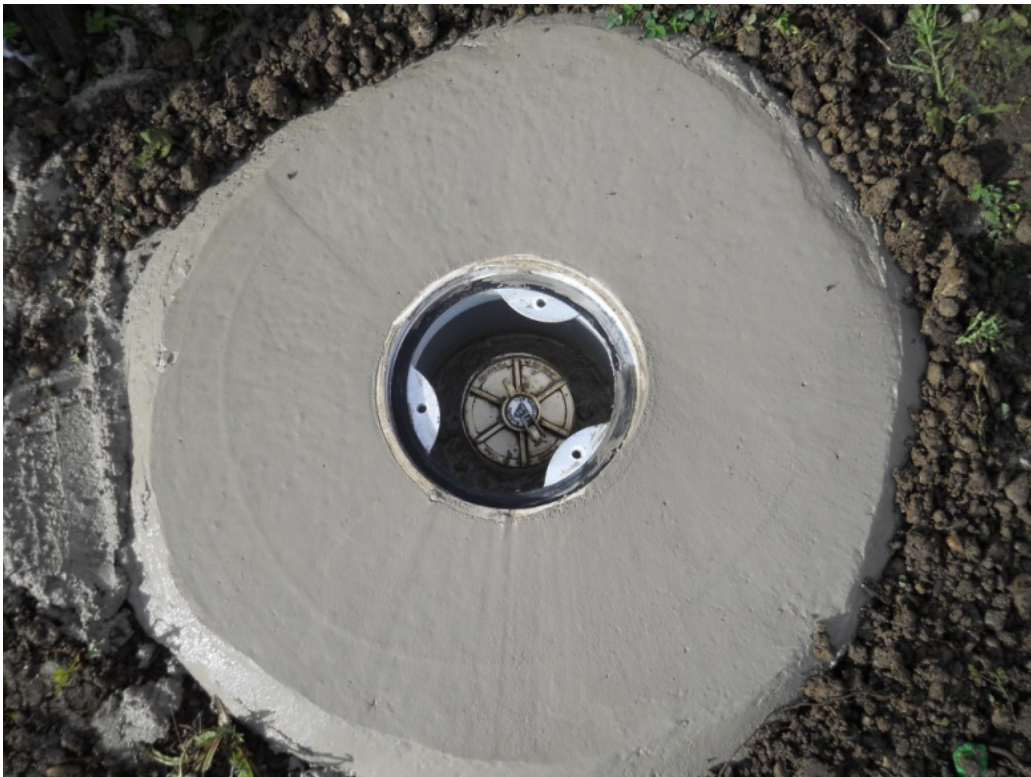
Photograph 2. Condition of well RW-2 after repair.
