KITTITAS VALLEY FIRE DISTRICT 2
REMEDIAL ACTION INTEGRATED PLANNING GRANT #G1200098

FINAL REPORT

**MOUNTAIN VIEW BROWNFIELD REDEVELOPMENT PLANNING PROJECT
400 EAST MOUNTAIN VIEW AVENUE
ELLENSBURG, WASHINGTON**

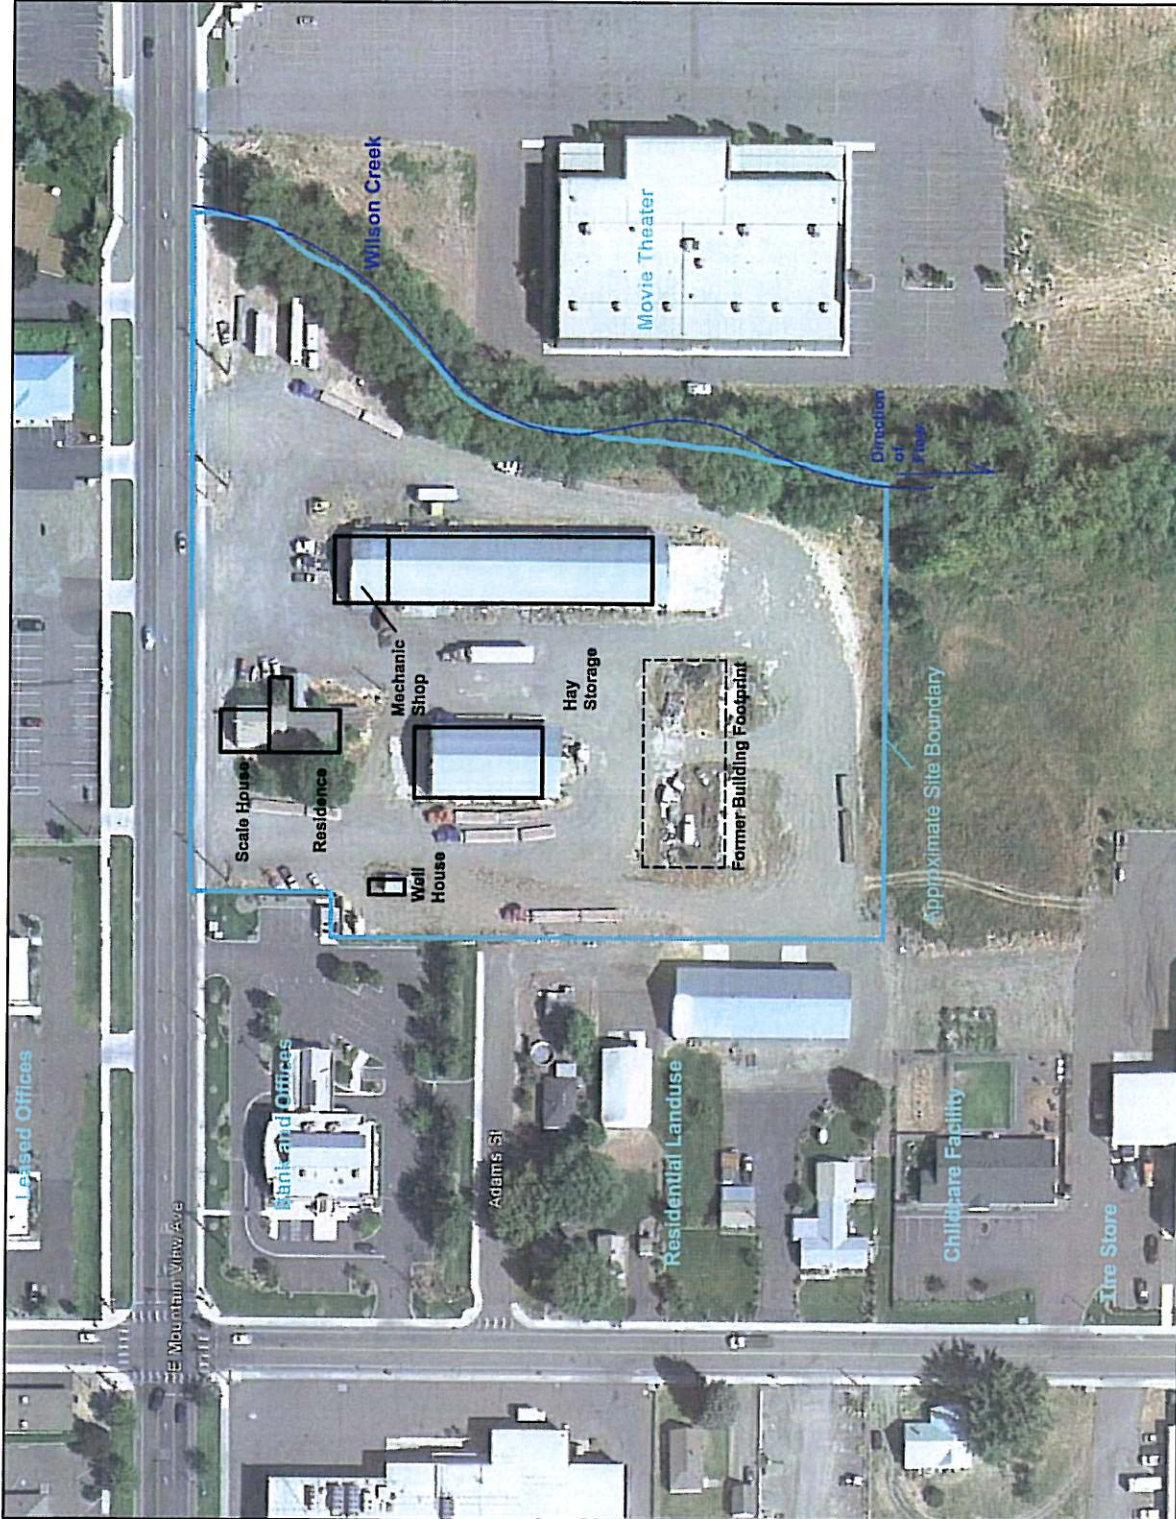
FIGURE
2

General Site Features

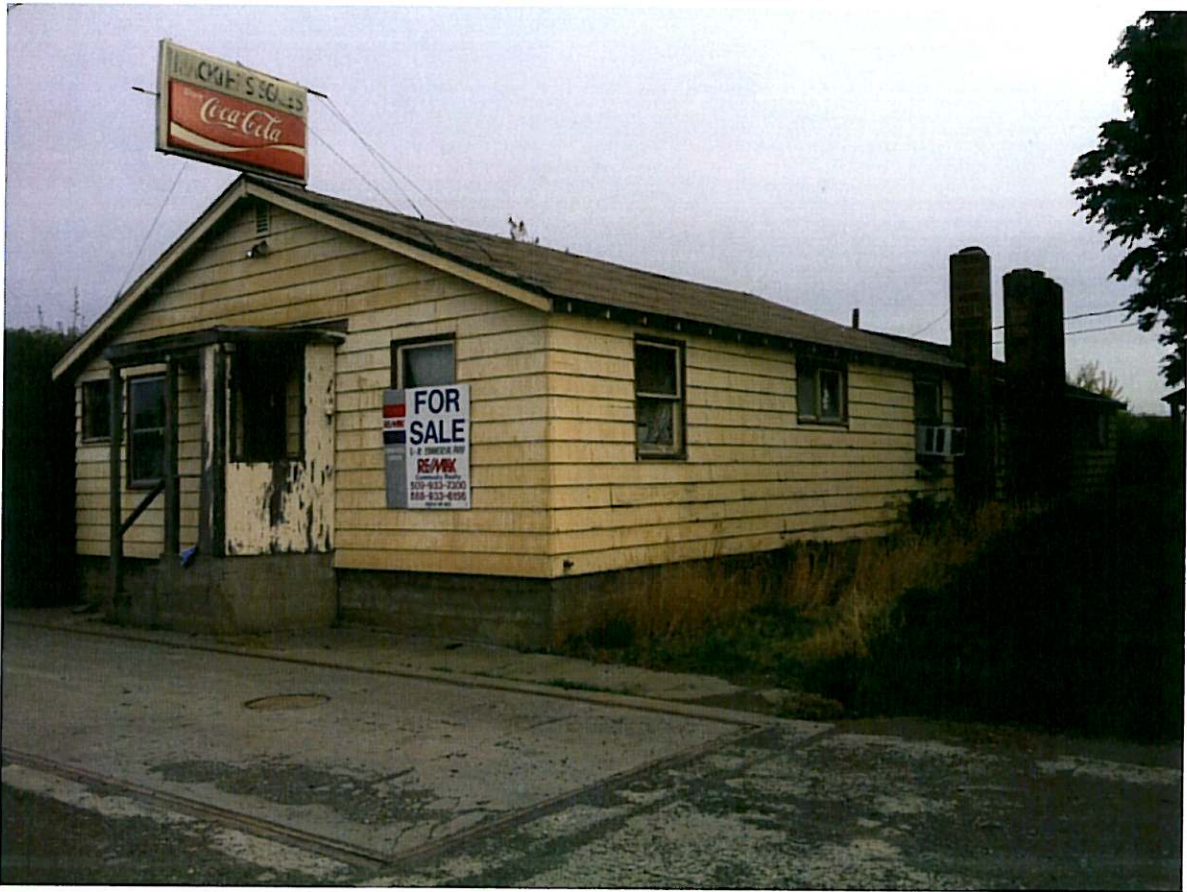
Figure 6. Circa 1950s residence/scale house located on the Mackner Scales property.

The front door to the house is centered on its primary north elevation. A small poured-concrete porch with square cut supports and a flat roof shelters the entry. Along the exterior of the east

elevation is one narrow chimney and a wider brick chimney to the south. Both are made of large red concrete bricks. The northern half of this elevation has two one-over-one double-hung sash windows on either side of a two-light wood-frame side-by-side sliding window. The windows on the south half of the elevation consist of two large fixed single light windows with side-by-side sliding window between them. The southern elevation is dominated by the flat-roof garage that is off-set to the east and includes a concrete block lower wall with clapboards above. A wood-panel door is located west of the garage door opening. Midway along the east wall of the house is a gable-roof car port that sits perpendicular to the building. It is a simple structure supported by square-cut wood supports. Vegetation grows close to this elevation blocking some of the windows.

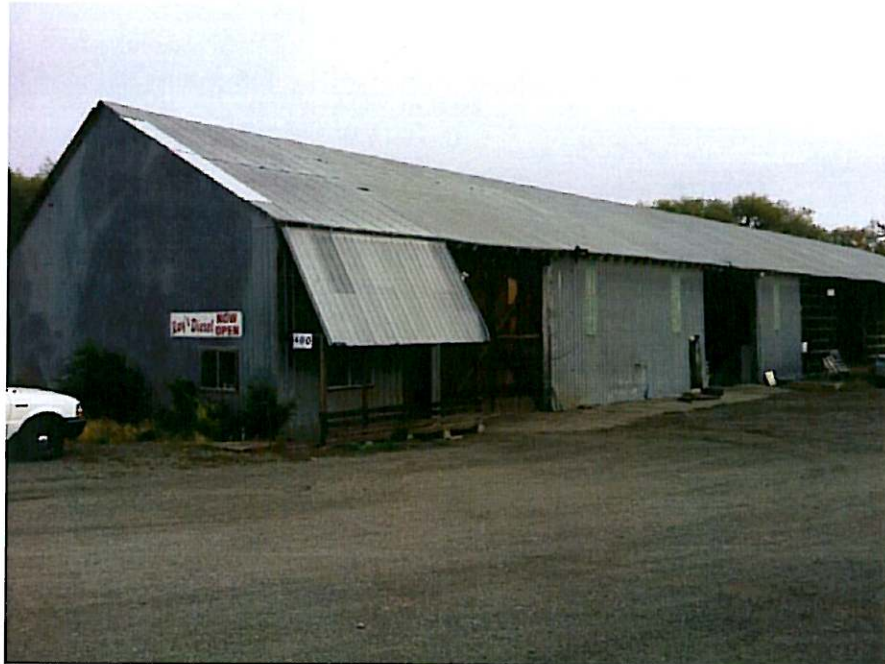
Figure 8. View of the west elevation of this barn and diesel repair shop located east of scale house/residence.

This gable-roof building, like the other hay barns on the property, is a simple pole building consisting of a concrete pad with timber posts evenly spaced along the walls and two rows of poles on the interior of the building. On the exterior walls many posts have two brackets that tie into the roof for support. At the top of the posts, boards stretch to interior posts providing horizontal support. The roof structure consists of a grid of wood boards laid over wood rafters.

The building’s roof and walls are sheathed with metal siding. The building measures approximately 220 feet long (north to south) and 55 feet wide (east to west).

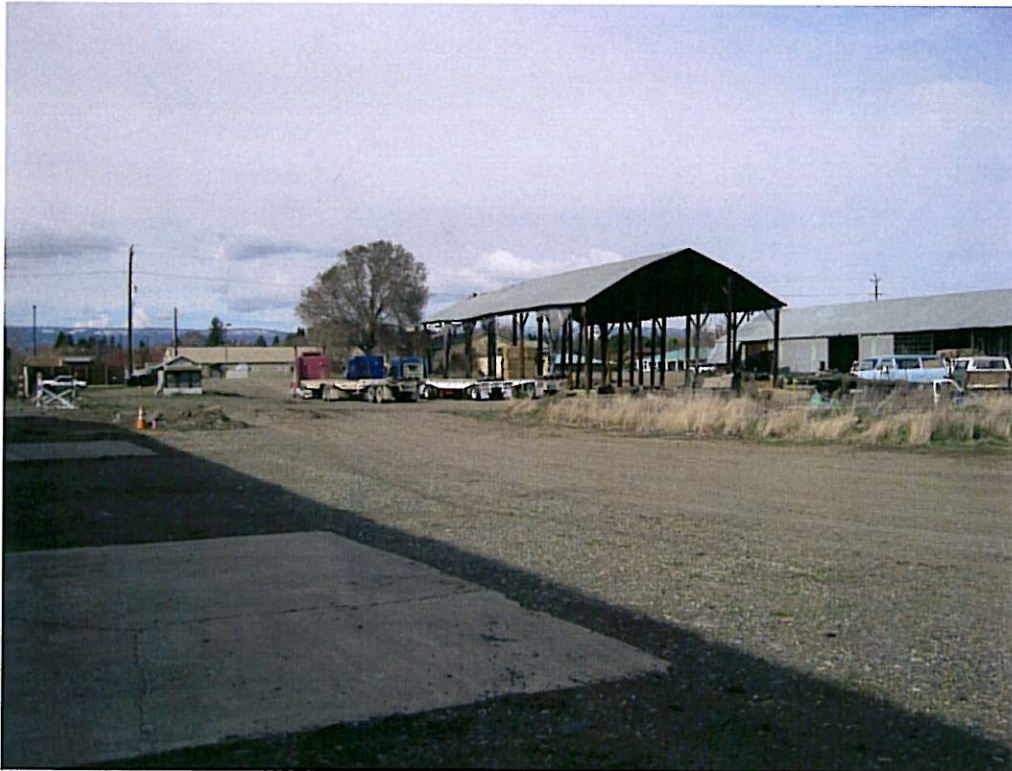
Figure 9. This hay shed is located on the west side of the project area.

Like the neighboring diesel shop/barn, this smaller pole building for hay storage was also constructed in the mid-1950s using similar utilitarian materials and design. It has a gable roof, concrete pad floor and measures approximately 100 feet long (north to south) and 55 feet wide (east to west). The building has seven posts on the east and west sides of the building. On its gable ends to the north and south, slightly longer posts support the roof midway between the

center of the building and the exterior walls. The interior of the building includes additional vertical support poles.
