Port Angeles Harbor Sediment Characterization Study Port Angeles, Washington

Sediment Investigation Report

December 2012

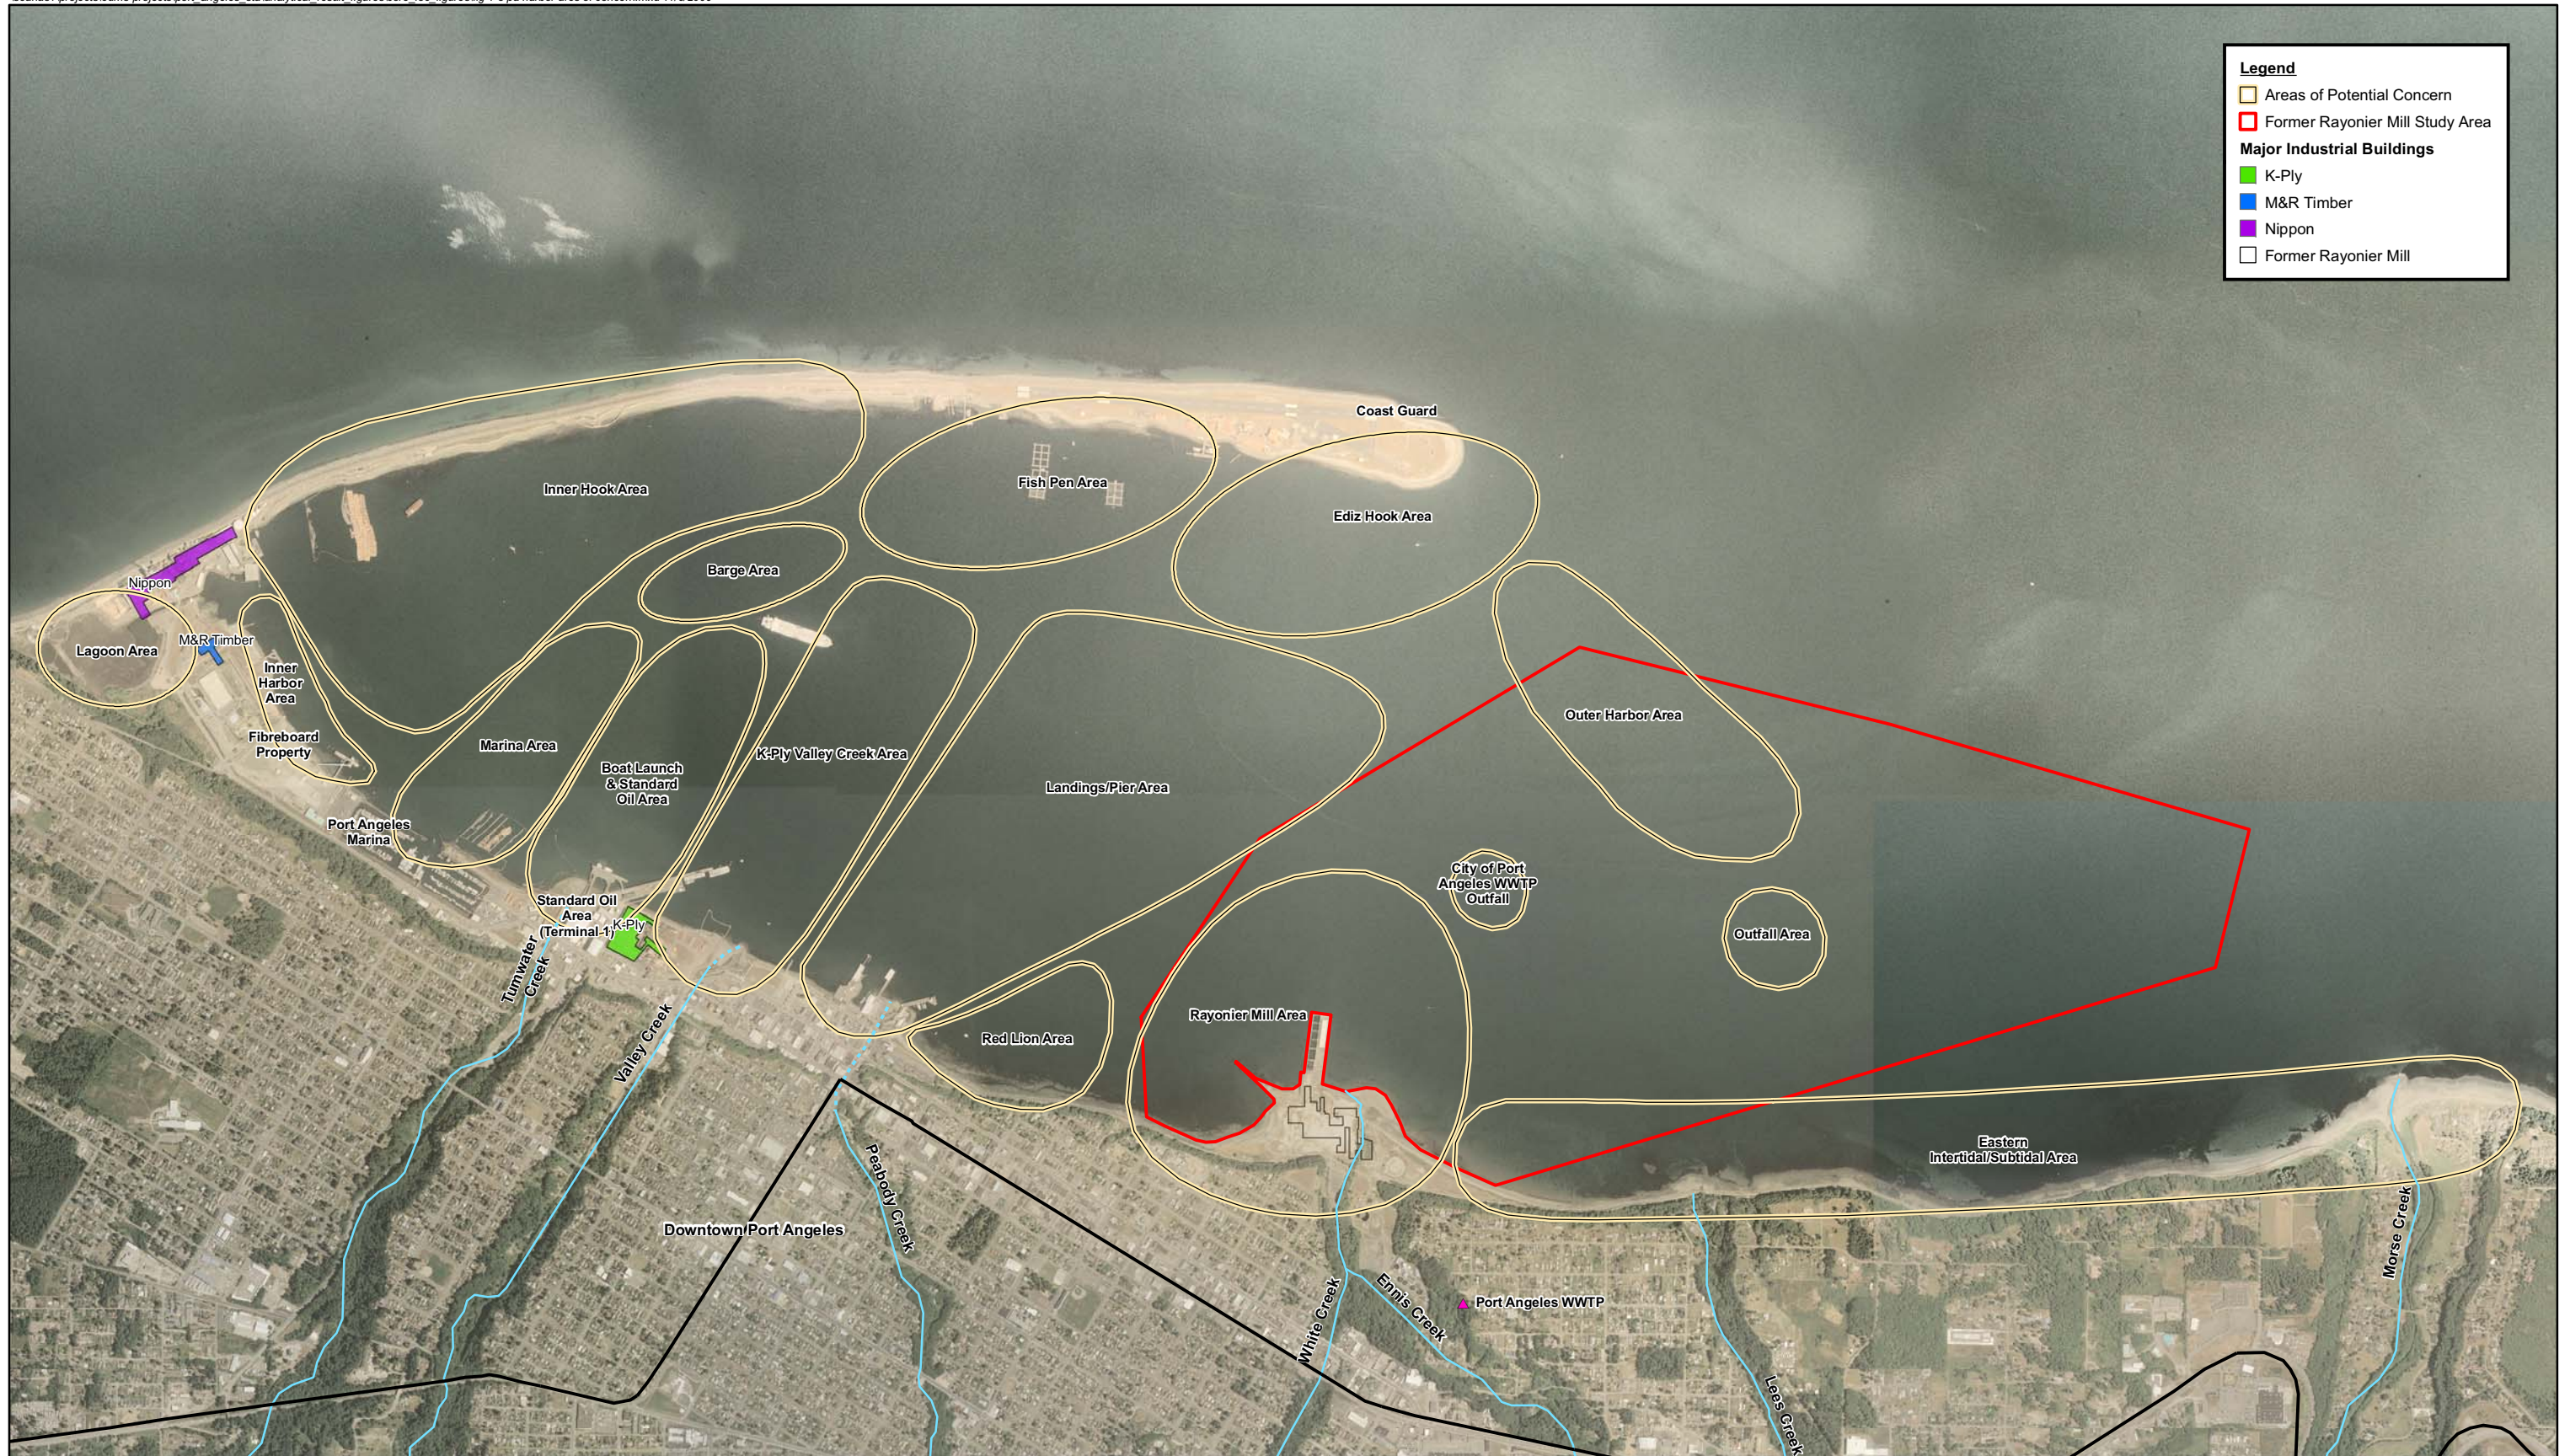
Figure 1-3
Port Angeles Harbor, Washington

**Port Angeles Harbor
Areas of Concern**

Based on these considerations, the harbor was subdivided into 16 AOPCs (Figure 1–3). The AOPC identified in Figure 1–3 as the Rayonier Mill area was further divided into an additional seven areas. After discussion with Ecology, Dungeness Bay was selected as the reference area for both the Harbor-Wide and Rayonier Mill study areas (E & E 2008c). A detailed discussion of each AOPC within the two study areas can be found in the *Port Angeles Sampling and Analysis Plan* (E & E 2008d).

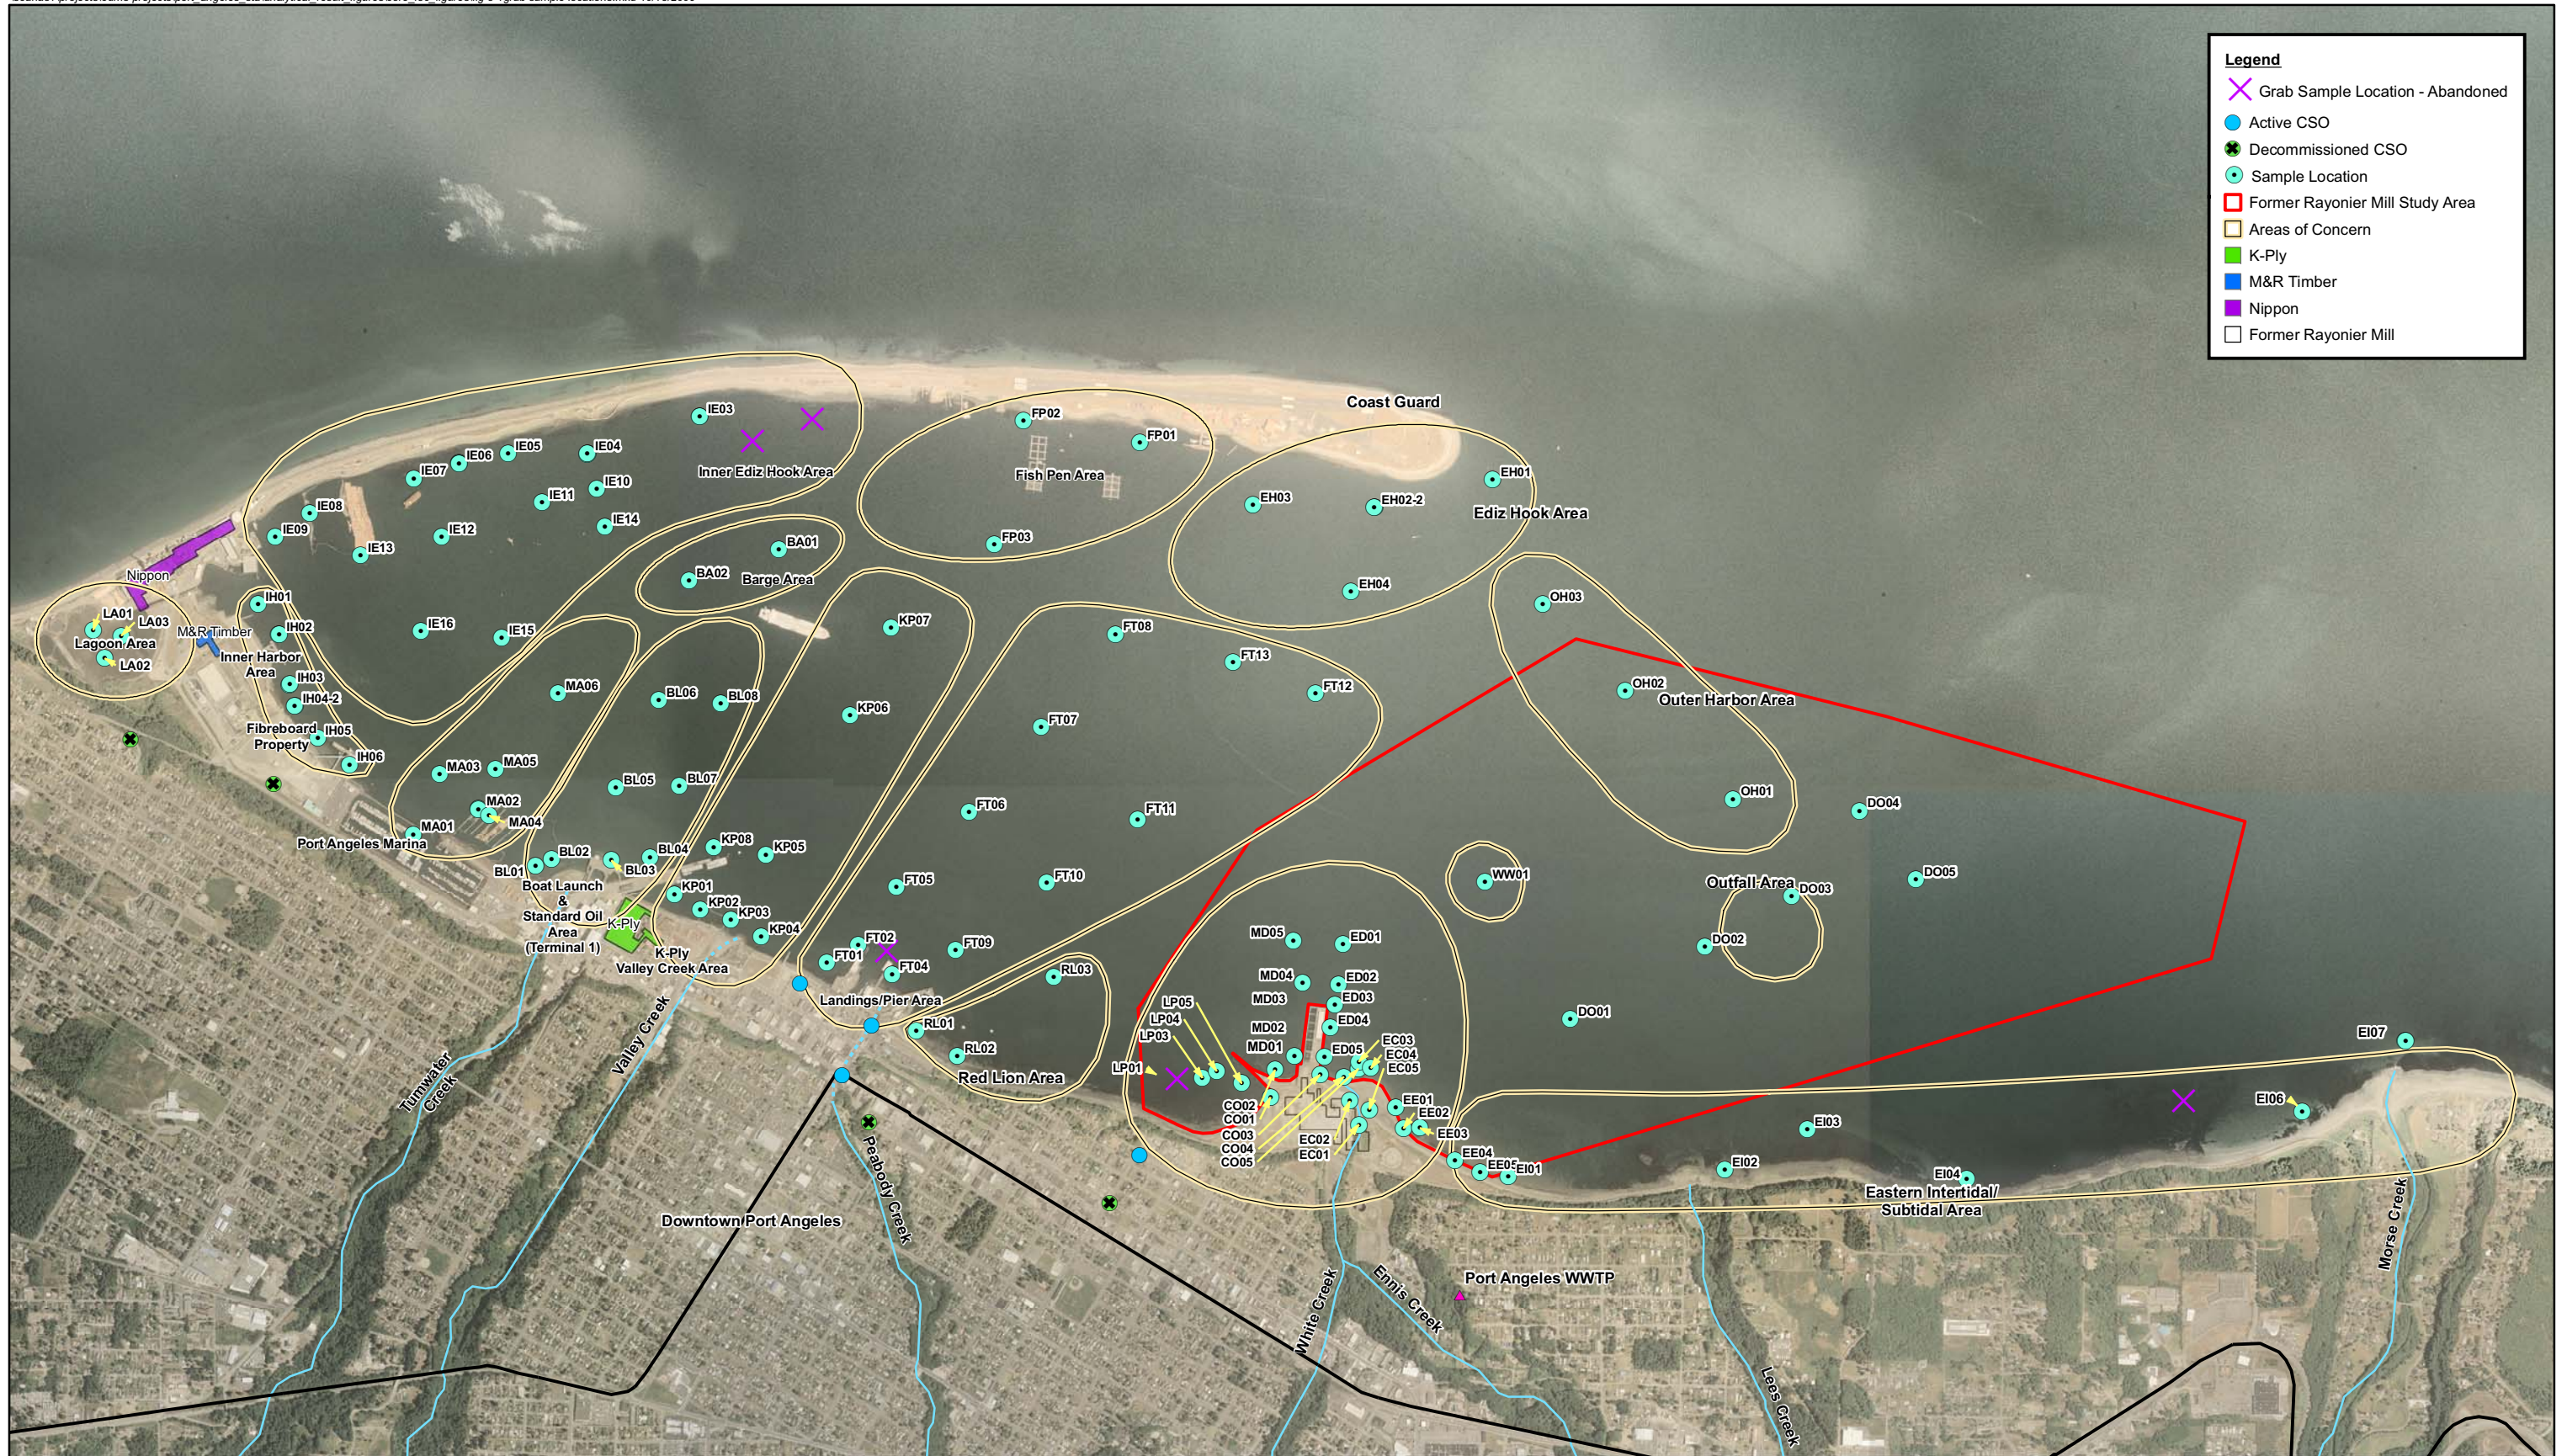
Figure 2-1

**Port Angeles Harbor
CSOs, Outfalls, & Wood Debris
Location Map**

Five major wood-processing companies have operated and discharged process effluent into Port Angeles Harbor at various times from 1917 to the present (Figure 2-1). These facilities and their dates of operation are:

The city of Port Angeles operates several facilities along the harbor (Figure 2-1). The city wastewater treatment plant (WWTP) is located near the Rayonier site and has one deepwater outfall that began discharging in 1969. Since that time, the WWTP has had occasional untreated effluent discharges to the harbor (Ecology 1976). In 2006, the WWTP inadvertently released 6

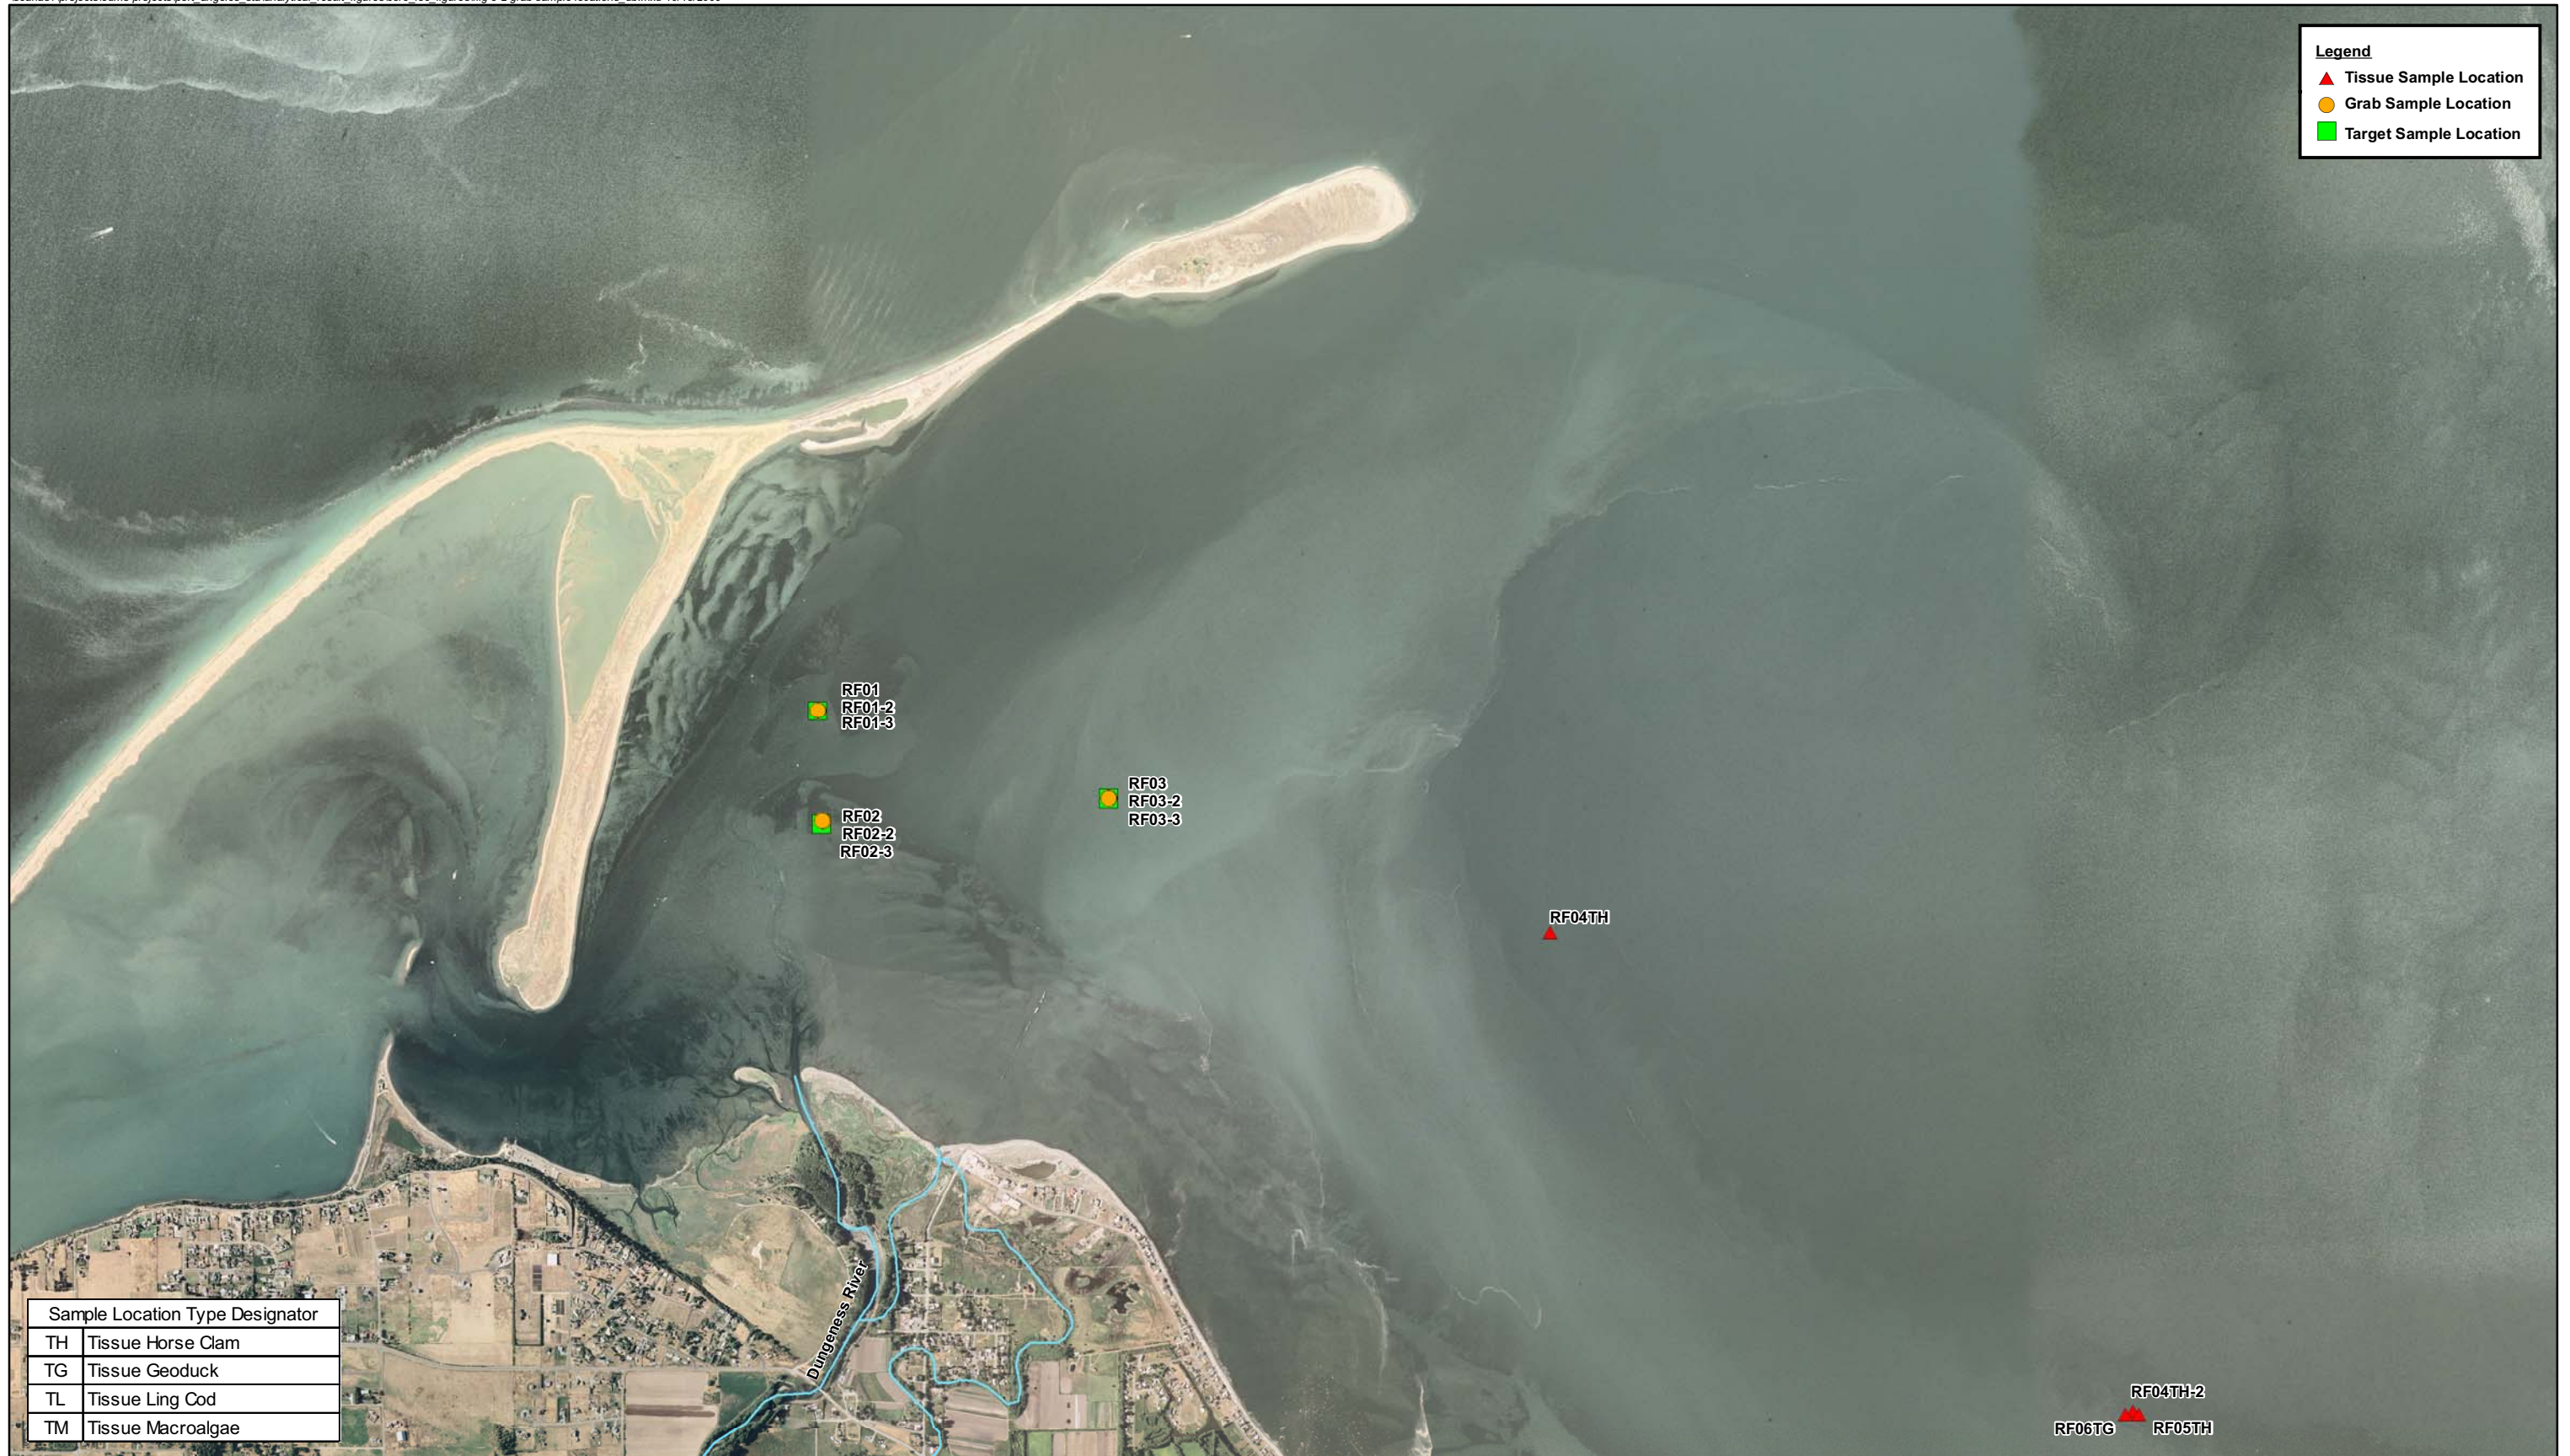
**Port Angeles Harbor
 Grab Sample Locations**

Surface sediment samples (upper 10 centimeters) were collected from 113 stations in the Port Angeles Harbor and Rayonier Mill areas using a grab sampling device in subtidal areas, or by hand in shallow subtidal or intertidal areas (Figure 3-1 and Table B-1, Appendix B). The upper 10-centimeter depth is considered the biologically active zone and is therefore most relevant to assess ecological risk. Samples from three additional stations were collected from Dungeness Bay as reference samples for the bioassay, sediment, and tissue analyses (Figure 3-2 and Table B-1, Appendix B). The station-naming conventions are presented in Table 3-1 for the Harbor-Wide study area and the reference sample locations and in Table 3-2 for the Rayonier Mill study area.

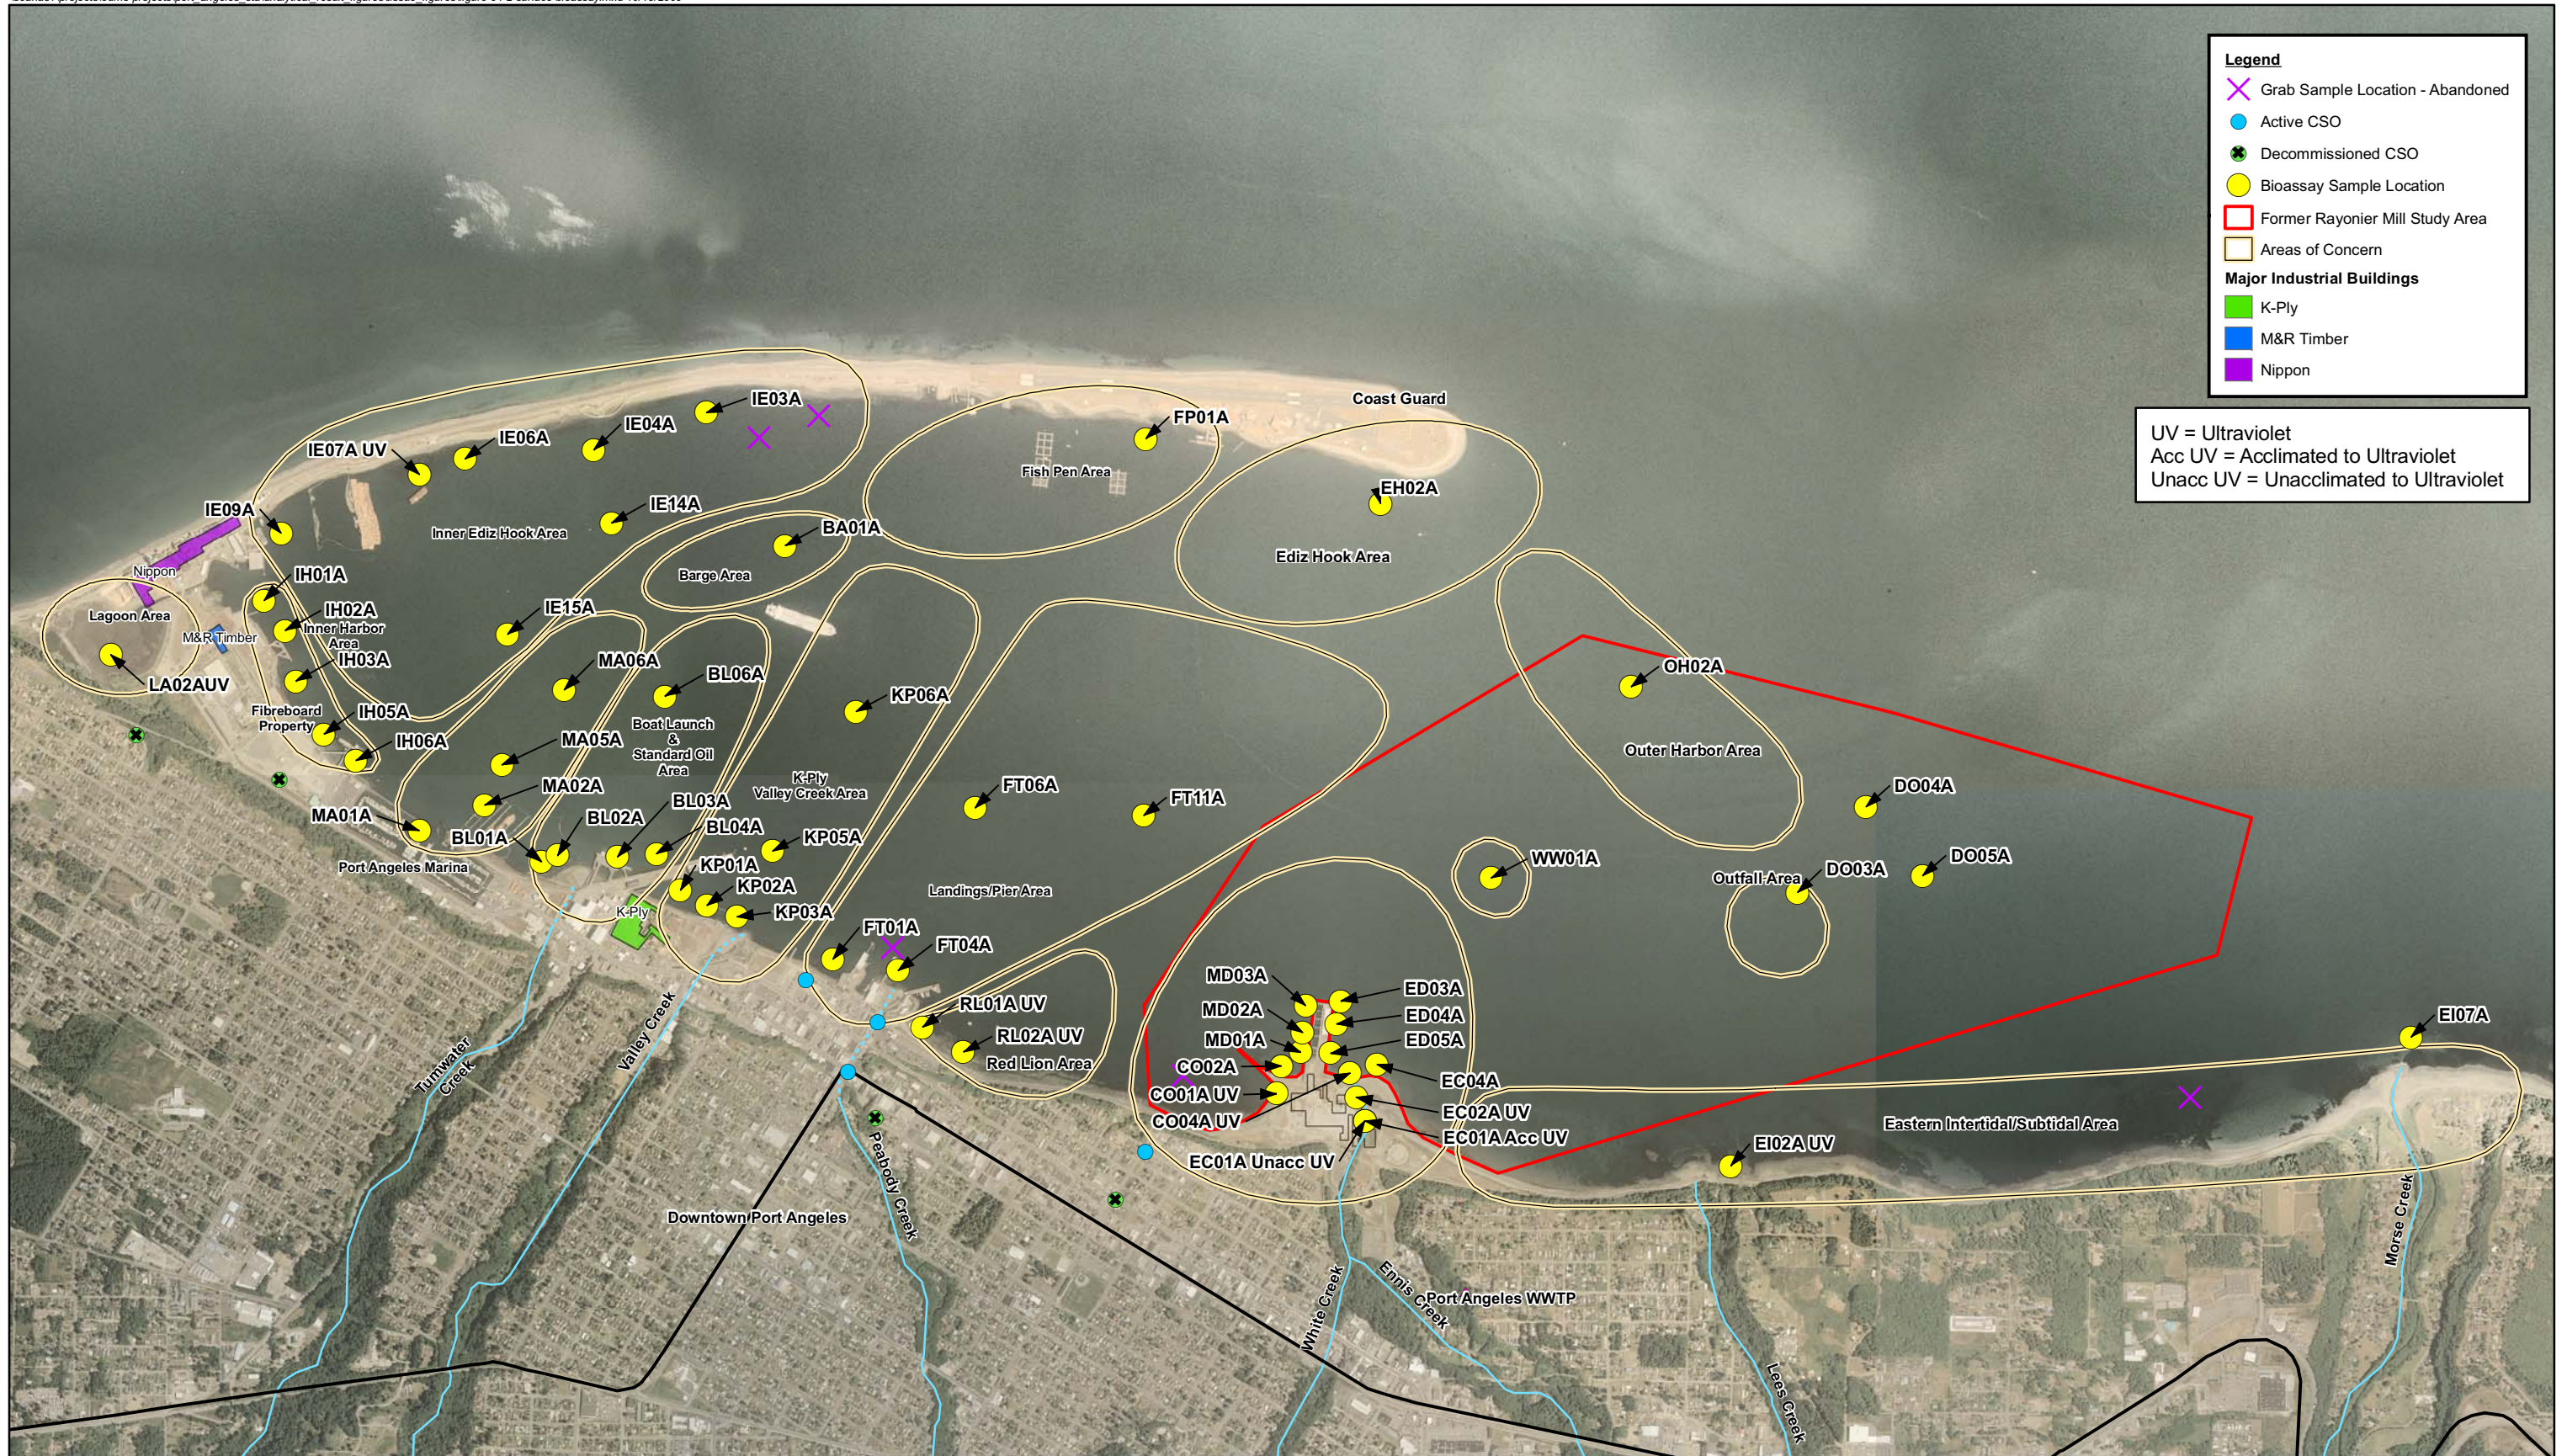
Figure 3-2

Dungeness Bay Sample Locations

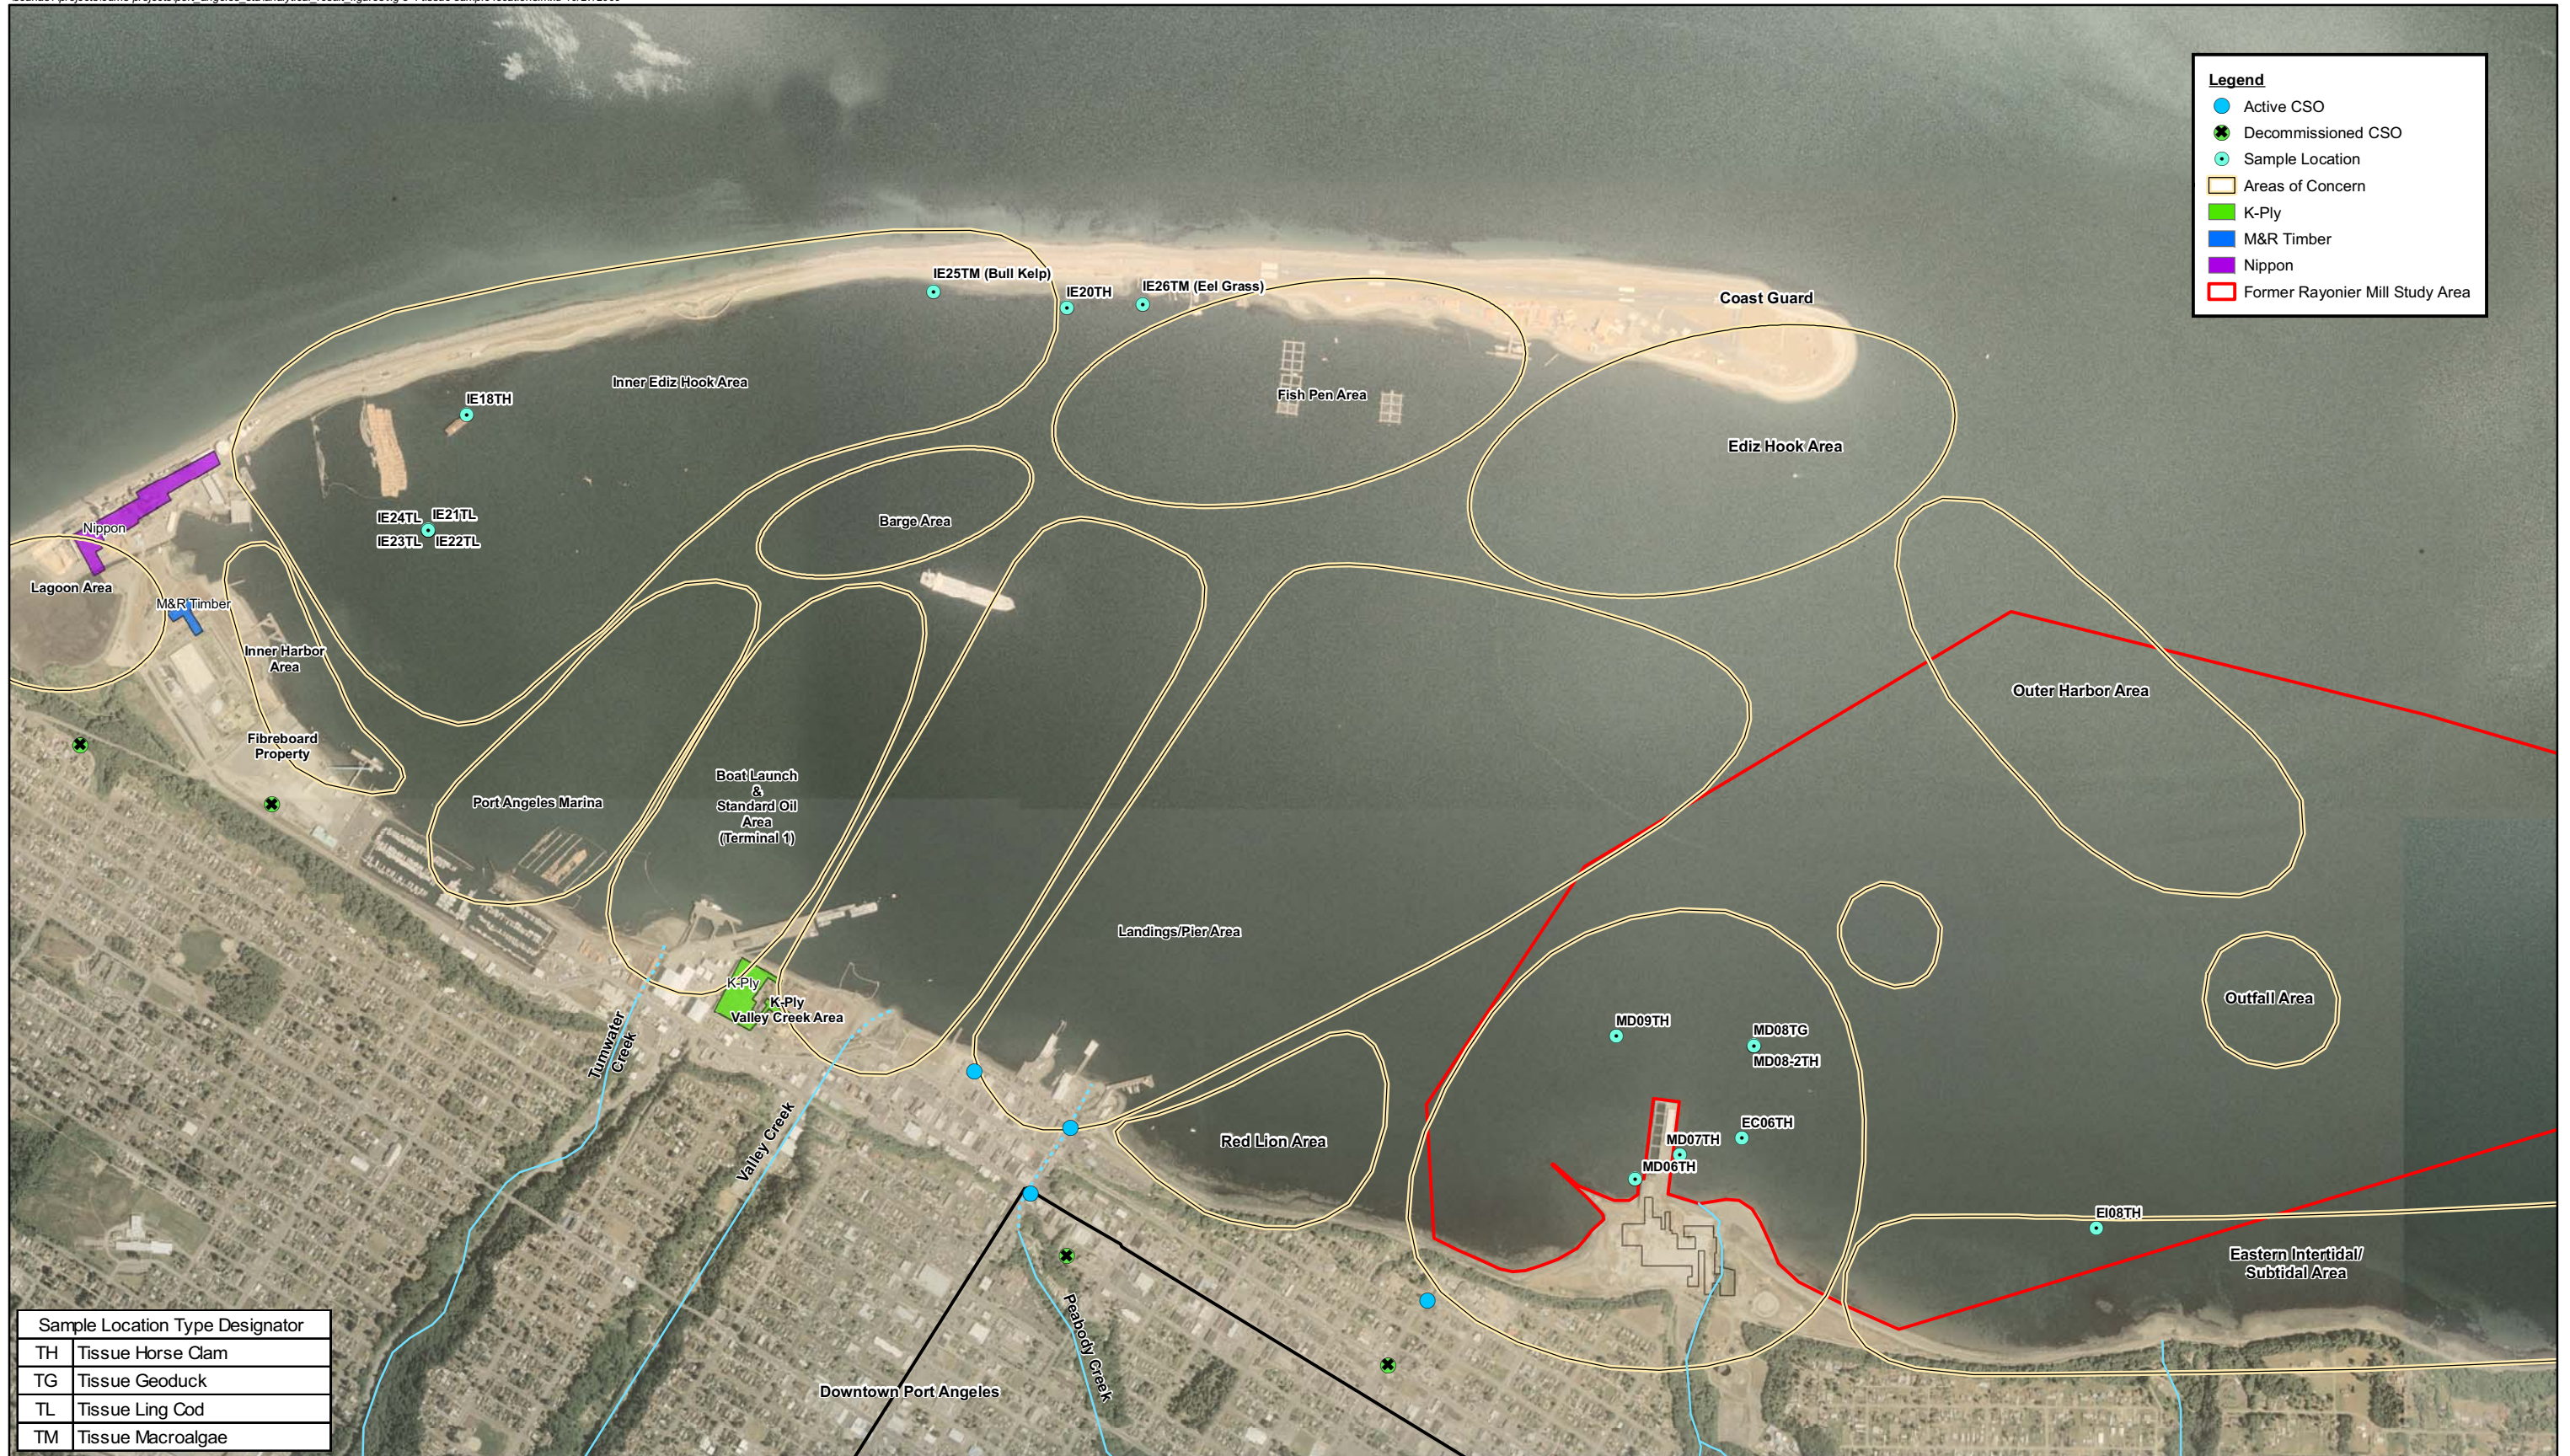
Figure 3-3

Harbor-wide Bioassay Sample Locations

Bioassay tests were conducted on selected surface sediment samples from the Harbor-Wide and the Rayonier Mill study areas (Figure 3-3). Two acute and one chronic test were conducted to evaluate impairment to the test species due to contact with the sediment. The tests included the following: the acute 10-day amphipod test, the acute larval (echinoderm) test, and the chronic 20-day *Neanthes* test. Confirmation of toxicity in the tests, based on comparison to SMS
