Port Angeles Harbor Sediment Characterization Study Port Angeles, Washington

Sediment Investigation Report

December 2012

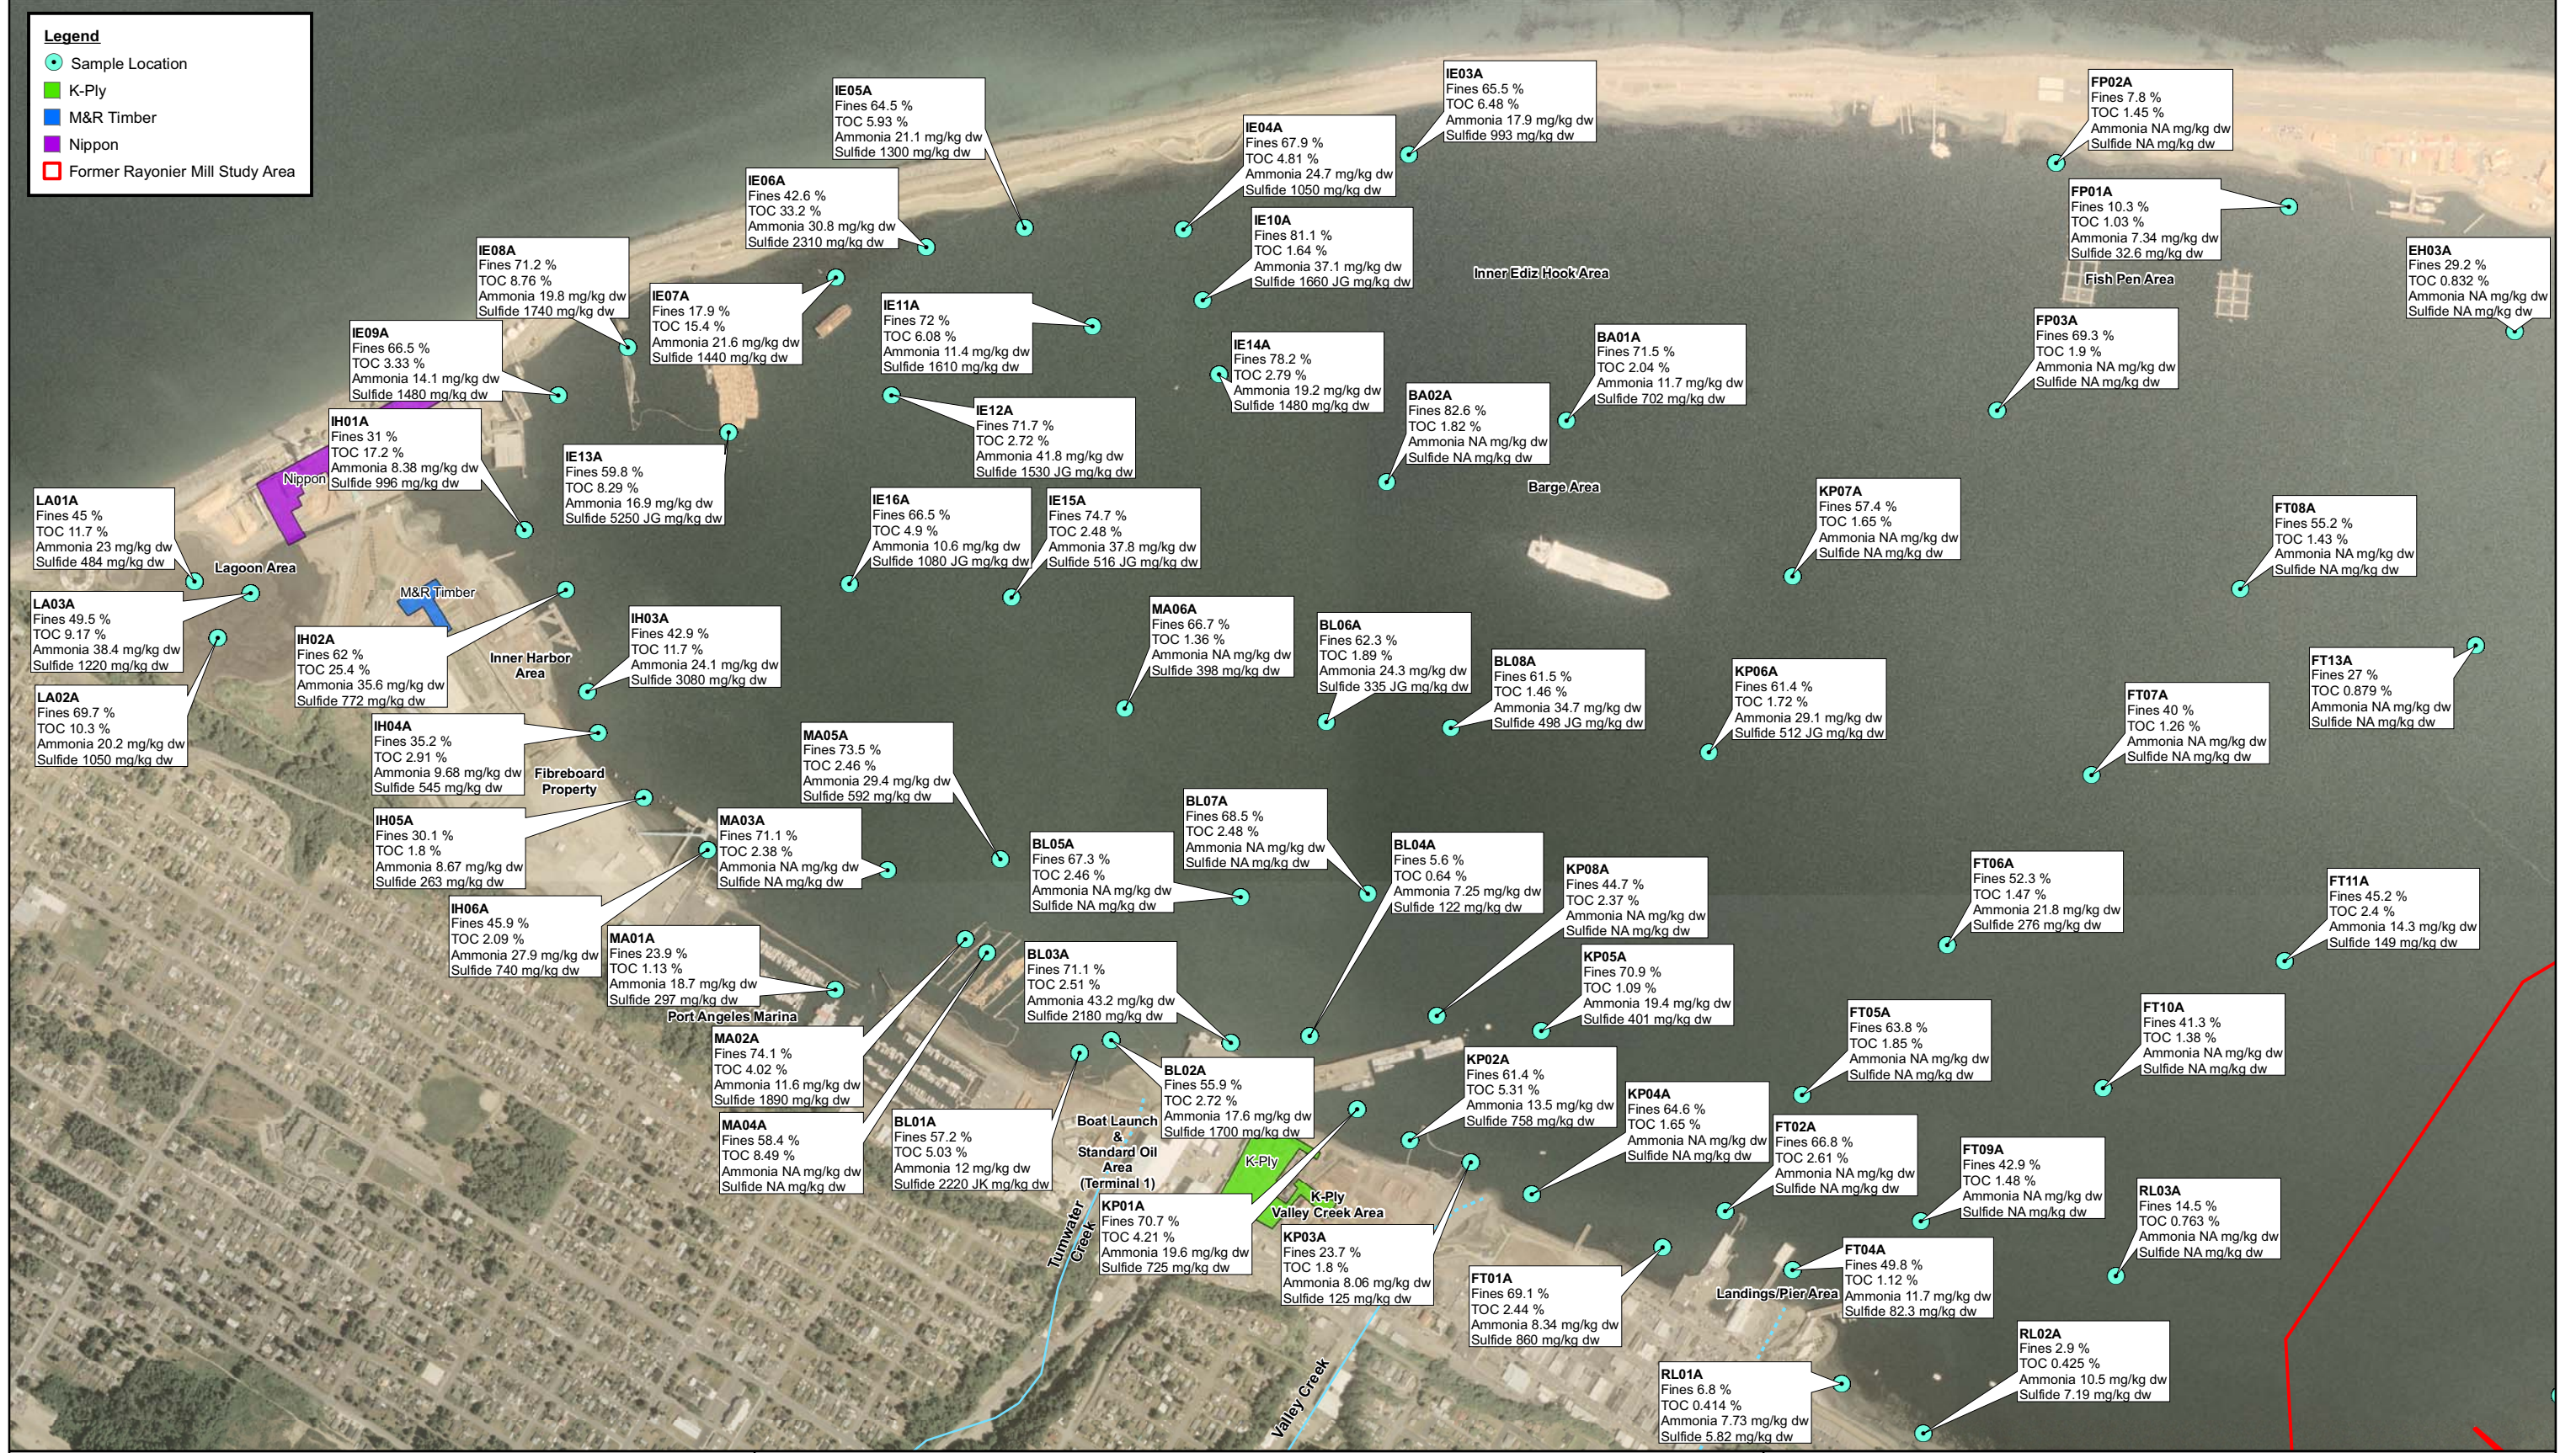
Figure 3-5
 Port Angeles Harbor, Washington

**Port Angeles Harbor
 Tissue Sample Locations**
 (for location of Reference Area Tissue Sample Locations see Figure 3-2)

Tissue samples were hand-collected by a self-contained underwater breathing apparatus (SCUBA) diver (Figure 3-5 and Table B-3, Appendix B). Ten pounds of eelgrass and bull kelp were collected and rinsed with site water. The diver grabbed and held onto the neck of horse clams and geoducks to prevent them from retracting into their burrows and washed away the sediment from the clams’ bodies using a high-powered water hose. The lingcod samples were collected by spear fishing. Many of these samples were composed of more than one specimen collected from the same station.

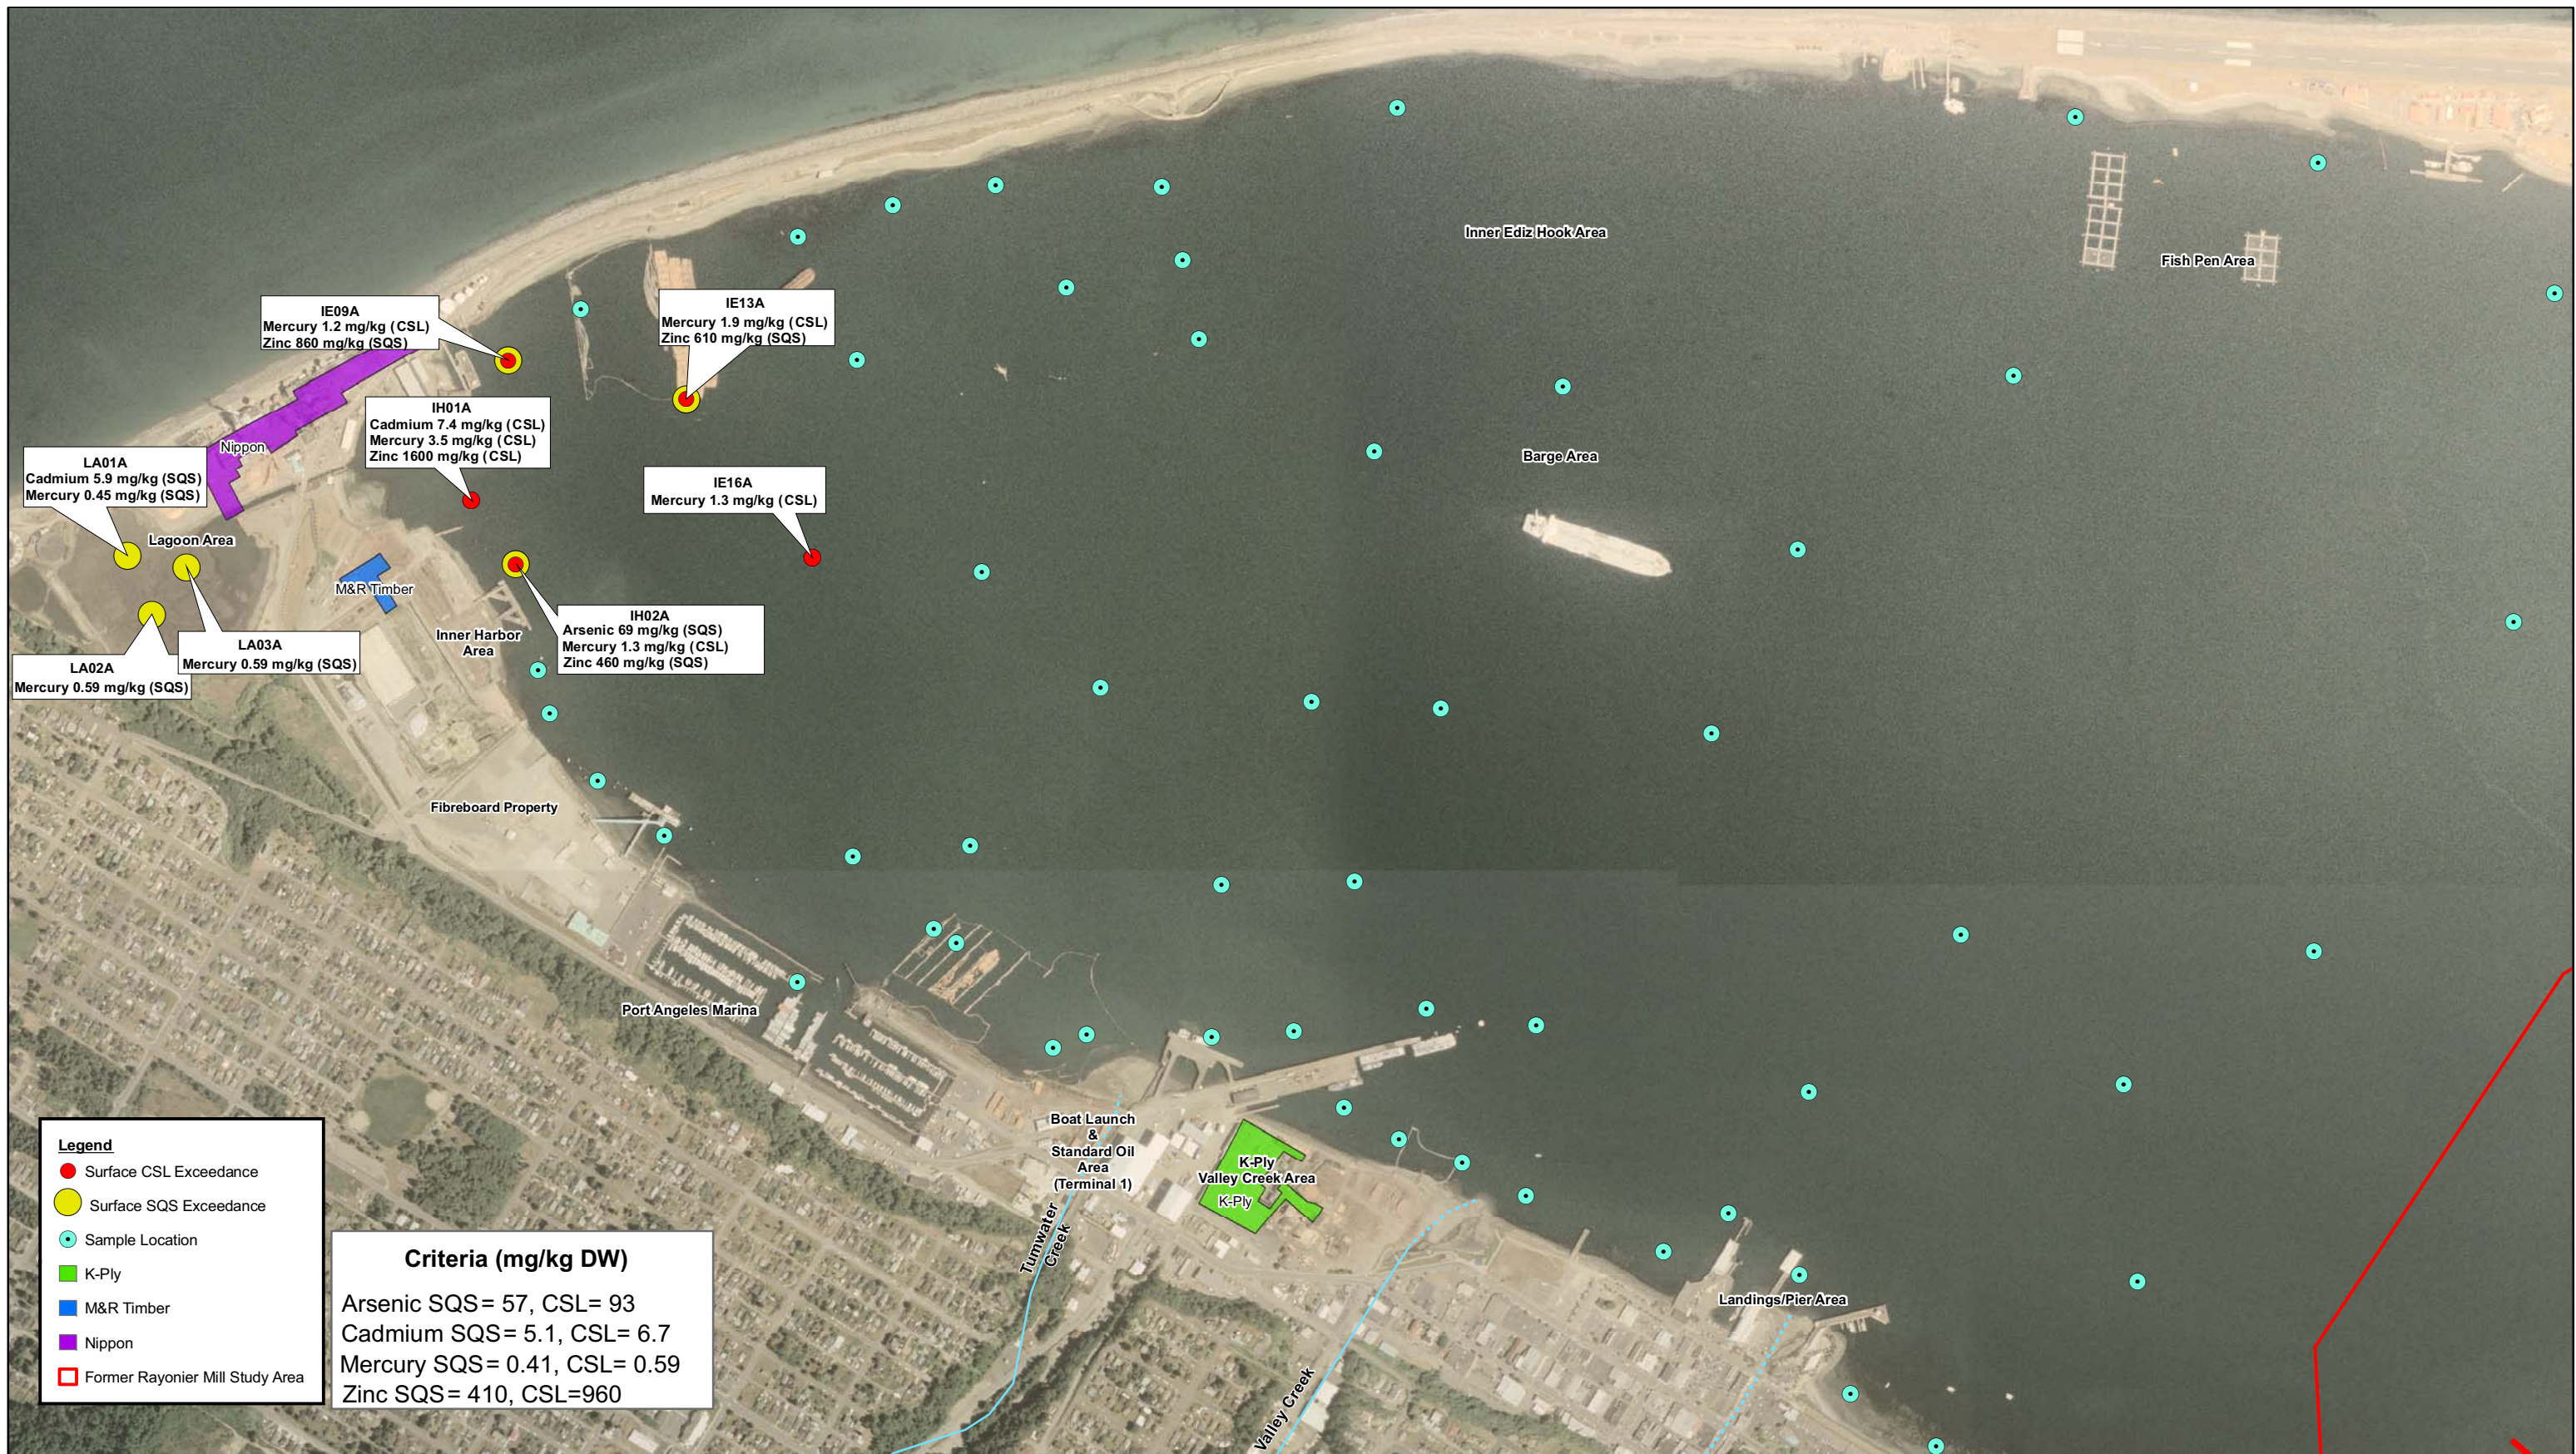
Figure 5.1-4
Dungeness Bay, Washington

Dungeness Bay
Percent Fines, Percent TOC, Ammonia, and Sulfide
Grab Sample Results

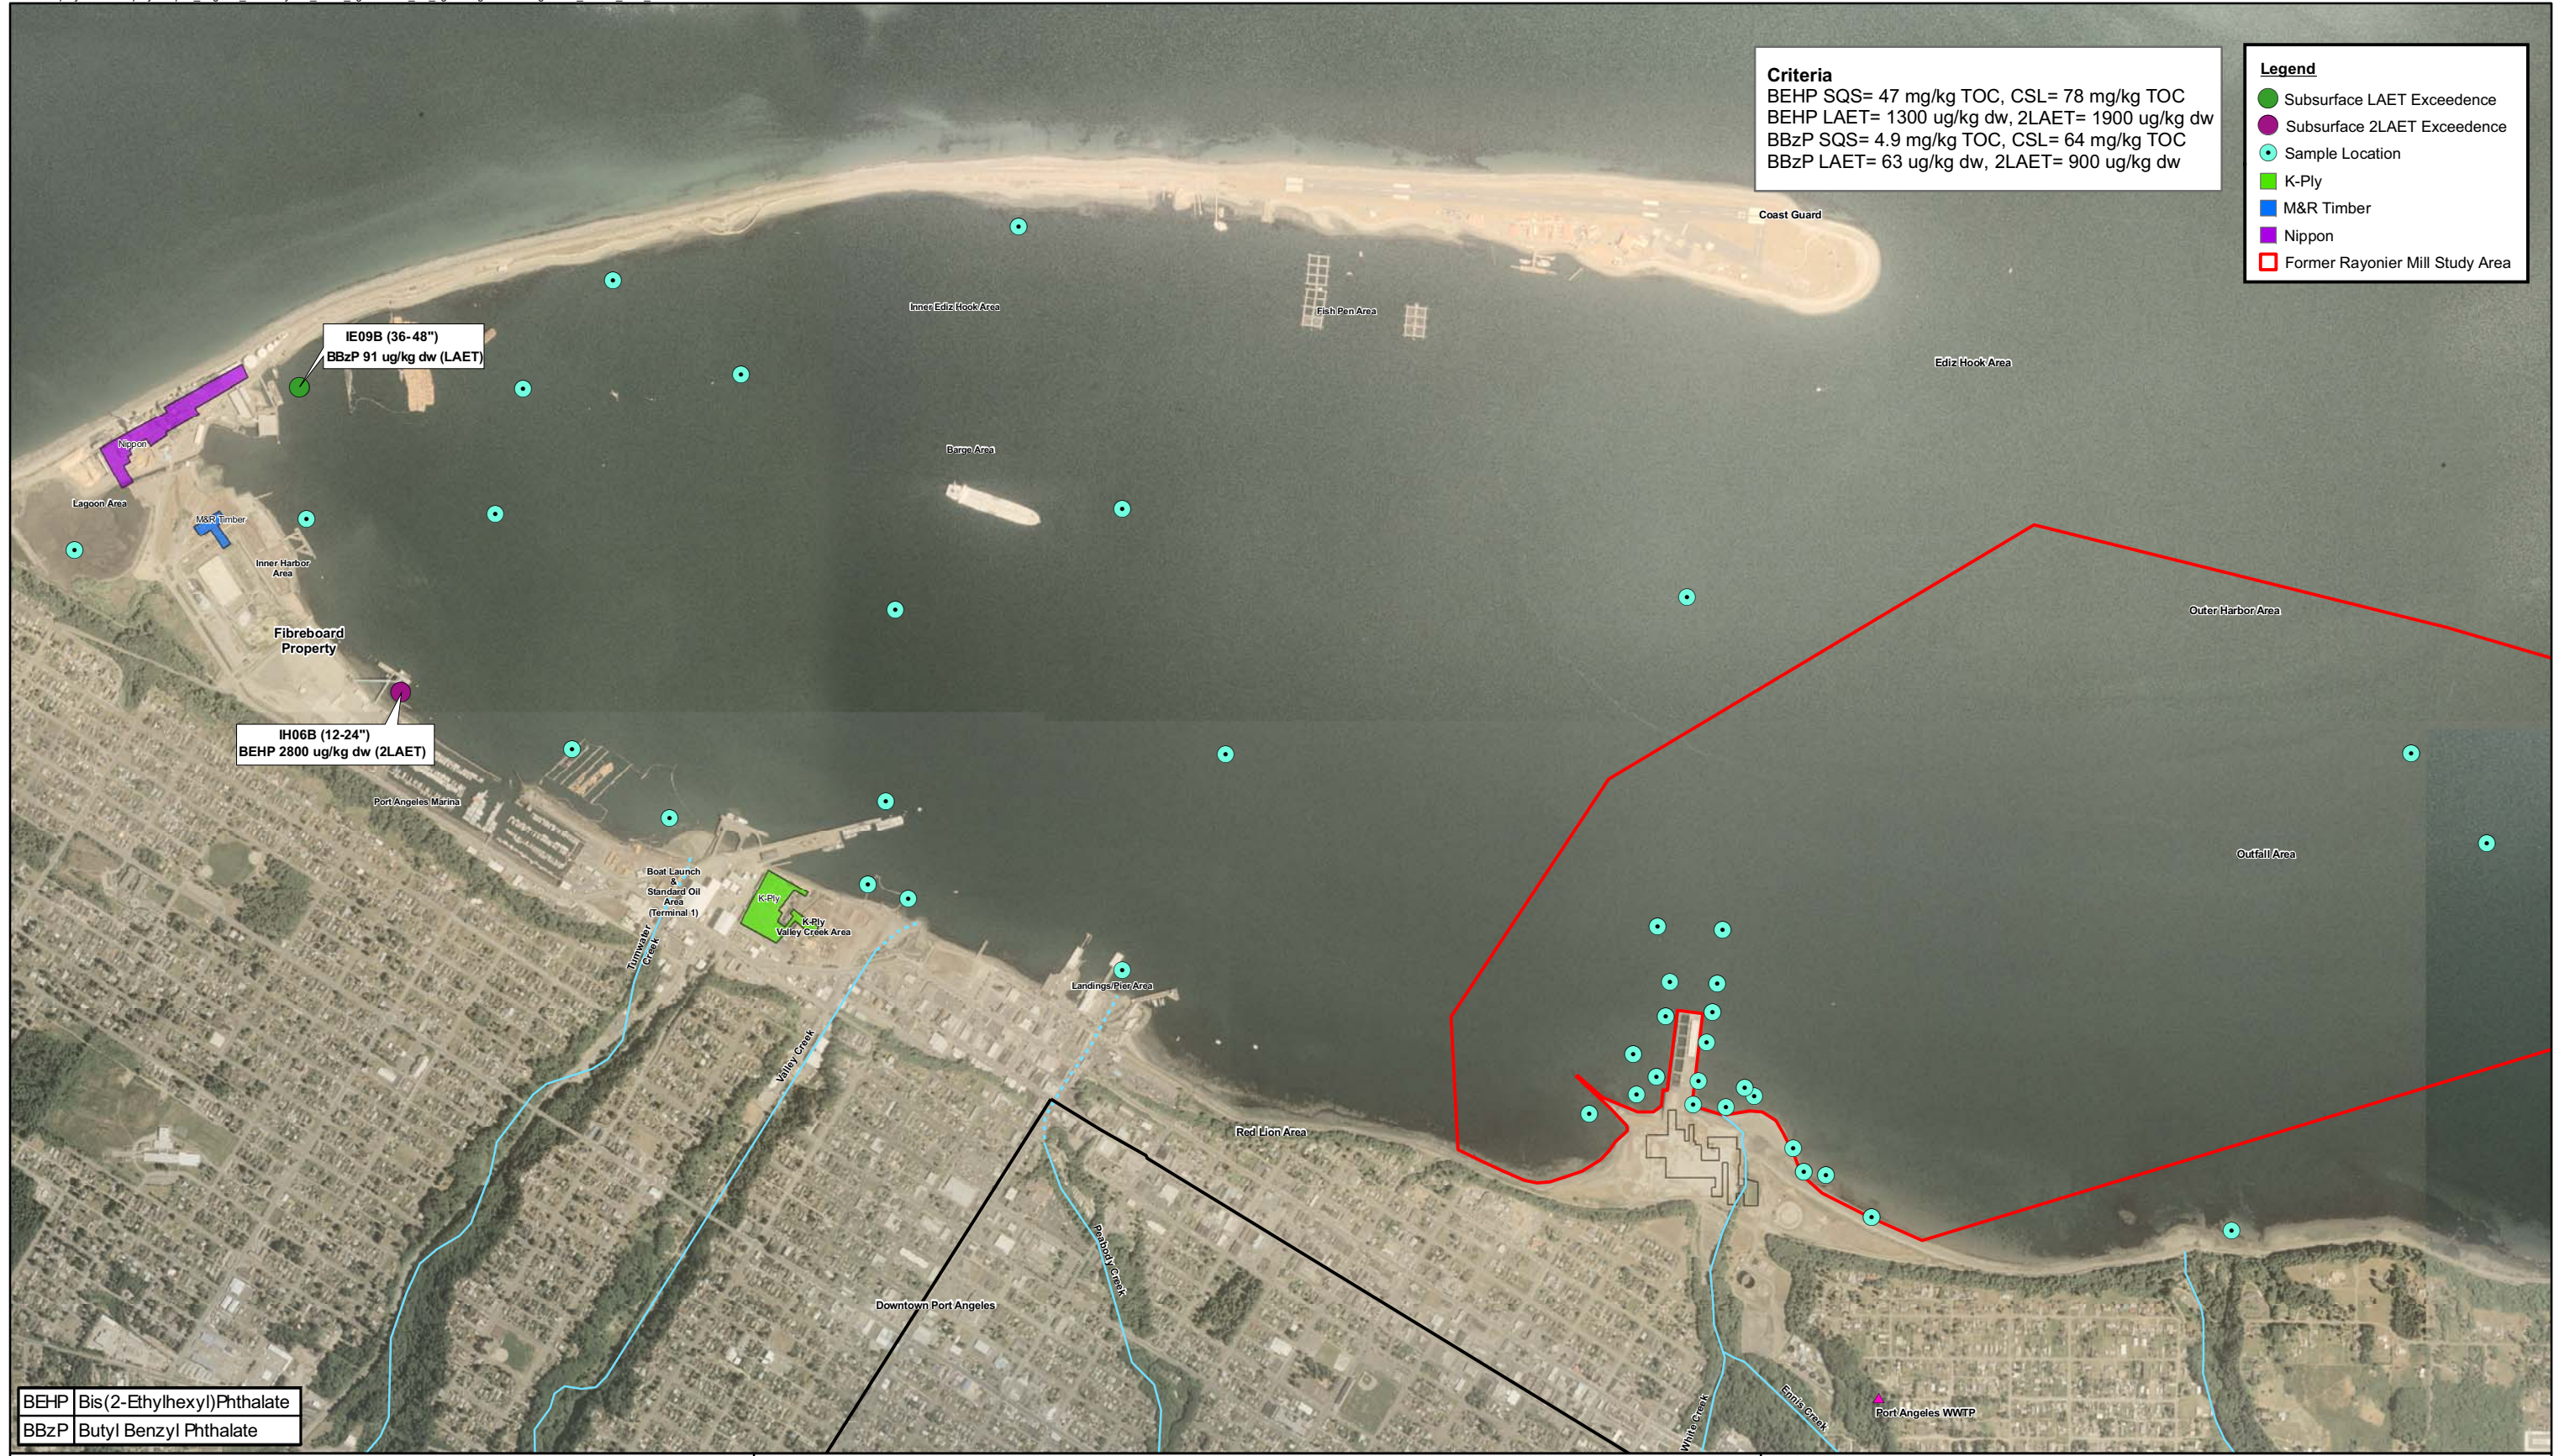
Figure 5.2-4
 Port Angeles Harbor, Washington

Criteria
 BEHP SQS= 47 mg/kg TOC, CSL= 78 mg/kg TOC
 BEHP LAET= 1300 ug/kg dw, 2LAET= 1900 ug/kg dw
 BBzP SQS= 4.9 mg/kg TOC, CSL= 64 mg/kg TOC
 BBzP LAET= 63 ug/kg dw, 2LAET= 900 ug/kg dw

Port Angeles Harbor
 Bis(2-Ethylhexyl)Phthalate and Butyl Benzyl Phthalate
 in Subsurface "B" Depth Cores

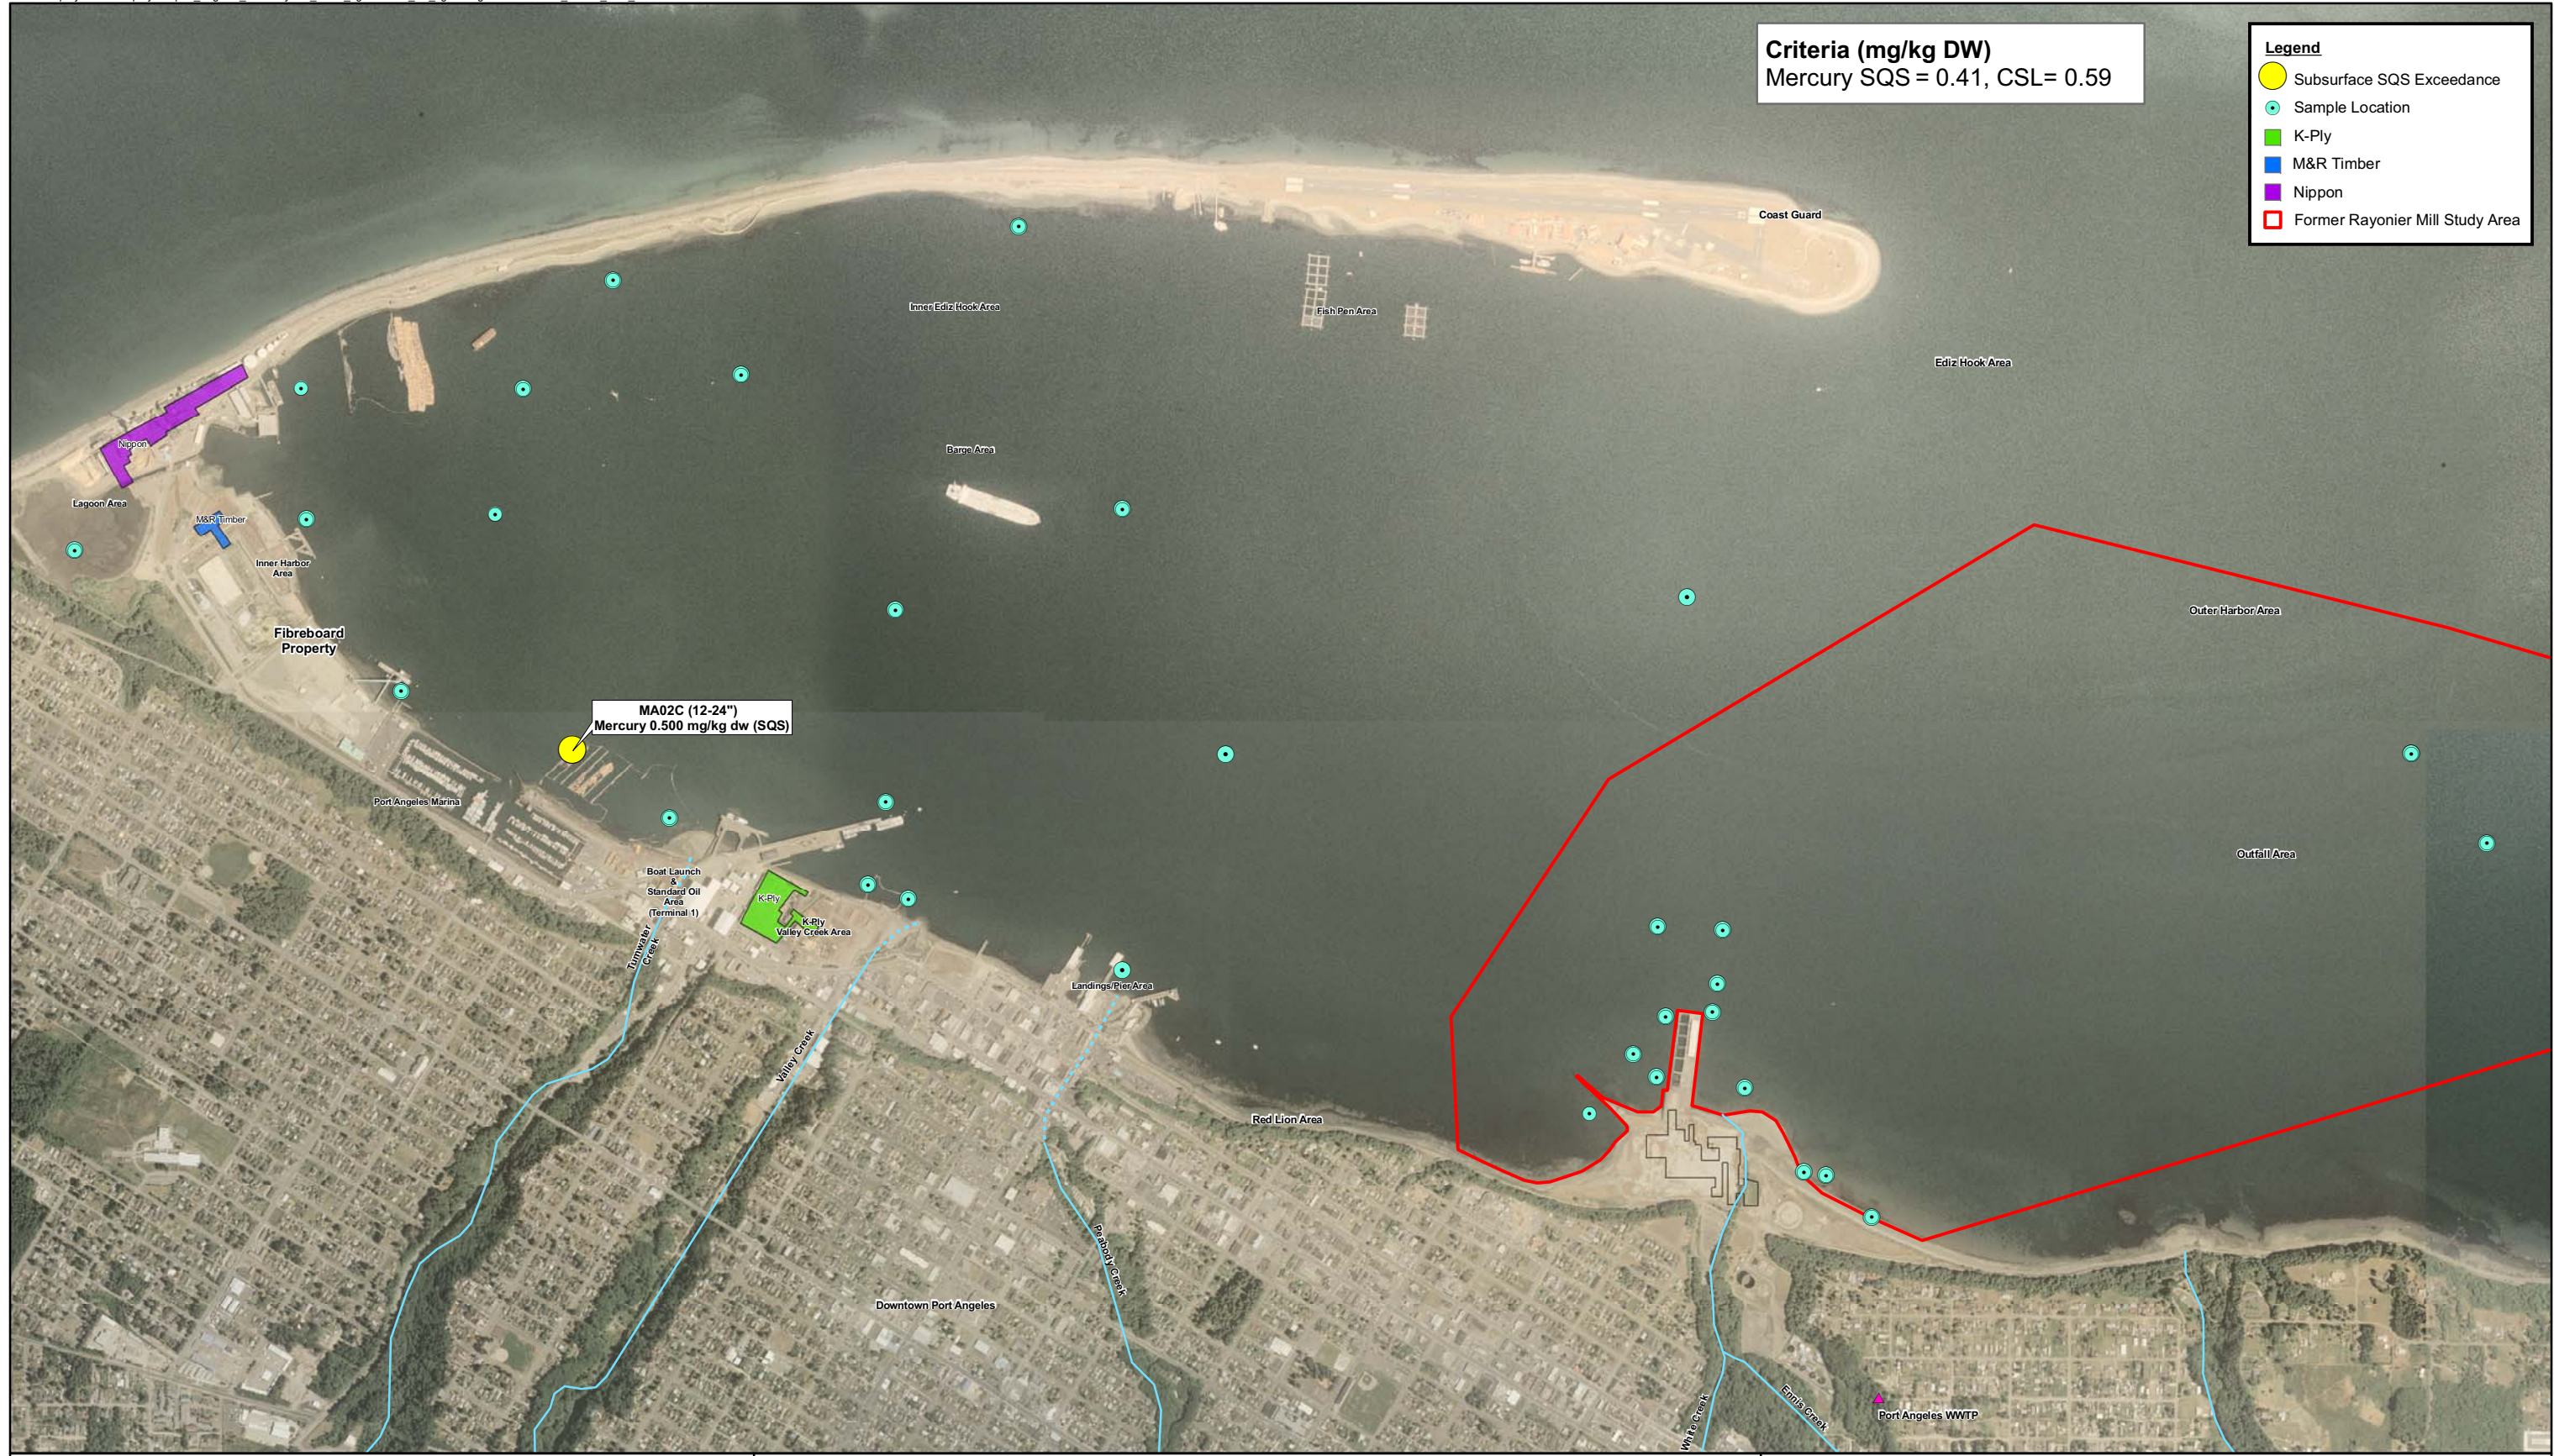
Figure 5.3-2
Port Angeles Harbor, Washington

Criteria (mg/kg DW)
Mercury SQS = 0.41, CSL = 0.59

Port Angeles Harbor
Mercury
in Subsurface "C" and "D" Cores

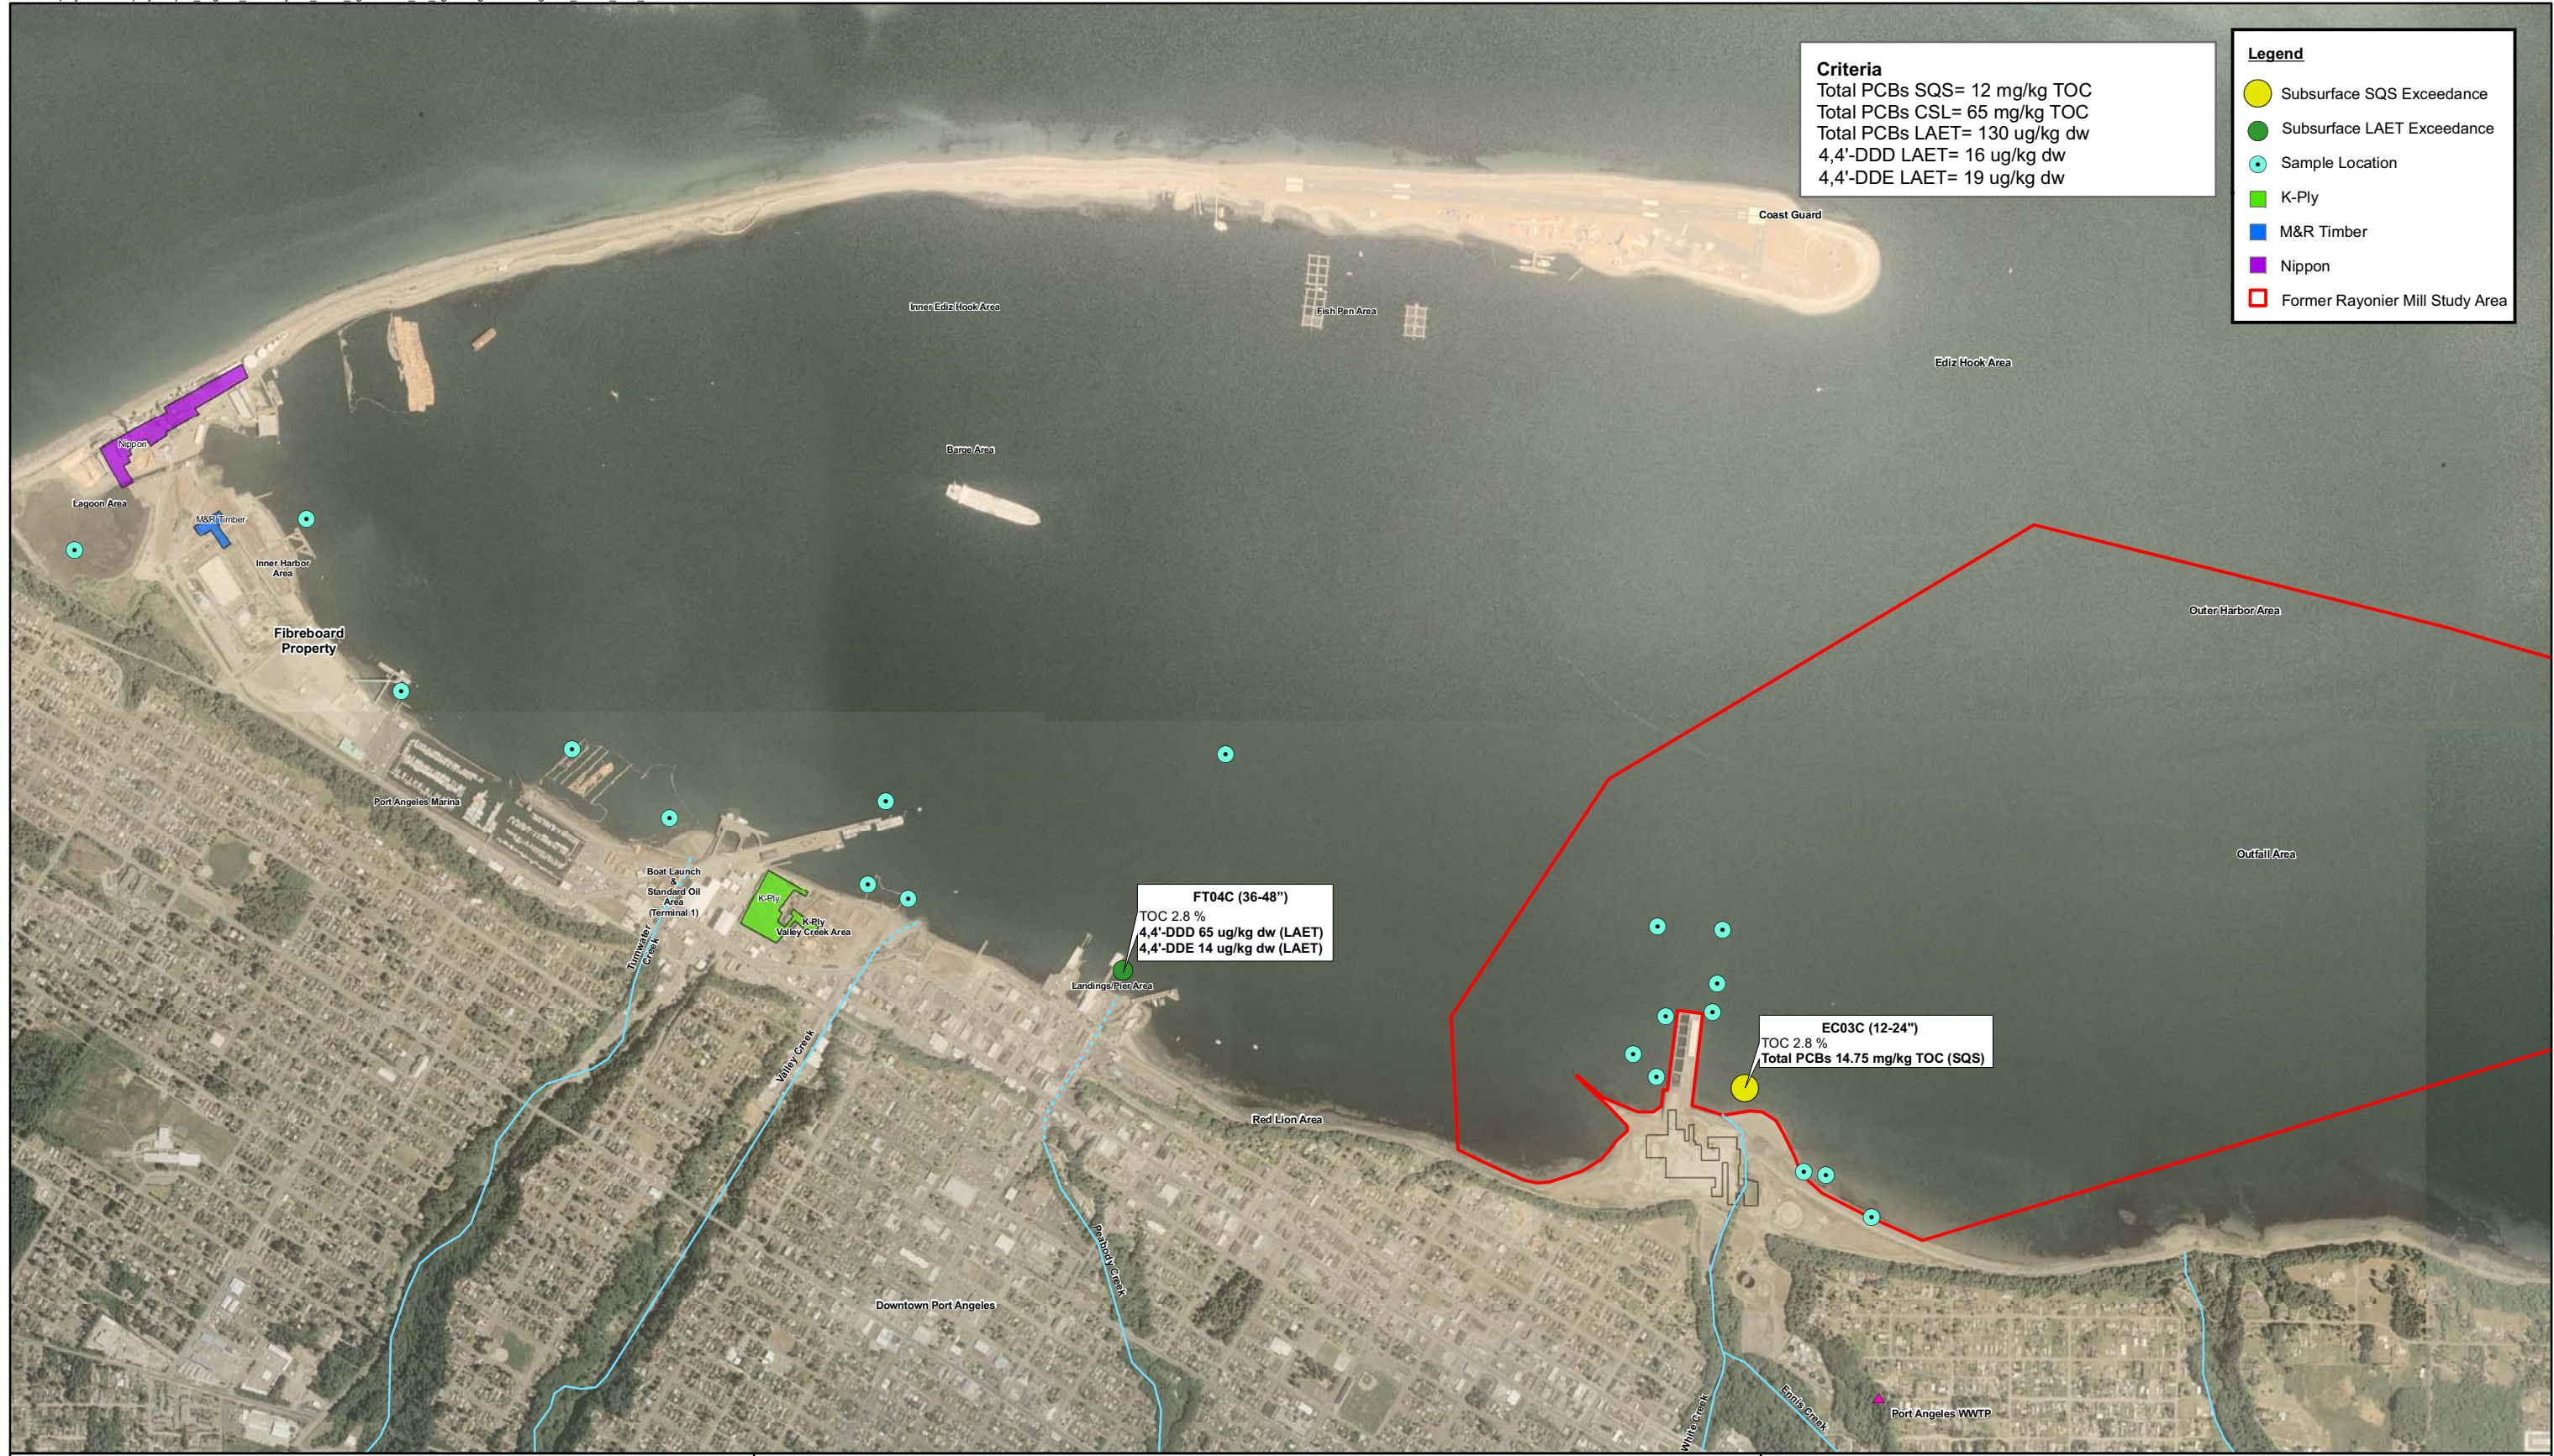
Figure 5.3-3
 Port Angeles Harbor, Washington

**Port Angeles Harbor
 PAHs
 in Subsurface "C" and "D" Cores**

Thirty-one subsurface “C” core sediment samples were analyzed for 7 LPAH and 10 HPAH compounds. The one subsurface “D” core sample was also analyzed for these compounds. The concentrations of individual PAH compounds are shown in Table C–C6 (Appendix C). The concentrations of total LPAH and HPAH compounds at each station are presented in Table C–C7 (Appendix C). Locations with PAH concentrations in exceedance of SMS/LAET criteria are presented in Figures 5.3–3.

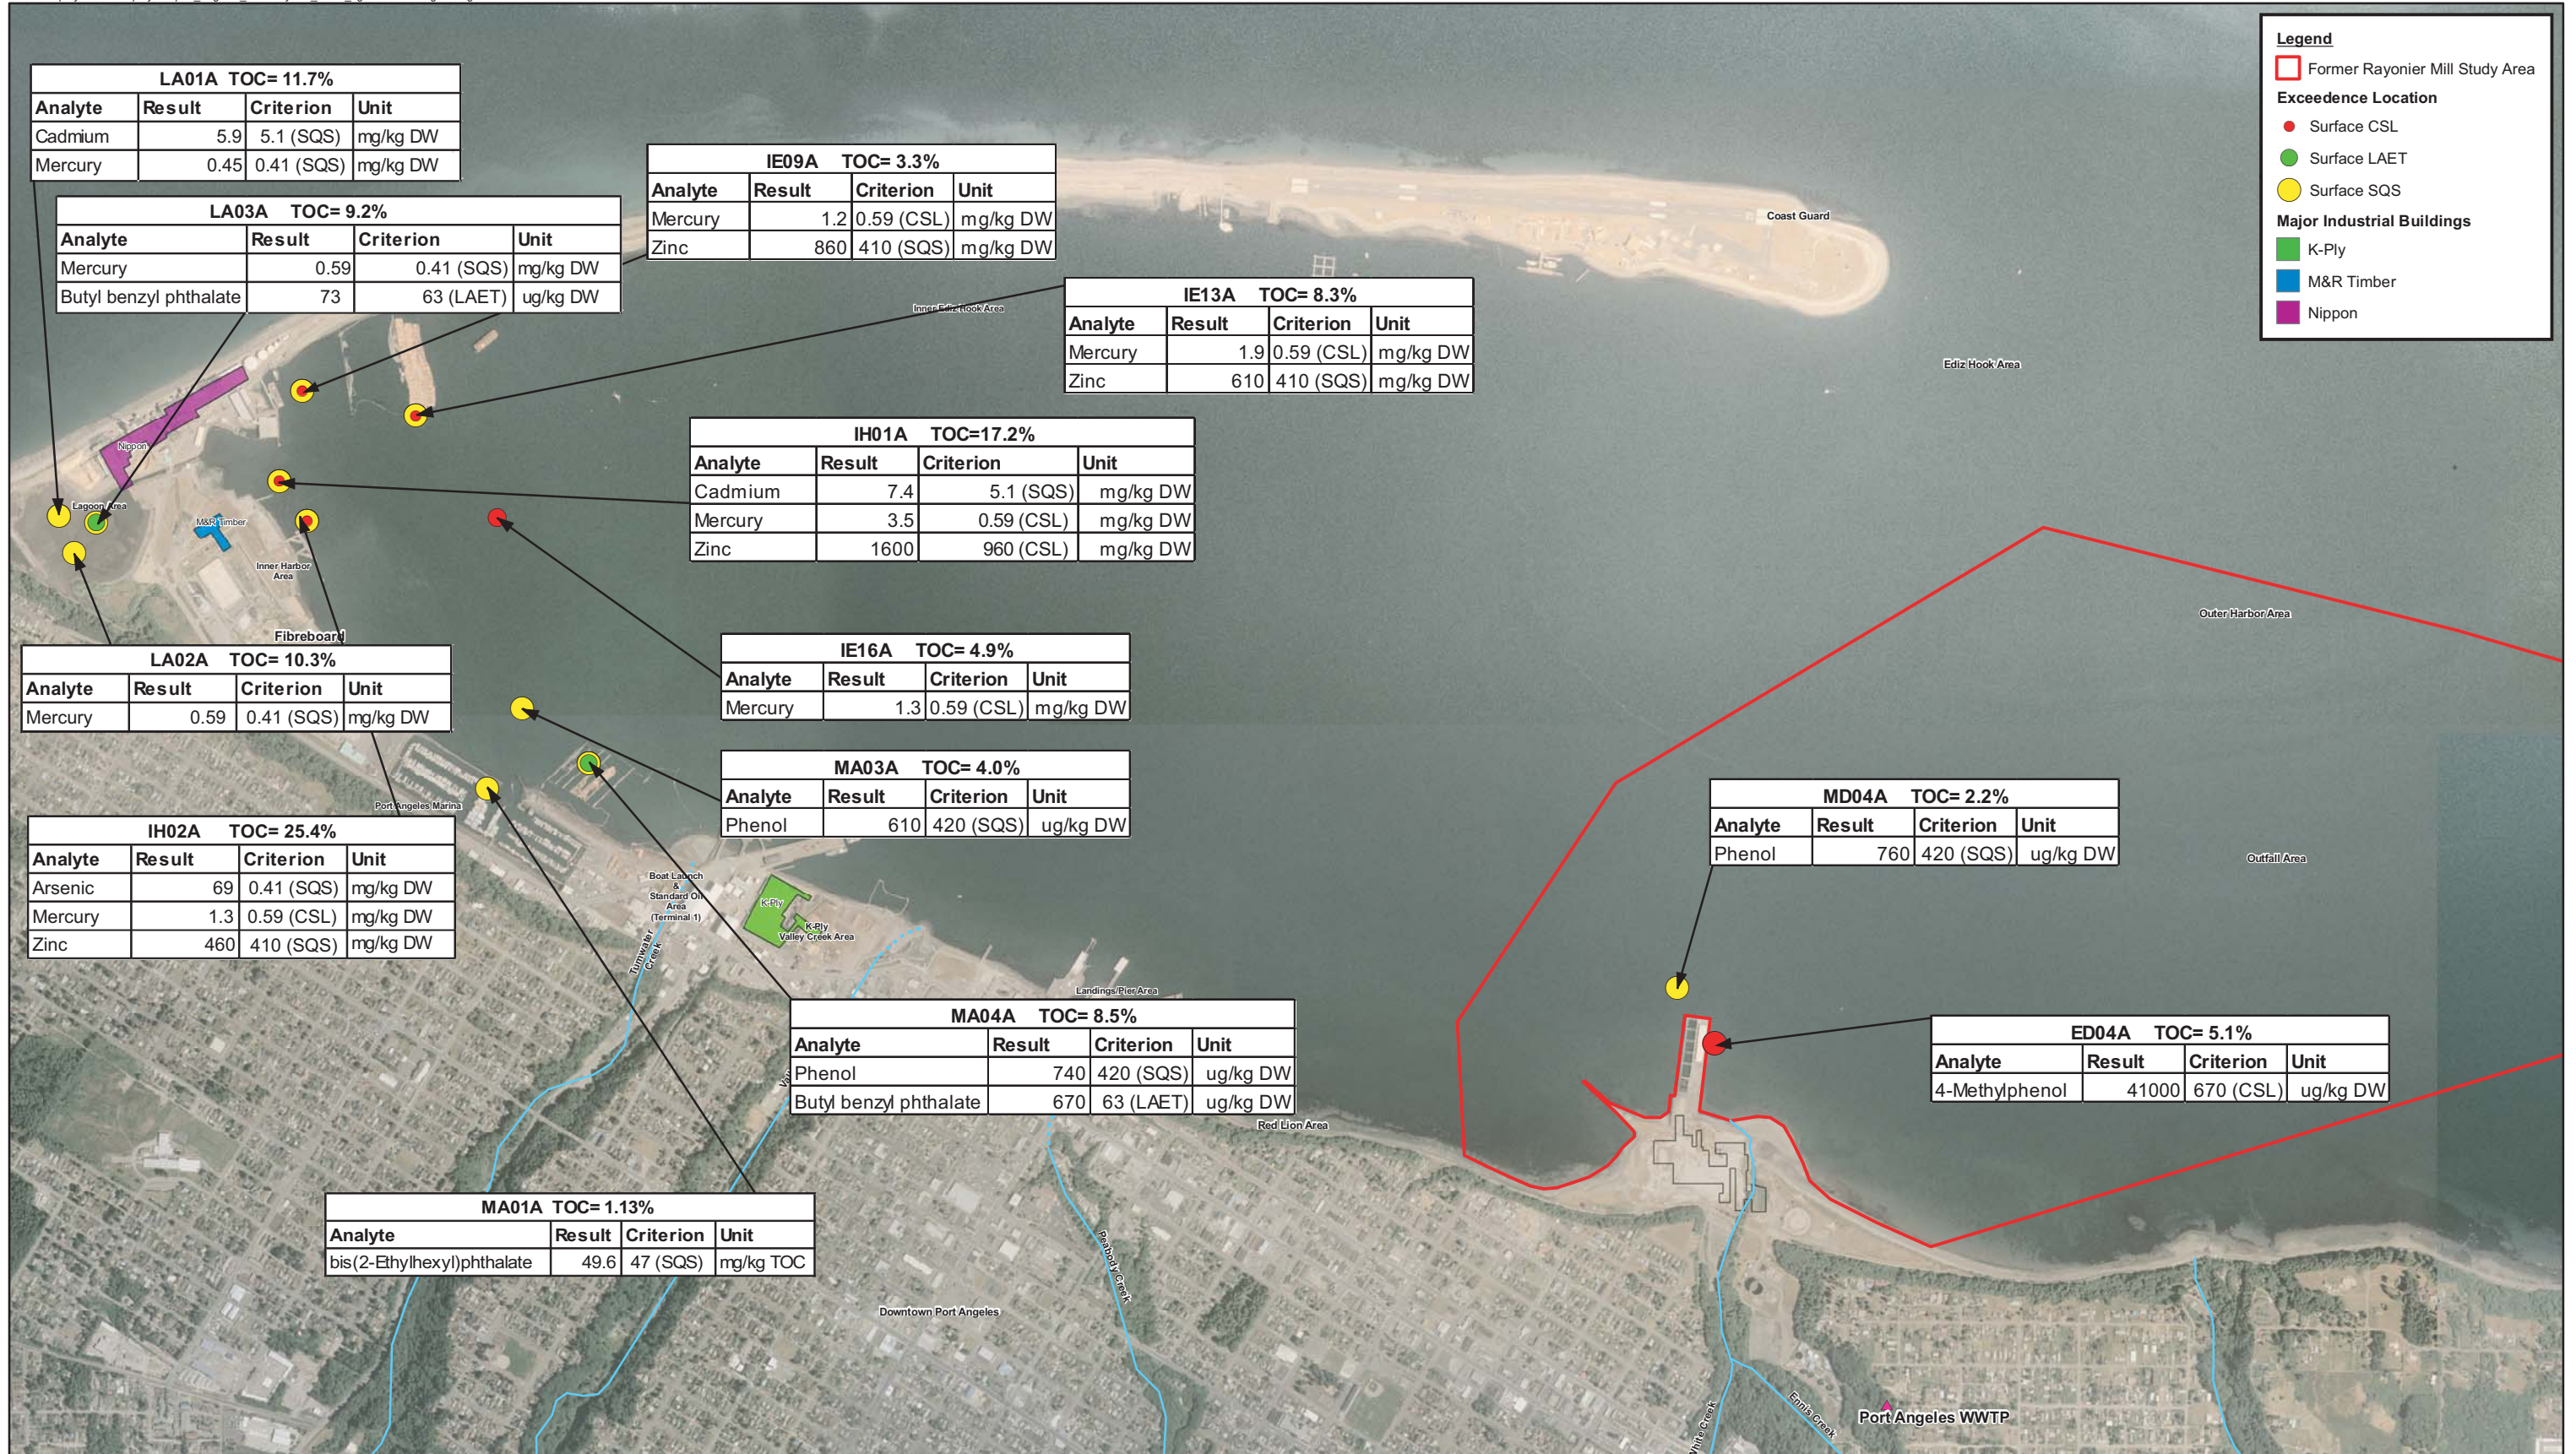
Figure 5.4-1
Port Angeles Harbor, Washington

Harbor-wide Surface Samples
in Exceedence of SQS, CSL or LAET
