Port Angeles Harbor Sediment Characterization Study Port Angeles, Washington

Sediment Investigation Report

December 2012

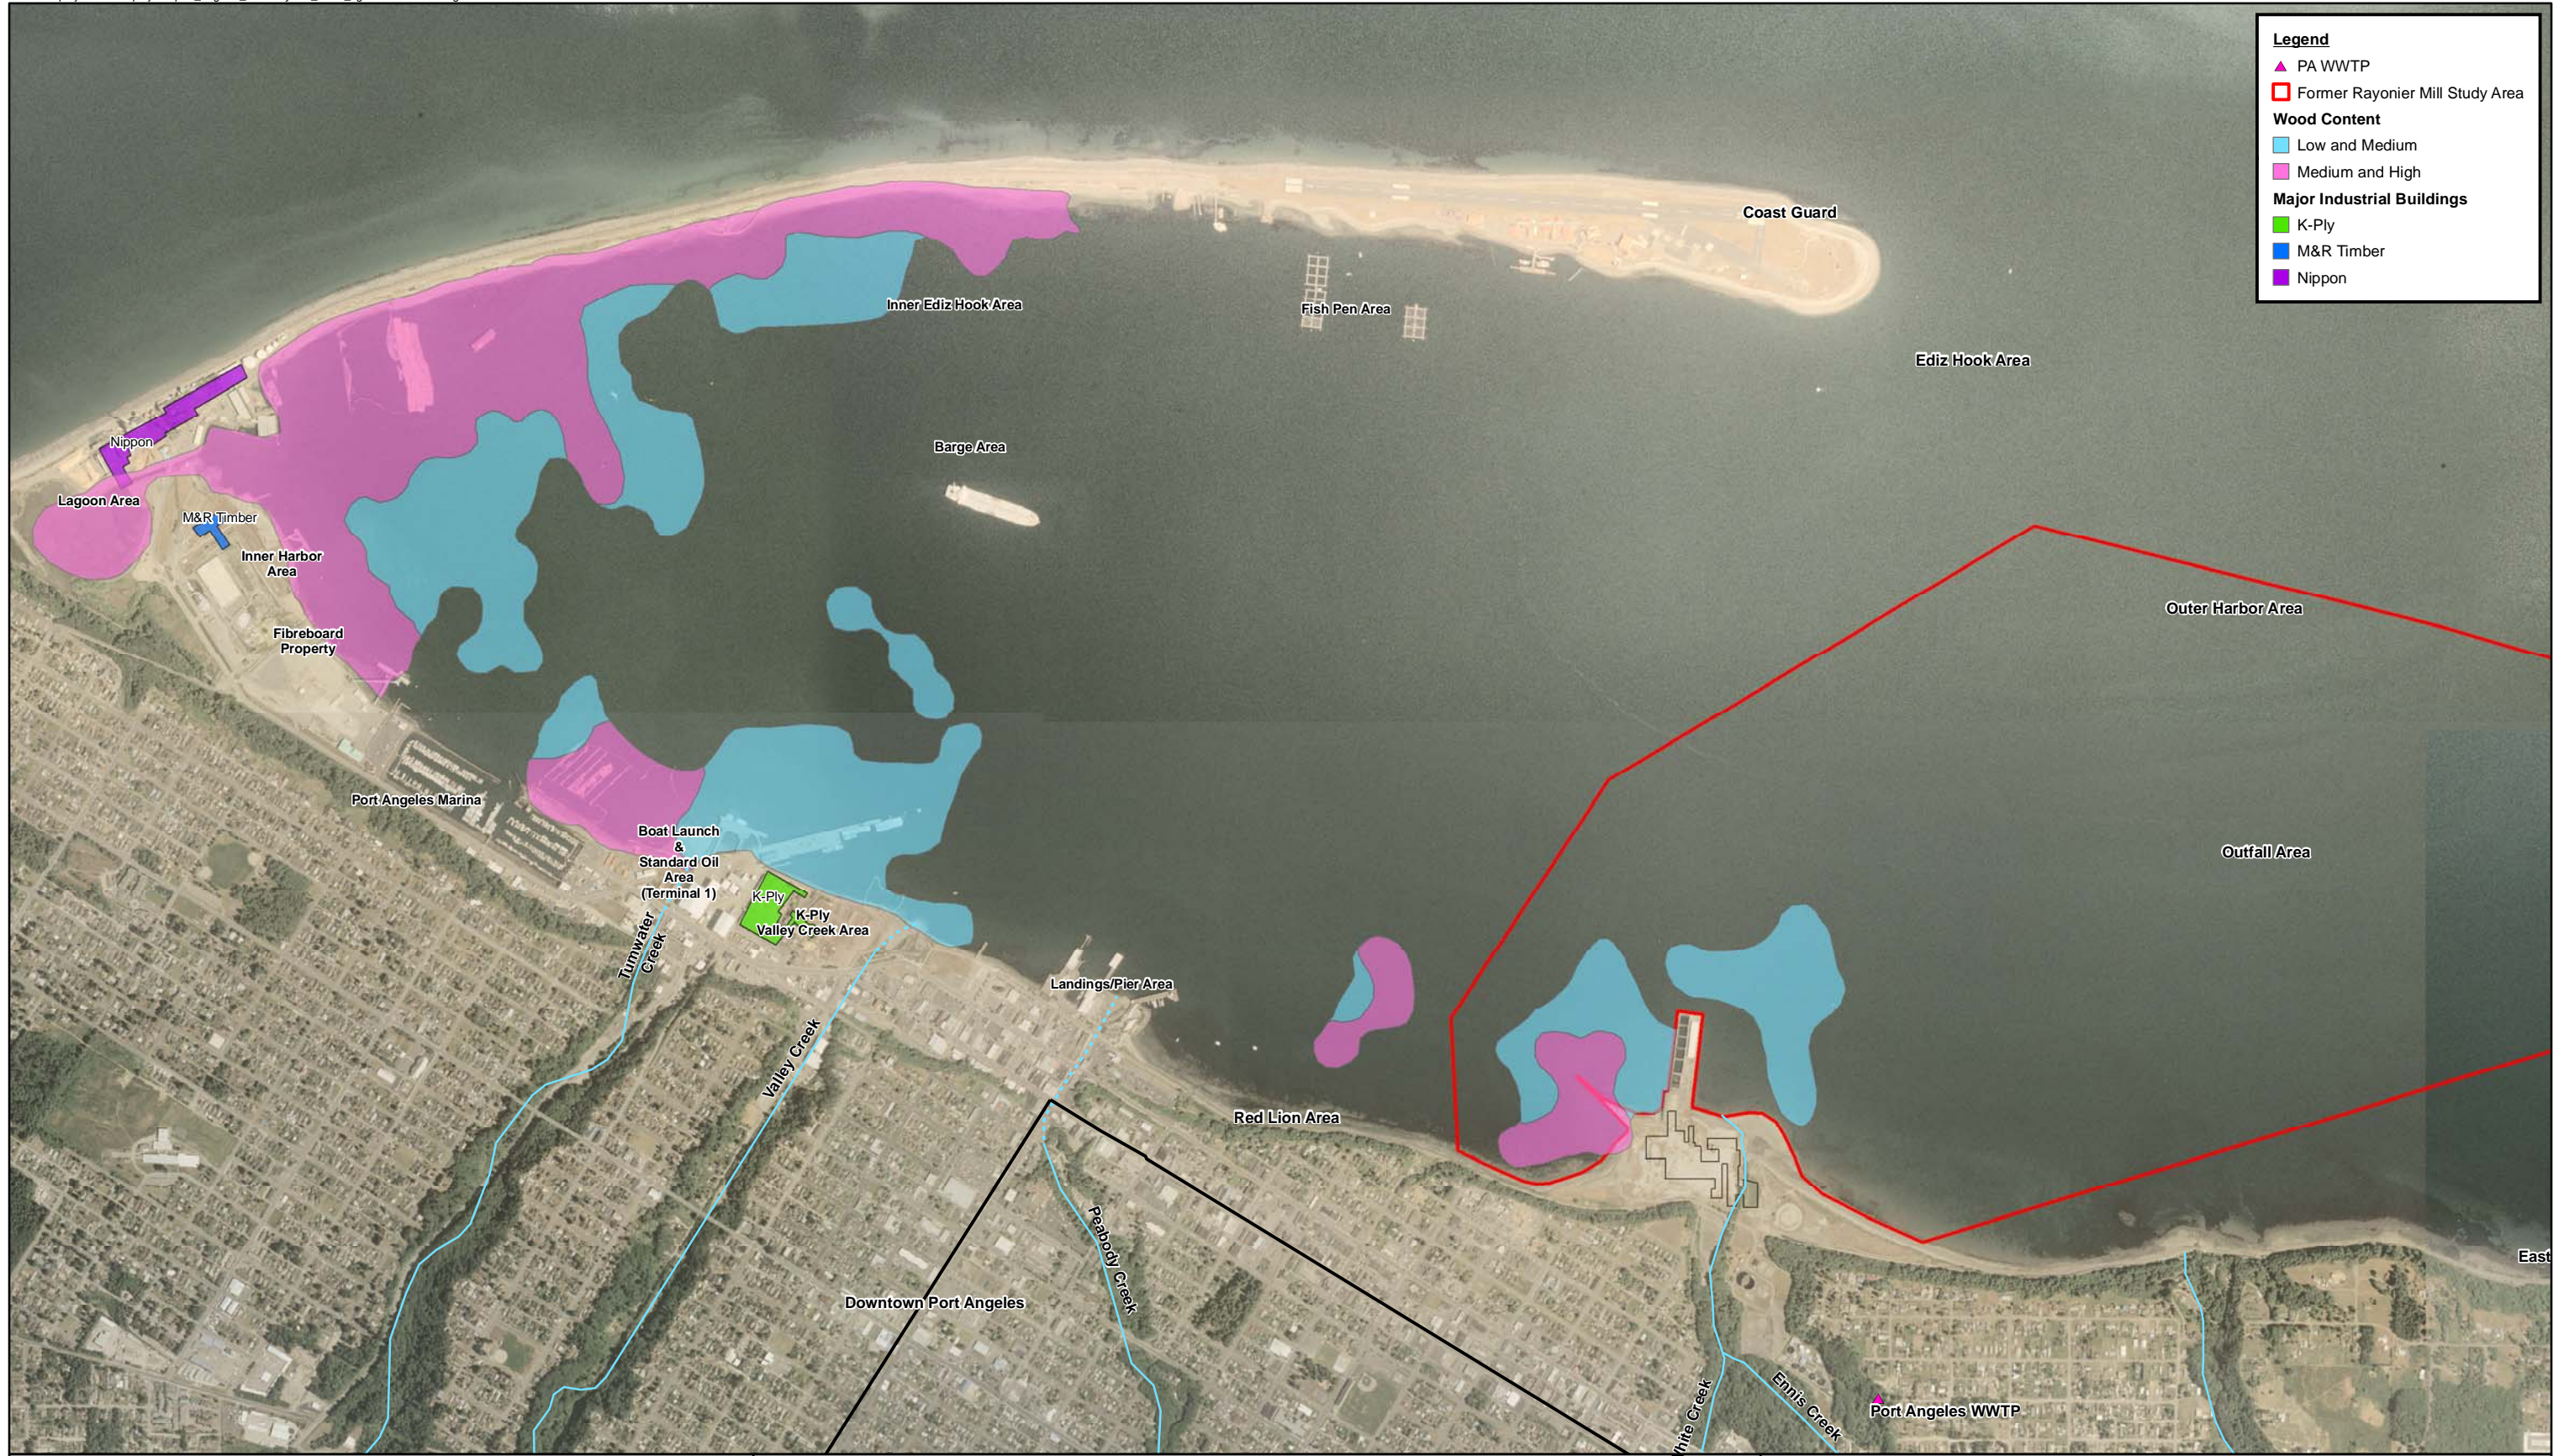
Figure 8-3
 Port Angeles Harbor, Washington

Port Angeles Harbor
Approximate Distribution of Wood Debris

Samples were collected as part of the
 sediment trend analysis (GeoSea 2009)

The largest amounts of wood debris have been observed along the western shoreline of the Inner Harbor and along the base of Ediz Hook (Figures 8–2 through 8–6). Other areas with measurable amounts of wood debris were located offshore of the Boat Haven Marina and surrounding the Rayonier Mill Dock and Log Pond.

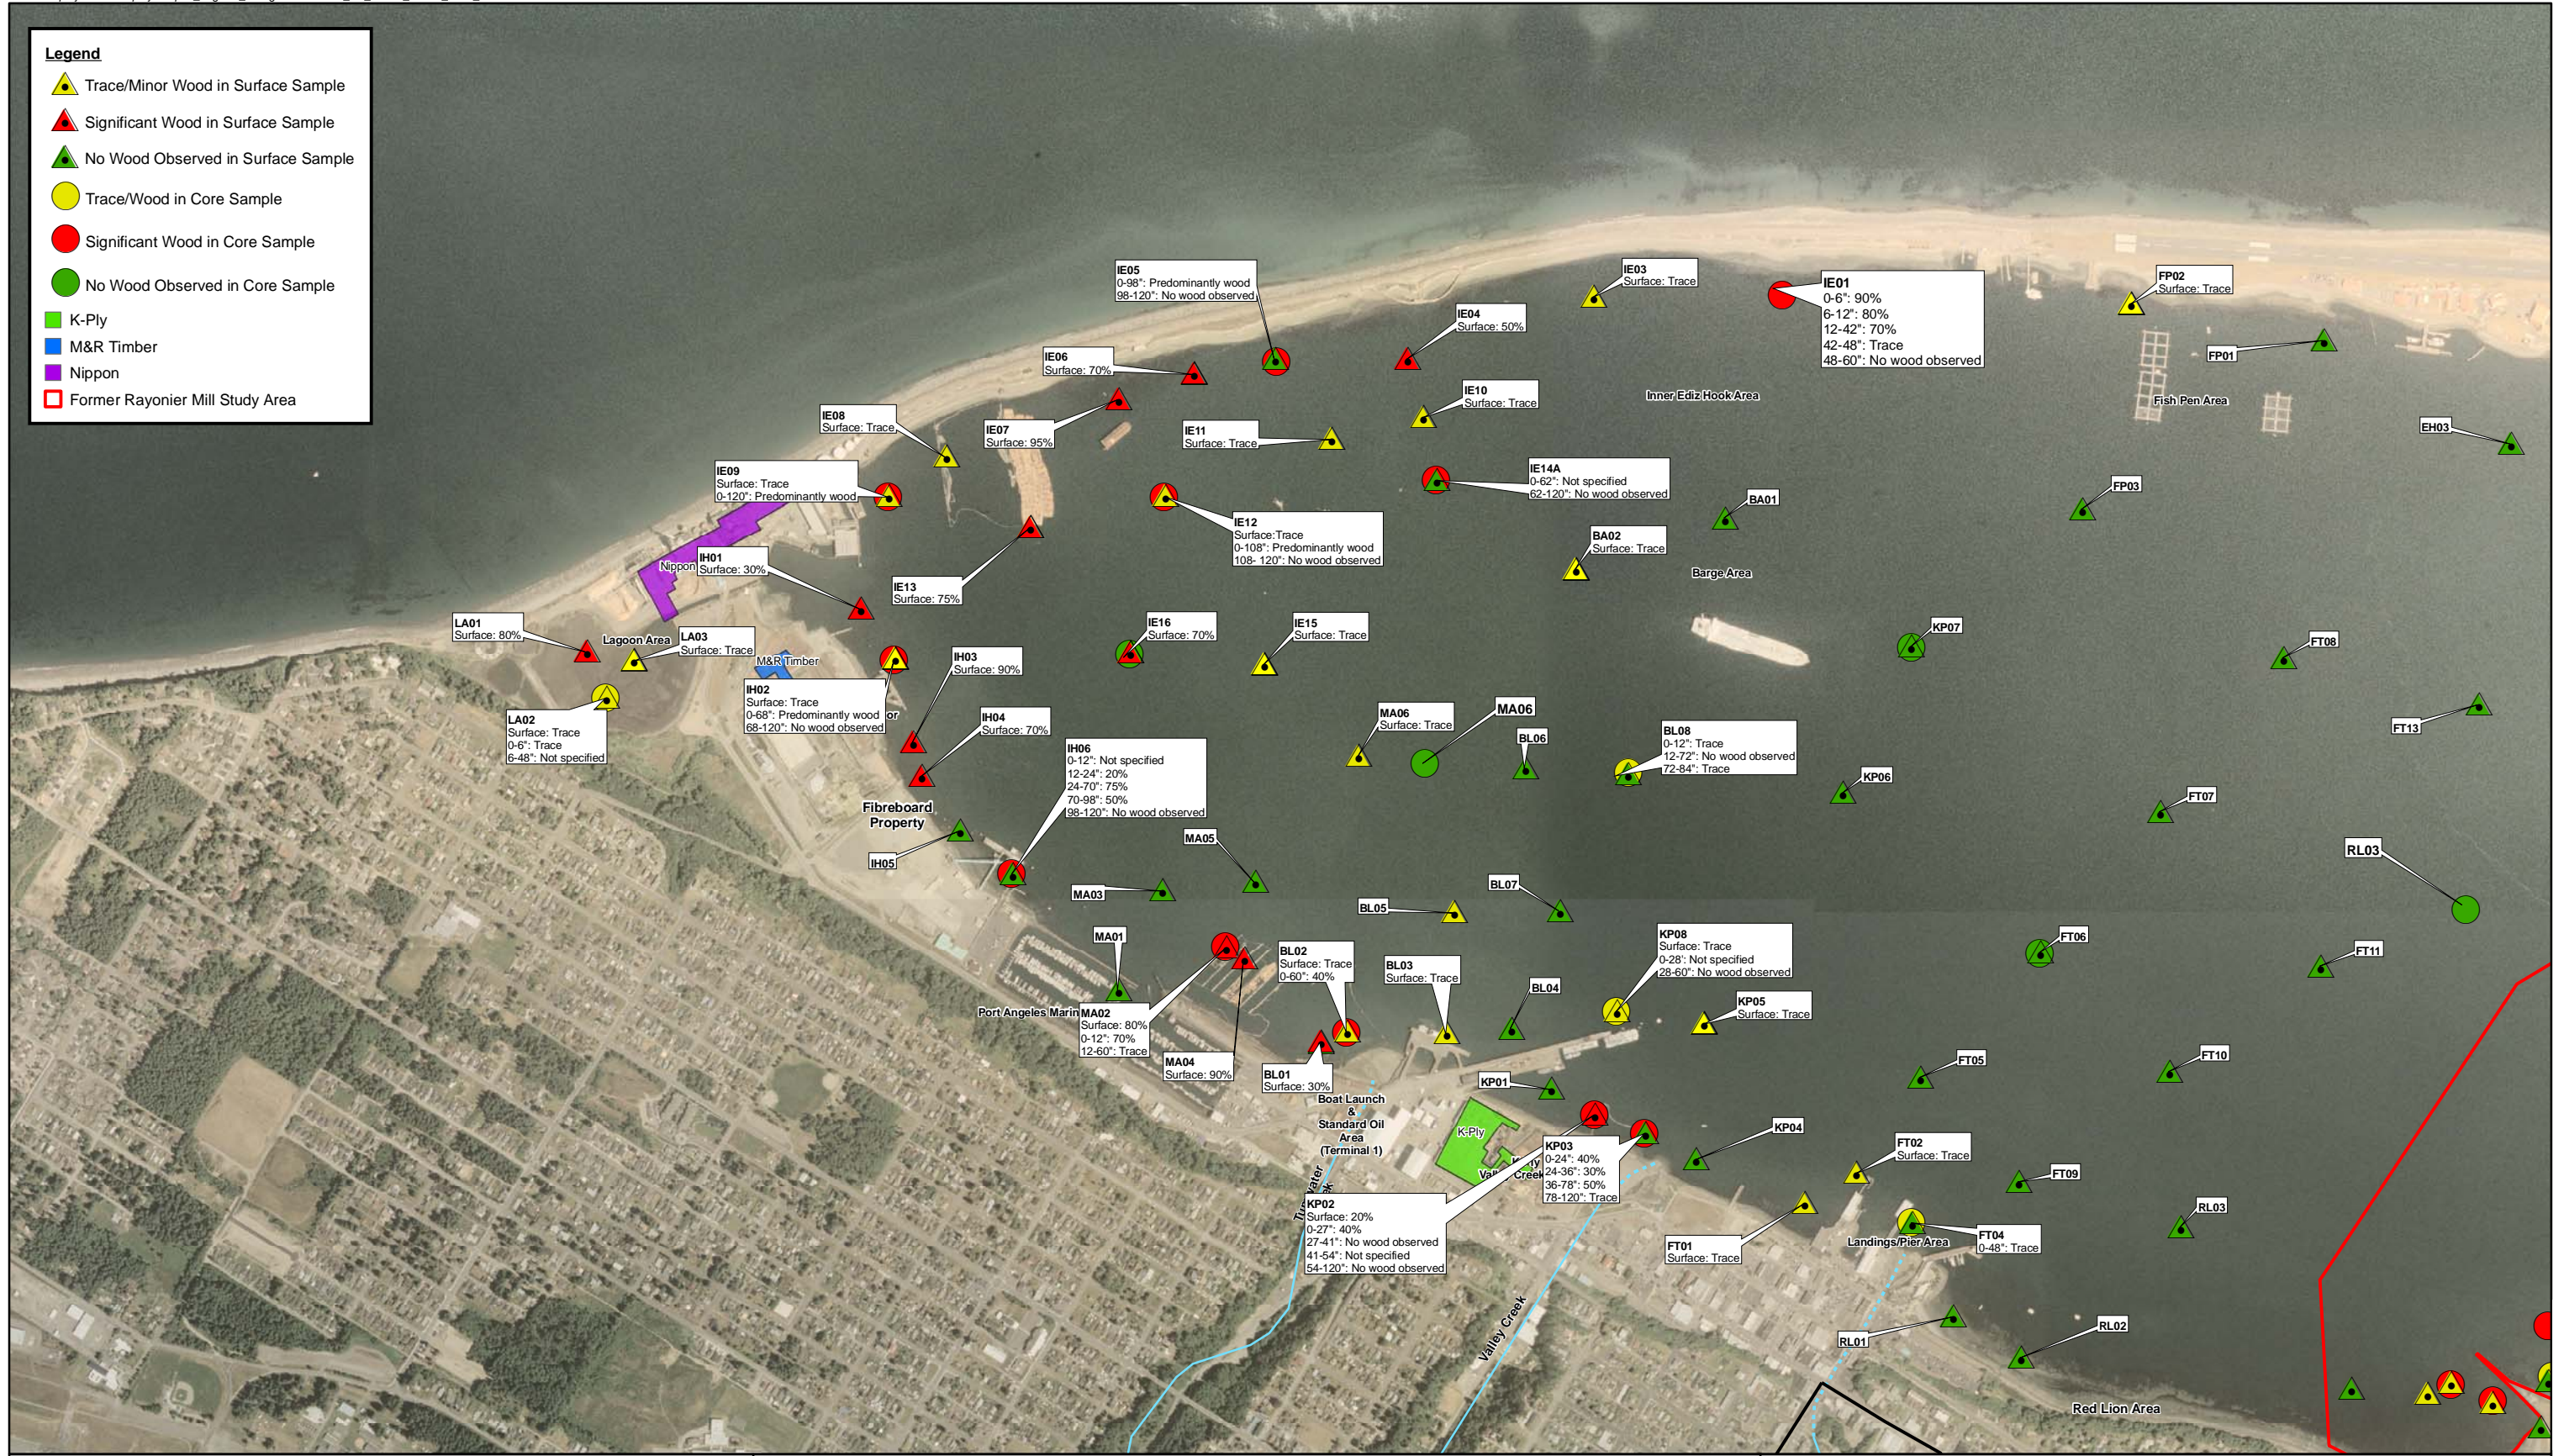
Figure 8-5

**Port Angeles Inner-Harbor
Wood Debris Distribution**

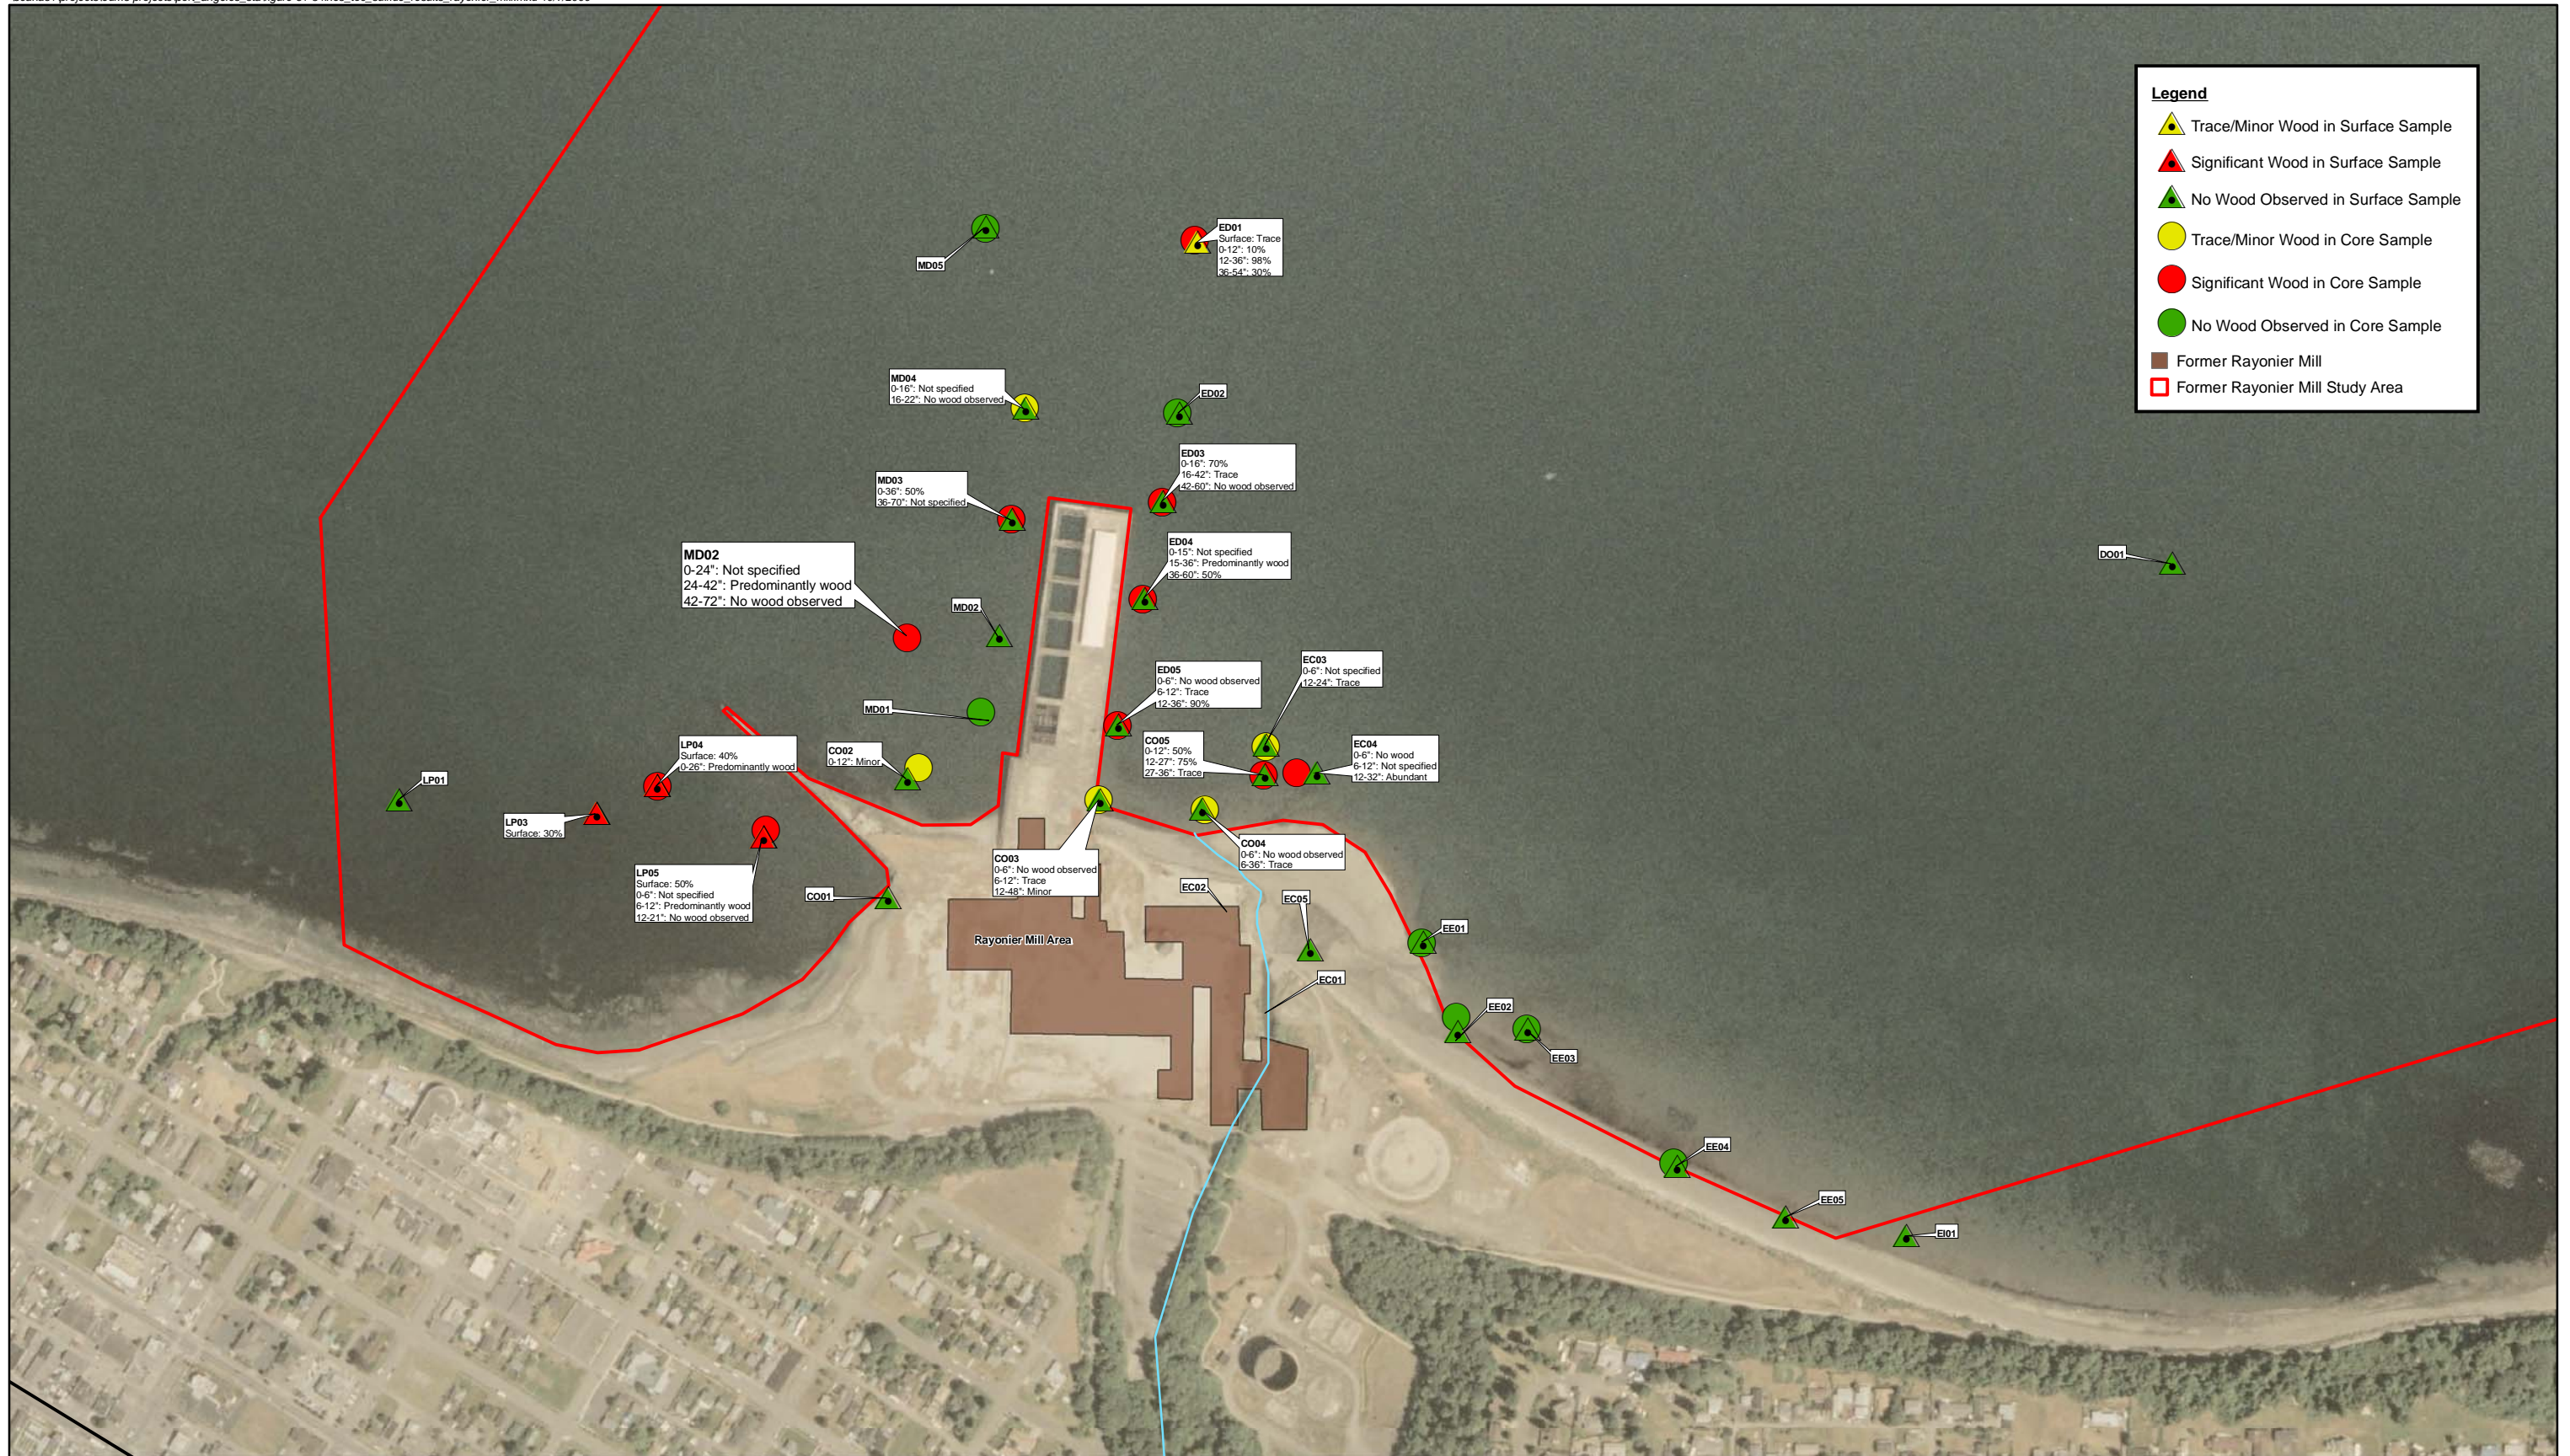
Figure 8-6
Port Angeles Harbor, Washington

Rayonier Mill Area
Wood Debris Distribution
