LUST CLOSURE/INTERIM REMEDIAL ACTION REPORT

**SUNNYSIDE VALLEY IRRIGATION DISTRICT
GRANDVIEW YARD
405 N. ELM
GRANDVIEW, WA 98930**

OCTOBER, 1994

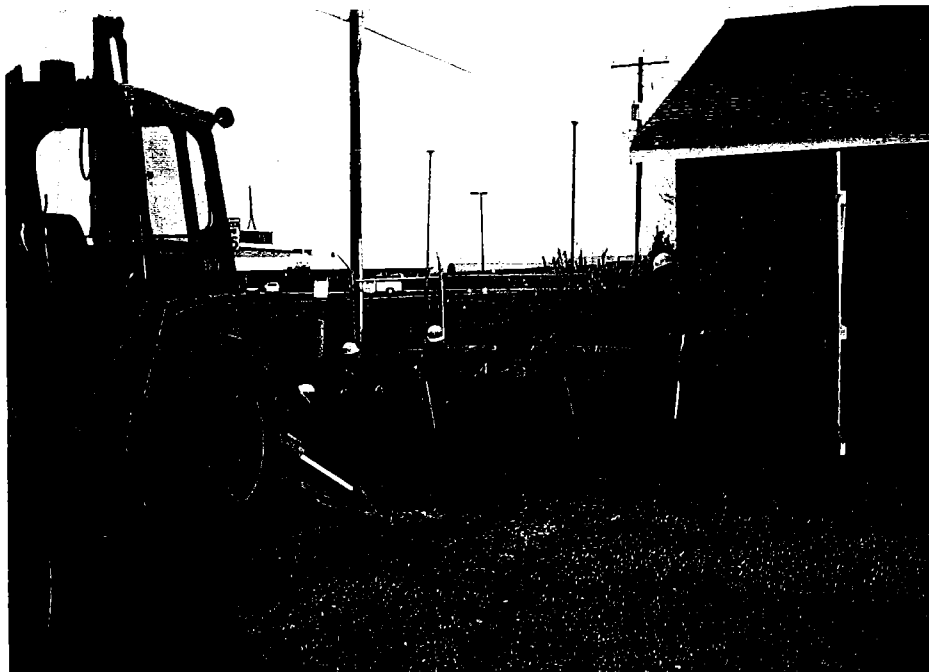
2) UST location on west
side of job 4/13/94

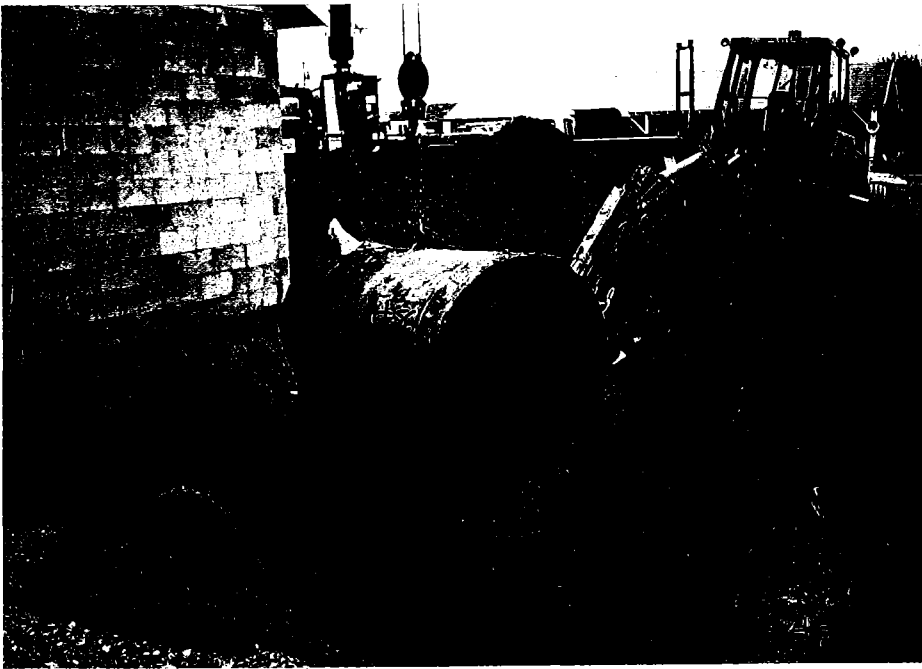
We removed attached soil and scale to completely expose the tanks. With the soil and scale removed, we carefully examined each tank. The tanks were in good condition with little evidence of corrosion and pitting. A layer of a black "tar" like substance was discovered beneath the diesel fuel tank, Tank #8. The layer was approximately 1 inch thick and was mixed with soil.

4) UST #8 4/13/94

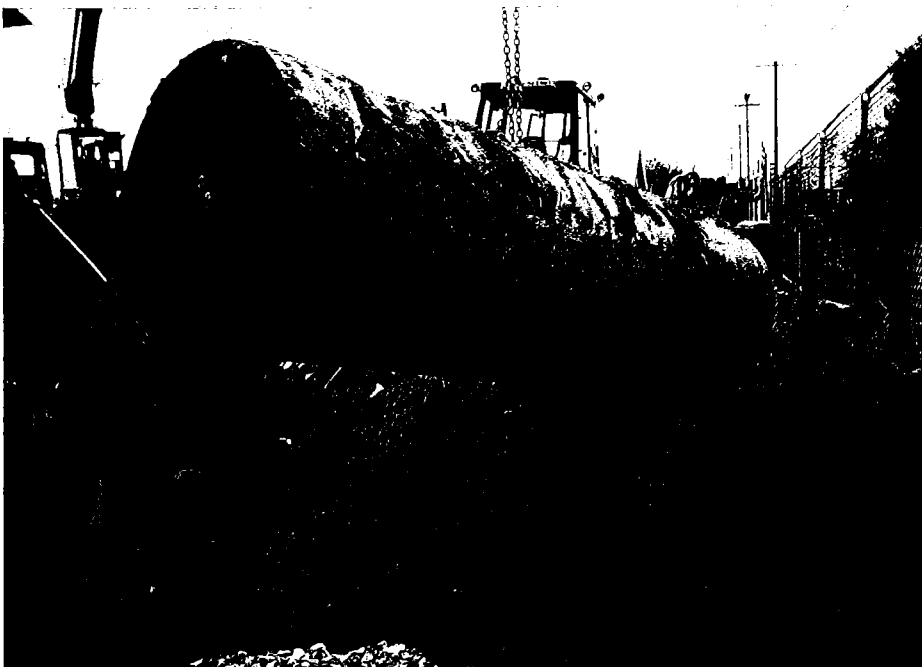
6) Tank #8 4/13/94

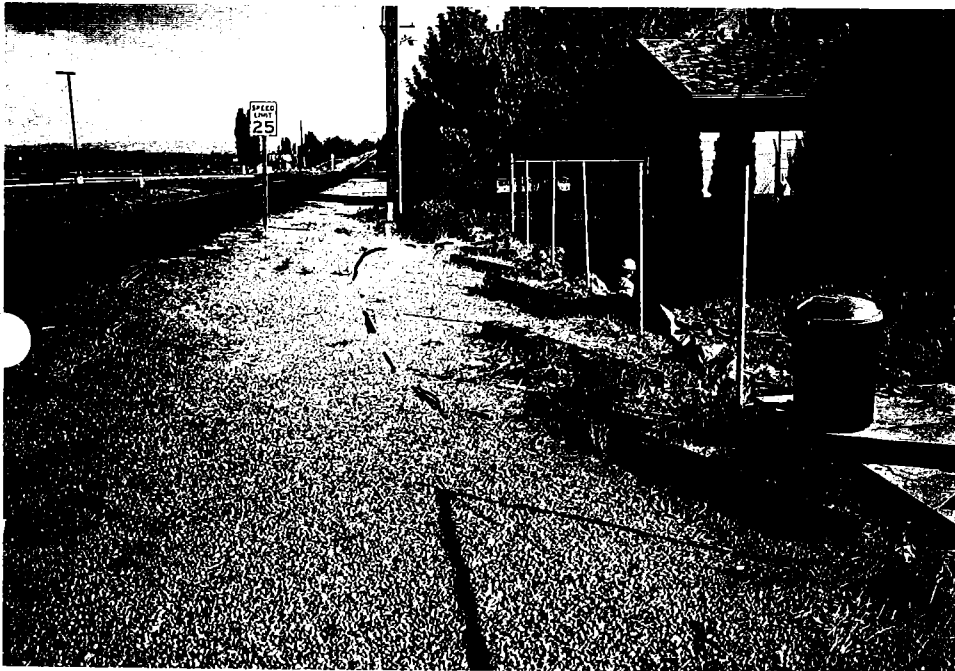
8) Area west of fence prior to expanding excavation 9/13/94 - outlined area is approximate extent of expanded excavation

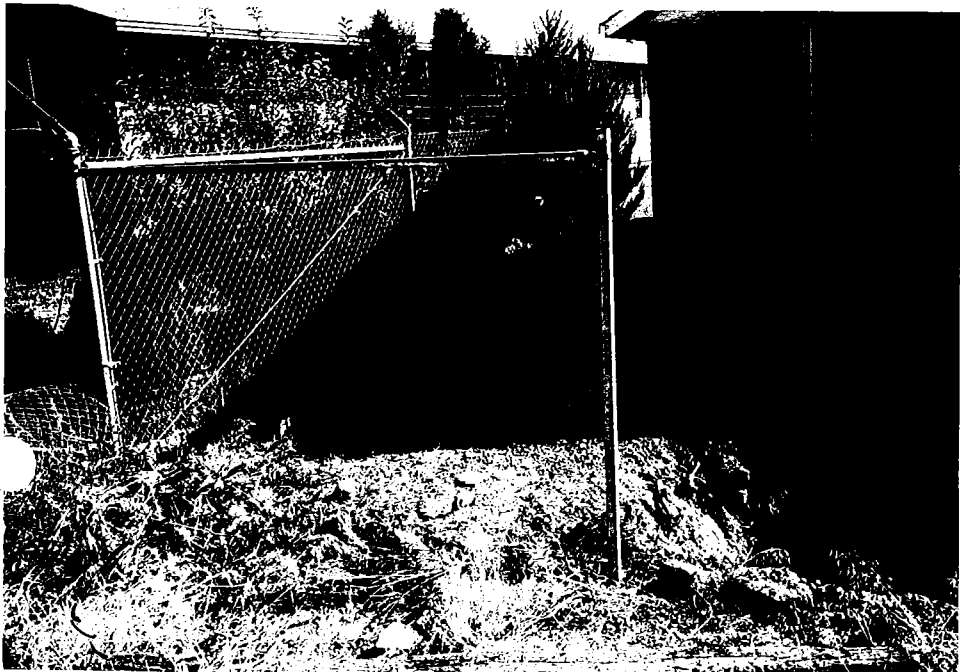
9) Area north of excavation prior to expanding excavation 9/18/94 - outlined area is approximate extent of expanded excavation
