Annual Groundwater Performance Monitoring Report

**Bothell Service Center Simon & Son
18107 Bothell Way NE
Bothell, Washington
FSID # 33215922**

July 14, 2020

Kane Environmental, Inc.
4015 13th Avenue West
Seattle, WA 98119

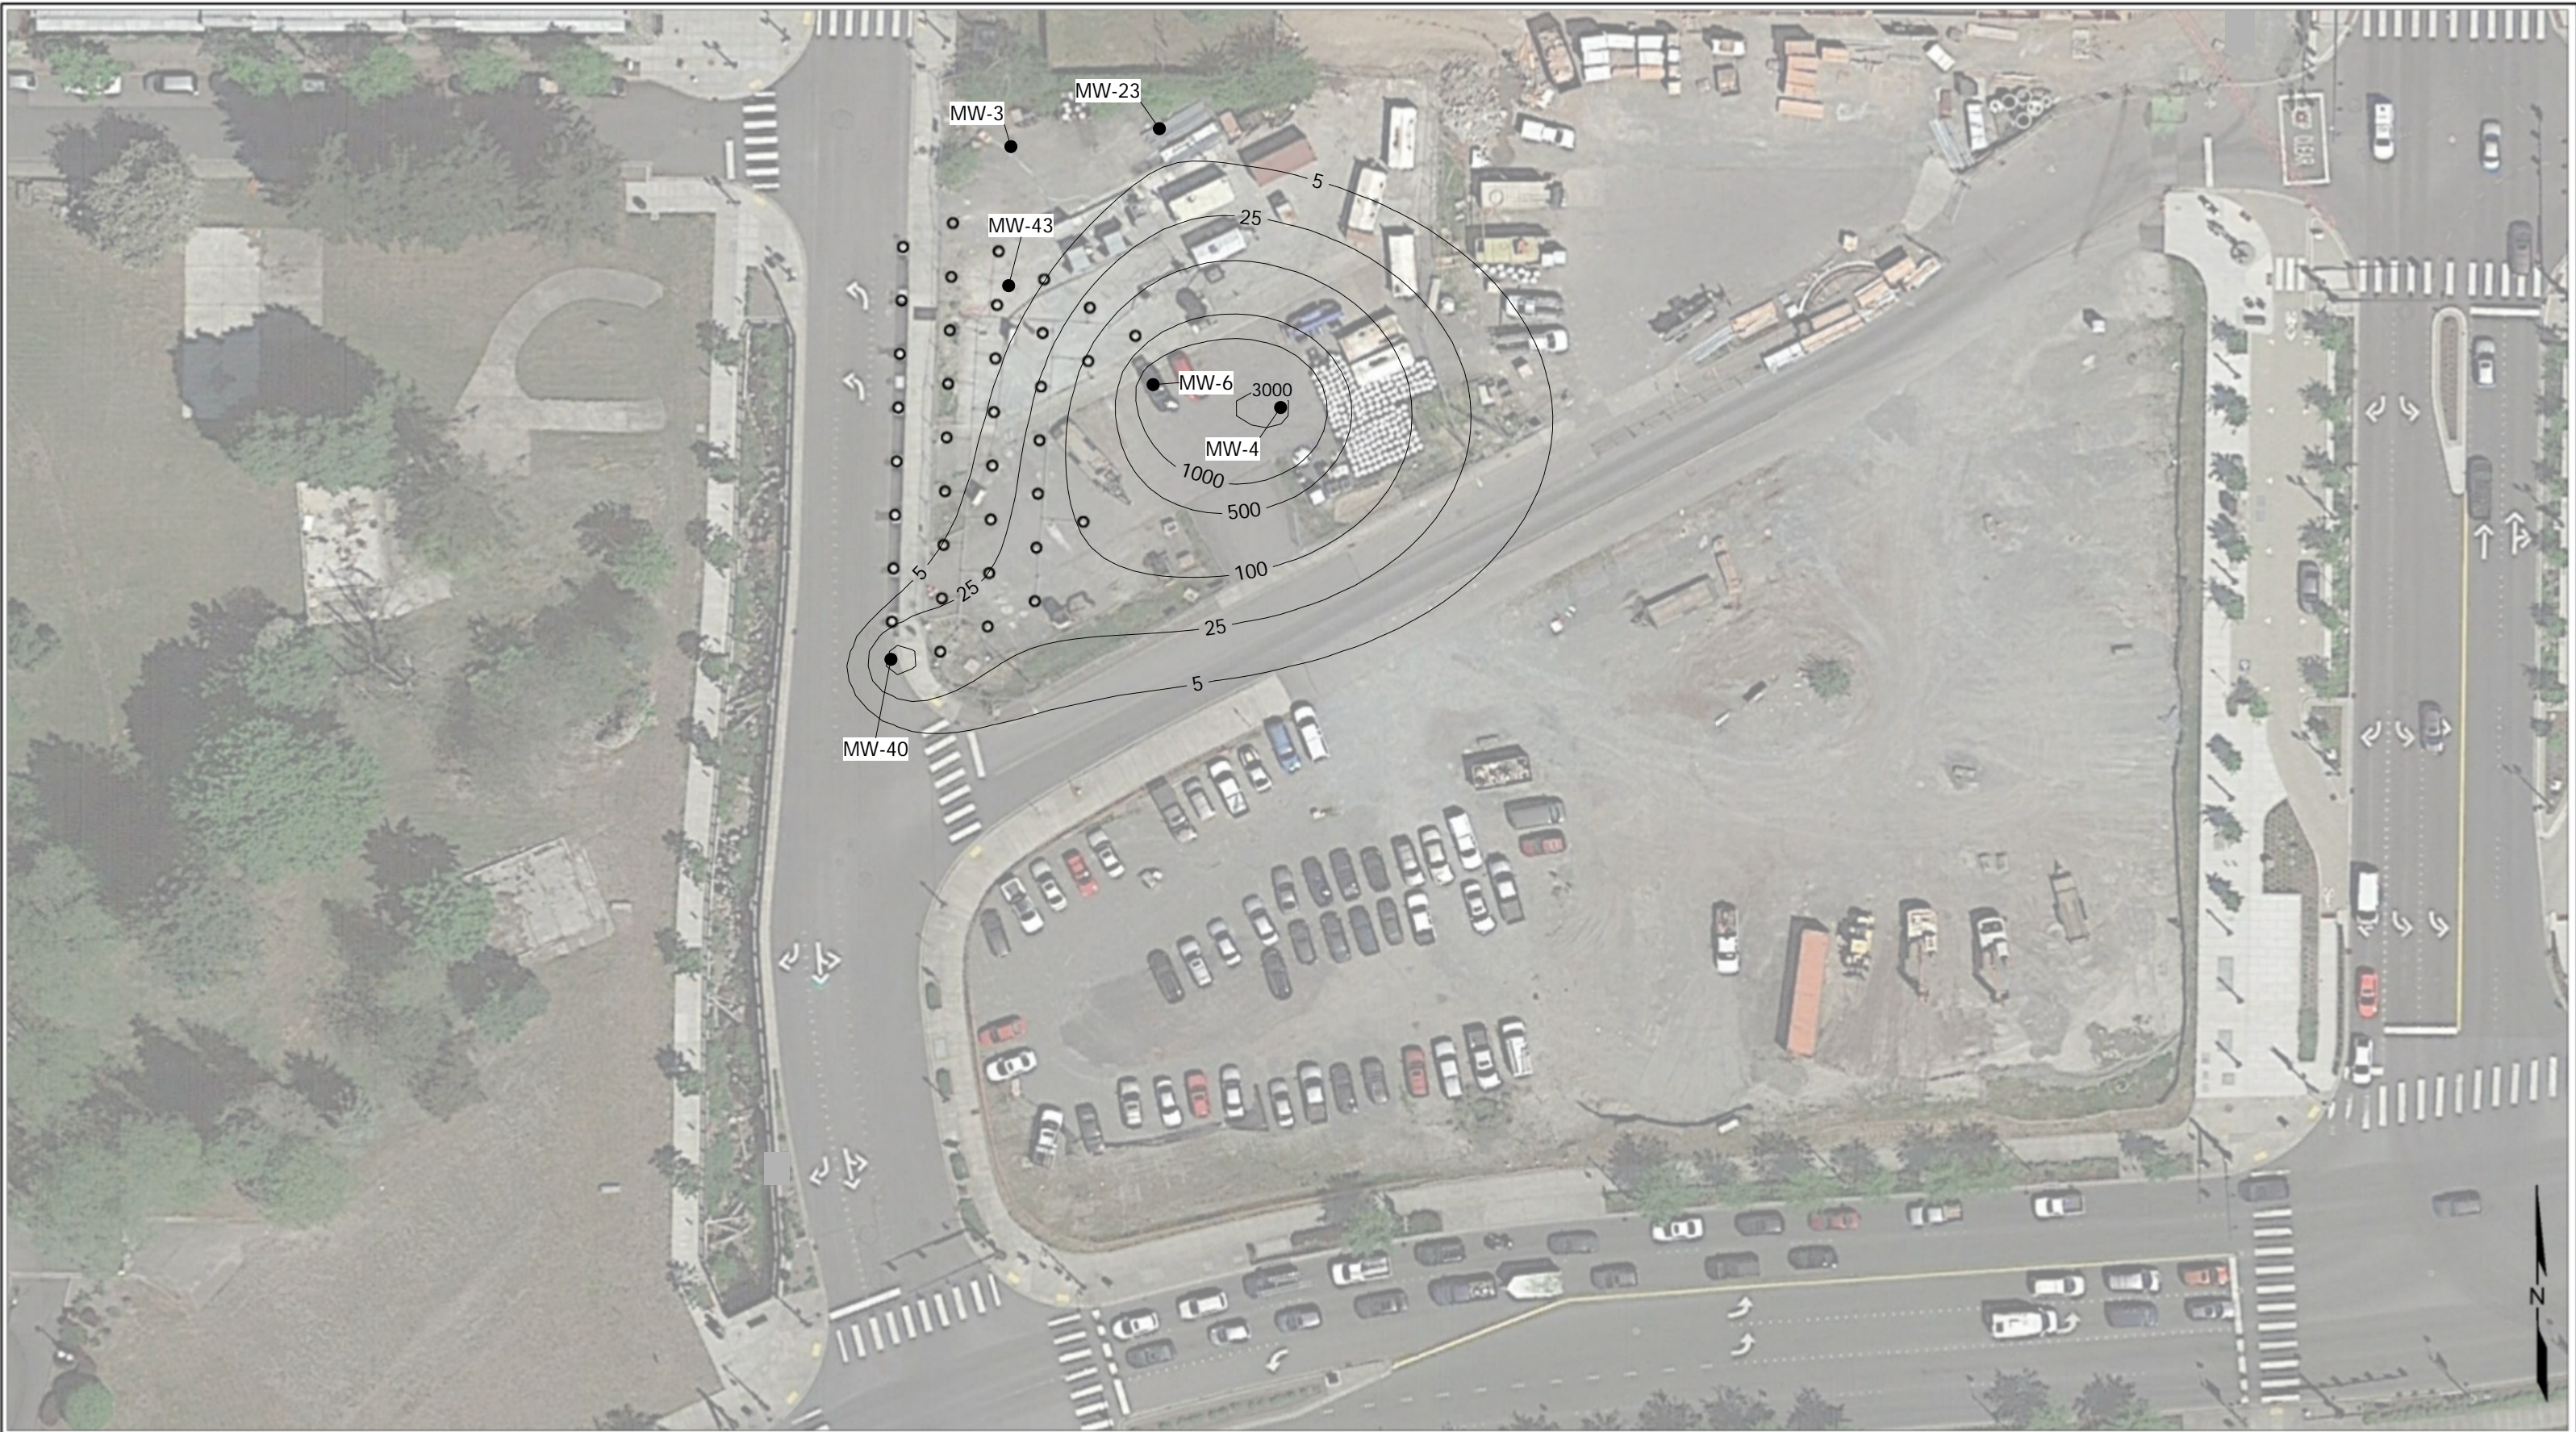
Figure
Groundwater Concentration Isopleths
in Shallow Wells
PCE - February 2019

HVOCs, including PCE, TCE, (cis) 1,2,-DCE, and vinyl chloride, were analyzed in all groundwater samples collected at the Site. See Table 1 for the shallow groundwater analytical results. In the shallow aquifer (approximately 0 to 25 feet bgs) PCE was detected at concentrations exceeding the MTCA Method A Cleanup Level of 5.0 µg/L at fourteen of the twenty-eight shallow wells sampled in 2019. During the performance monitoring events in July 2019 and October 2019, PCE was detected at concentrations above the MTCA Method A cleanup level at MW-4, MW-6, MW-27, MW-40, HZ-MW-1, HZ-MW-14S, HZ-MW-15S, S-MW-1, S-MW-2, and S-MW-5. MW-4 has consistently reported the highest concentrations of PCE detected during each sampling event, with concentrations ranging between 5,500 µg/L in May 2019 to 1,900 µg/L in October 2019.

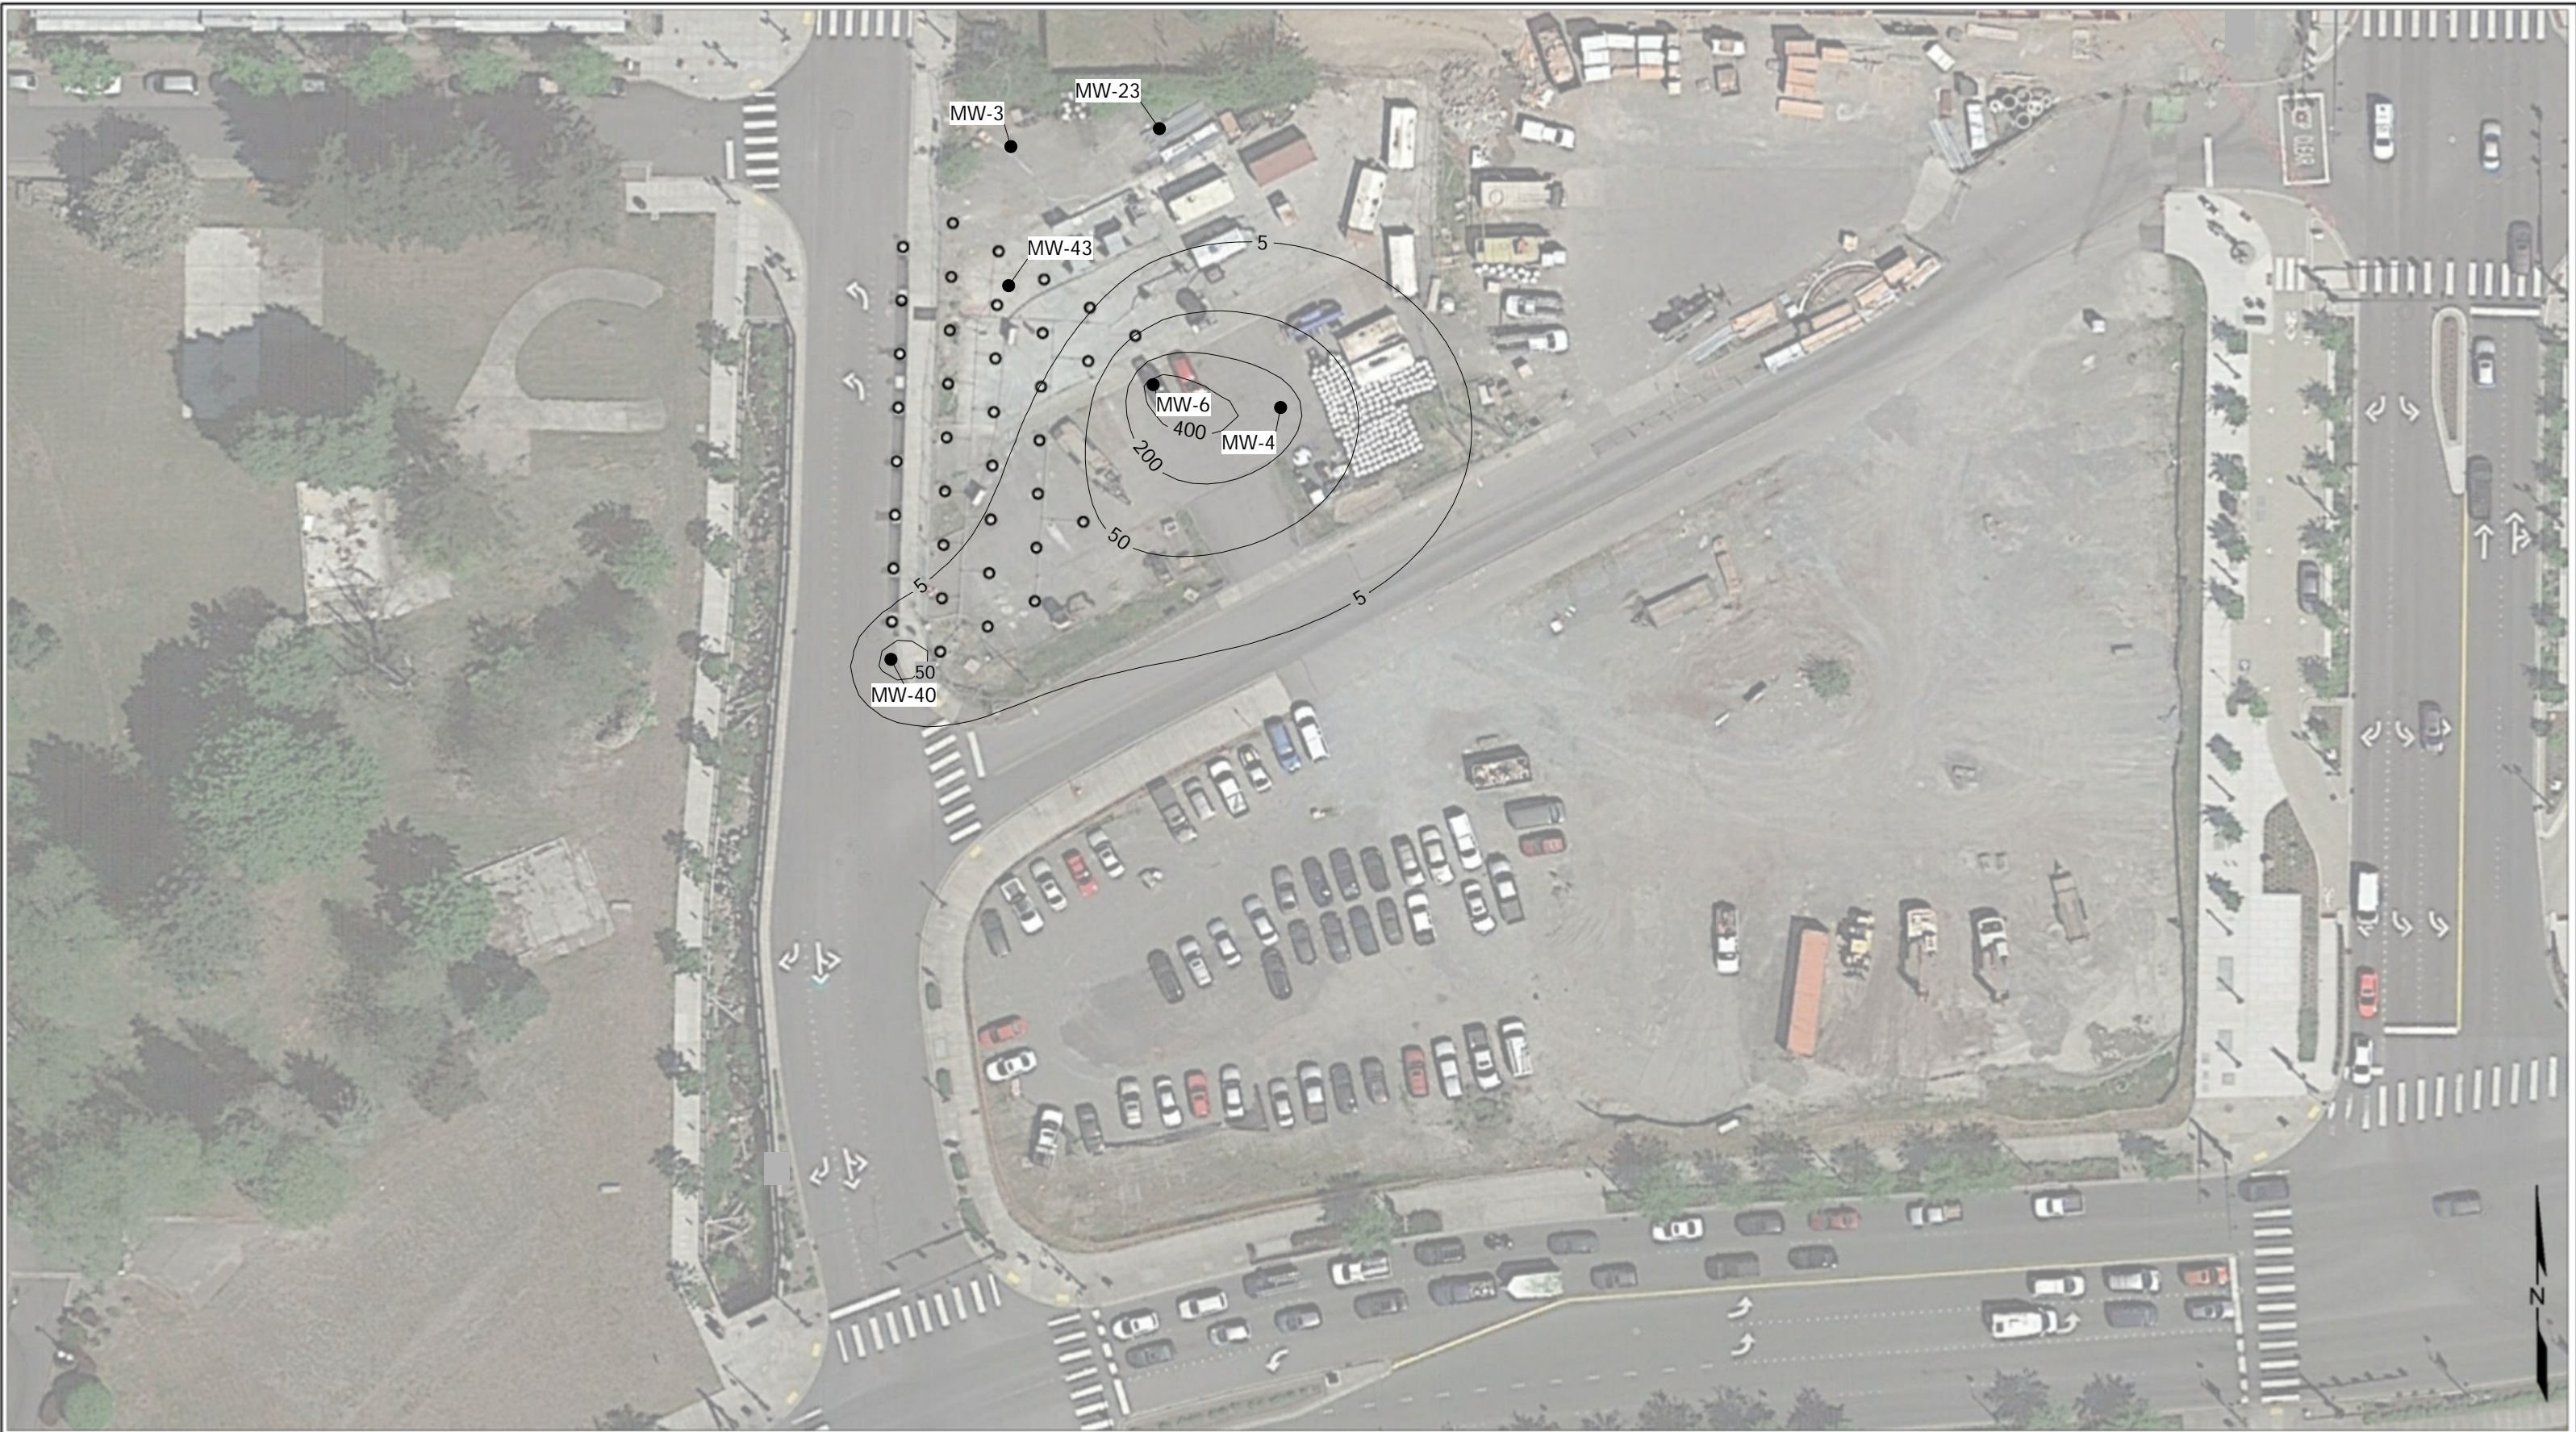
Figure
Groundwater Concentration Isopleths
in Shallow Wells
TCE - February 2019

TCE was detected at concentrations greater than the MTCA Method A Cleanup Level (5.0 µg/L) at seven of the twenty-eight shallow wells sampled in 2019. During the performance monitoring events in July 2019 and October 2019, TCE was detected at concentrations above the MTCA Method A Cleanup Level at MW-4, MW-6, MW-40, and HZ-MW-14S. MW-6 contained the highest concentration of TCE detected (1,100 µg/L) during the July 2019 sampling event and MW-4 reported the highest concentration (1,900 µg/L) during the October 2019 sampling event.

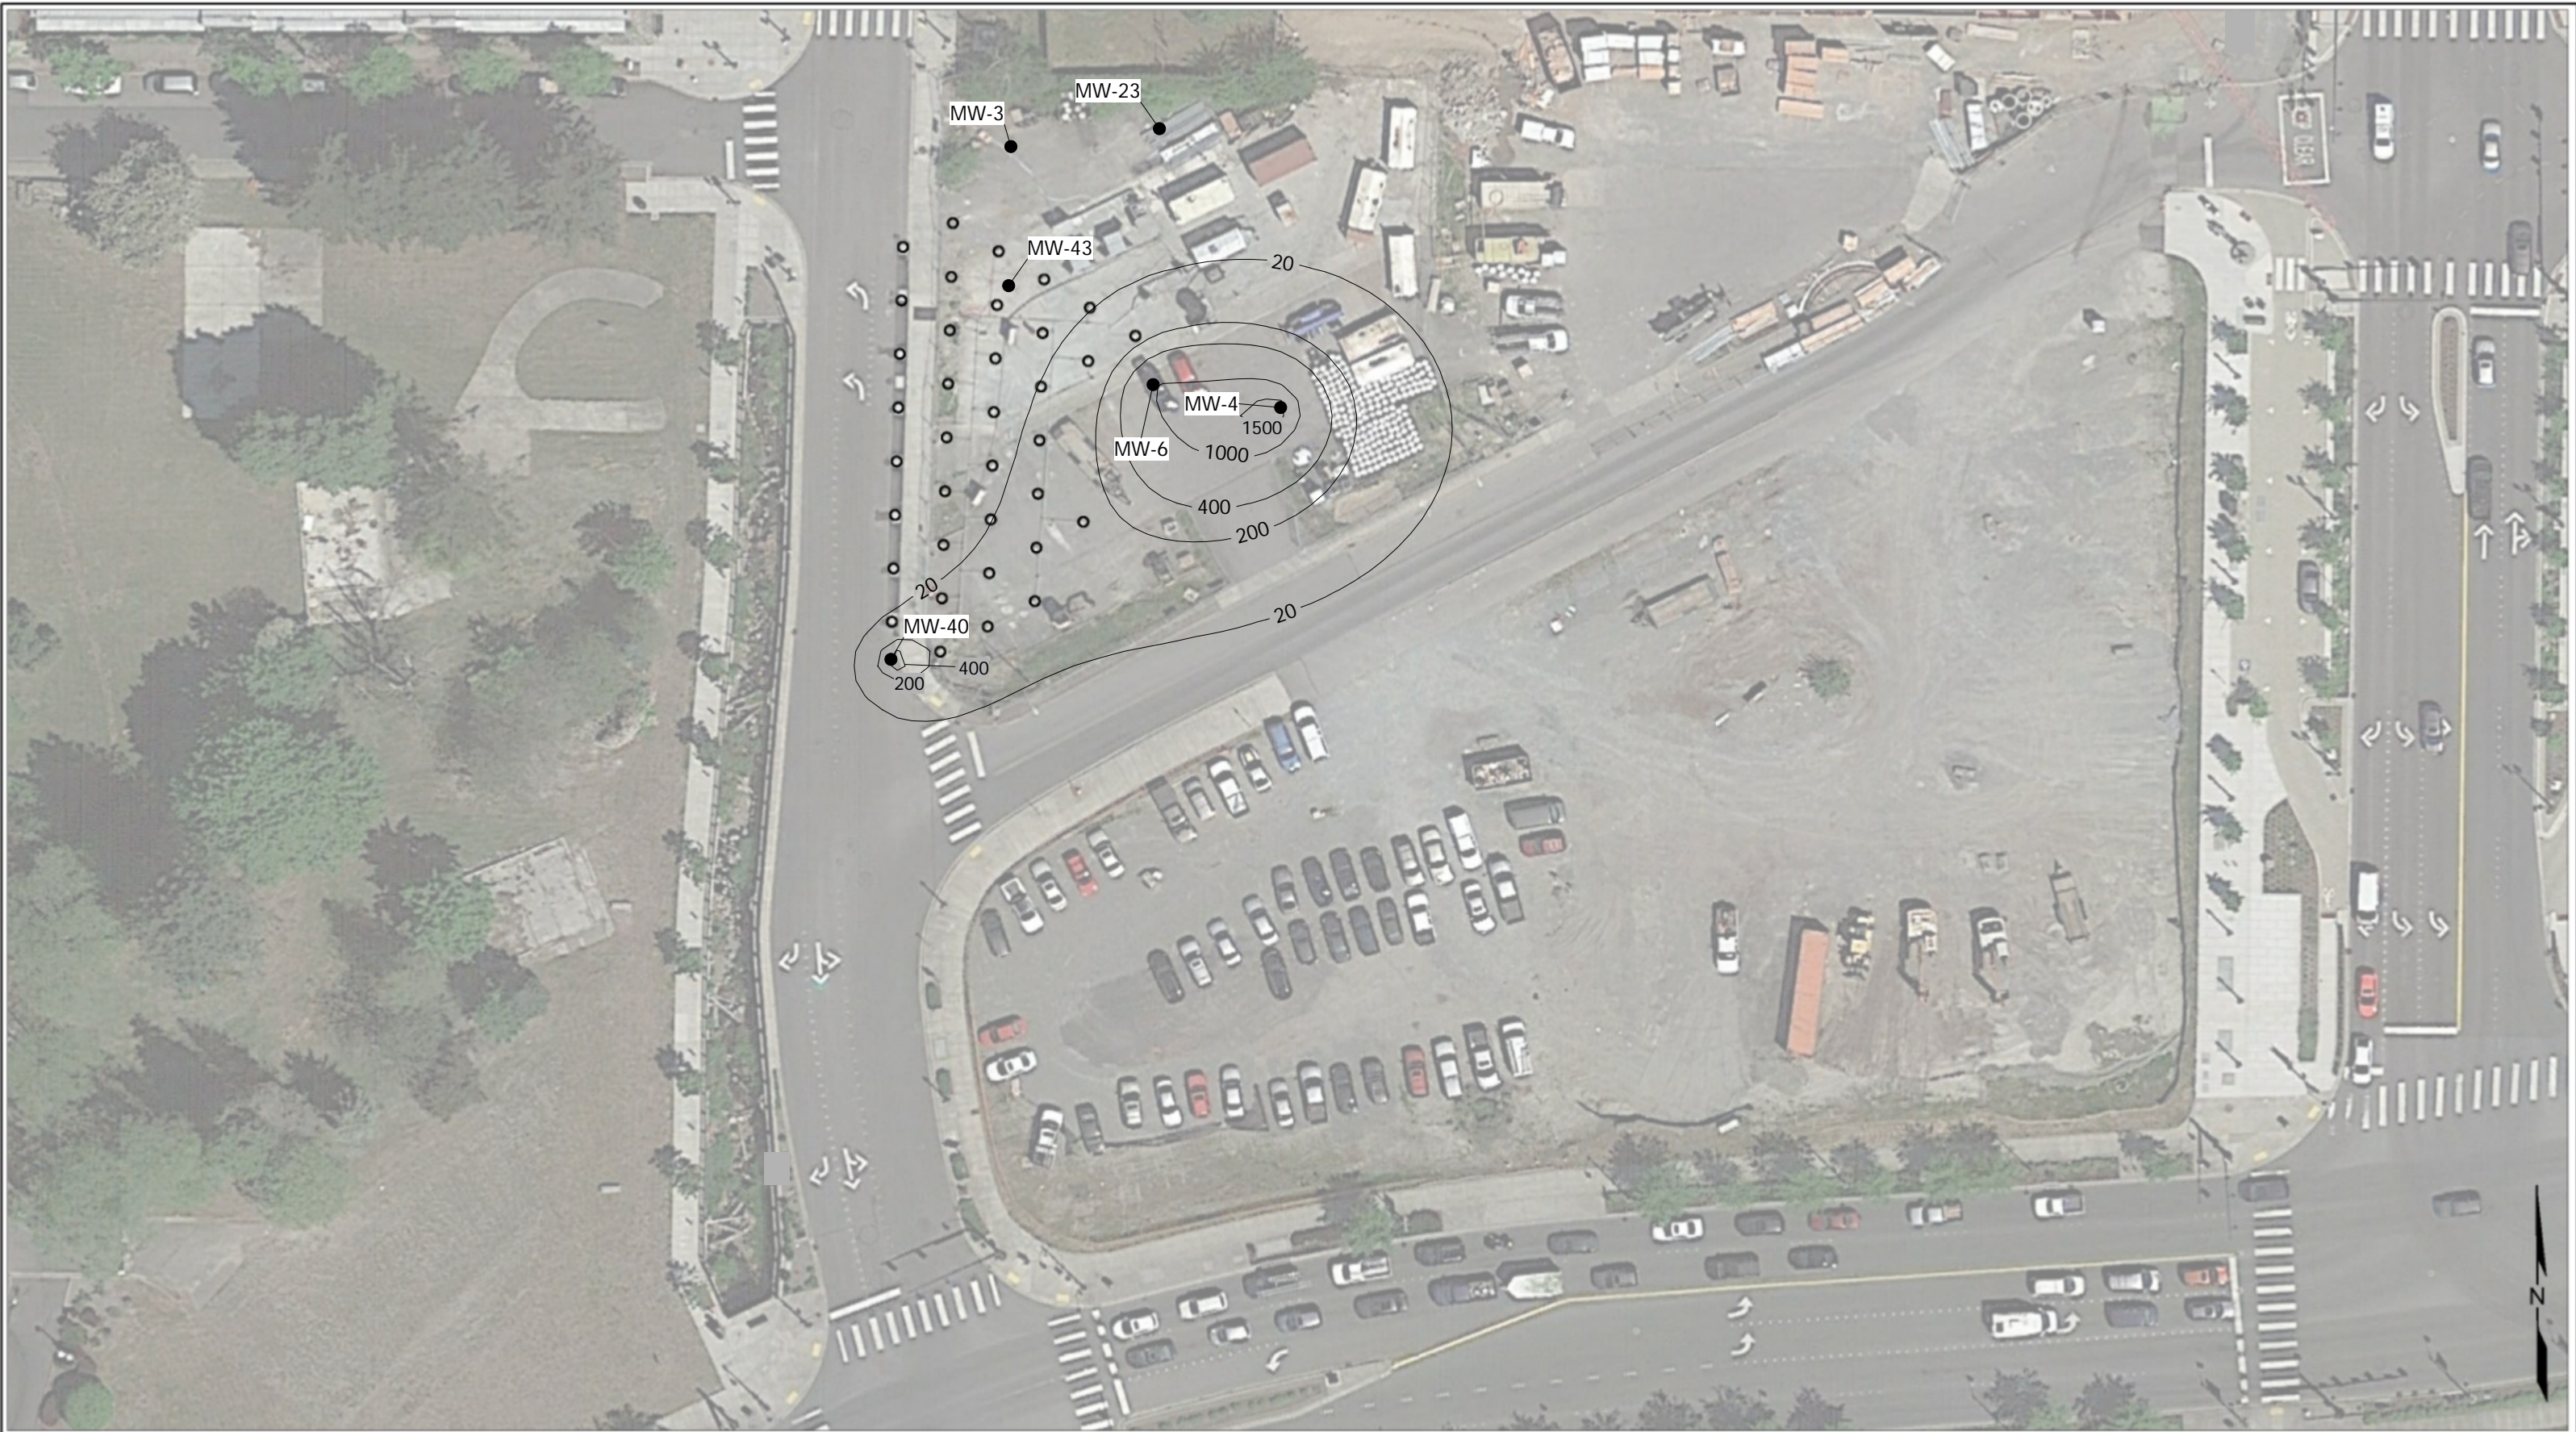
Figure
Groundwater Concentration Isopleths
in Shallow Wells
cis-1,2-DCE - February 2019

(cis) 1,2-DCE was detected at concentrations greater than the MTCA Method B Cleanup Level (16 µg/L) at seven of the twenty-eight shallow wells sampled in 2019. During the performance monitoring events in July 2019 and October 2019, (cis) 1,2-DCE was detected at concentrations above the MTCA Method B Cleanup Level at MW-4, MW-6, MW-40, and HZ-MW-34, and during the October 2019 sampling event, at MW-43. MW-40 contained the highest concentrations of (cis) 1,2-DCE during both the July 2019 and October 2019 sampling events, with concentrations of 4,700 µg/L and 1,500 µg/L, respectively.

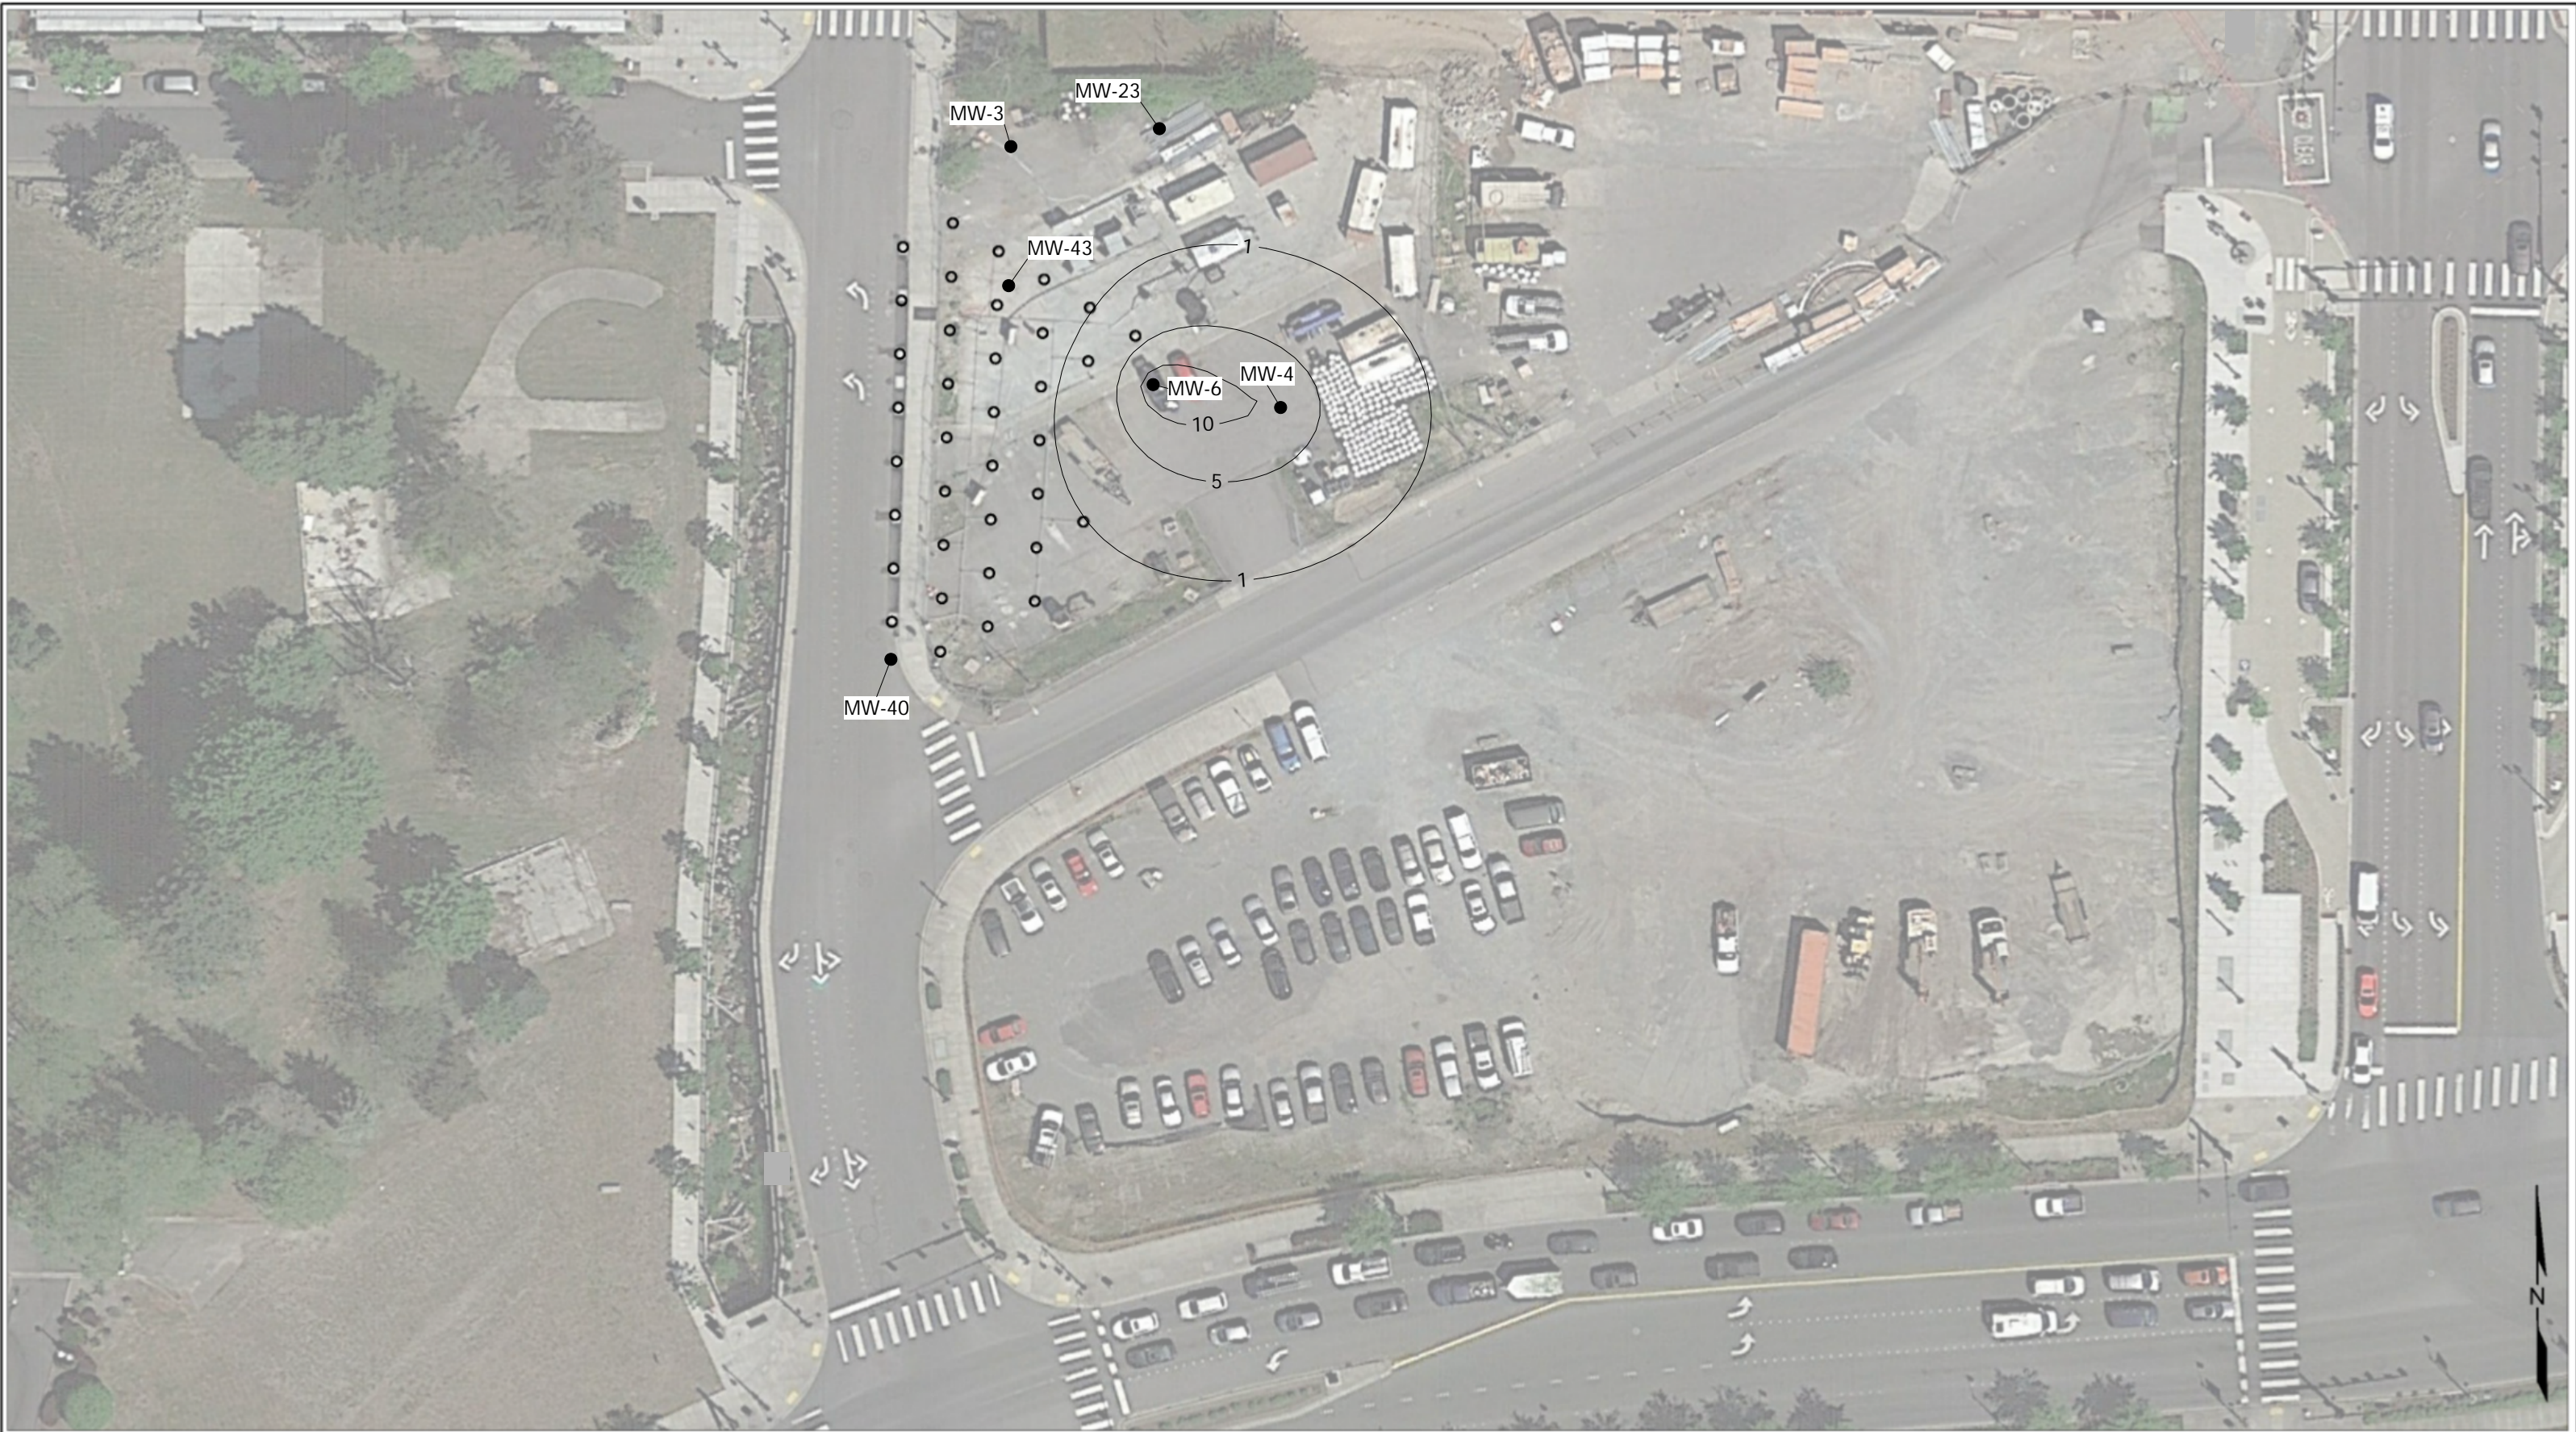
Figure
Groundwater Concentration Isopleths
in Shallow Wells
Vinyl Chloride - February 2019

Vinyl chloride was detected at concentrations greater than the MTCA Method A Cleanup Level (0.2 µg/L) at six of the twenty-eight shallow wells sampled in 2019. During the performance monitoring events in July 2019 and October 2019, vinyl chloride was detected at concentrations above the MTCA Method A Cleanup Level at MW-4, MW-6, MW-40, and HZ-MW-34, and during the October 2019 sampling event, at MW-43. MW-40 contained the highest concentrations of vinyl chloride during the July 2019 sampling event (11 µg/L)

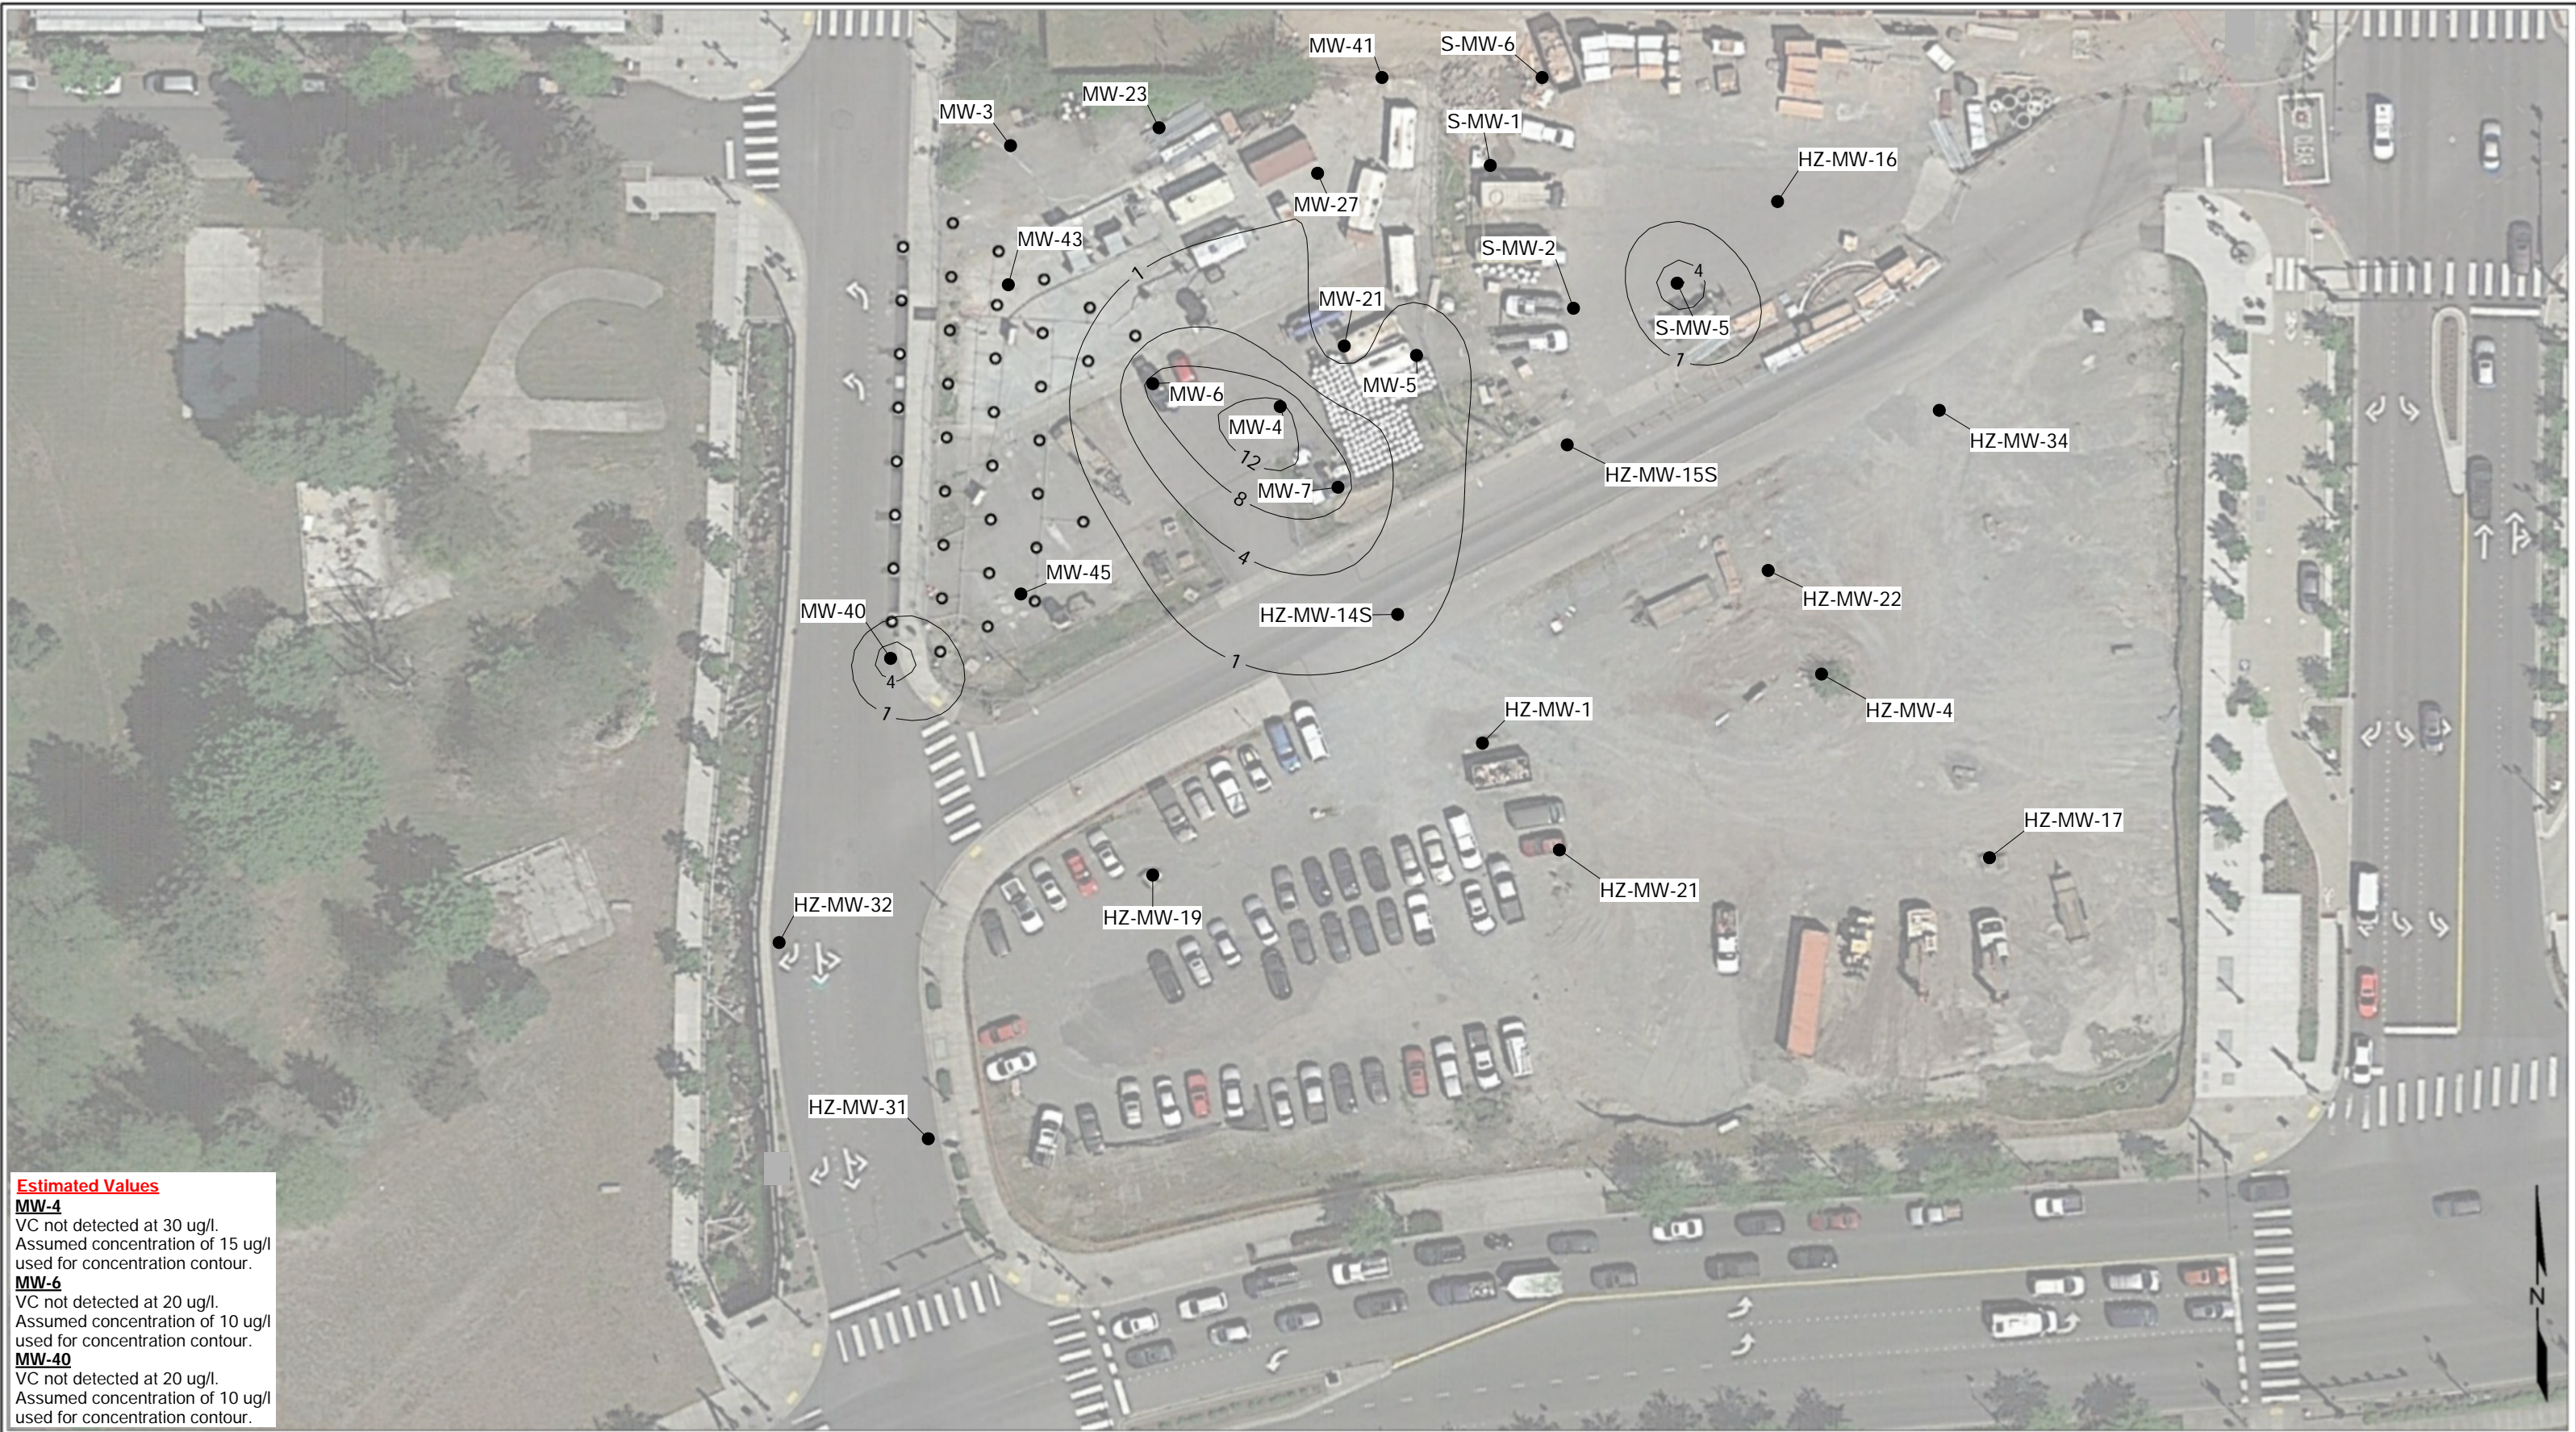
Figure
 Groundwater Concentration Isopleths
 in Shallow Wells
 Vinyl Chloride - Spring 2019

Estimated Values
MW-4
 VC not detected at 30 ug/l.
 Assumed concentration of 15 ug/l
 used for concentration contour.
MW-6
 VC not detected at 20 ug/l.
 Assumed concentration of 10 ug/l
 used for concentration contour.
MW-40
 VC not detected at 20 ug/l.
 Assumed concentration of 10 ug/l
 used for concentration contour.

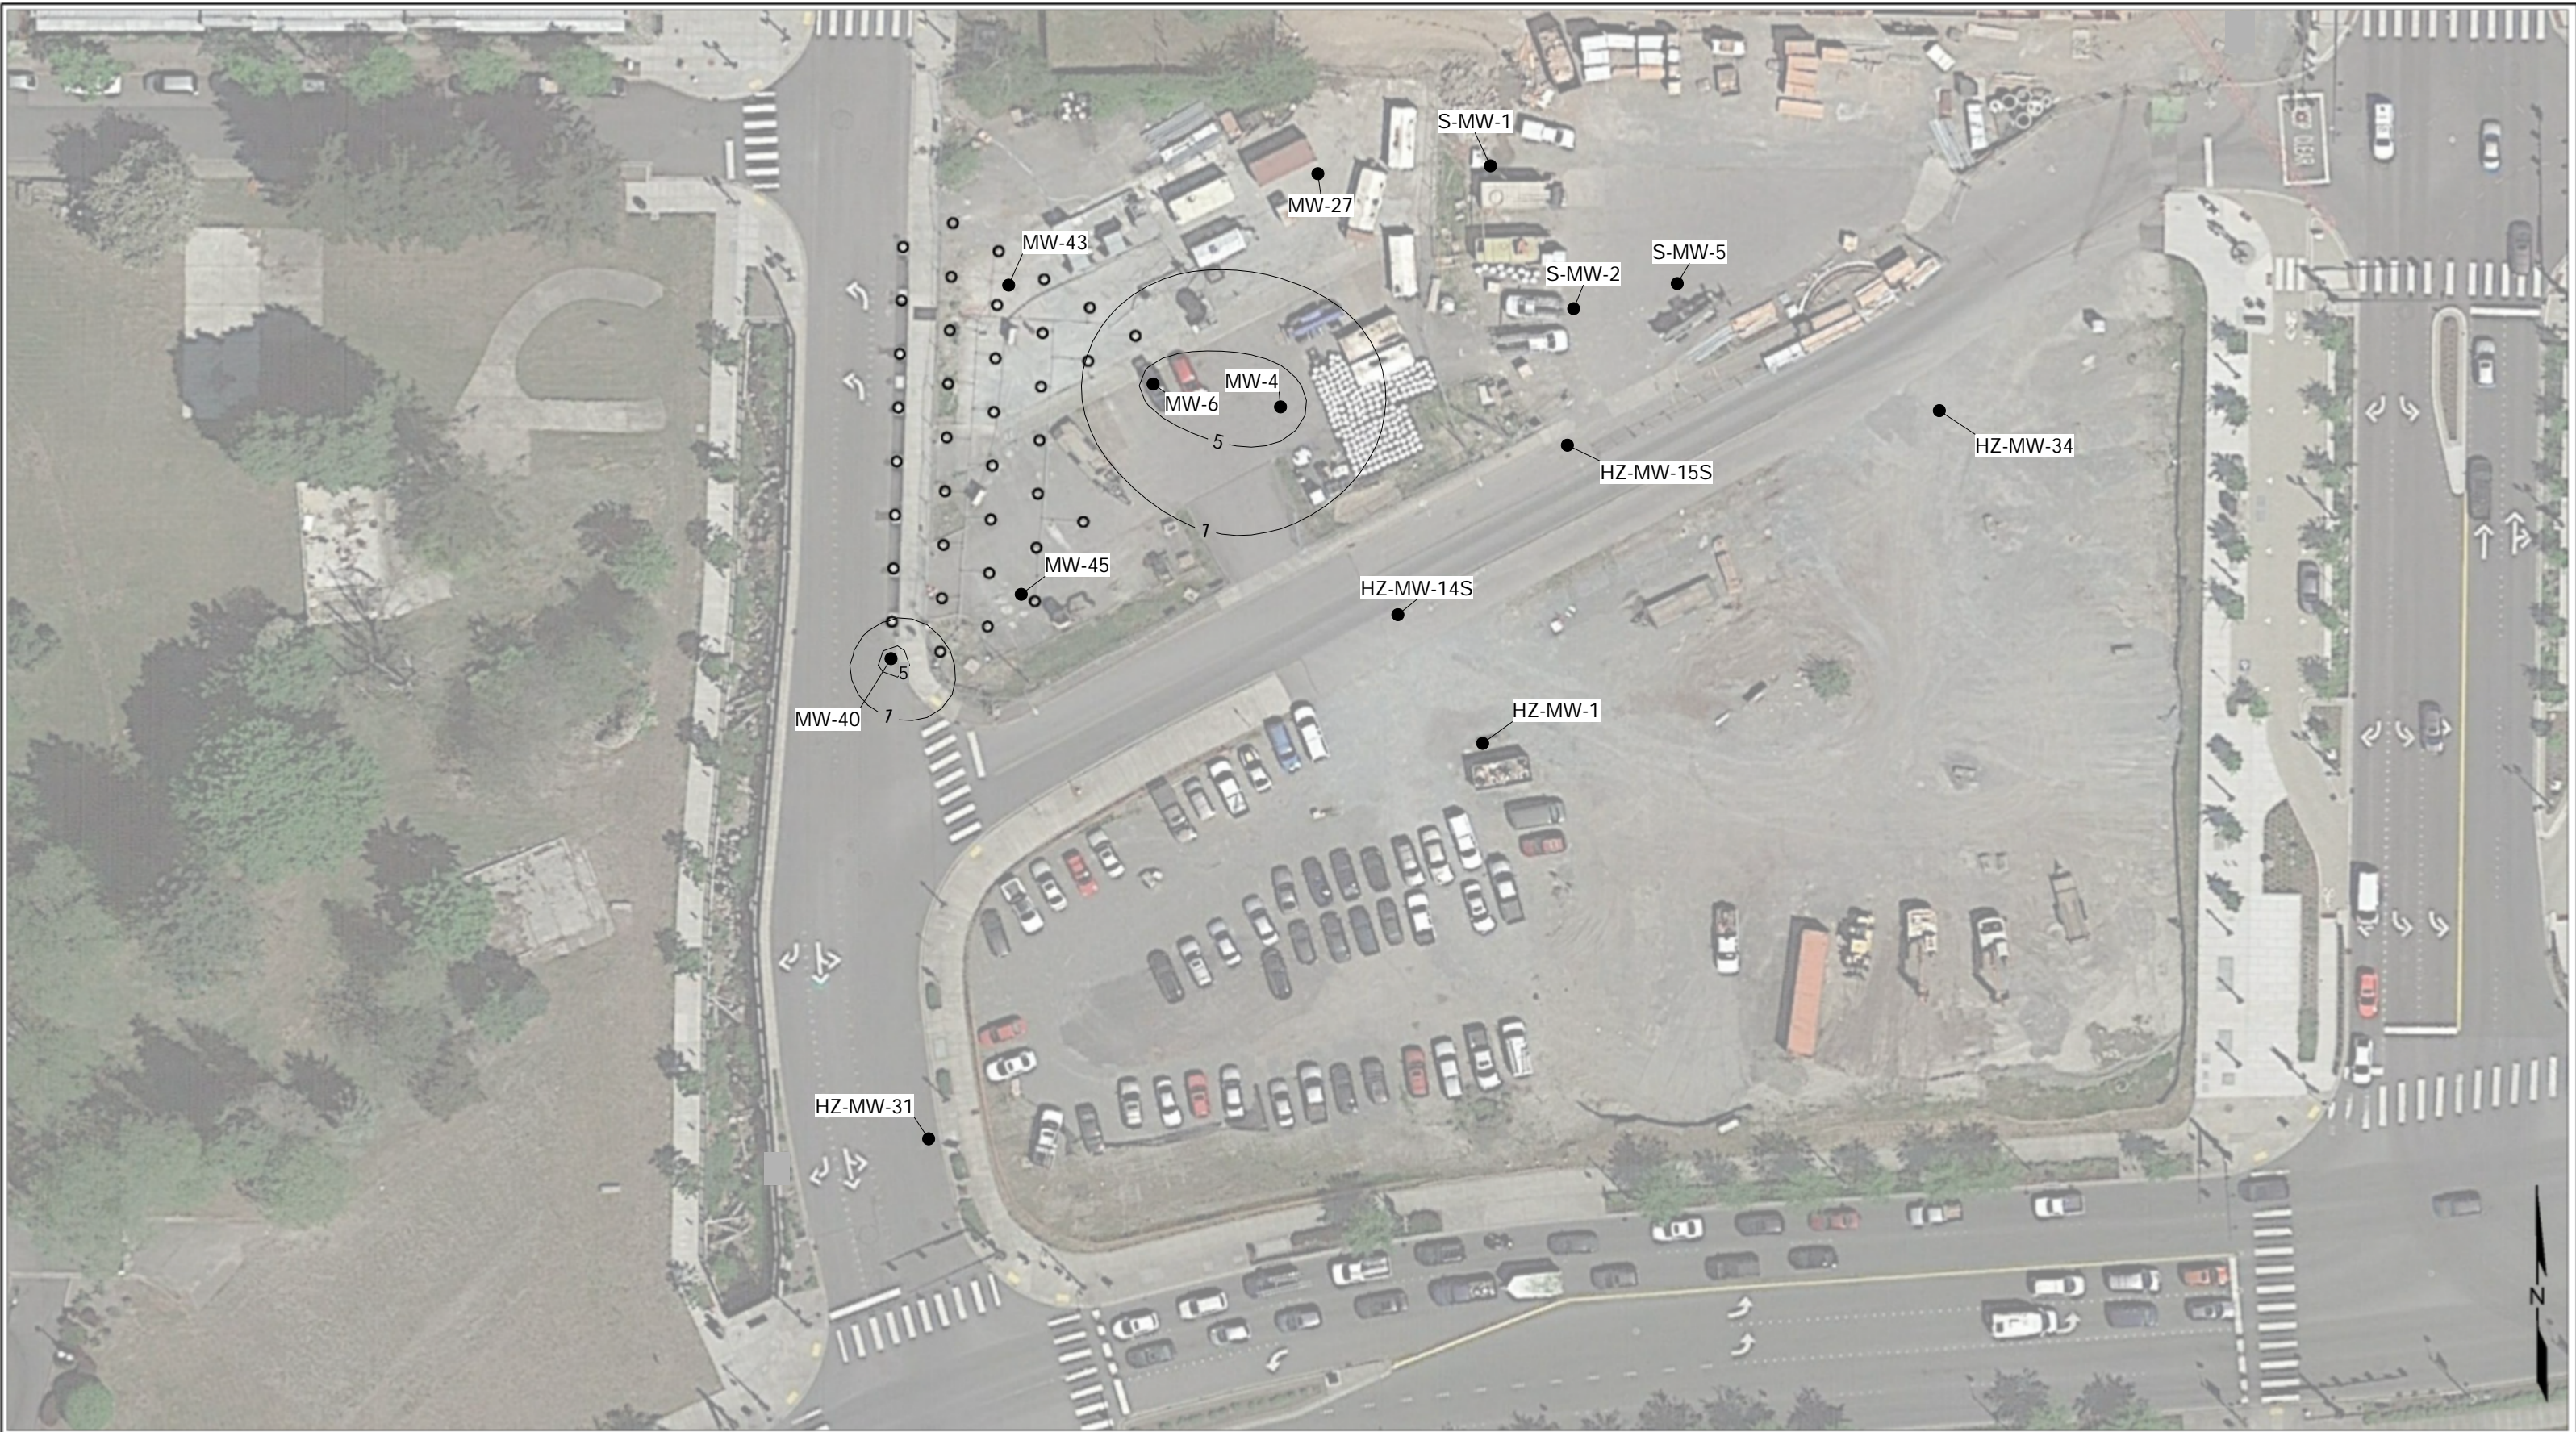
Figure
Groundwater Concentration Isopleths
in Shallow Wells
Vinyl Chloride - Summer 2019

and MW-4 contained the highest concentration during the October 2019 sampling event (7.5 µg/L). It should be noted that due to elevated concentrations of PCE, several samples were diluted so that the reporting limit for vinyl chloride was greater than the MTCA Method A Cleanup Level.
