Annual Groundwater Performance Monitoring Report

**Bothell Service Center Simon & Son
18107 Bothell Way NE
Bothell, Washington
FSID # 33215922**

July 14, 2020

Kane Environmental, Inc.
4015 13th Avenue West
Seattle, WA 98119

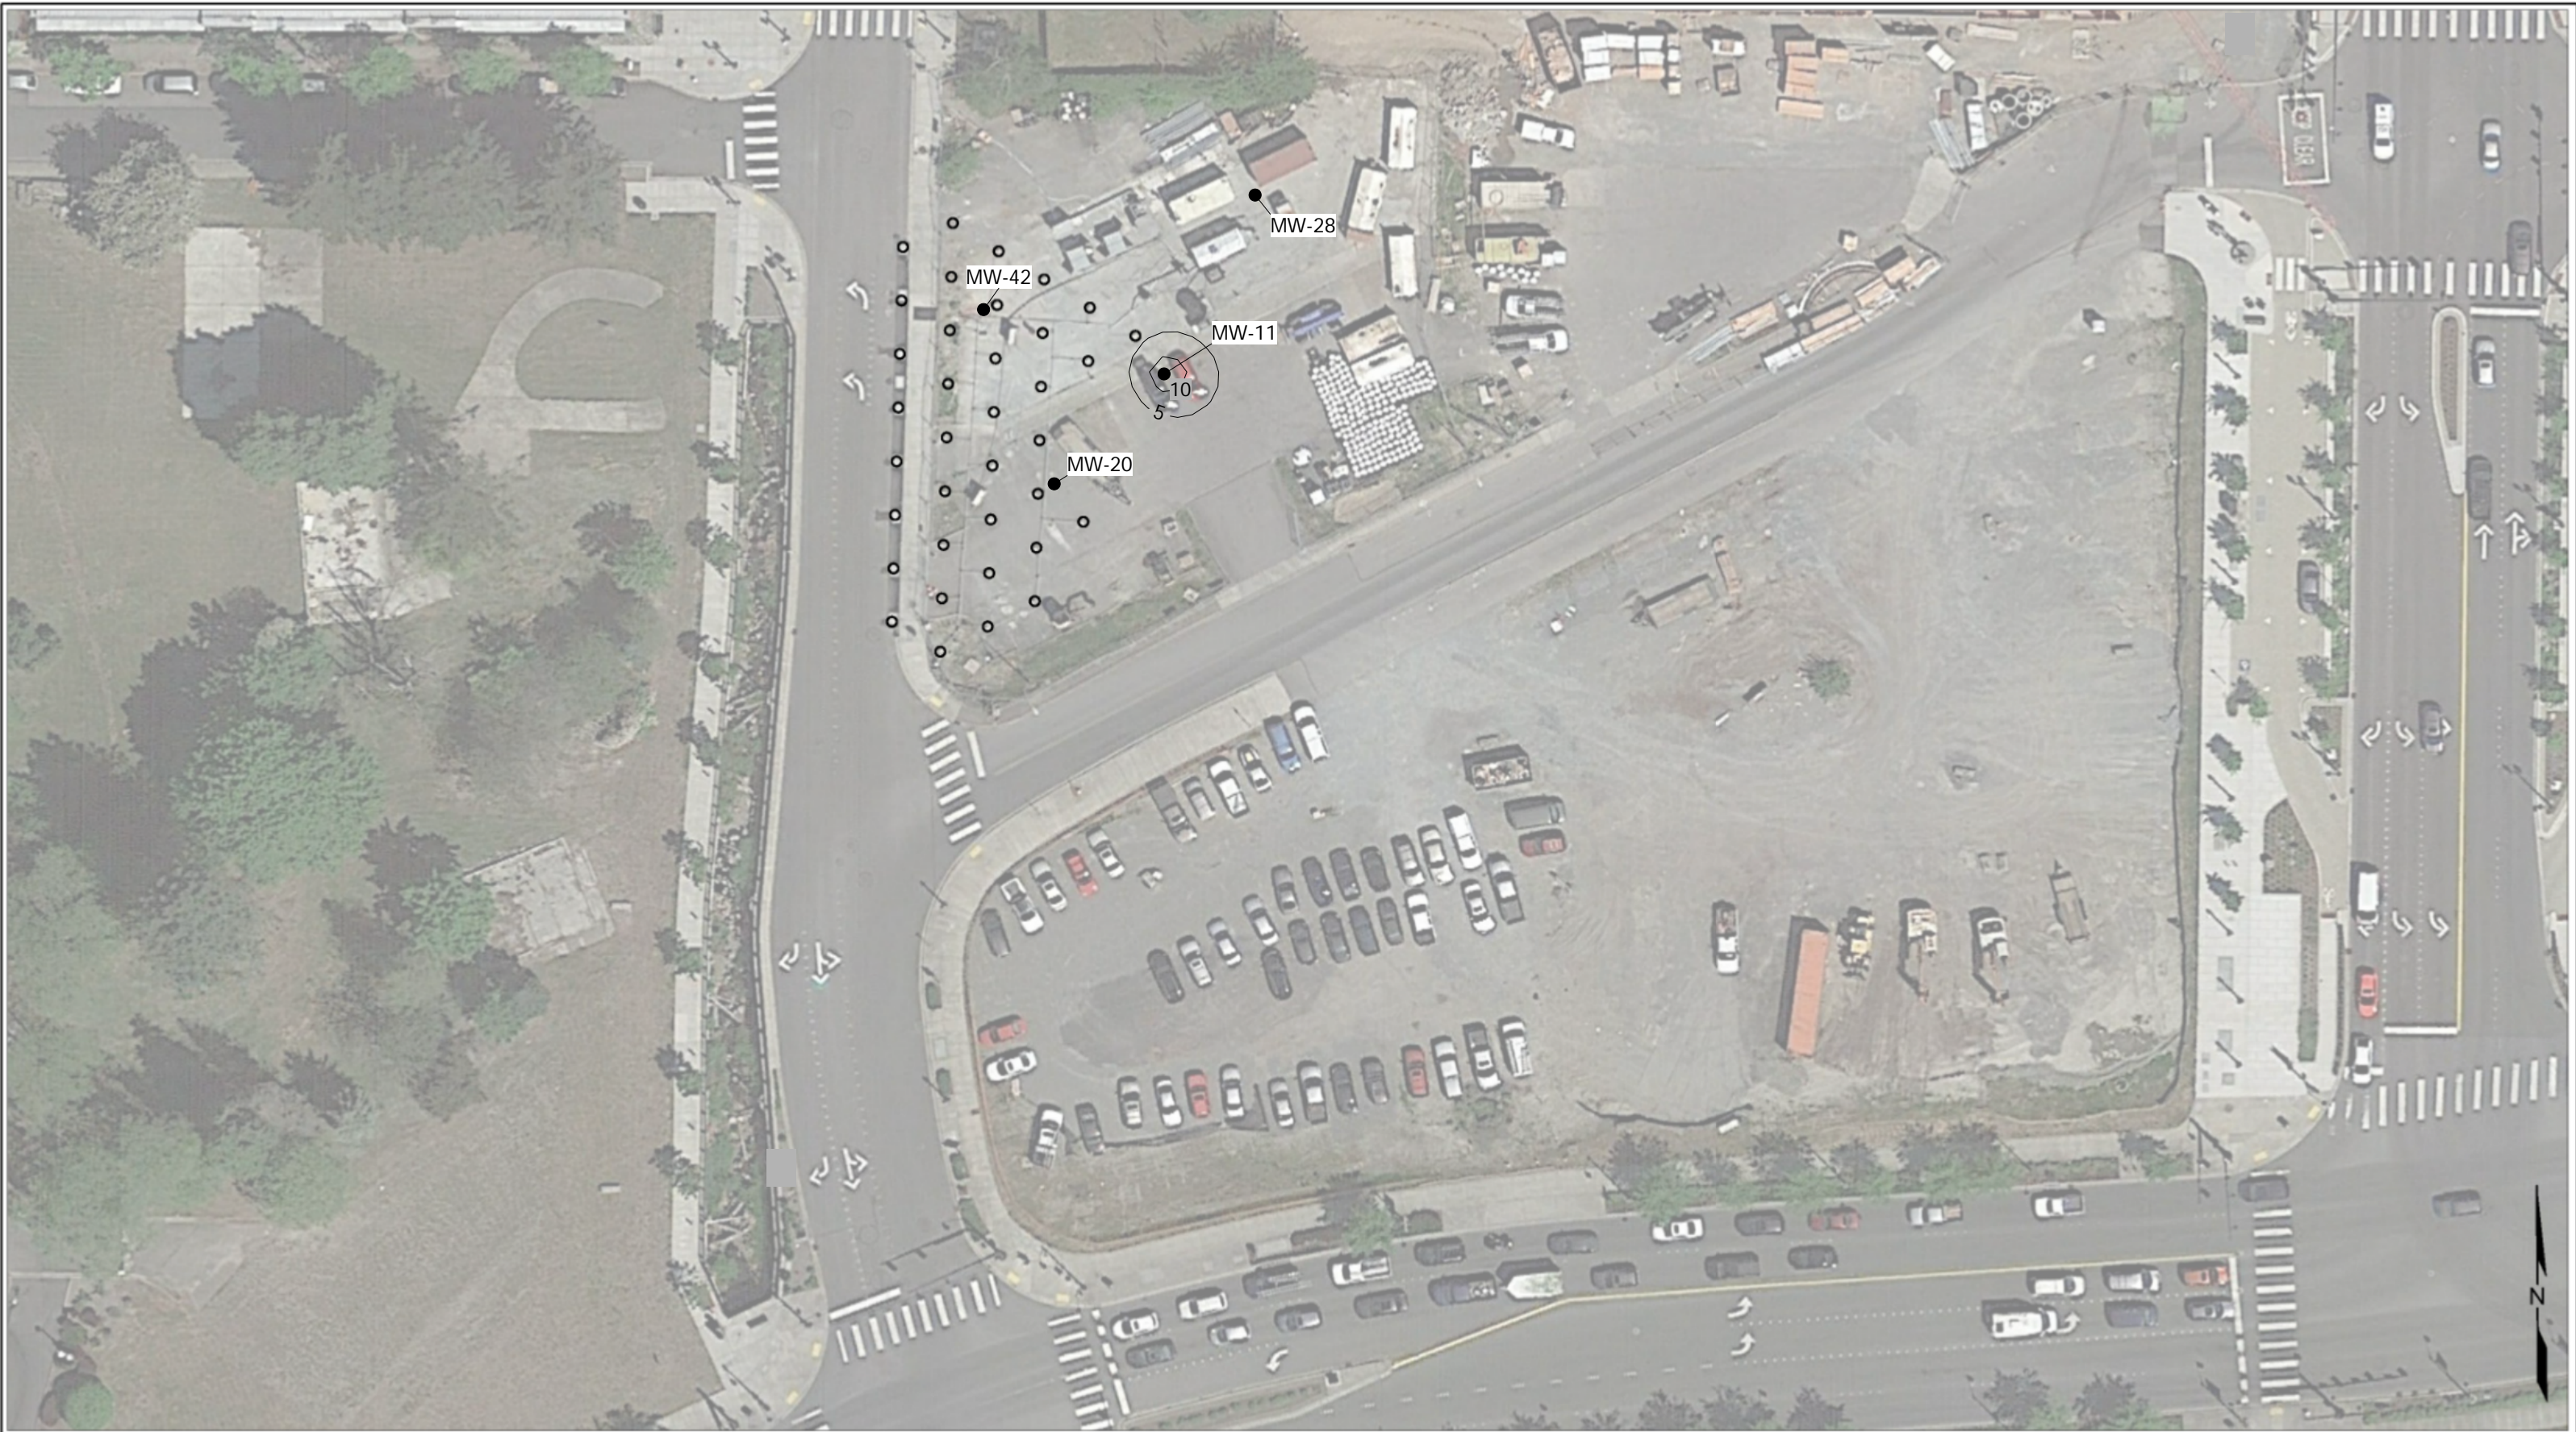
Figure
Groundwater Concentration Isopleths
in Intermediate Wells
PCE - February 2019

Analytical results for the groundwater samples collected from the intermediate wells is included in Table 2. In the intermediate aquifer (approximately 25 to 35 feet bgs) PCE was detected at concentrations exceeding the MTCA Method A Cleanup Level of 5.0 µg/L at five of the fifteen intermediate wells sampled in 2019. During the performance monitoring events in July 2019 and October 2019, PCE was detected at concentrations above the MTCA Method A cleanup level at MW-12, HZ-MW-14D, and HZ-MW-15D. MW-11 and HZ-MW-26 reported concentrations of PCE in exceedance of the MTCA Method A Cleanup Level during the July sampling event, but by the October sampling event, reported concentrations below the cleanup level. HZ-MW-15D has consistently reported the highest concentrations of PCE detected during each sampling event, with concentrations ranging between 10,000 µg/L in May 2019 to 7,700 µg/L in October 2019.

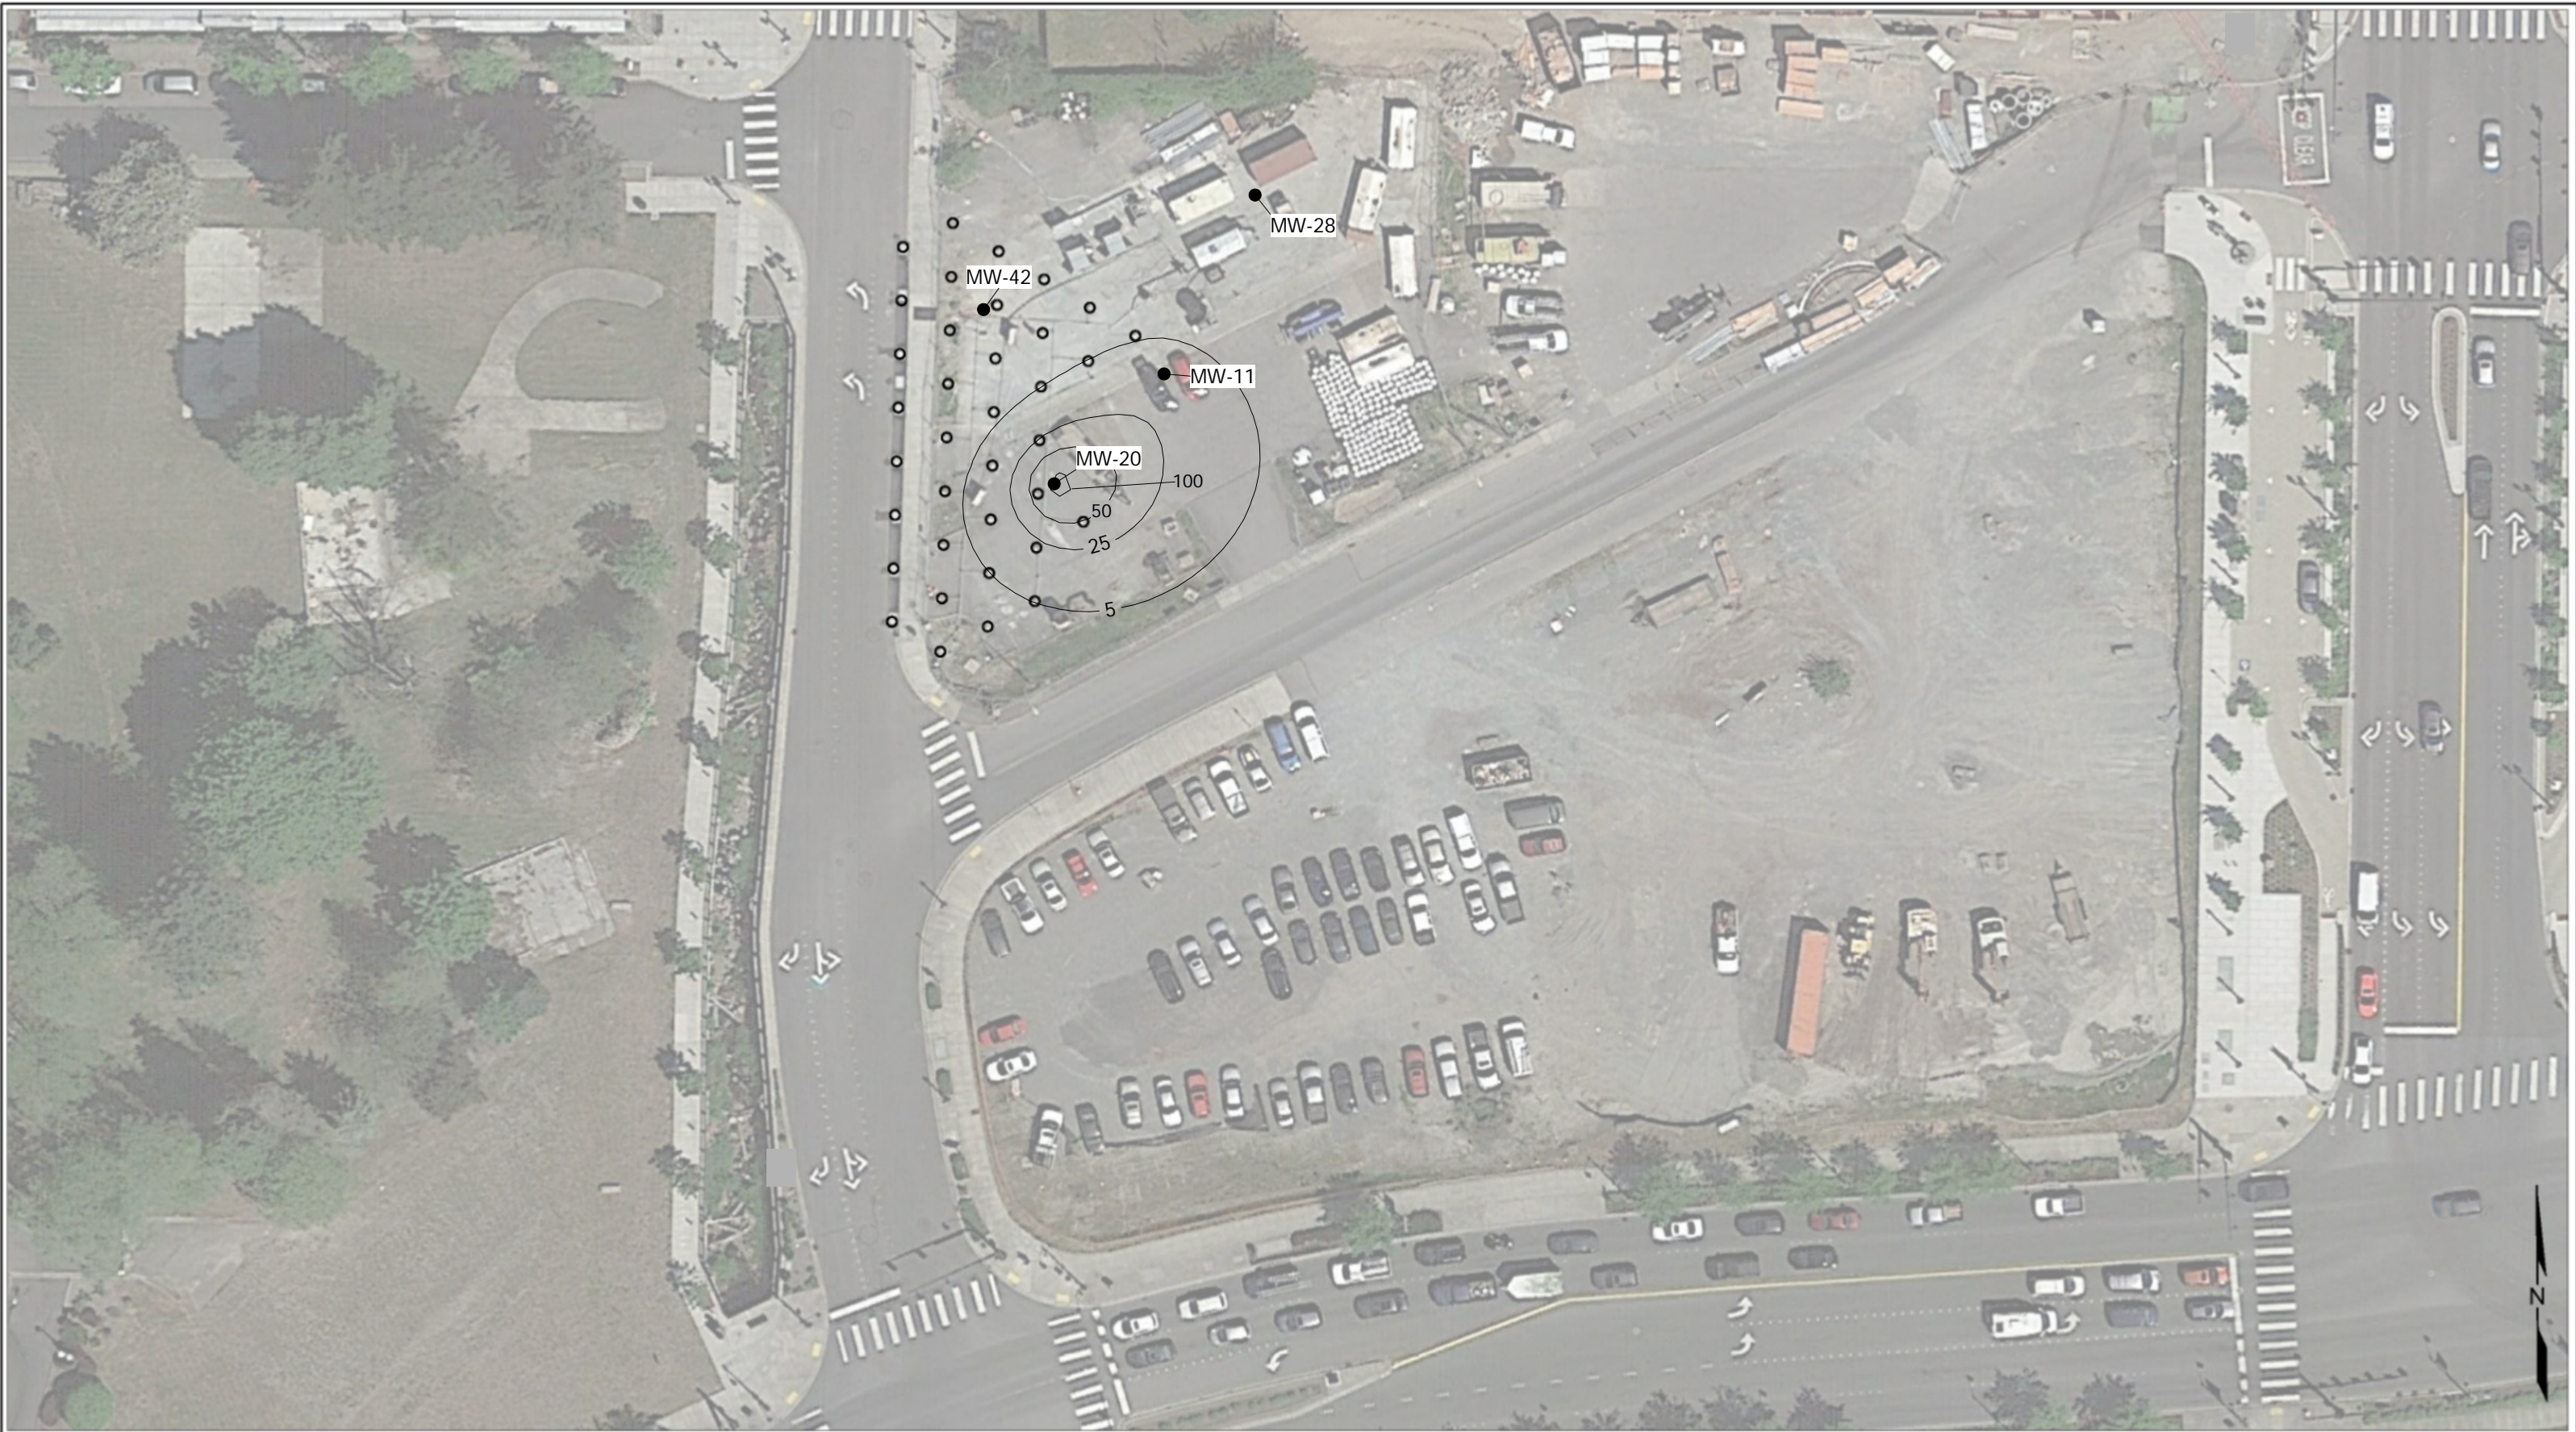
Figure
Groundwater Concentration Isopleths
in Intermediate Wells
TCE - February 2019

TCE was detected at concentrations greater than the MTCA Method A Cleanup Level (5.0 µg/L) at five of the fifteen intermediate wells sampled in 2019. During the performance monitoring events in July 2019 and October 2019, TCE was detected at concentrations above the MTCA Method A Cleanup Level at MW-12, MW-20, and HZ-MW-15D. MW-11 reported a concentration of TCE in exceedance of the cleanup level during the July sampling event, but the concentration was below the cleanup level during the October sampling event. Conversely, HZ-MW-14D reported a concentration of TCE below the cleanup level during the July sampling event, but above the cleanup level during the October sampling event. HZ-MW-15D contained the highest concentration of TCE detected during both the July and October 2019 sampling events, reporting concentrations of 390 µg/L and 410 µg/L, respectively.

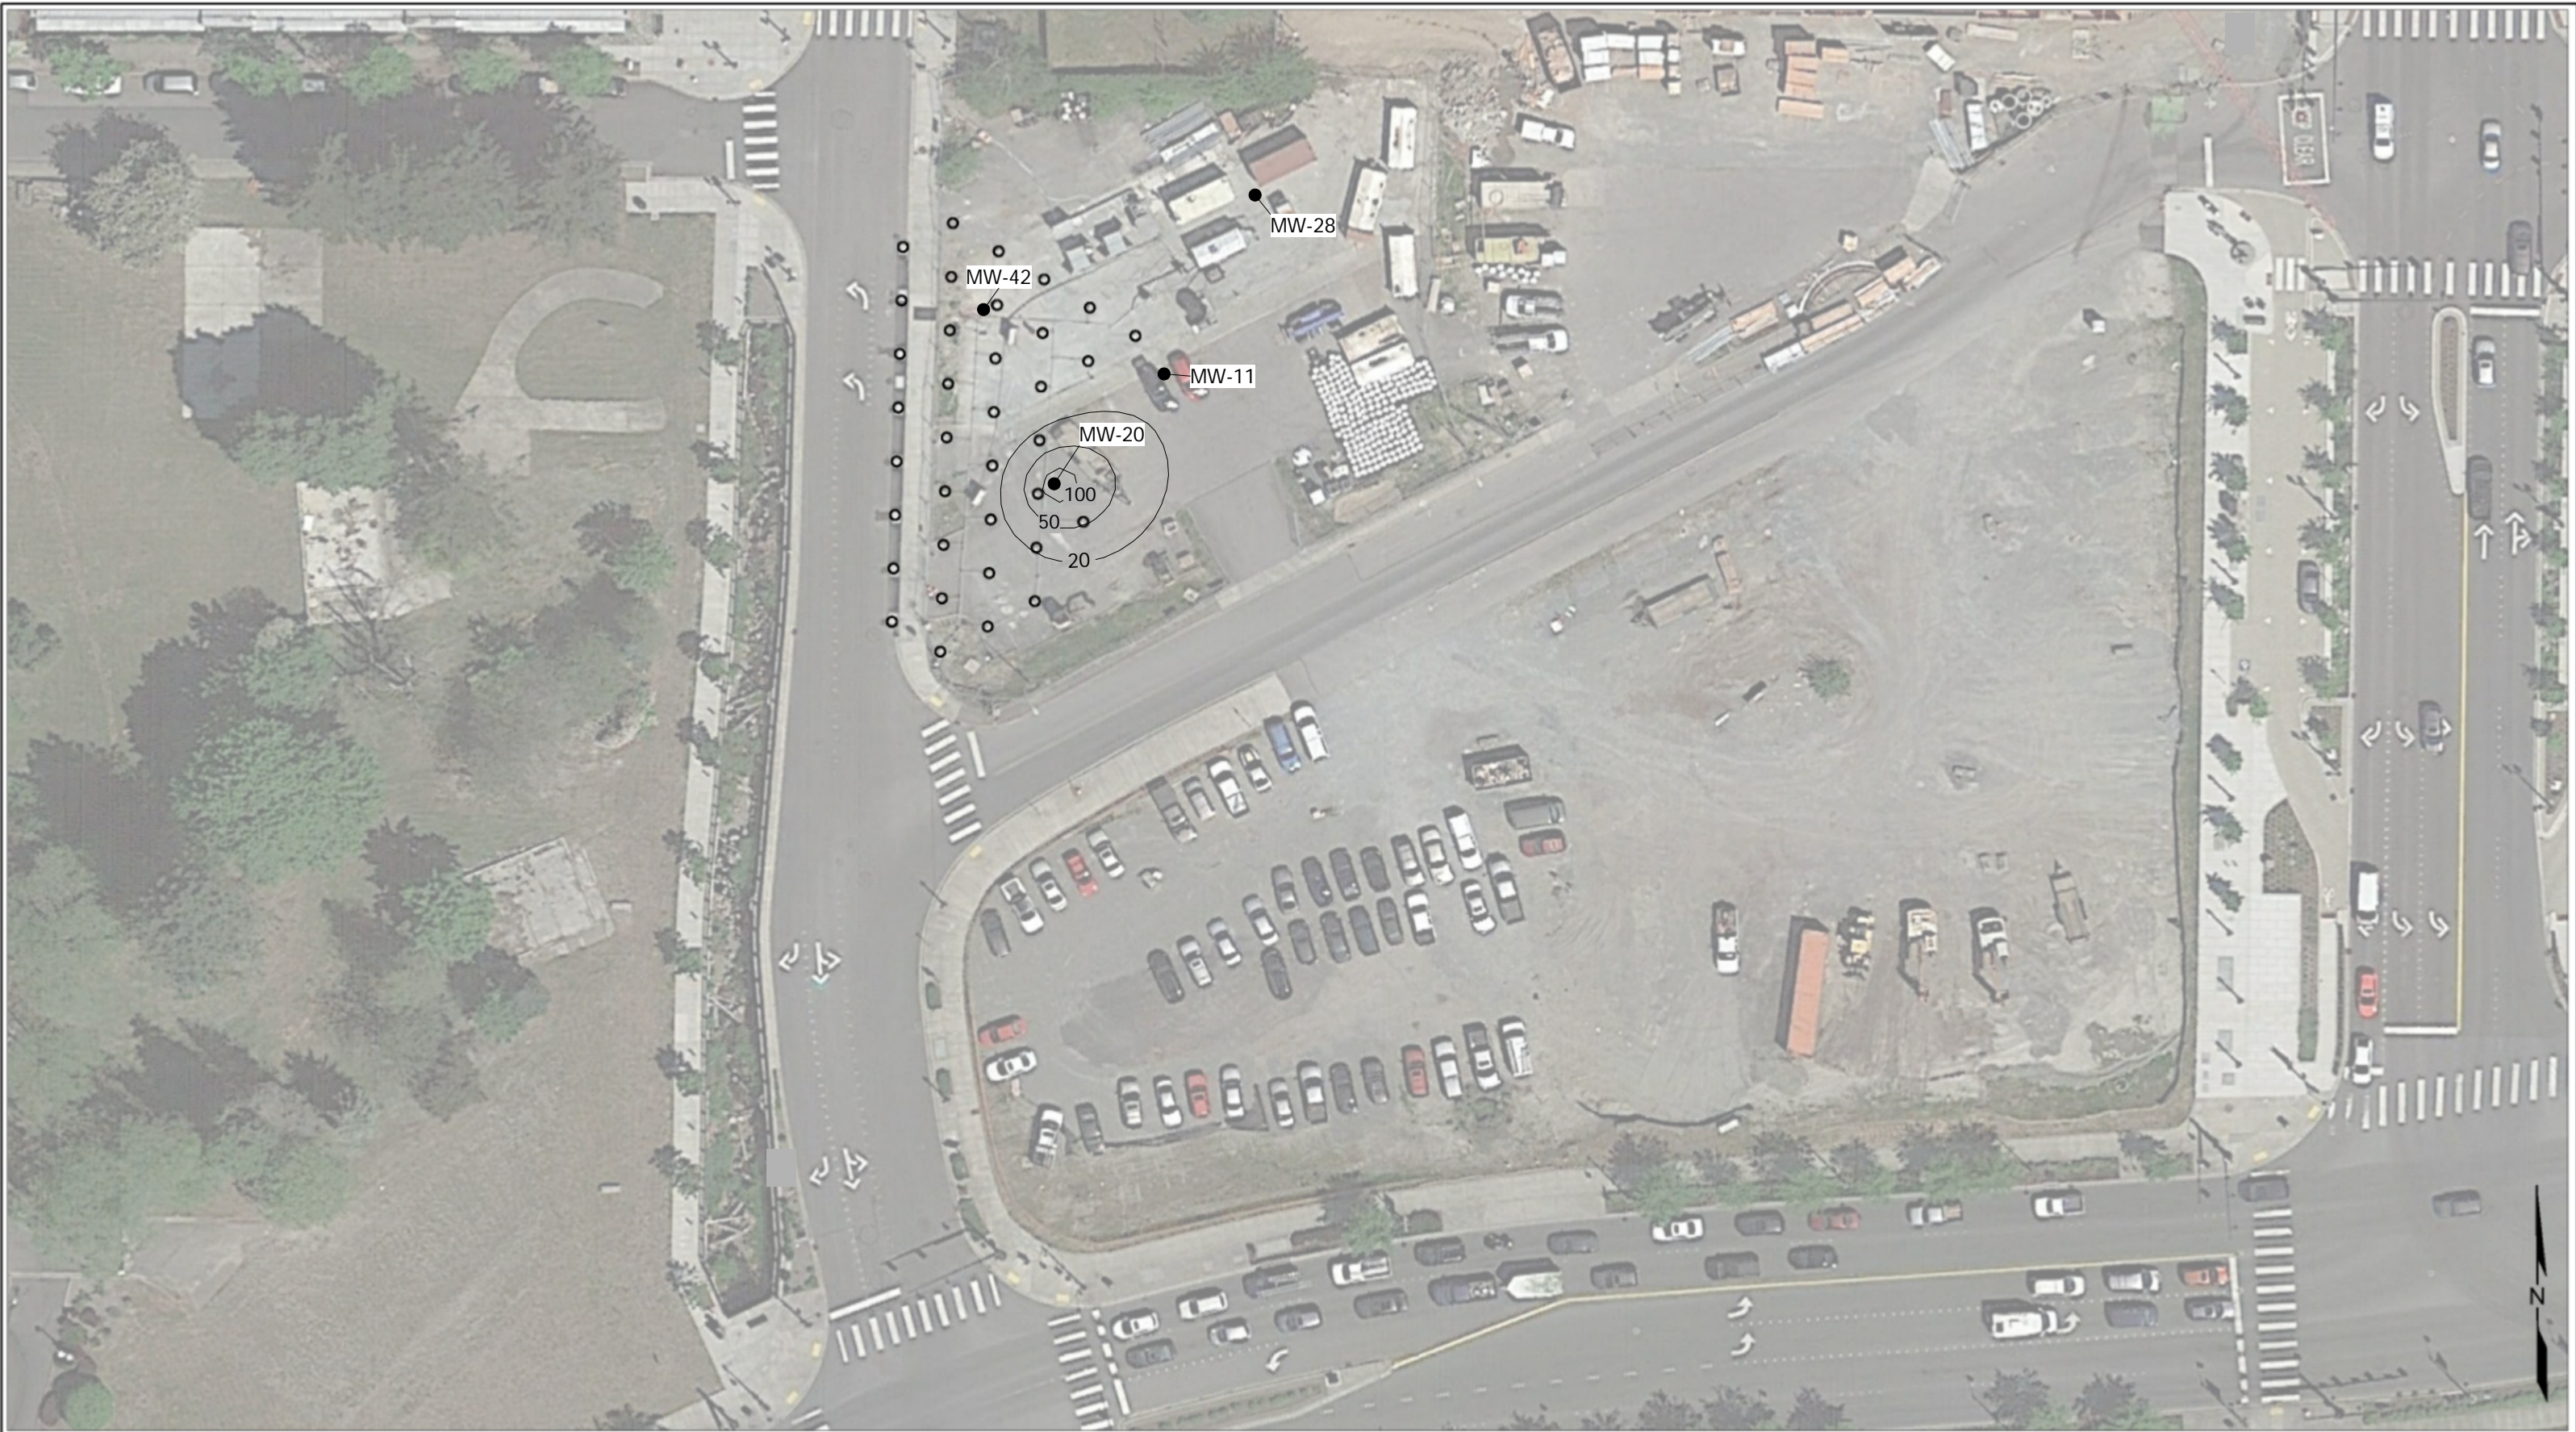
Figure
Groundwater Concentration Isopleths
in Intermediate Wells
cis-1,2-DCE - February 2019

(cis) 1,2-DCE was detected at concentrations greater than the MTCA Method B Cleanup Level (16 µg/L) at eight of the fifteen intermediate wells sampled in 2019. During the performance monitoring events in July 2019 and October 2019, (cis) 1,2-DCE was detected at concentrations above the MTCA Method B Cleanup Level at MW-12, MW-20, HZ-MW-15D, HZ-MW-24, and HZ-MW-29, and during the October 2019 sampling event, at MW-11. MW-12 contained the highest concentrations of (cis) 1,2-DCE during the July 2019 sampling event (630 µg/L) and HZ-MW-15D contained the highest concentration during the October 2019 sampling event (360 µg/L).

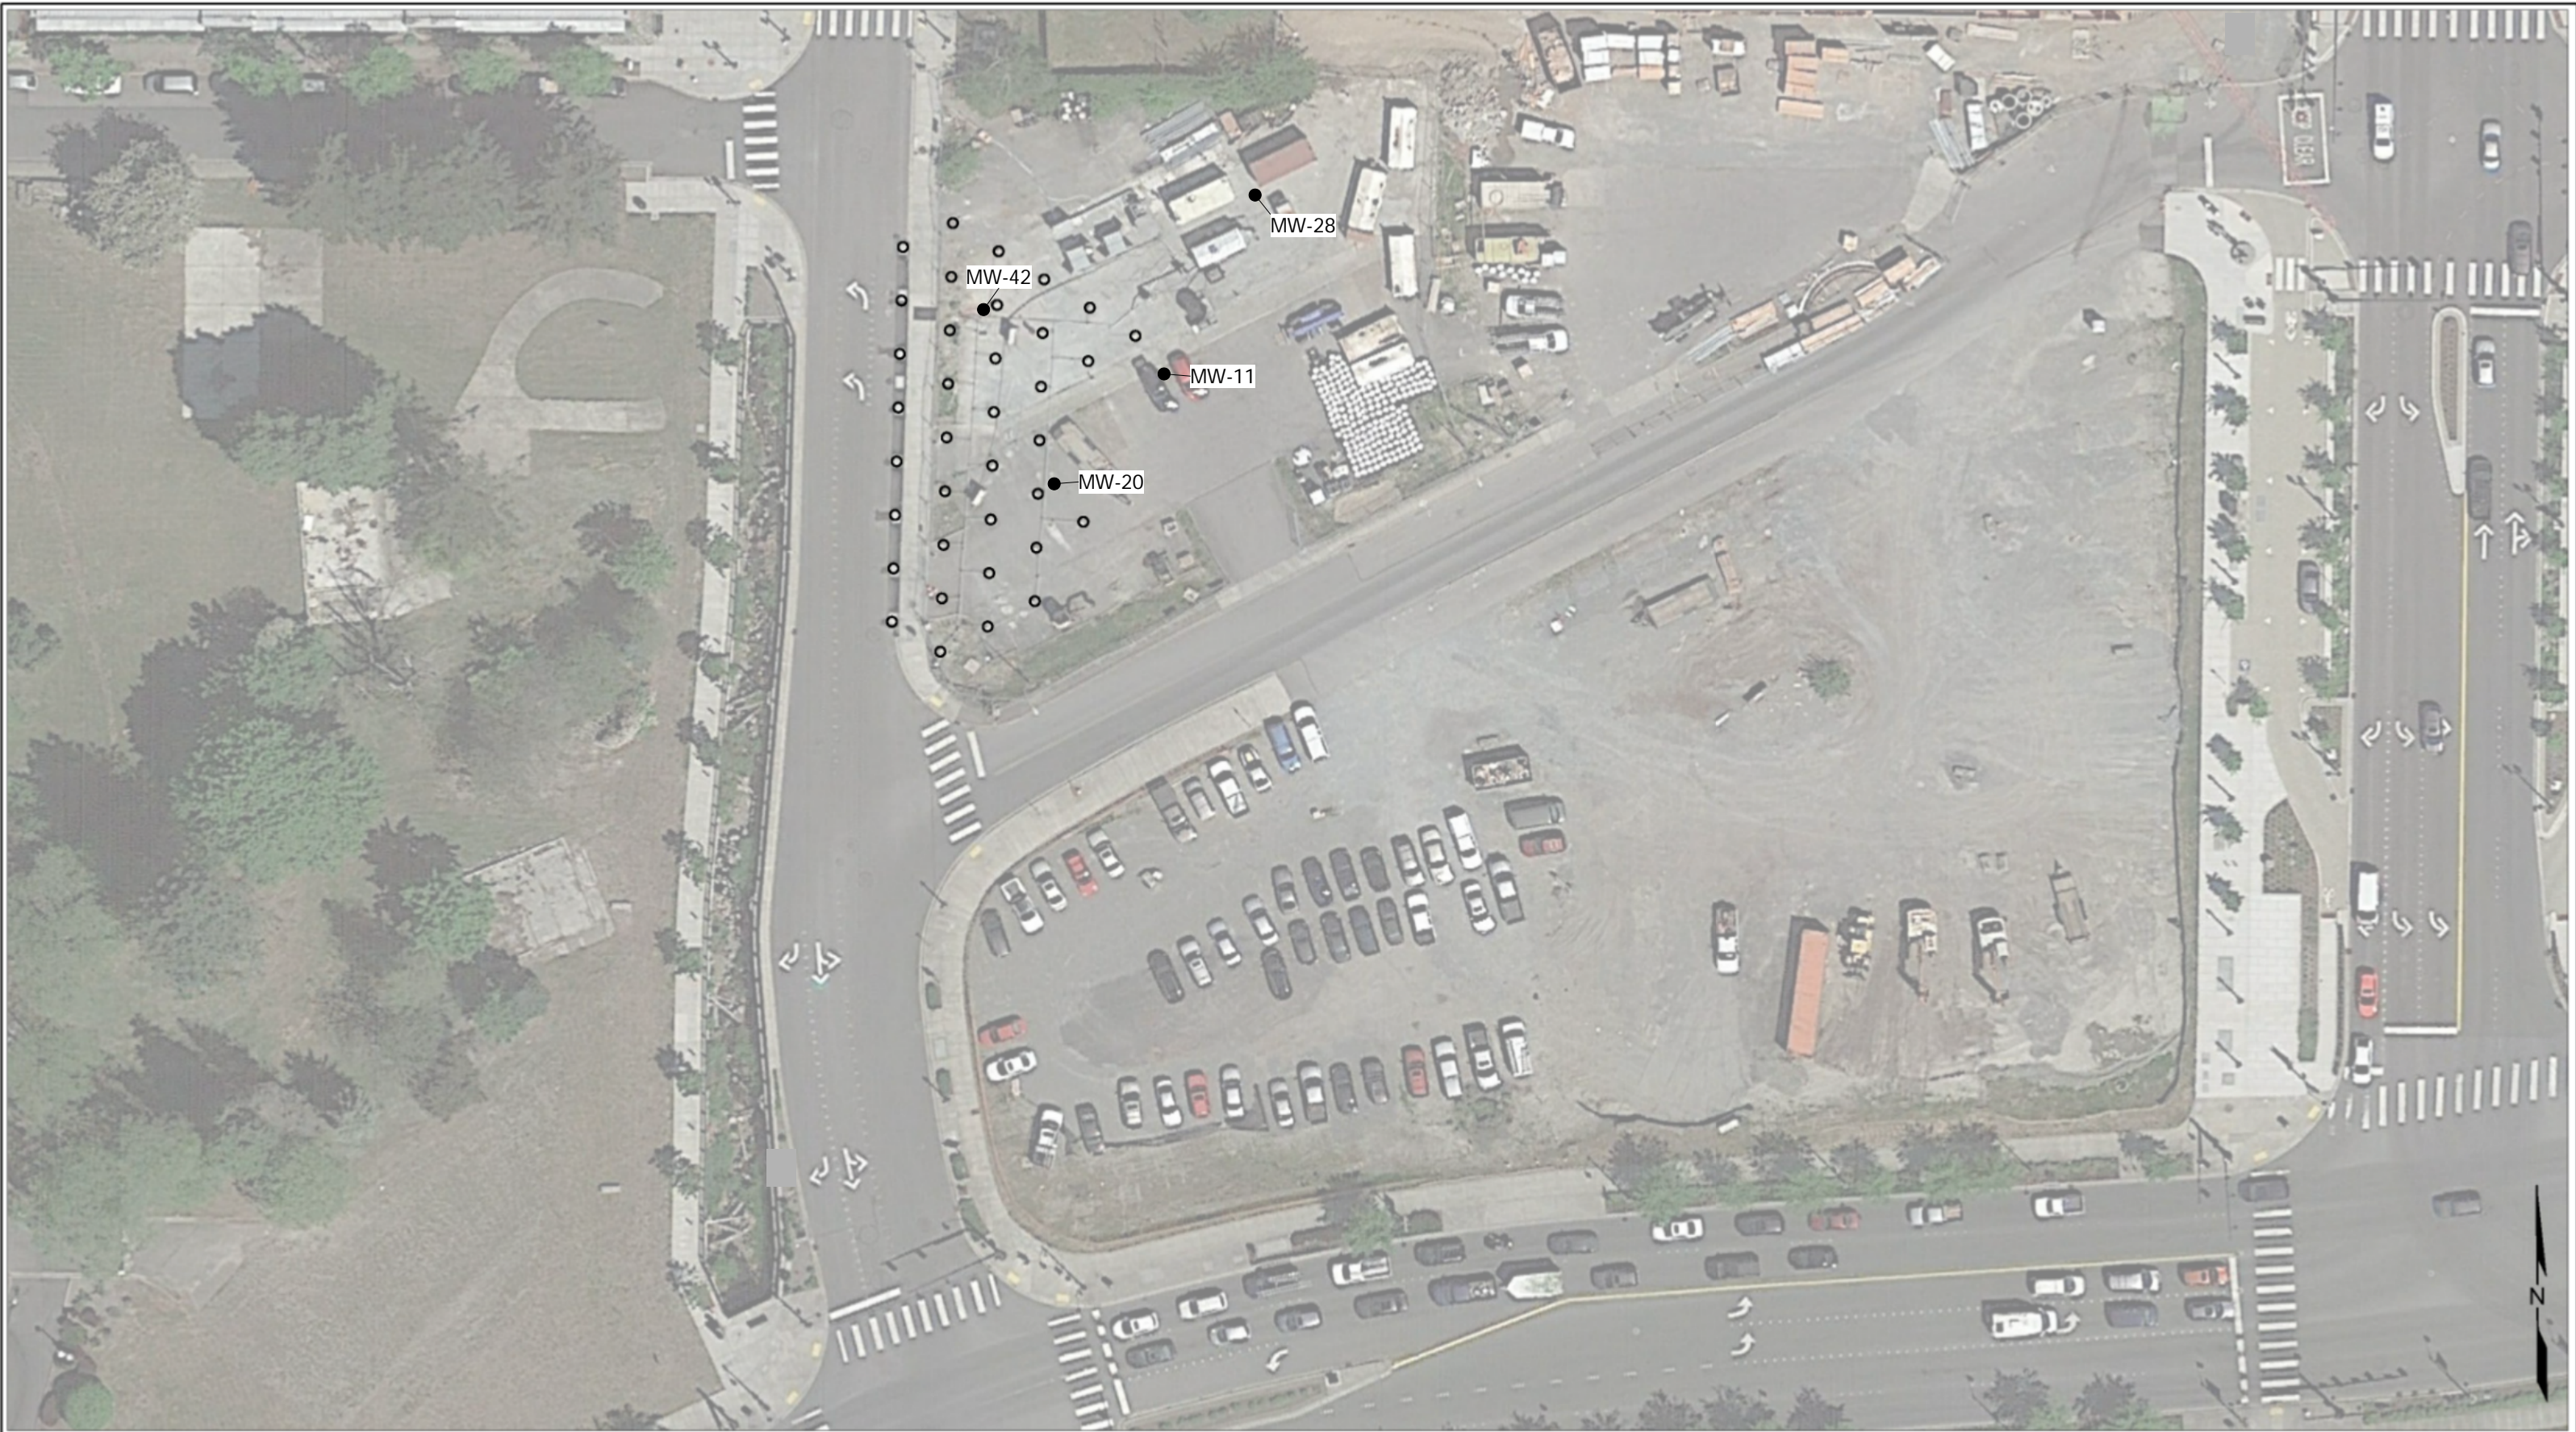
Figure
 Groundwater Concentration Isopleths
 in Intermediate Wells
 Vinyl Chloride - February 2019

Vinyl chloride was detected at concentrations greater than the MTCA Method A Cleanup Level (0.2 µg/L) at six of the fifteen intermediate wells sampled in 2019. During the performance monitoring events in July 2019 and October 2019, vinyl chloride was detected at concentrations above the MTCA Method A Cleanup Level at MW-11, MW-12, HZ-MW-14D, HZ-MW-24, and HZ-MW-29, and during the October 2019 sampling

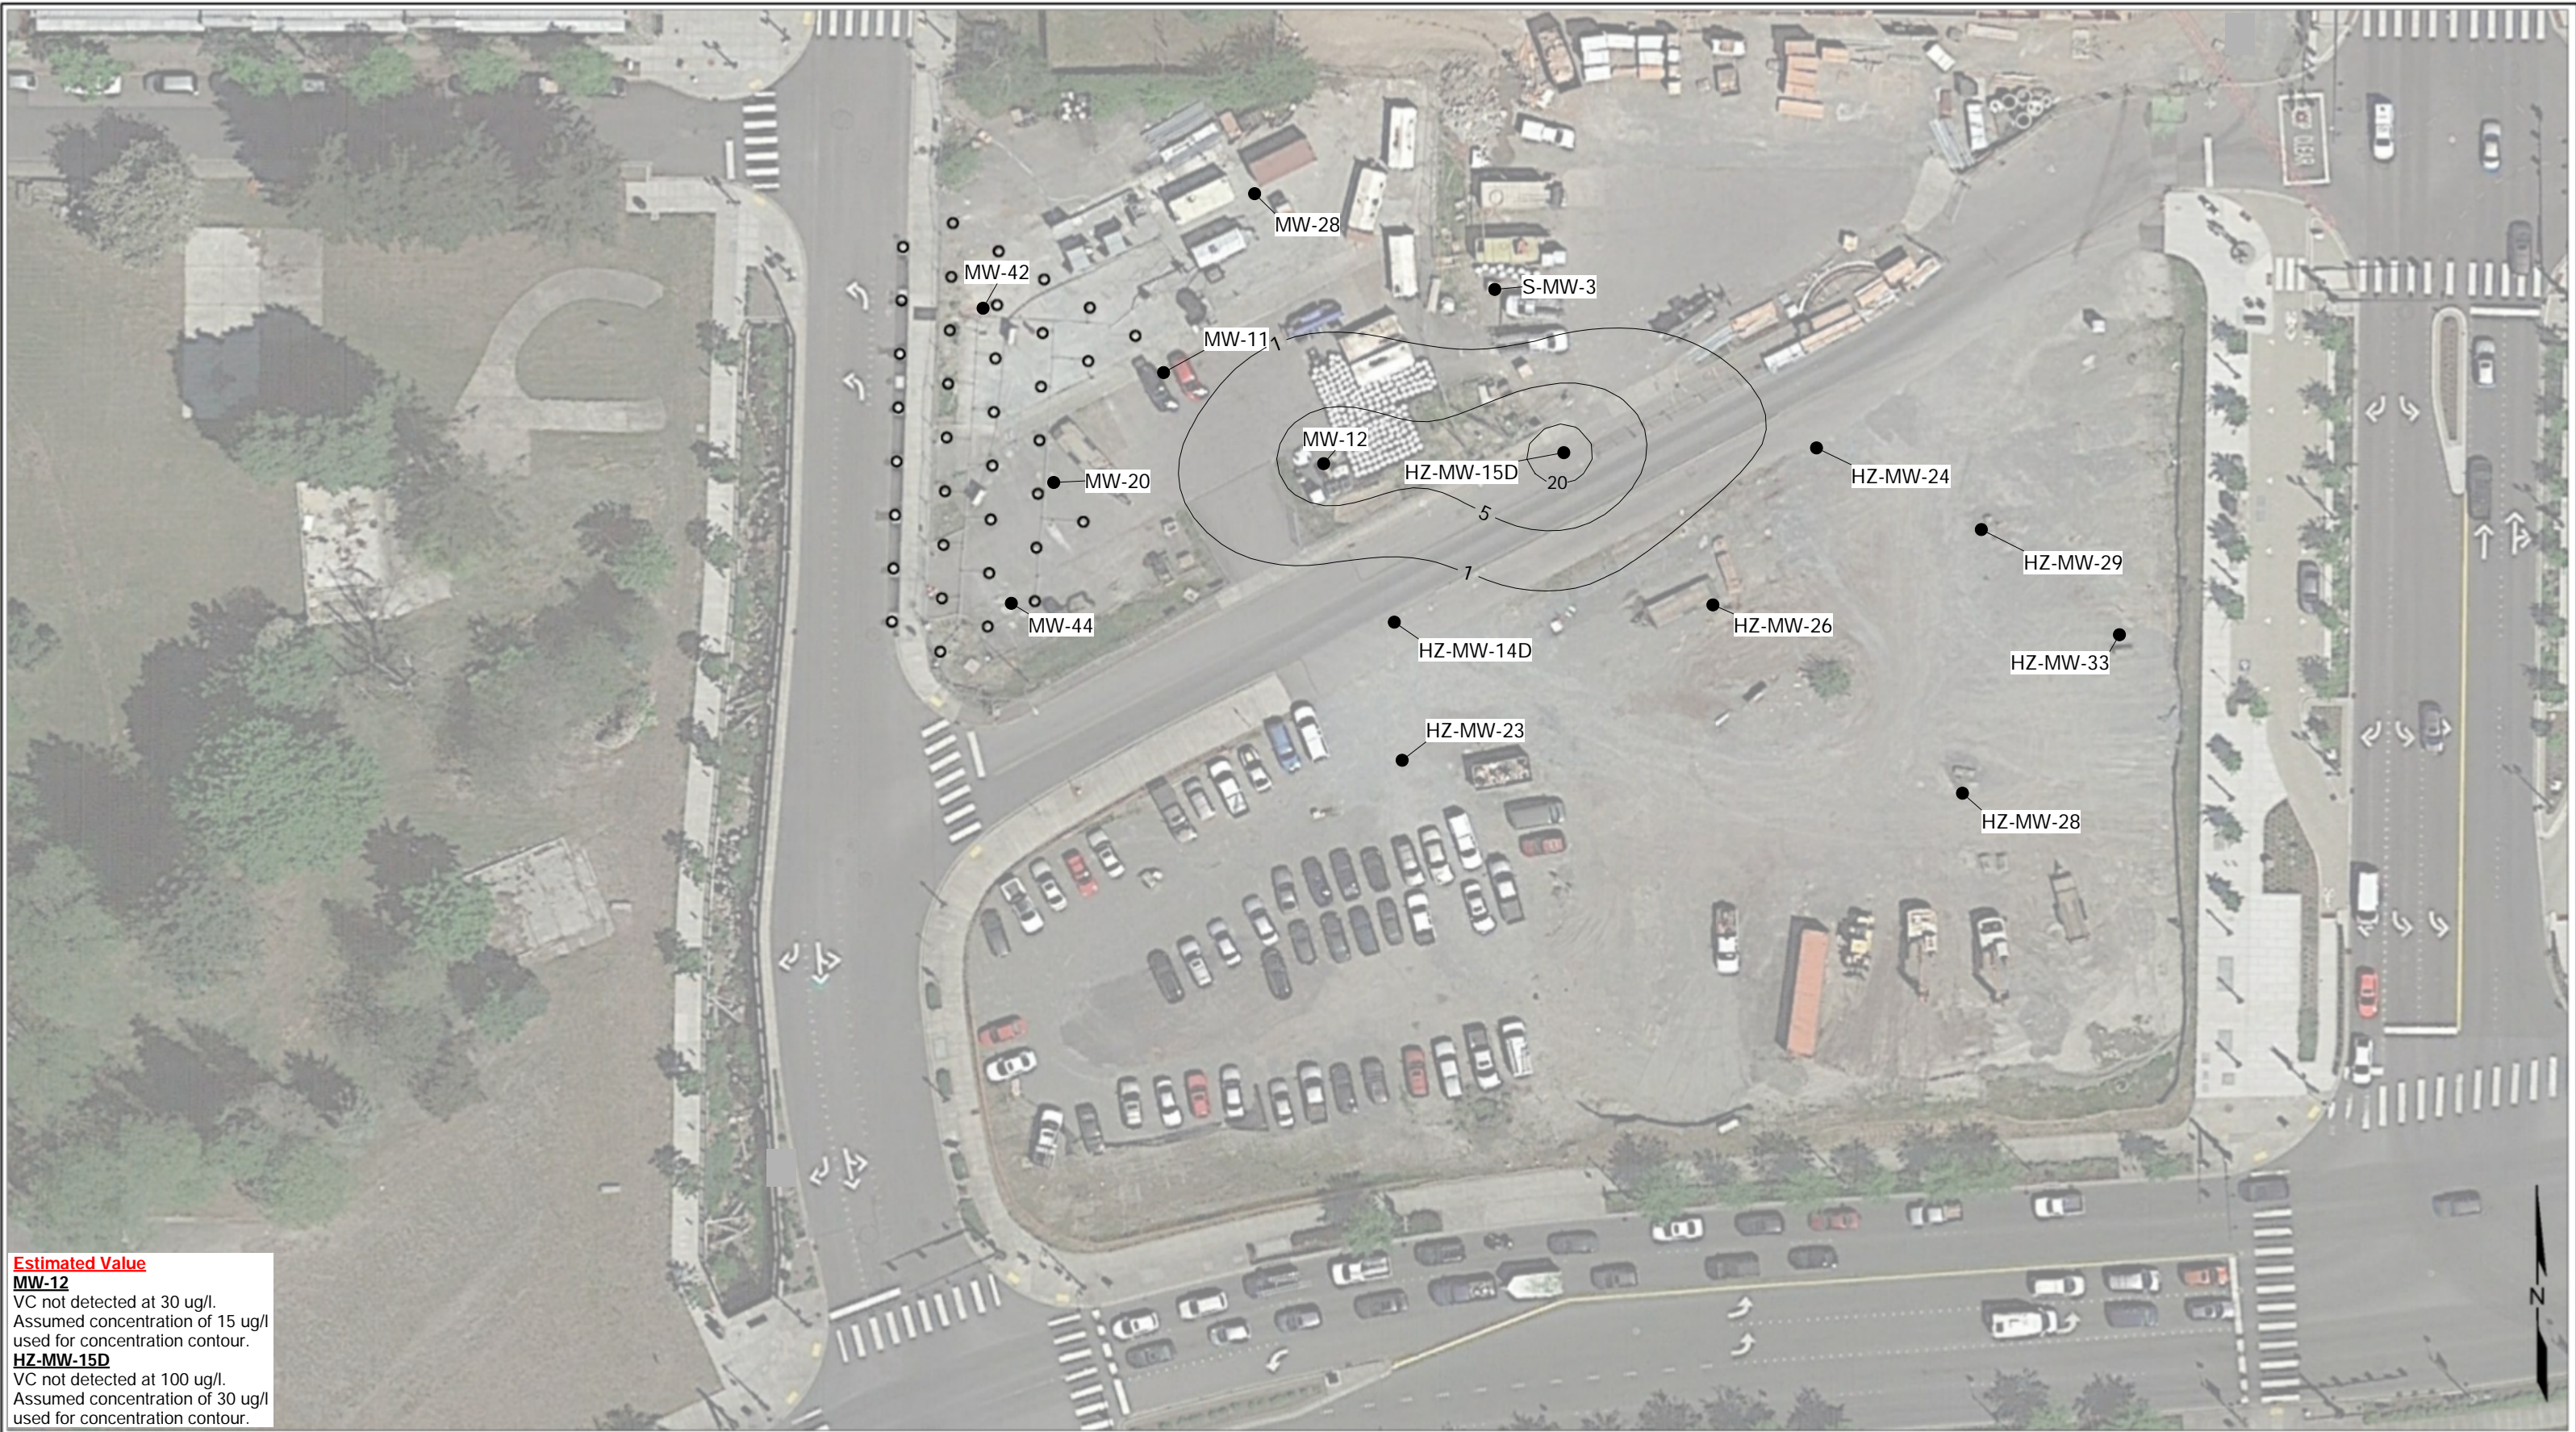
Figure
 Groundwater Concentration Isopleths
 in Intermediate Wells
 Vinyl Chloride - Spring 2019

Estimated Value
MW-12
 VC not detected at 30 ug/l.
 Assumed concentration of 15 ug/l
 used for concentration contour.
HZ-MW-15D
 VC not detected at 100 ug/l.
 Assumed concentration of 30 ug/l
 used for concentration contour.

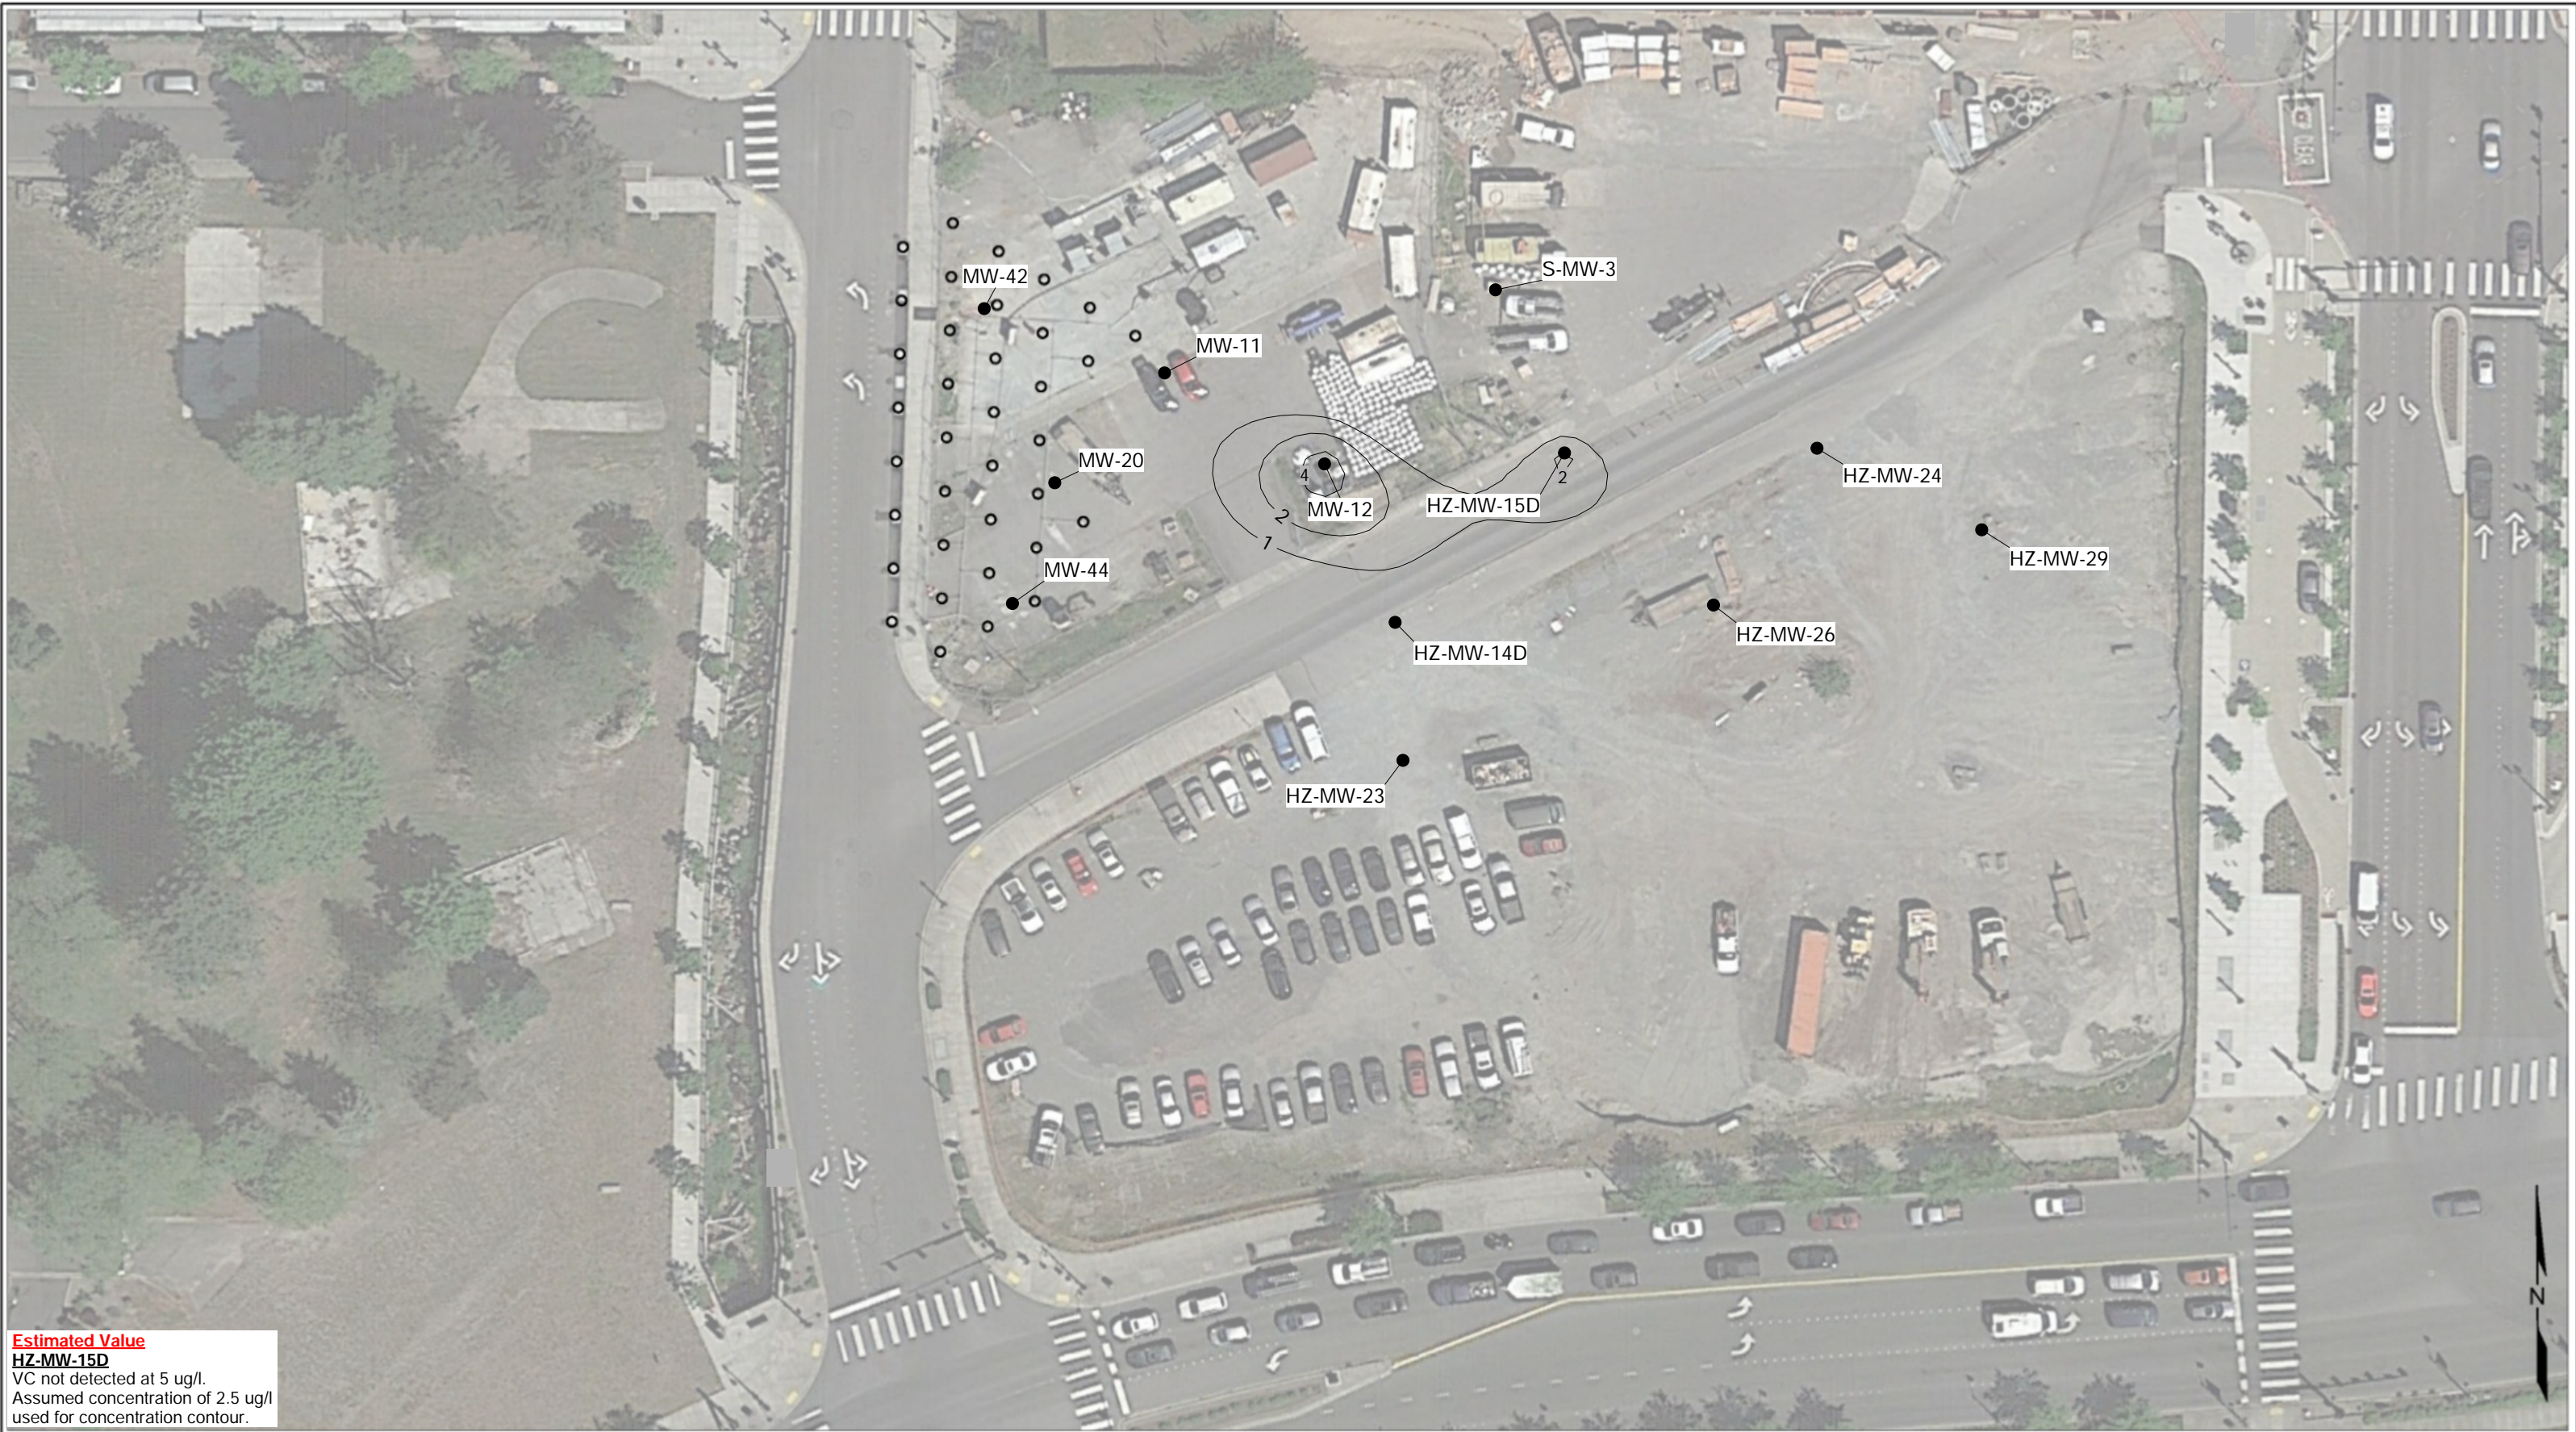
Figure
 Groundwater Concentration Isopleths
 in Intermediate Wells
 Vinyl Chloride - Summer 2019

event, at MW-44. MW-12 contained the highest concentrations of vinyl chloride during the July 2019 sampling event (6.2 µg/L) and MW-12 contained the highest concentration during the October 2019 sampling event (1.5 µg/L). It should be noted that due to elevated concentrations of PCE, several samples were diluted so that the reporting limit for vinyl chloride was greater than the MTCA Method A Cleanup Level.

Estimated Value
HZ-MW-15D
 VC not detected at 5 ug/l.
 Assumed concentration of 2.5 ug/l
 used for concentration contour.
