Annual Groundwater Performance Monitoring Report

**Bothell Service Center Simon & Son
18107 Bothell Way NE
Bothell, Washington
FSID # 33215922**

July 14, 2020

Kane Environmental, Inc.
4015 13th Avenue West
Seattle, WA 98119

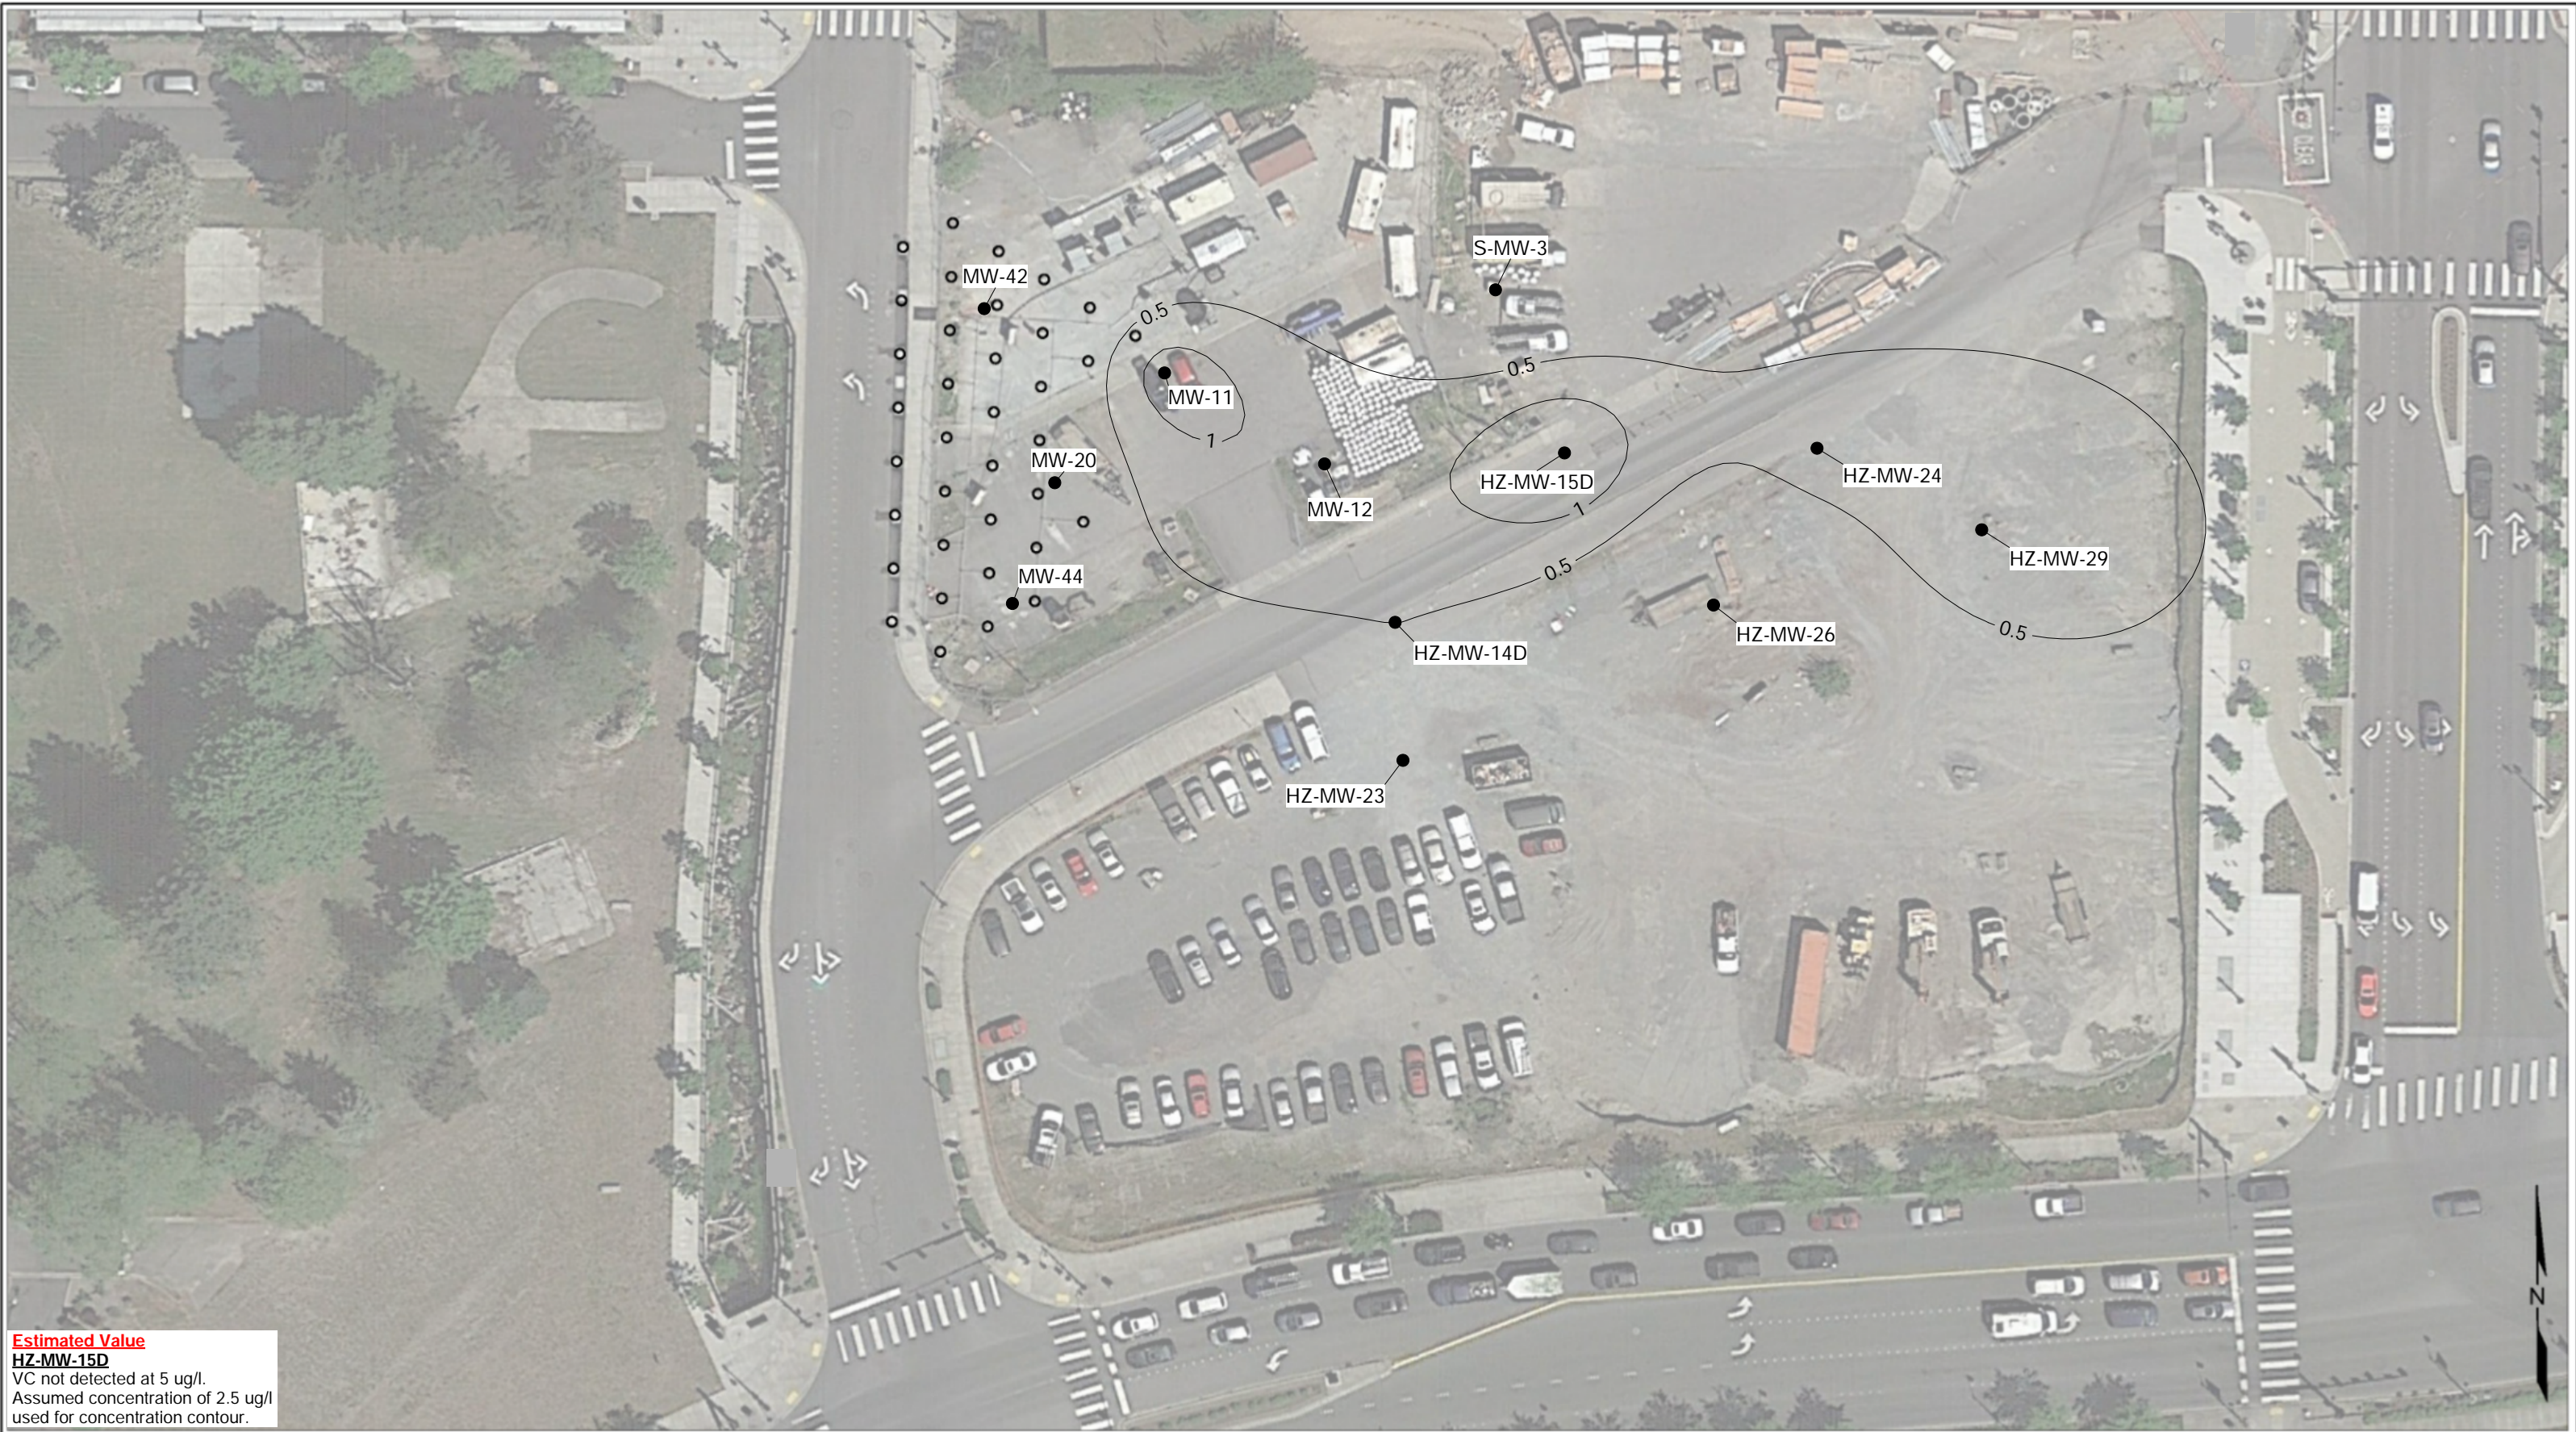
event, at MW-44. MW-12 contained the highest concentrations of vinyl chloride during the July 2019 sampling event (6.2 µg/L) and MW-12 contained the highest concentration during the October 2019 sampling event (1.5 µg/L). It should be noted that due to elevated concentrations of PCE, several samples were diluted so that the reporting limit for vinyl chloride was greater than the MTCA Method A Cleanup Level.

Estimated Value
HZ-MW-15D
 VC not detected at 5 ug/l.
 Assumed concentration of 2.5 ug/l
 used for concentration contour.
