RE: ***July 2021 Groundwater Sampling Results Report***  
*Lacey Urban Center*  
7239 Martin Way East  
Olympia, Washington 98516  
AEG Project No. 18-236

**July 2021 Groundwater Sampling Results Report**

Lacey Urban Center, Olympia, Washington

AEG Project No. 18-236

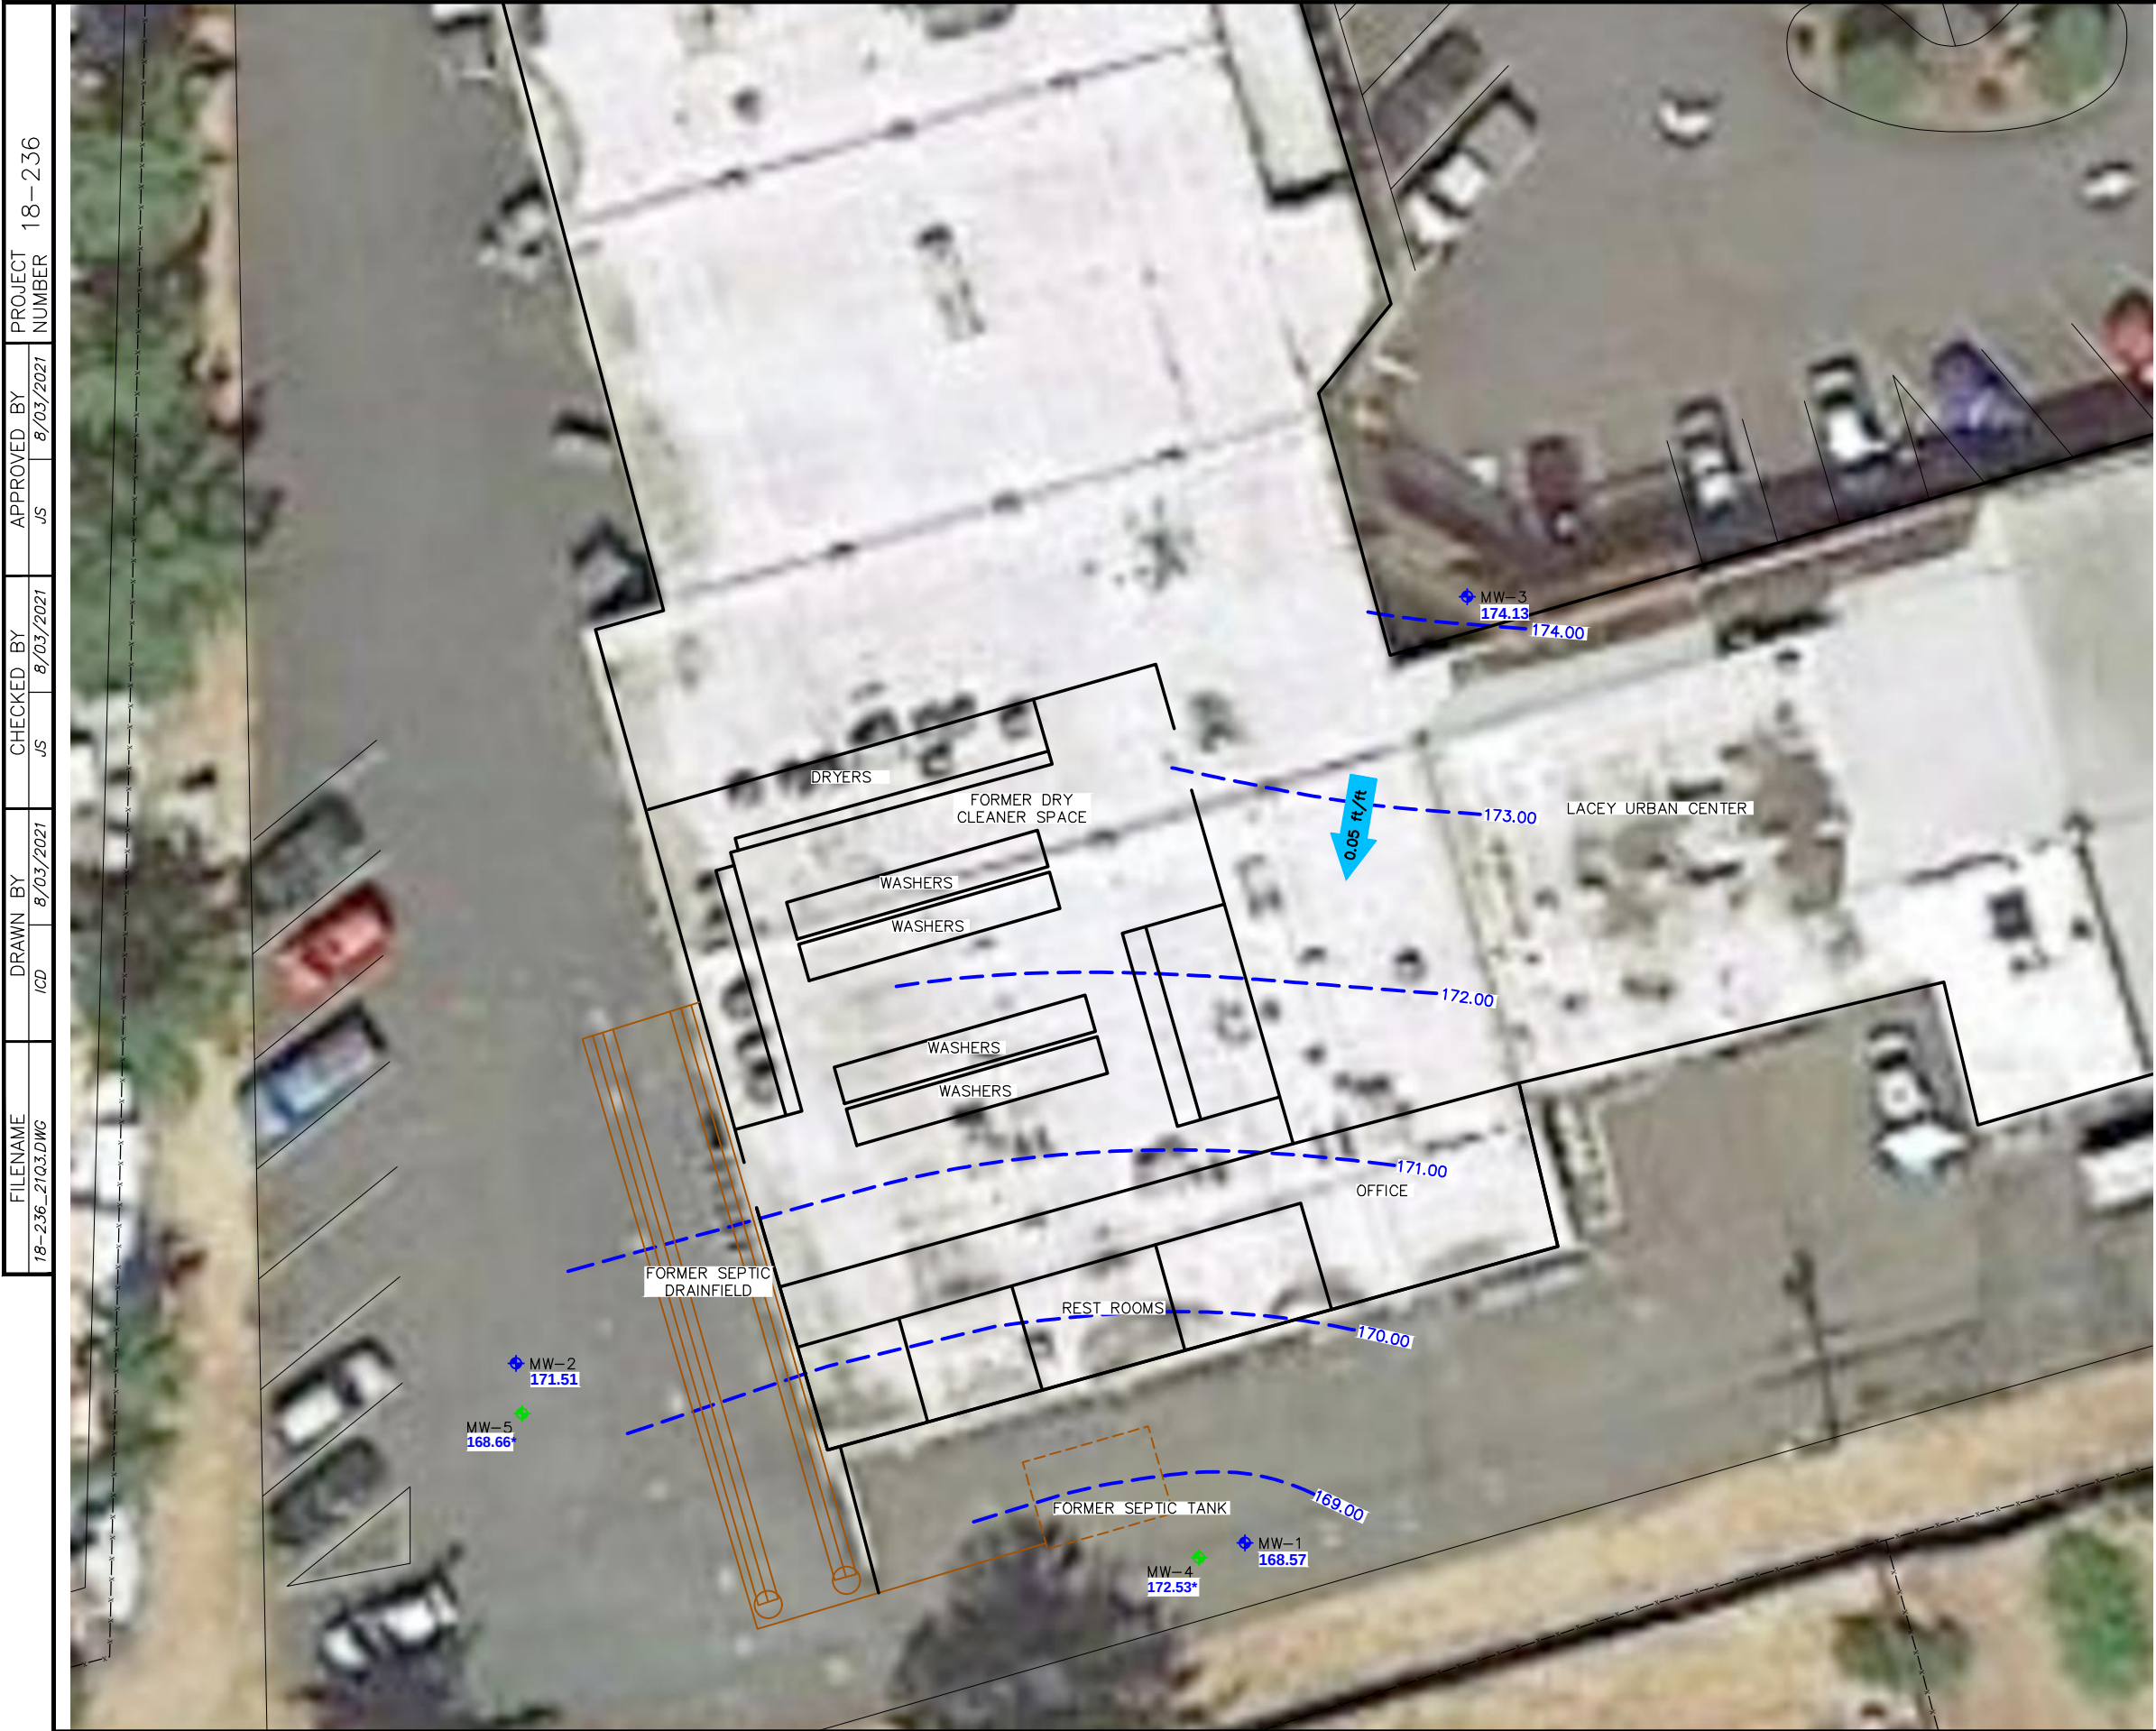
FIGURE 2

The calculated groundwater gradient for the July 2021 sampling event is primarily towards the south-southwest, with an approximate gradient of 0.05 feet per foot (Figure 2, *Groundwater Elevation Contour Map 07/19/2021*).

GROUNDWATER ELEVATION CONTOUR MAP  
07/19/2021
