REMEDIAL ACTION WORK PLAN ADDENDUM NO. 1

**MANHATTAN VILLAGE SHOPPING CENTER AND
HARRIS PROPERTIES
VCP NW1873
NORMANDY PARK, WASHINGTON**

JUNE 29, 2021

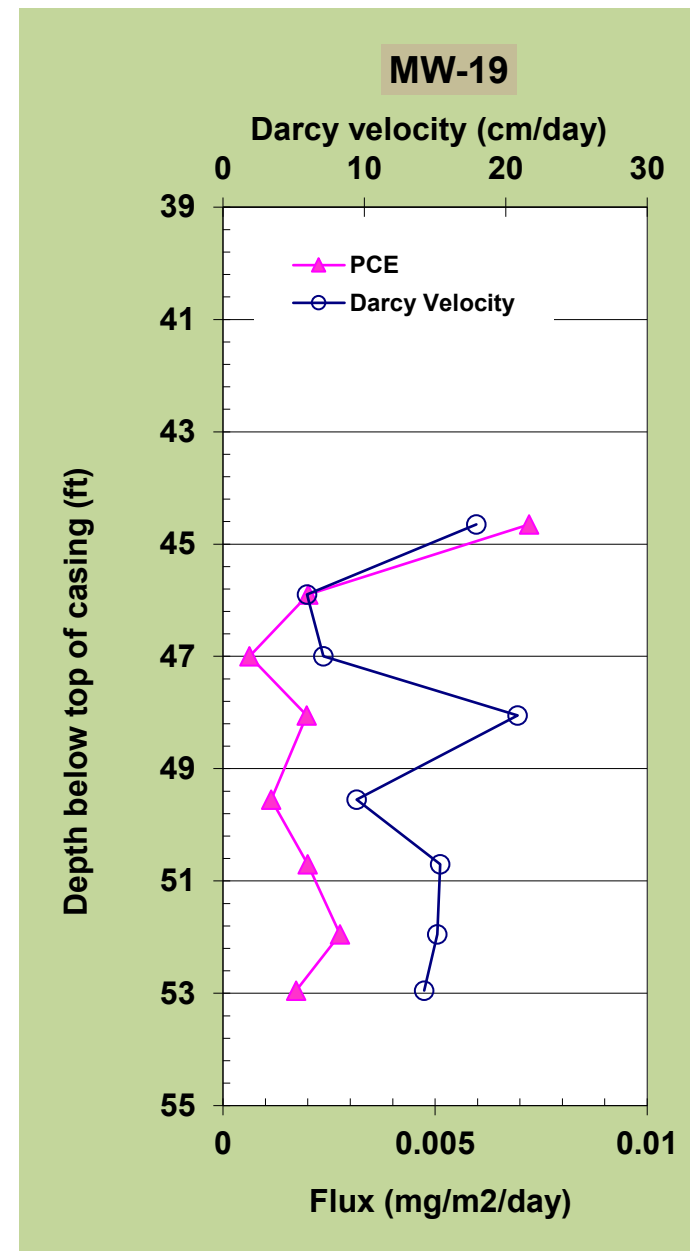
Chart F1. MW-19

Well_ID	Sample_ID	Depth below top of well casing (ft)	Darcy Velocity (cm/day)	PCE (ug/L)
MW-19	MW-19-43.9-45.3	44.7	17.9	0.040
	MW-19-45.3-46.4	45.9	5.9	0.034
	MW-19-46.4-47.5	47.0	7.1	0.009
	MW-19-47.5-48.5	48.1	20.8	0.009
	MW-19-49.0-50.0	49.6	9.5	0.012
	MW-19-50.0-51.3	50.7	15.4	0.013
	MW-19-51.3-52.5	52.0	15.2	0.018
	MW-19-52.5-53.3	53.0	14.2	0.012
MW-20	MW-20-35.3-36.4	35.9	9.1	0.308
	MW-20-36.4-37.5	37.0	7.8	0.647
	MW-20-36.4-37.5 DUP	37.0	7.9	0.716
	MW-20-37.5-38.5	38.1	8.1	0.705
	MW-20-38.5-39.6	39.1	12.7	0.174
	MW-20-40.0-41.2	40.7	3.7	0.608
	MW-20-41.2-42.5	41.9	4.3	0.240
	MW-20-42.5-43.5	43.1	5.5	0.086
MW-20-43.5-44.3	44.0	15.4	0.038

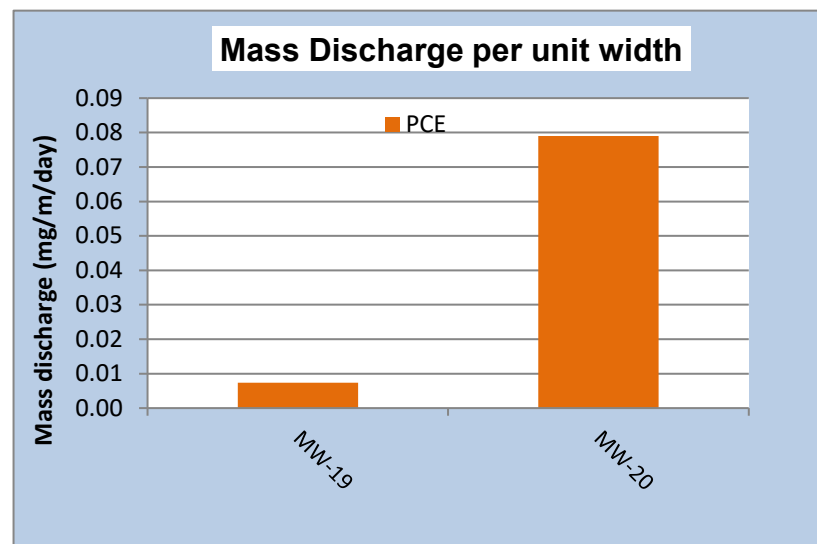
Table F3. Mass discharge per unit width for aquifer of each well

Well	Darcy Velocity (cm/day)	PCE Discharge (mg/m/day)
MW-19	13.2	0.01
MW-20	8.3	0.08

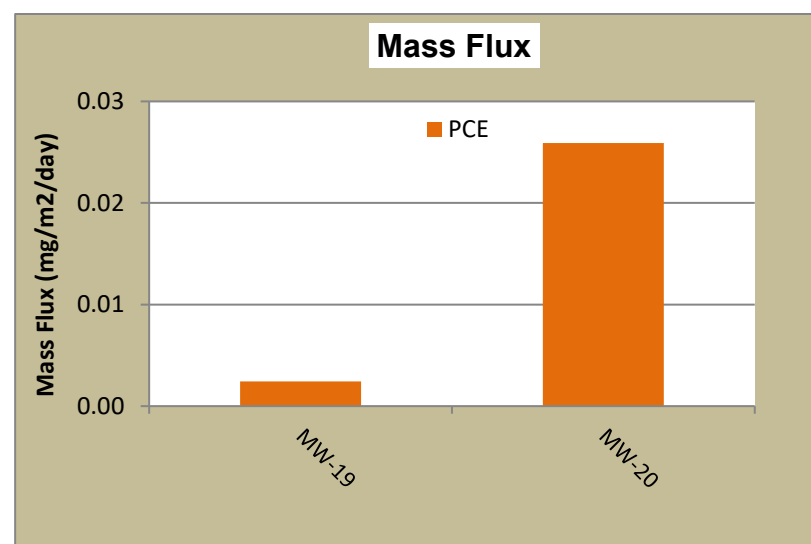
Table F4. Well average values of mass flux based on PFMs

Well	Darcy Velocity (cm/day)	PCE flux (mg/m ² /day)
MW-19	13.2	0.002
MW-20	8.3	0.026

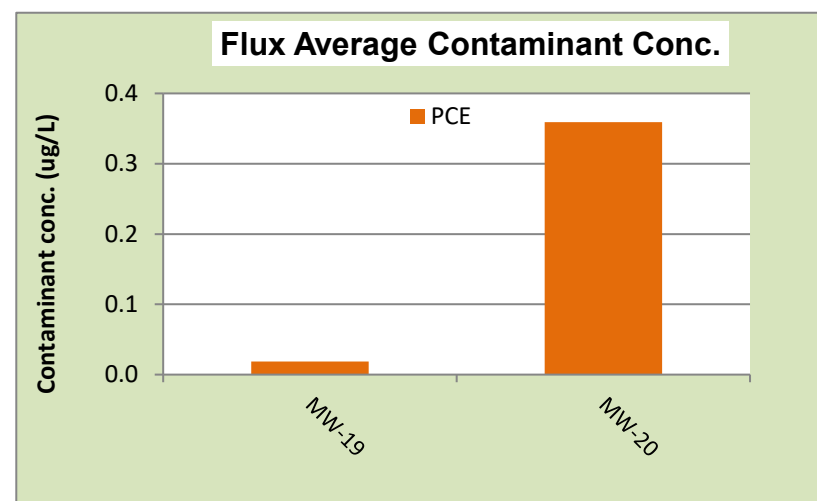
Table F5. Flux average contaminant concentration on PFMs

Well	Darcy Velocity (cm/day)	PCE (ug/L)
MW-19	13.2	0.02
MW-20	8.3	0.36
