**Final
Remedial Investigation/Feasibility Study
Former Kaiser Aluminum Property
3400 Taylor Way
Tacoma, Washington**

August 23, 2012

**Port of Tacoma
Tacoma, Washington**

**LANDAU
ASSOCIATES**
130 2nd Avenue South
Edmonds, WA 98020
(425) 778-0907

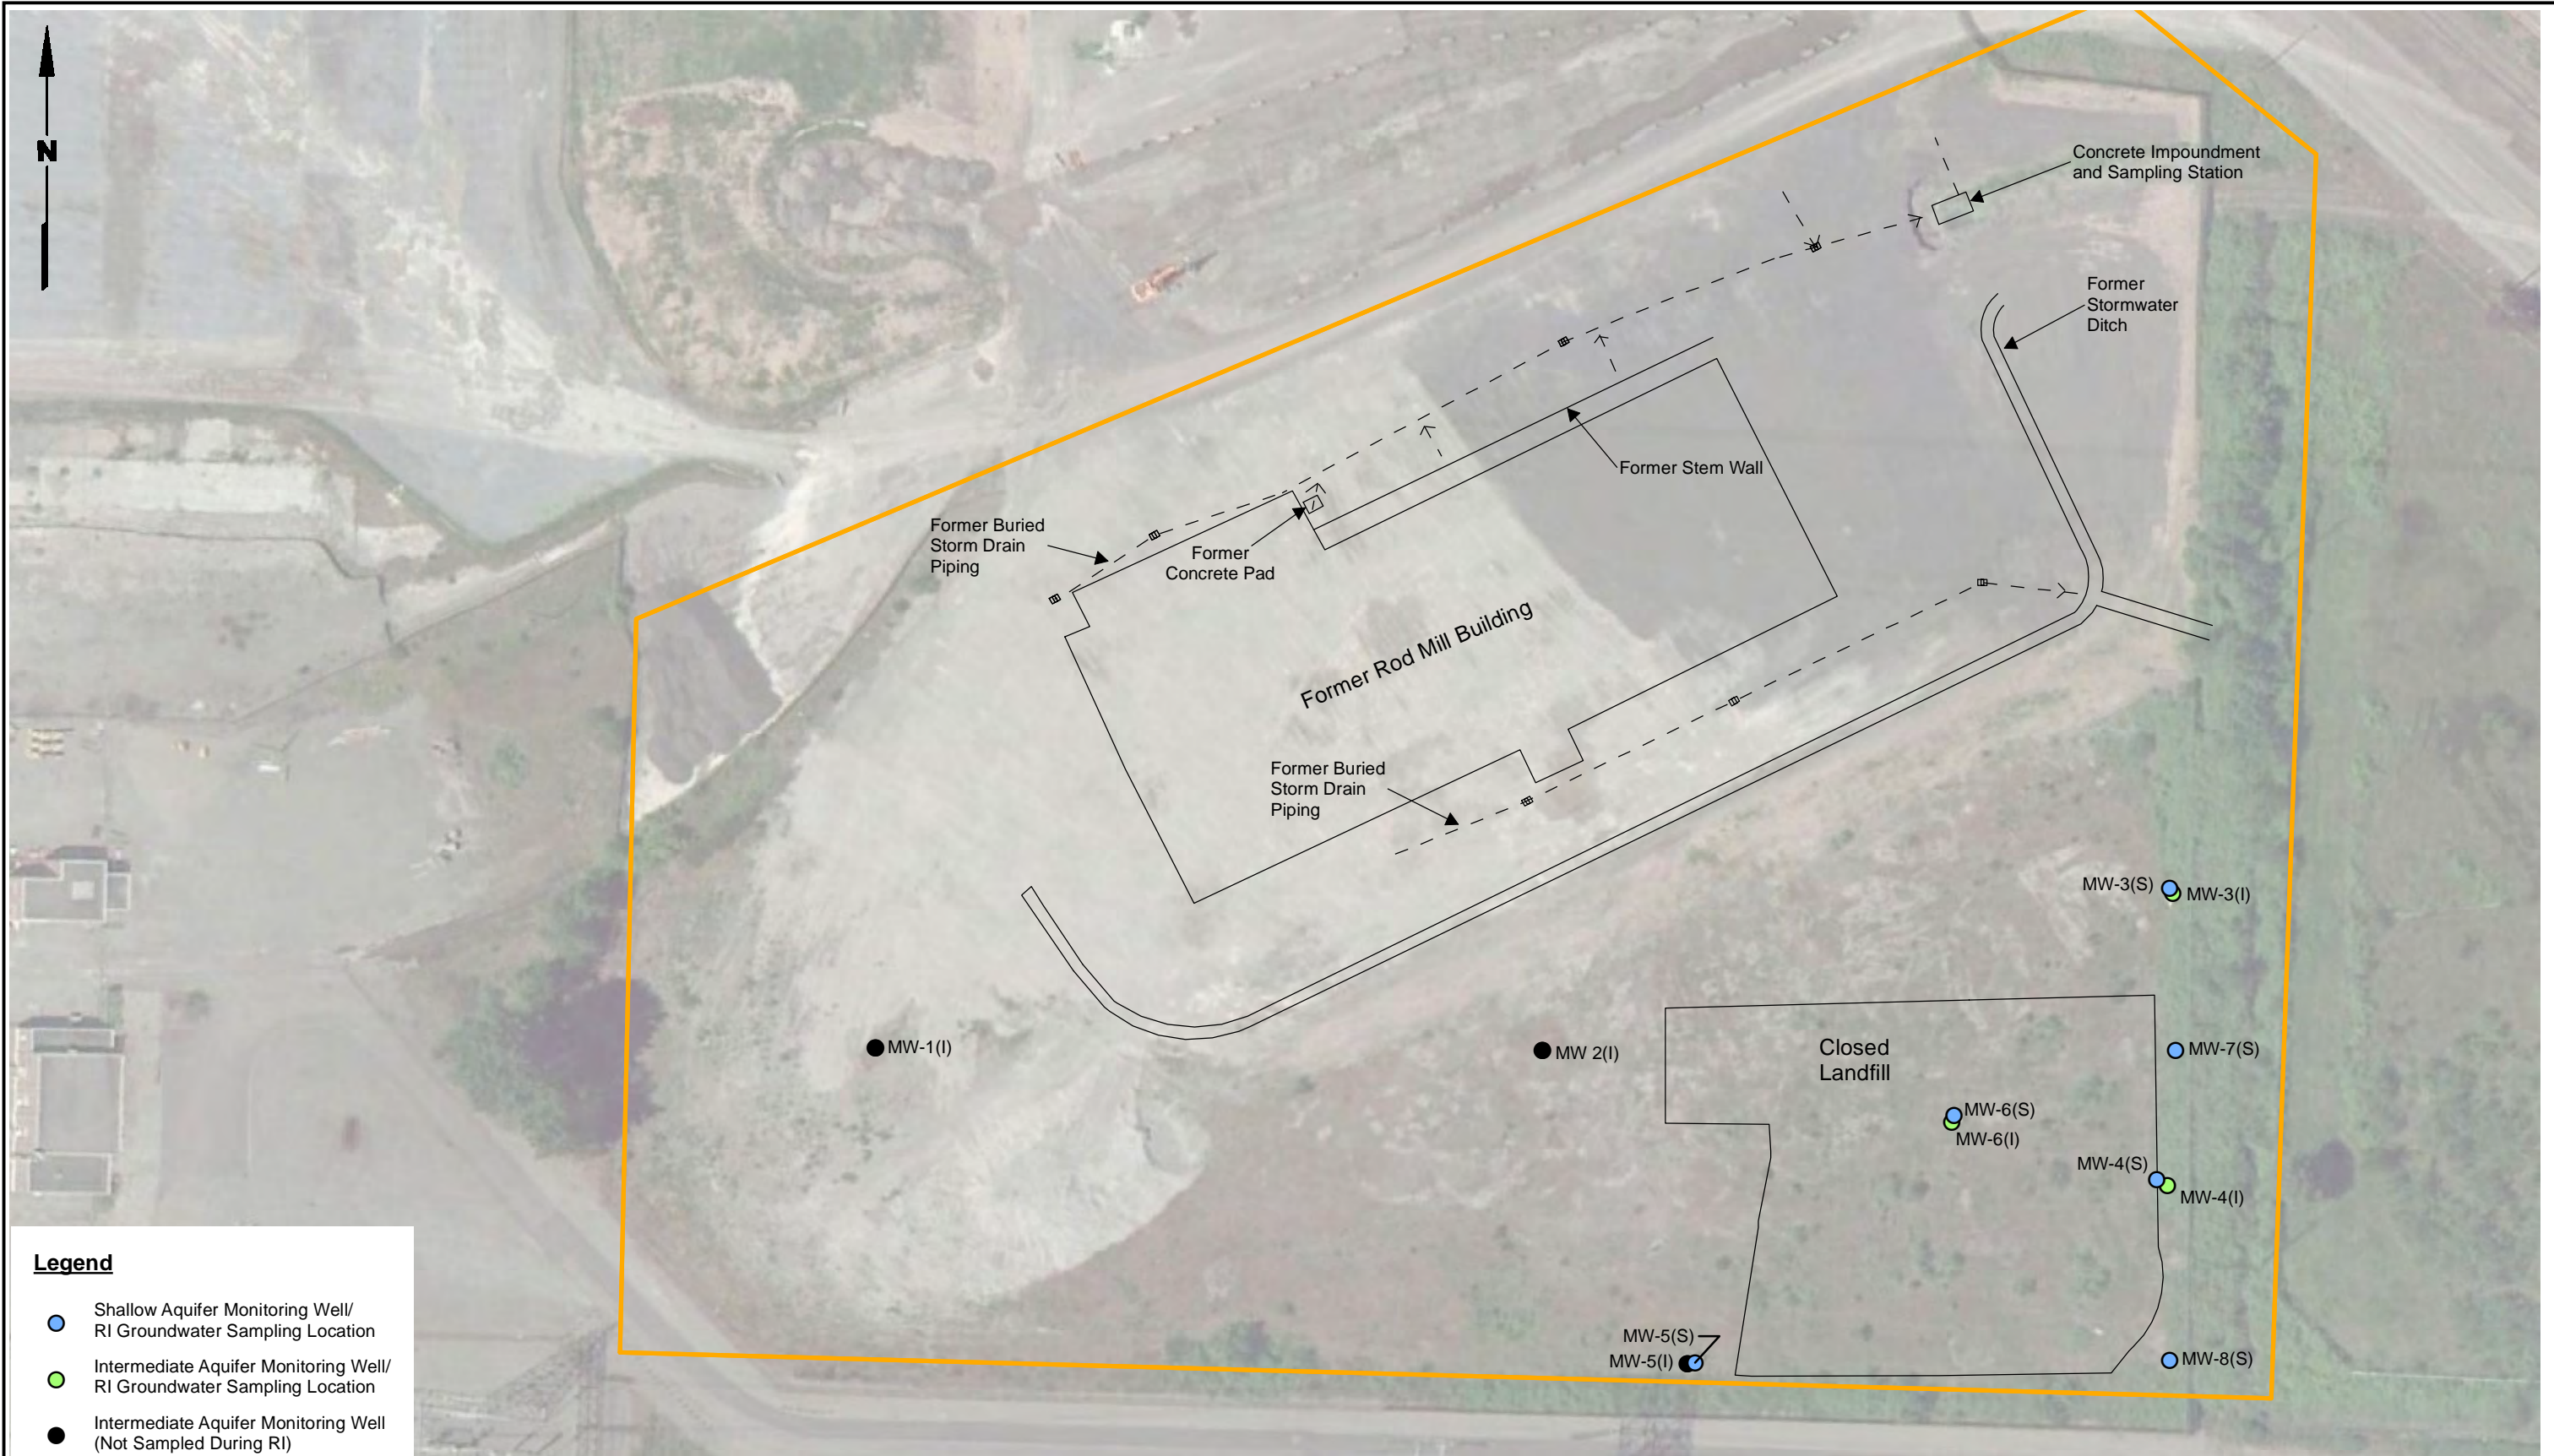
Figure
9

**SPL Area RI and Previous
Test Pit Locations**

samples were also analyzed for total cyanide. All of the soil samples were collected from depth intervals at least 0.5 ft below any visible carbon-containing material, as described in Section 4.1.3. The analytical results for the soil samples and a comparison of the results to the preliminary cleanup levels are presented in Table 5. As shown in Table 5, total cyanide was not detected above the preliminary cleanup level in any of the soil samples. One cPAH, chrysene, was detected at a concentration above the preliminary cleanup level in one soil sample; however, the concentration was less than two times the preliminary cleanup level. The exceedance occurred in the soil sample collected from a depth interval of 3-3.5 ft BGS at test pit MA-41, which is located in the western portion of the SPL Area, as shown on Figure 9.

To evaluate disposal options for the waste material in the SPL Area if removal and offsite disposal is selected as a remedial action, waste characterization samples were collected from four test pit locations, SPL-MA33, SPL-MA37, SPL-MA39, and SPL-MA41 (Figure 9). The samples were analyzed for the constituents for which criteria are available under the land disposal restrictions. The analytical results are presented in Table 9. PAHs, total and TCLP metals, as well as cyanide, post-chlorination cyanide, and fluoride were detected in all of the waste characterization samples.

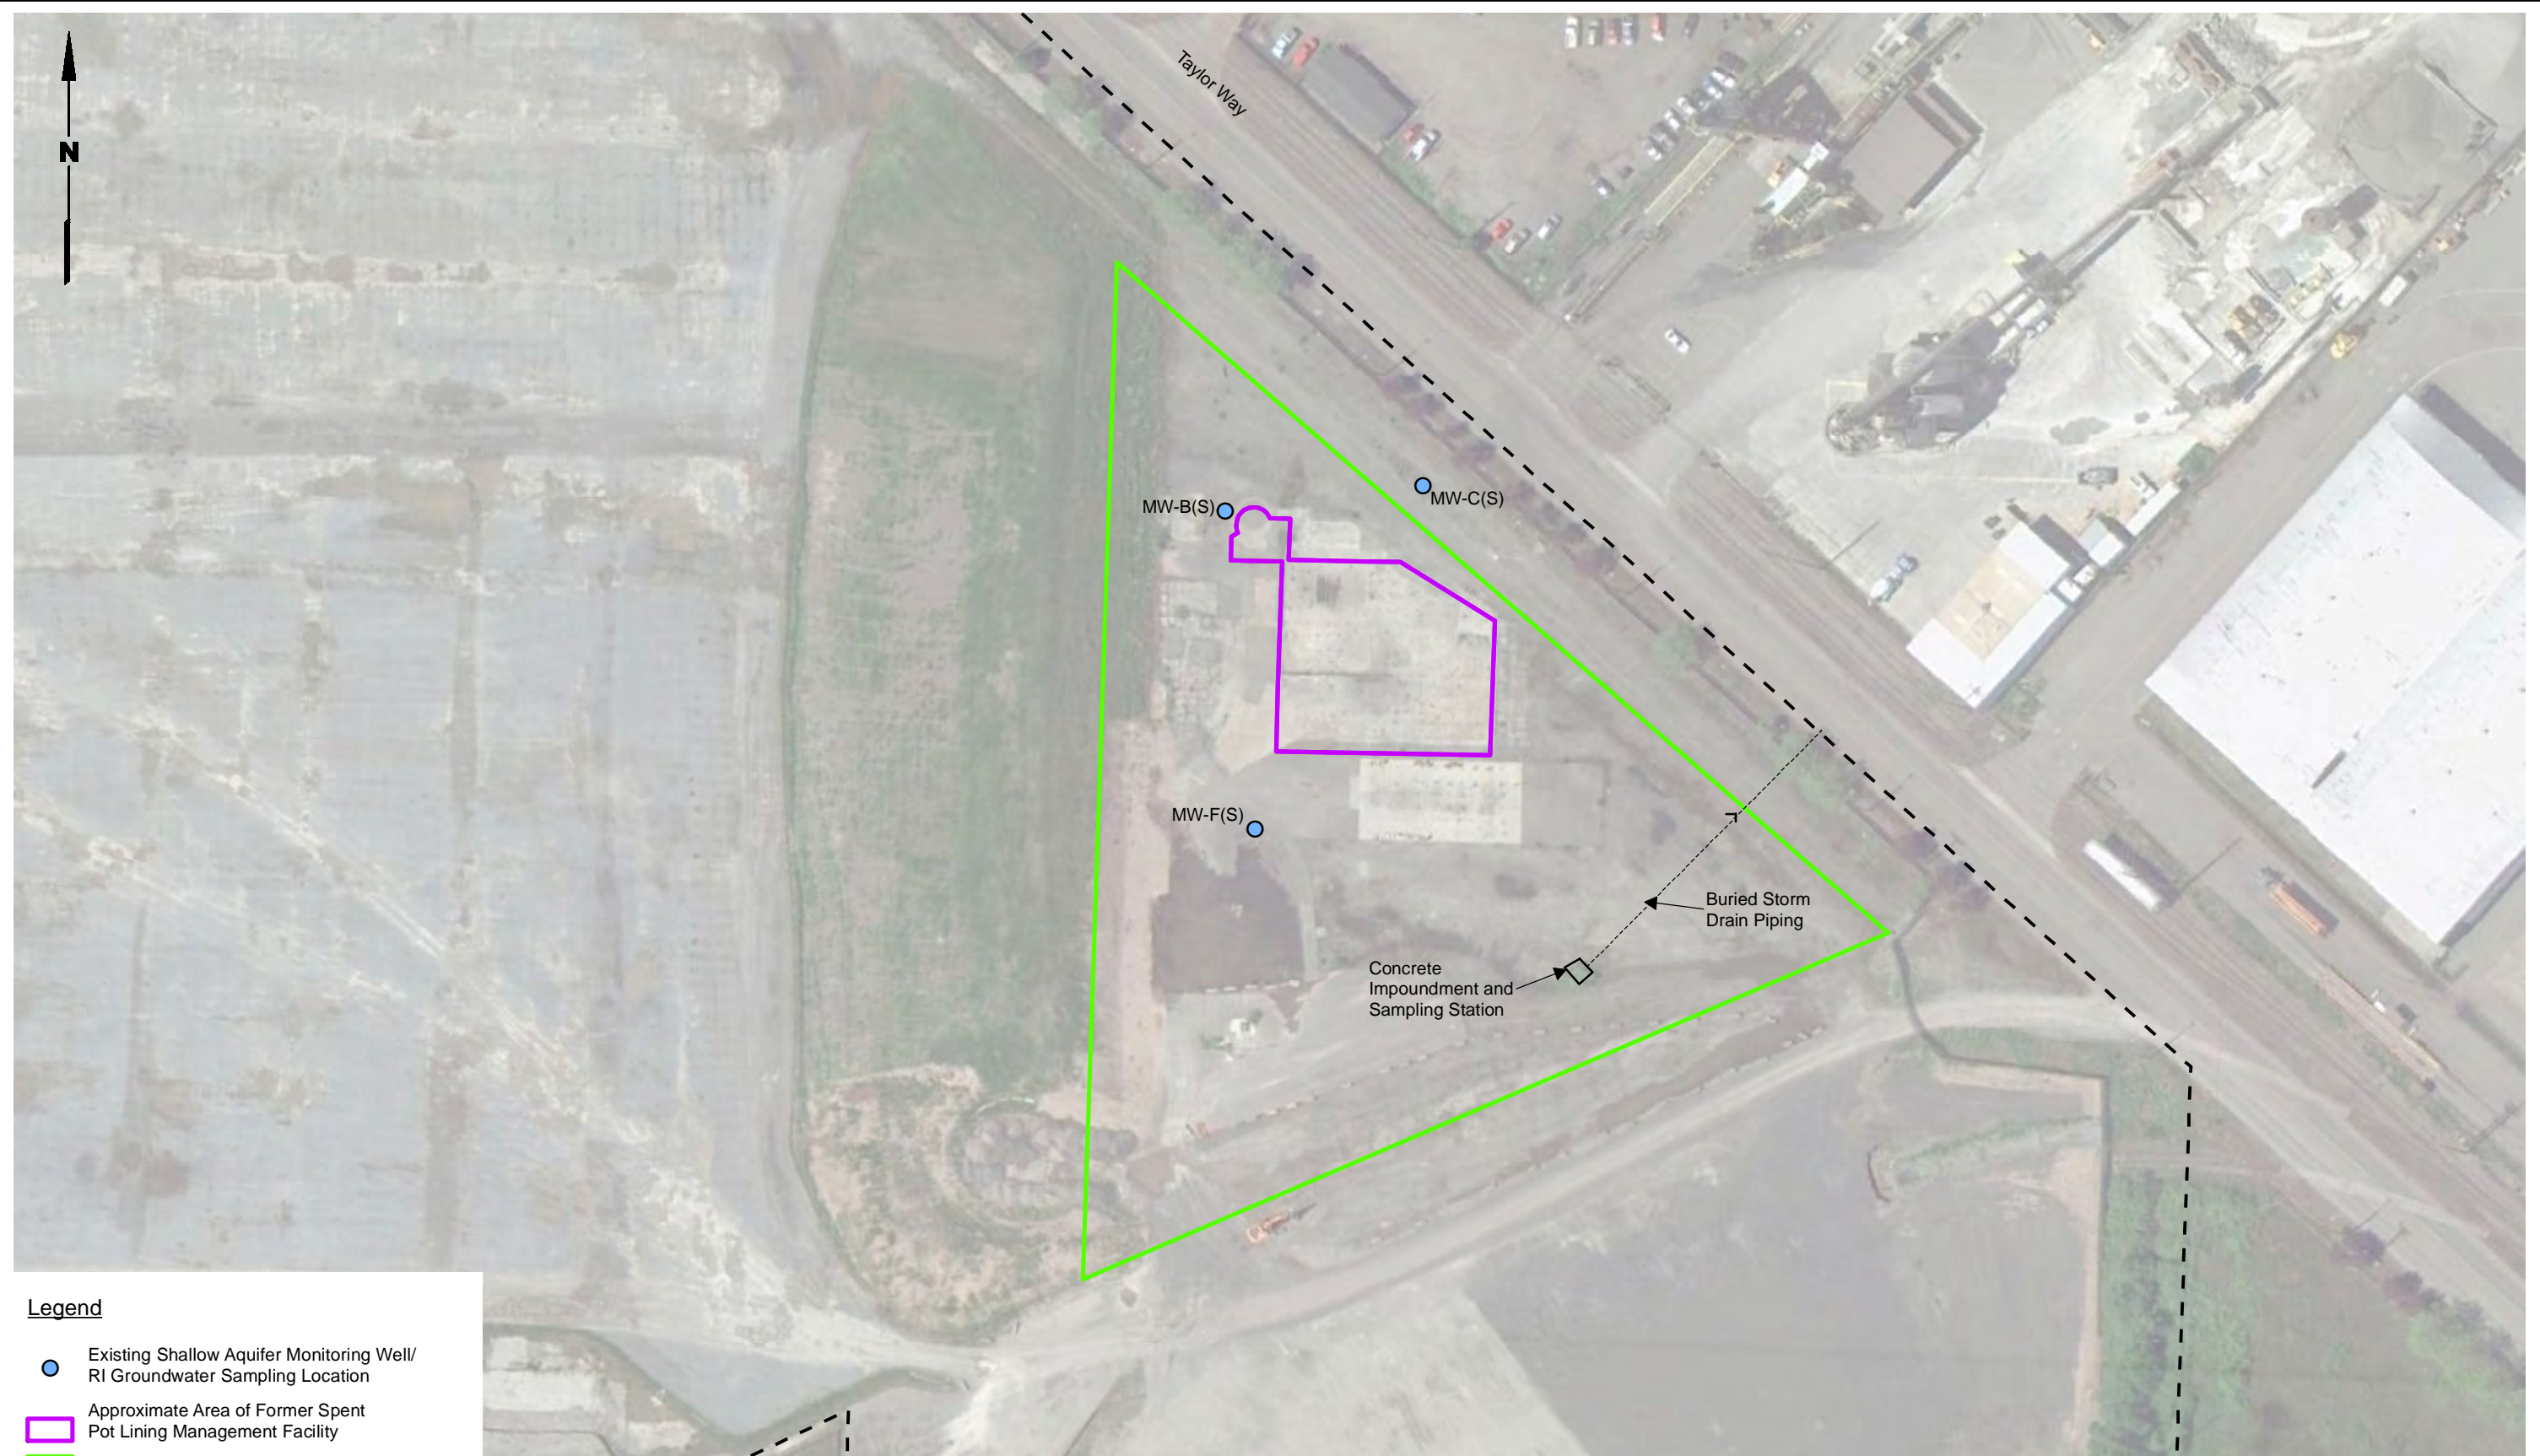
Y:\Projects\118032\020.004\MapDocs\RIFS\Figure 12 SPL_GW_Monitoring_Locations.mxd 7/3/2012 NAD_1983_StatePlane_Washington_South_FIPS_4602_Feet

- Existing Shallow Aquifer Monitoring Well/
RI Groundwater Sampling Location
- Approximate Area of Former Spent
Pot Lining Management Facility
- Approximate Spent Pot Lining Area (SPL Area)
- Site Boundary

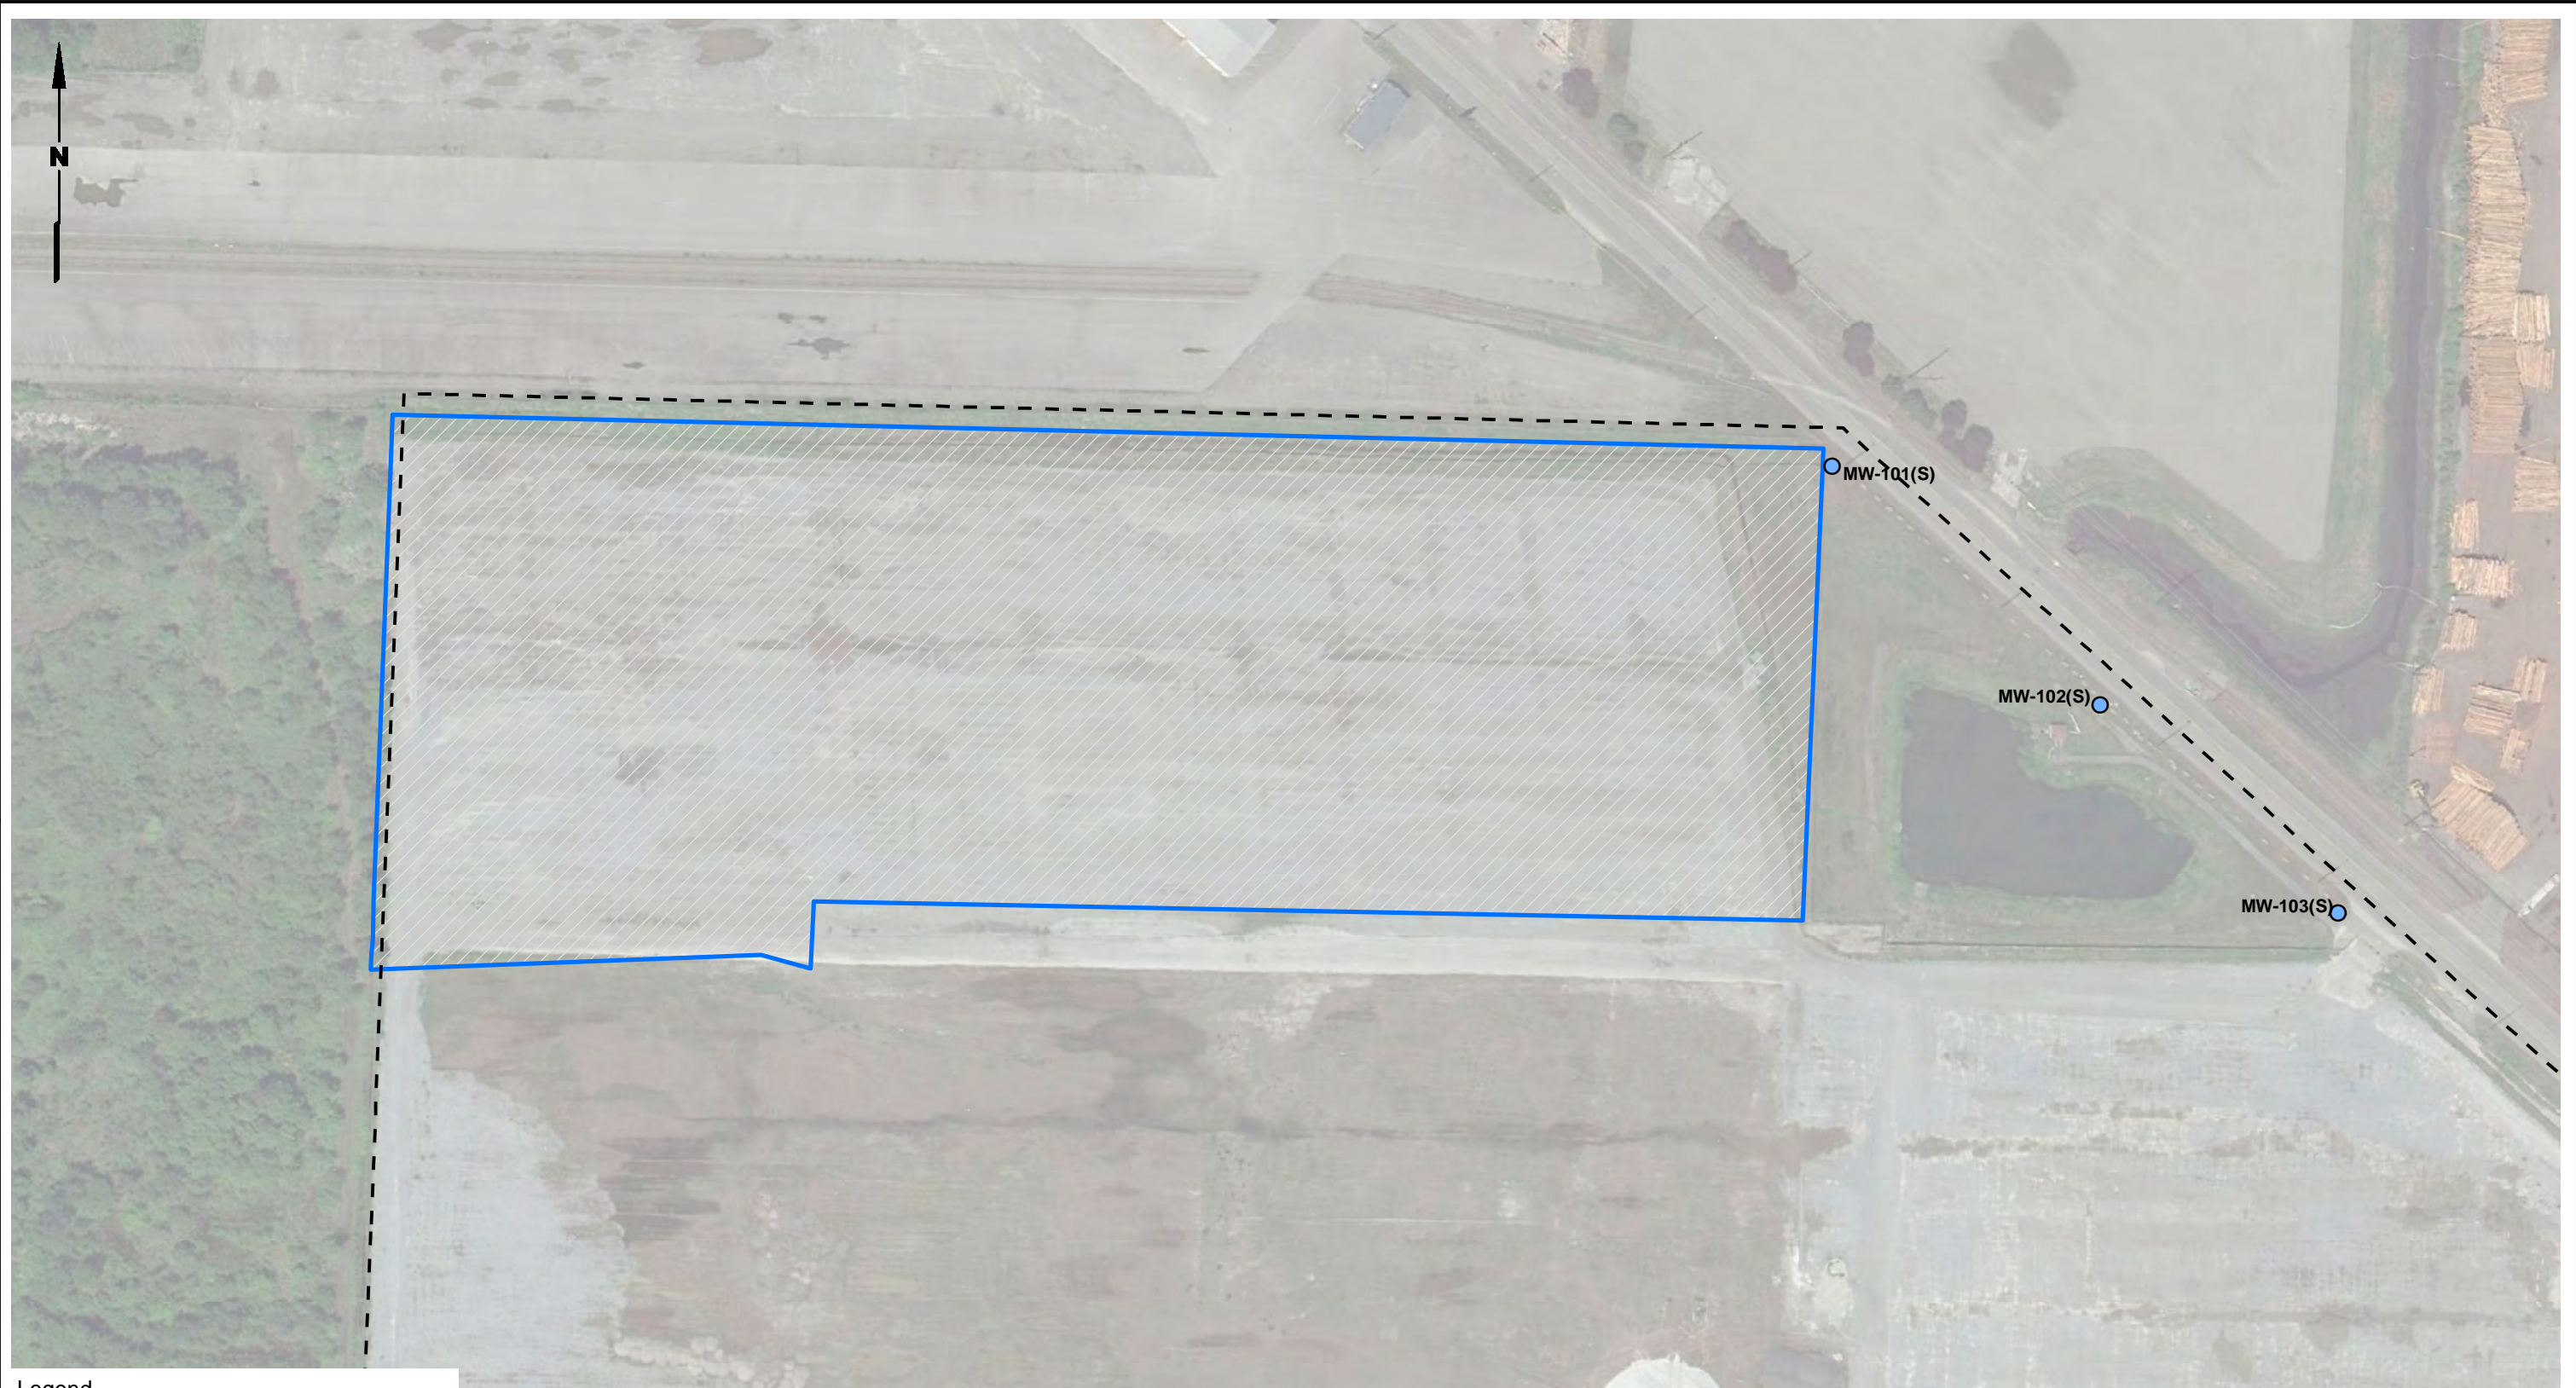
Y:\Projects\1180320\20.004\MapDocs\IFS\Figure 33 Log Yard Cleanup Areas.mxd 7/2/2012 NAD 1983 StatePlane Washington South FIPS 4602 Feet

- MW-101(S) ● Off-Site Monitoring Well Location
- ▨ Former Log Area Capped with 4-8 ft of Clean Soil Fill Material
- - - Site Boundary

As discussed in Sections 2.4 and 7.3, wood waste and slag was removed and the Former Log Yard Area was capped with approximately 4 to 8 ft of clean soil fill material; these previous soil cleanup and filling activities were conducted with Ecology's concurrence. The capped area is shown on Figure 33. Below any remaining residual slag, fill materials consisting of poorly graded sand and dense gravel with sand and silt are present. While there were concentrations of copper and zinc in soil at concentrations exceeding the preliminary cleanup levels for the protection of groundwater, the concentrations do not exceed preliminary cleanup levels protective of direct contact, and concentrations of these metals in groundwater are below preliminary cleanup levels. Concentrations of arsenic in soil samples collected prior to waste removal and capping of the area exceed preliminary cleanup levels. This soil, if still present, has been capped. Results from downgradient wells indicate that arsenic in groundwater is not migrating offsite at concentrations above the preliminary screening levels except possibly at the northwest corner of the Site where groundwater is likely to be impacted by arsenic from the adjacent OFA/Pennwalt site. This demonstrates that residual concentrations of COCs in soil are protective of groundwater and, therefore, are protective of human health and the environment.
