STATE OF WASHINGTON
DEPARTMENT OF ECOLOGY

Re: Opinion on Proposed Cleanup of the following Site:

- **Site Name:** Former Unocal Hulco Bulk Plant
- **Site Address:** 301 N Columbia, Olympia
- **Facility/Site No.:** 58484616
- **Cleanup Site ID No.:** 4808
- **VCP Project No.:** SW1146

Description and Diagrams of the Site

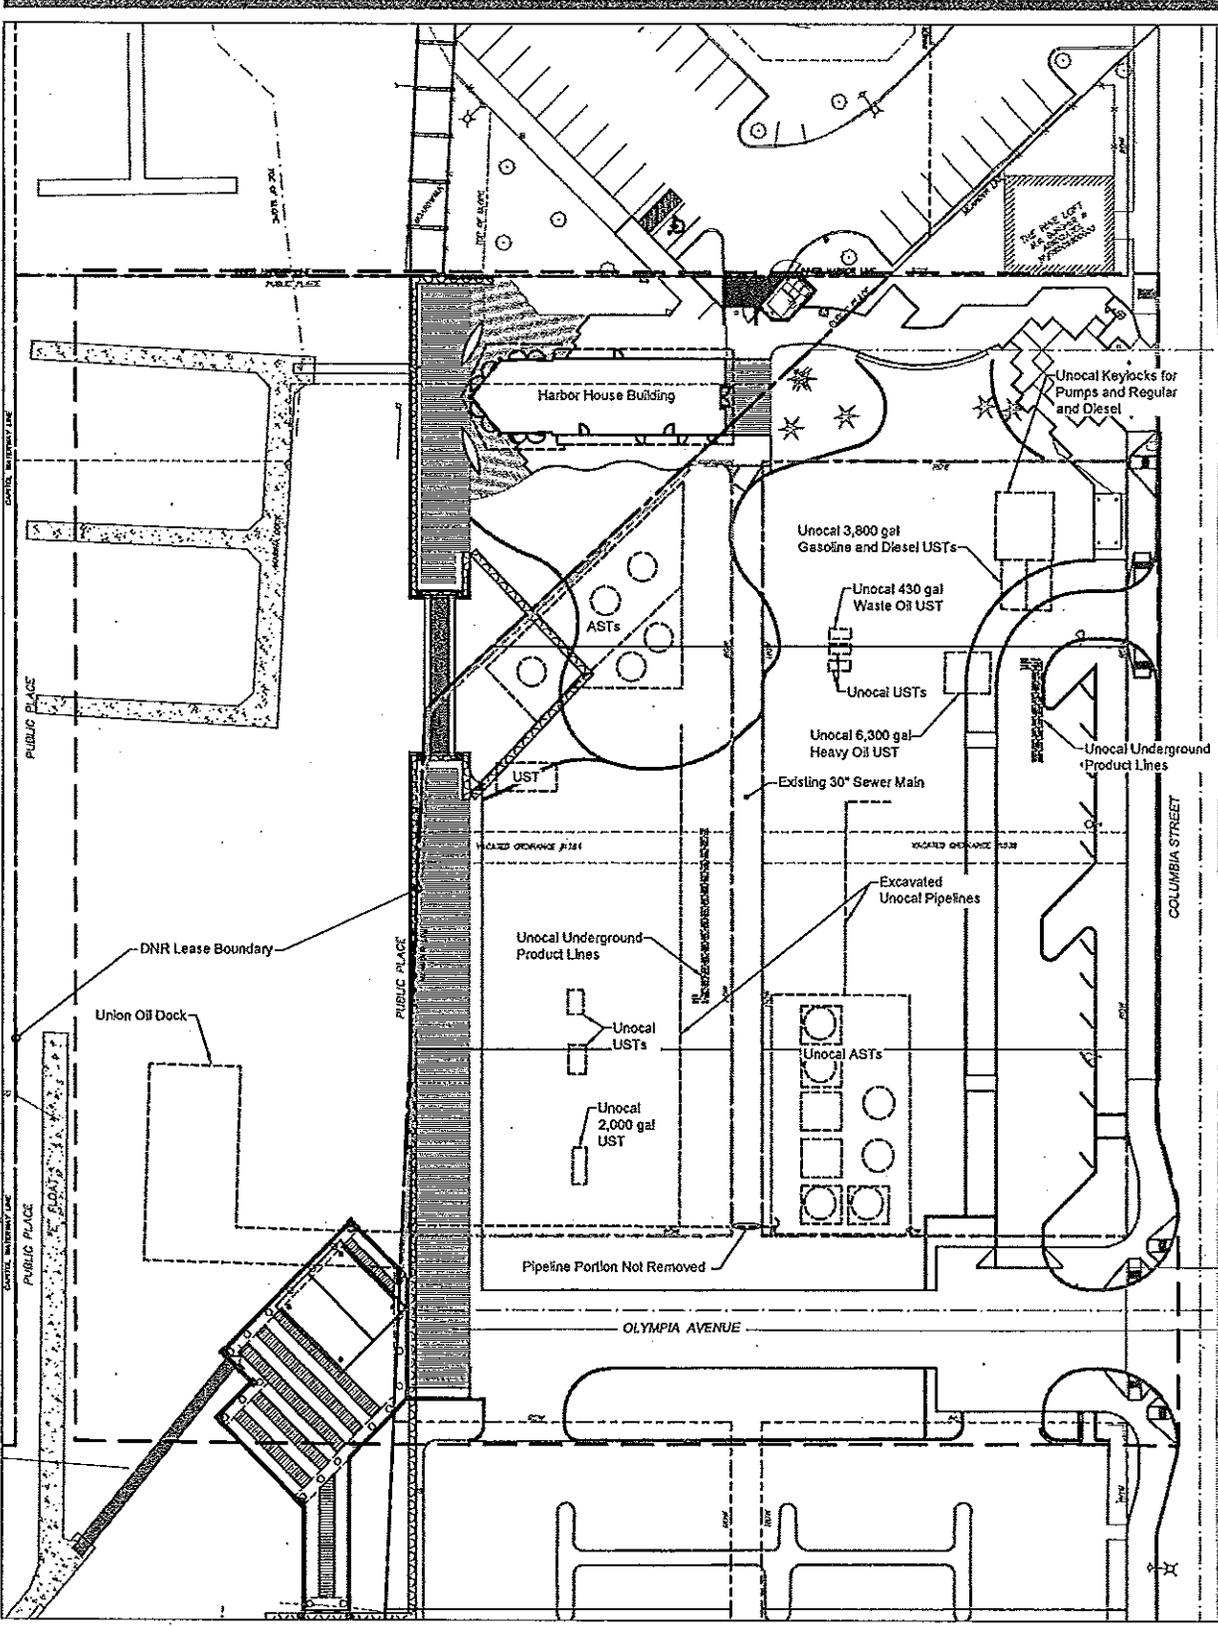
Figure 2
 Current and Historical Property Boundaries and Features
 Remedial Investigation / Feasibility Study
 Former Unocal Bulk Plant 0828 and Hulco Property

The Site comprises Thurston County Tax Parcel Nos. 78507100200 (former Unocal property) and 78507100100 (former Hulco property), which are both currently owned by the City of Olympia (City). In addition, a portion of the Site along the shoreline is owned by the State of Washington and managed by the Department of Natural Resources. The Unocal Bulk Plant operated on the Site from about 1910 to 1993. The Hulco property was a bulk fuel storage facility operated by different companies, including Shell Oil Company (Shell) and Atlantic Richfield Company (ARCO). The Shell/ARCO bulk plant operated from about 1924 to about 1980. The Site is currently occupied by a portion of the recently redeveloped Percival Landing Park (park) (see attached Figure 2).

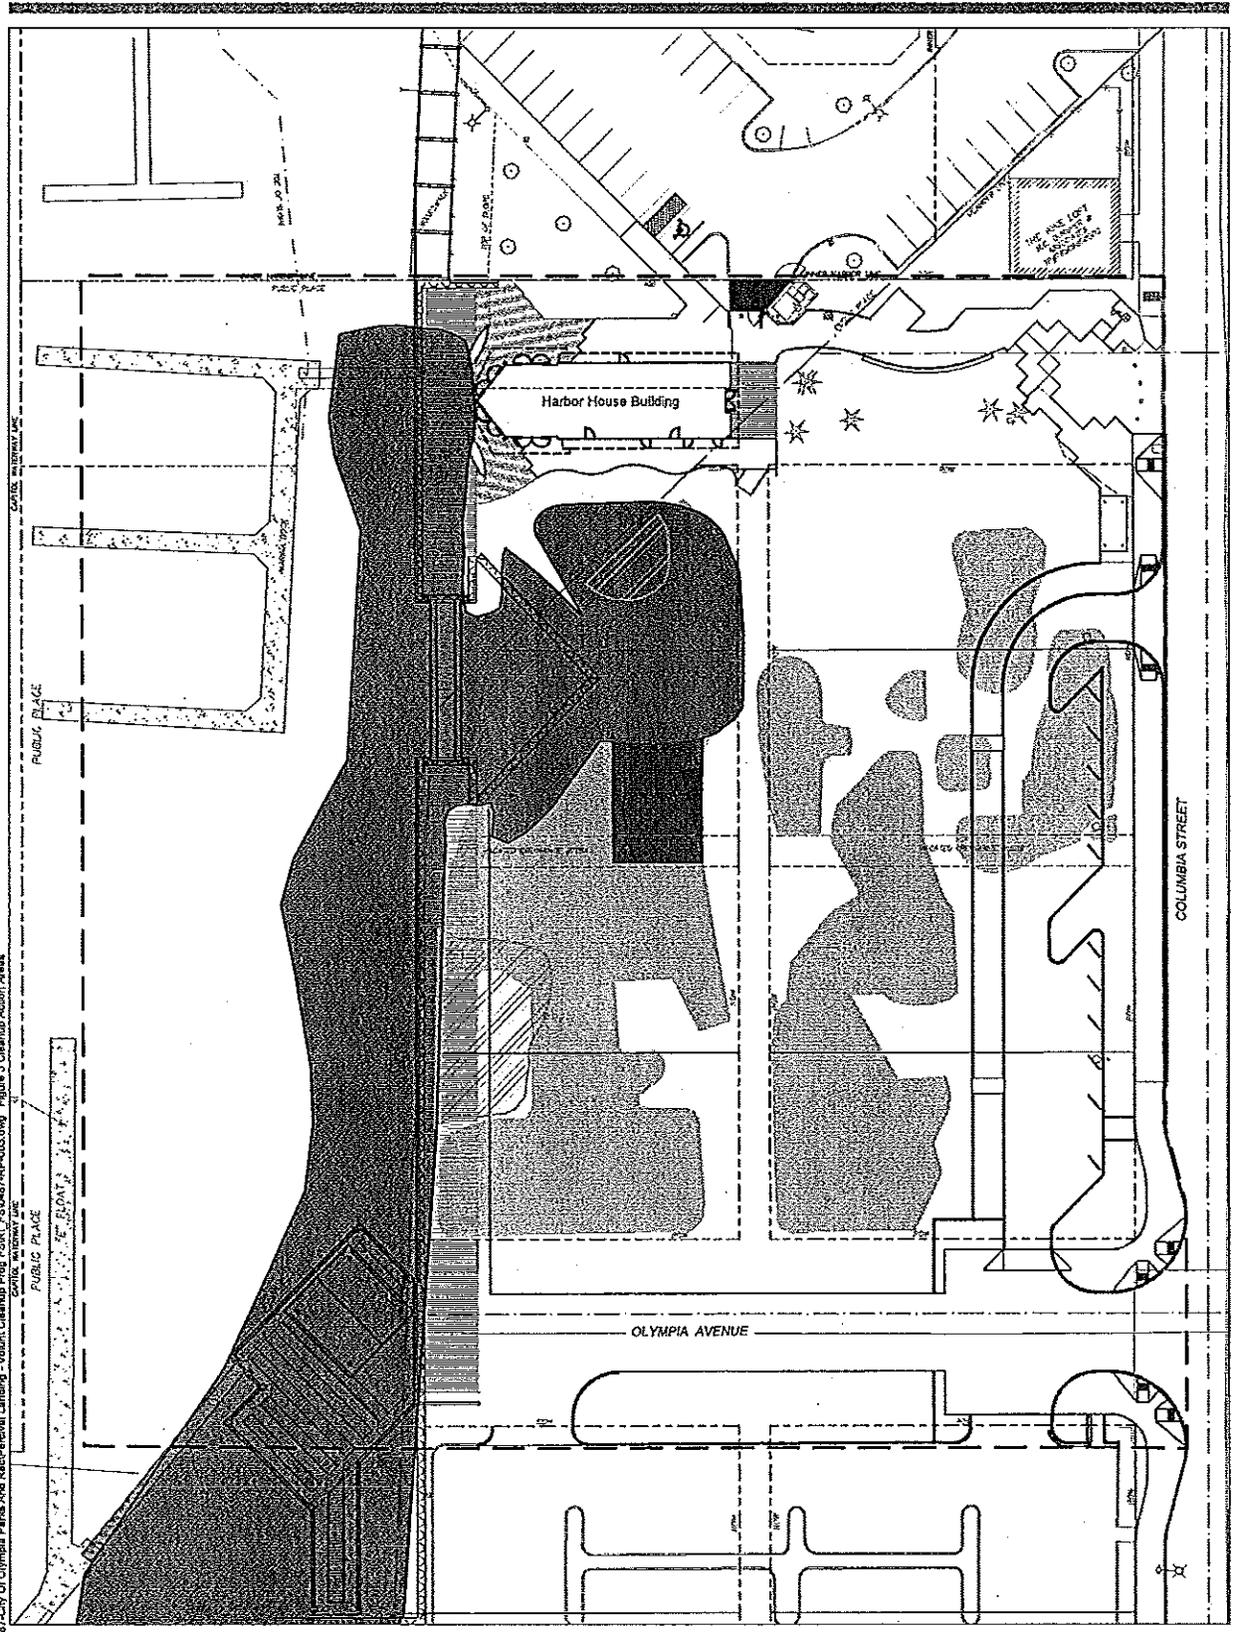
Figure 3
 Cleanup Action Areas
 Remedial Investigation / Feasibility Study
 Former Unocal Bulk Plant 0828 and Hulco Property

In 1995, a sizable cleanup was conducted on both parcels when the bulk plants ceased operations. Additional soil was removed in 2001. Please see Section 3 (Selection of cleanup action) for further details on this cleanup action. Following the cleanup, on October 20, 2003, Ecology issued a No Further Action (NFA) letter for the Site. However, the NFA stated that contaminated soils remained in the west wall of the excavated portion of the Site below the boardwalk, and in the northwest section adjacent a retaining wall (see attached

Figure 3). These soils were left in place due to concerns over compromising the structural integrity of the boardwalk and retaining wall. Reportedly, soil contamination was also left in place along the common boundary of the former Unocal and Hulco properties in the center of the Site, and along the southern boundary of the properties. Five monitoring well locations (MW-12 through MW-15, and B-7) located along the western boundary of the Site, adjacent to the boardwalk, were used to demonstrate compliance for groundwater, which was reportedly achieved for all contaminants of concern (COCs) sometime in 2002.

- In 1995, a substantial cleanup was conducted at the Site. An estimated 9,438 tons of petroleum-contaminated soil were excavated and disposed of at the Kitsap County Sanitary Landfill. About 55% of this soil originated from the Hulco property and 45% from the Unocal property. Also, about 60,000 gallons of treated wastewater was discharged to nearby catchbasins per Ecology guidance. Confirmation soil samples collected from the base and sidewalls of the excavation indicated the presence of residual contamination in some areas (see attached Figure 3).

- In 2001, an additional 890 tons of petroleum-contaminated soil was excavated from the Site and disposed of at Olympic View Landfill. Also, about 63,000 gallons of water from dewatering activities was discharged to the sanitary sewer per LOTT approval. Confirmation soil samples collected from the limits of the excavation identified residual contamination adjacent to the boardwalk and a retaining wall (see attached Figure 3).

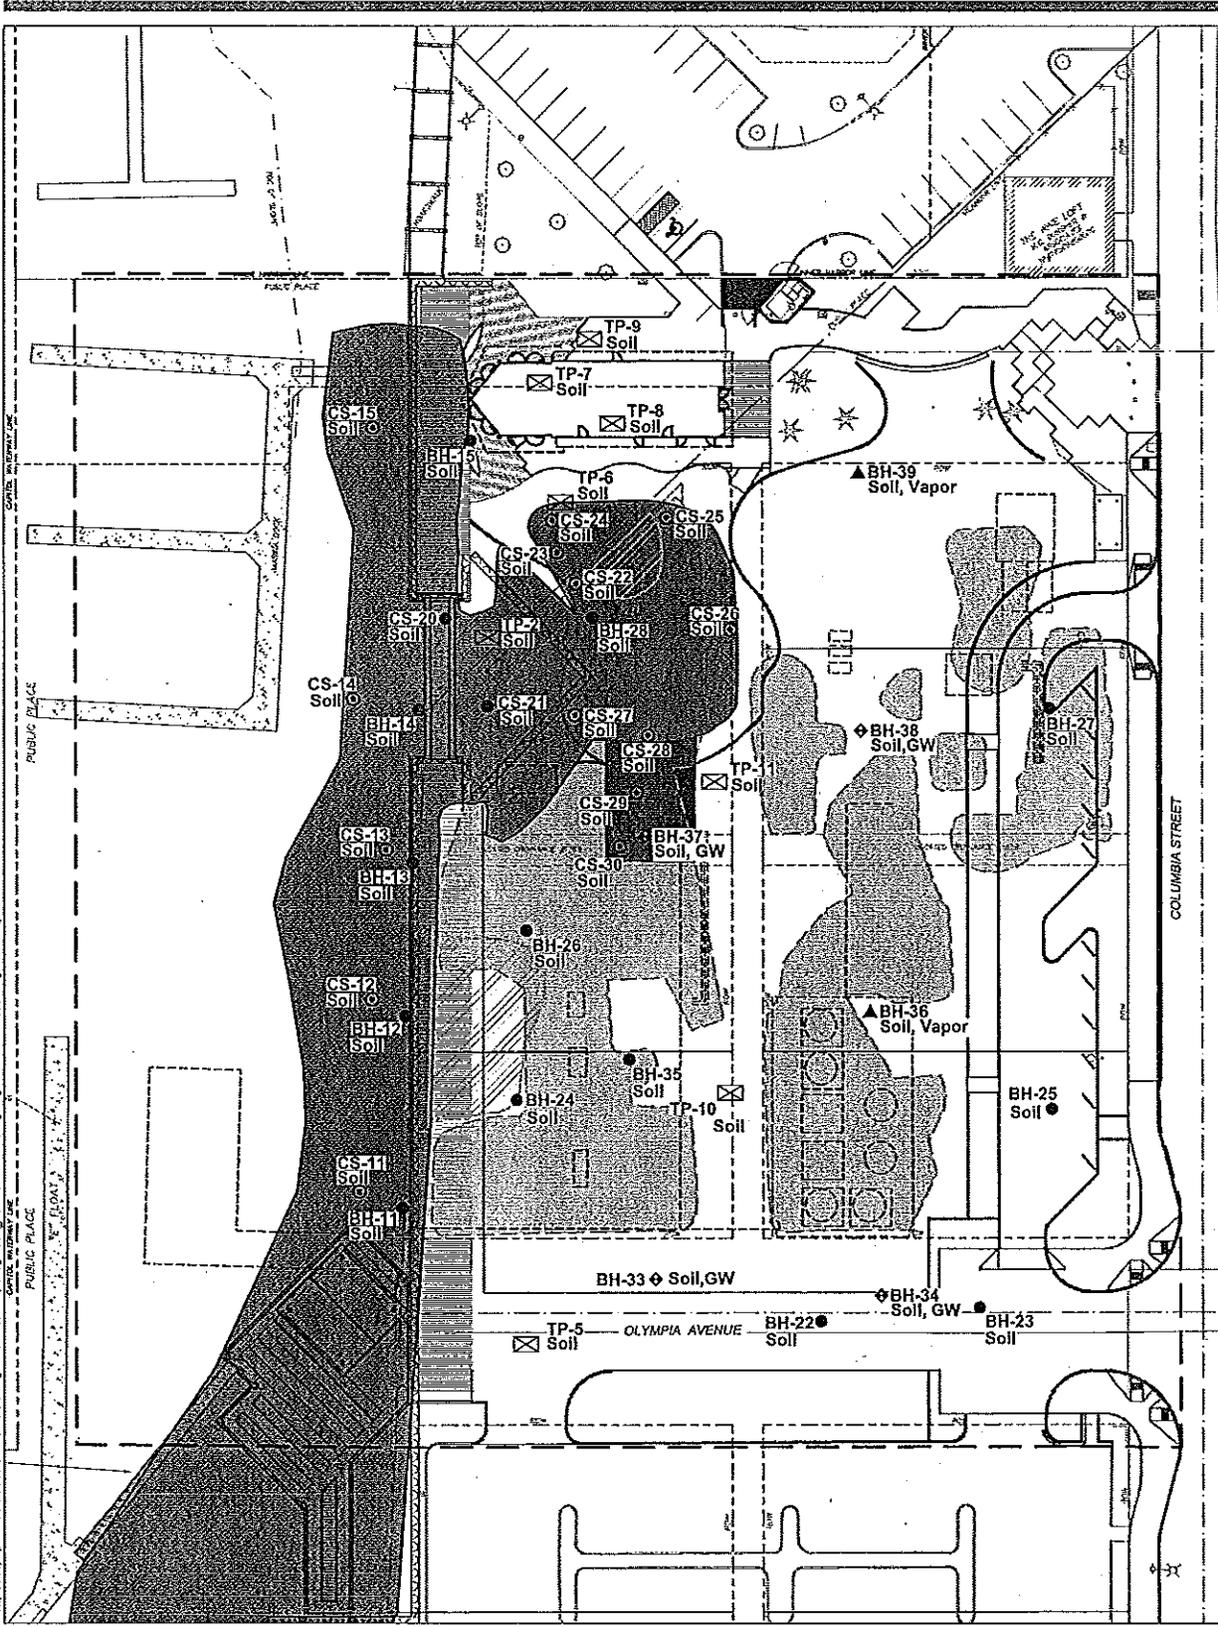
Figure 4
 Remedial Investigation Sample Locations
 Remedial Investigation / Feasibility Study
 Former Unocal Bulk Plant 0828 and Hulco Property

As a follow up to this investigation, Anchor advanced an additional seven soil borings (BH-33 through BH-39) and excavated two test pits (TP-10 and TP-11) on the Site in June 2011. Soil samples were collected from each location at multiple depths, and groundwater samples were collected from four of the borings (BH-33, BH-34, BH-37, and BH-38) from a temporary wellpoint screen interval of about 6 to 11 feet below ground surface (bgs). Two soil vapor samples were also collected from borings BH-36 and BH-39 (sample locations and analyses are shown in Figure 4 and Table 1, respectively).
