# SITE HAZARD ASSESSMENT

**SITE NAME: Seattle DOT Mercer Parcels**

Cleanup Site ID: 14784

**Vicinity Map**

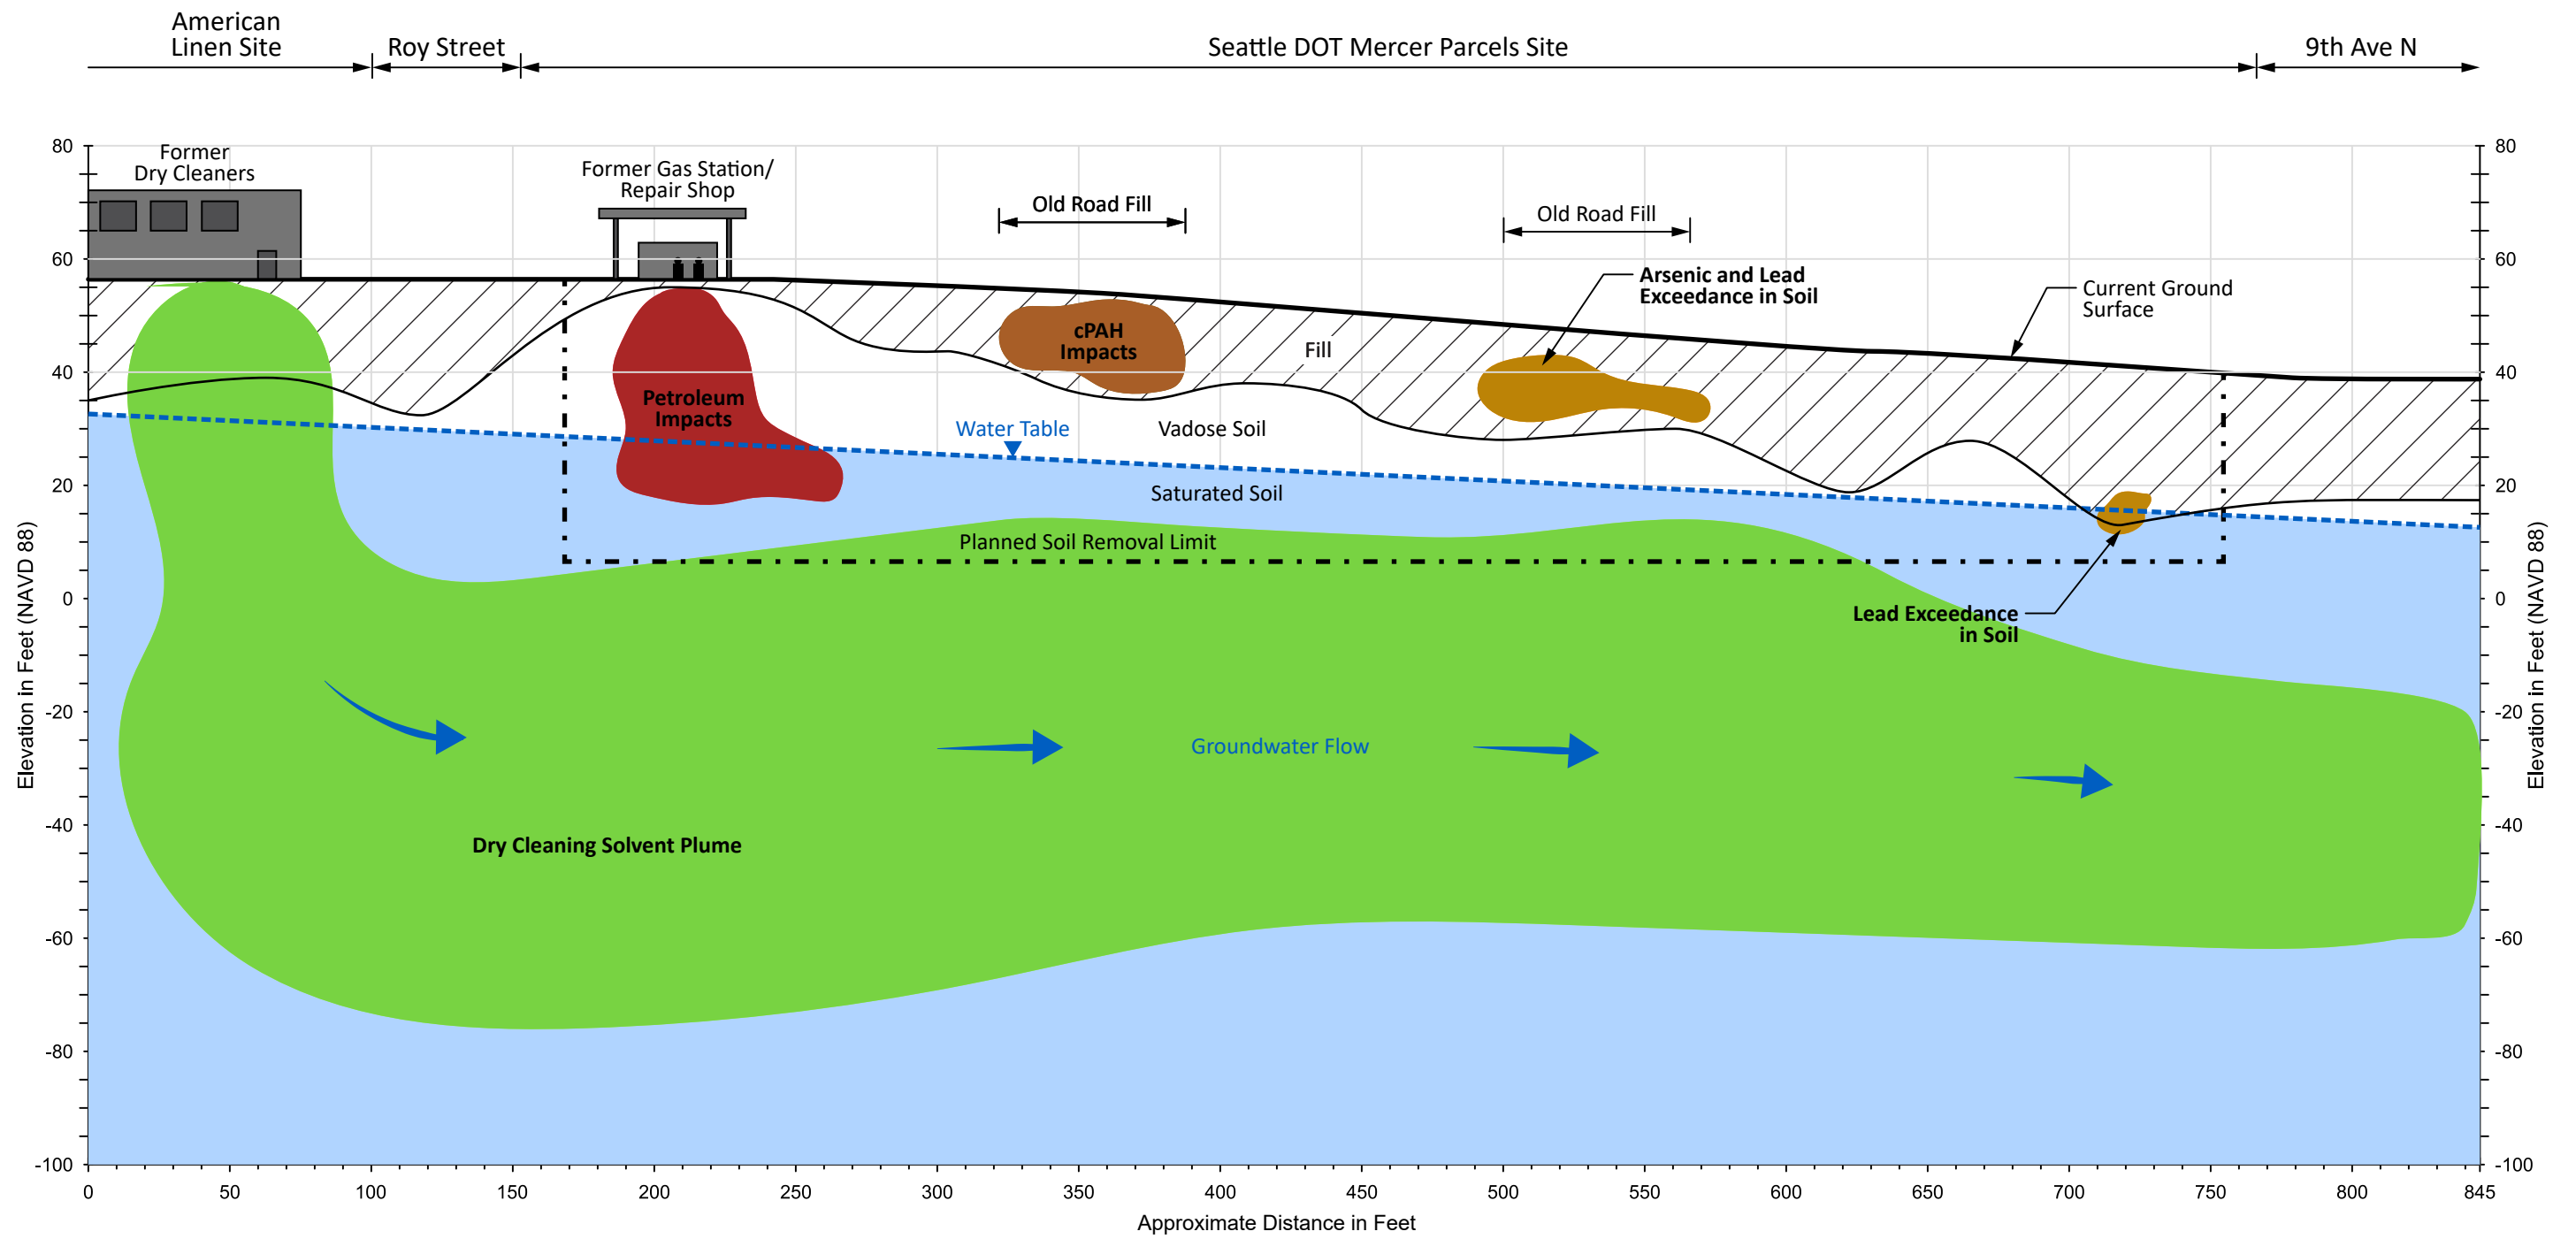
A division of Haley & Aldrich	
Figure <b>7-11</b>

Releases of chlorinated solvents (tetrachloroethene and degradation products) at the Maryatt Industries/American Linen site to the north have traveled in deep groundwater under the Site in a plume that is distinct from, and unrelated to, the releases at the Site (Figure 7-11). The chlorinated solvents are being evaluated in relation to the Maryatt Industries/American Linen site (CSID 12004) and are not evaluated in this SHA.

Seattle DOT Mercer Parcels Site Seattle, Washington	
<b>Generalized Diagrammatic Conceptual Cross Section</b>	
19409-04	06/21

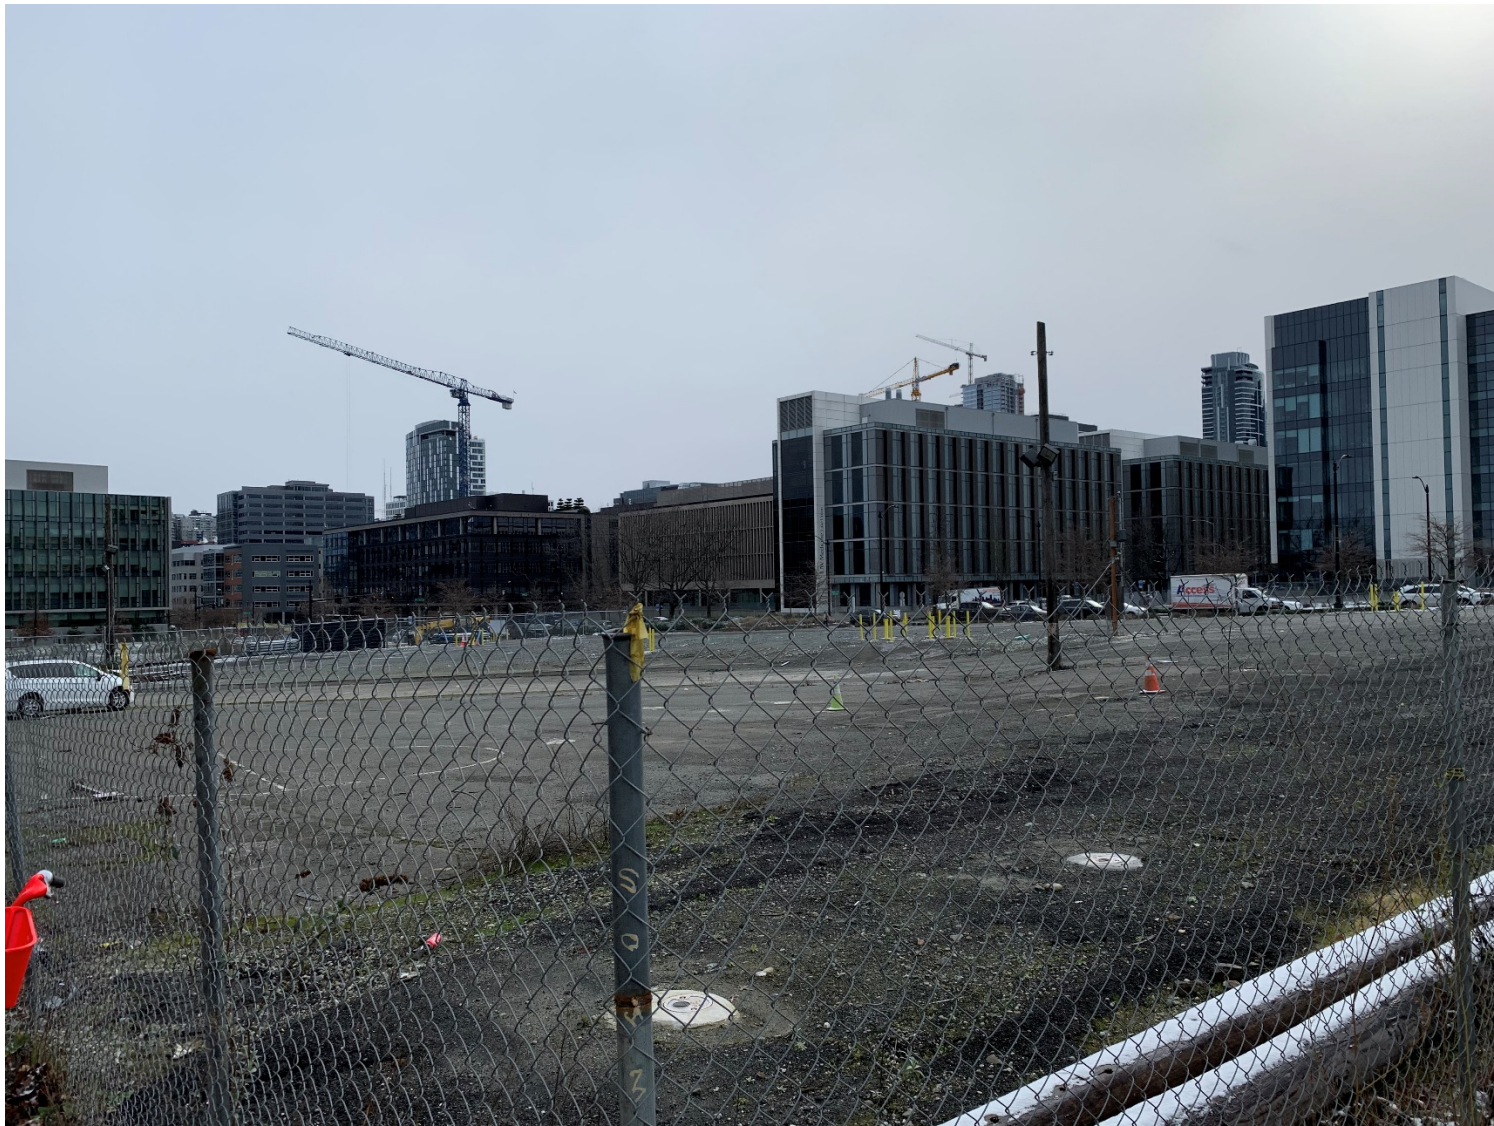
Figure 1. Seattle DOT Mercer Parcels looking southwest, February 2021.

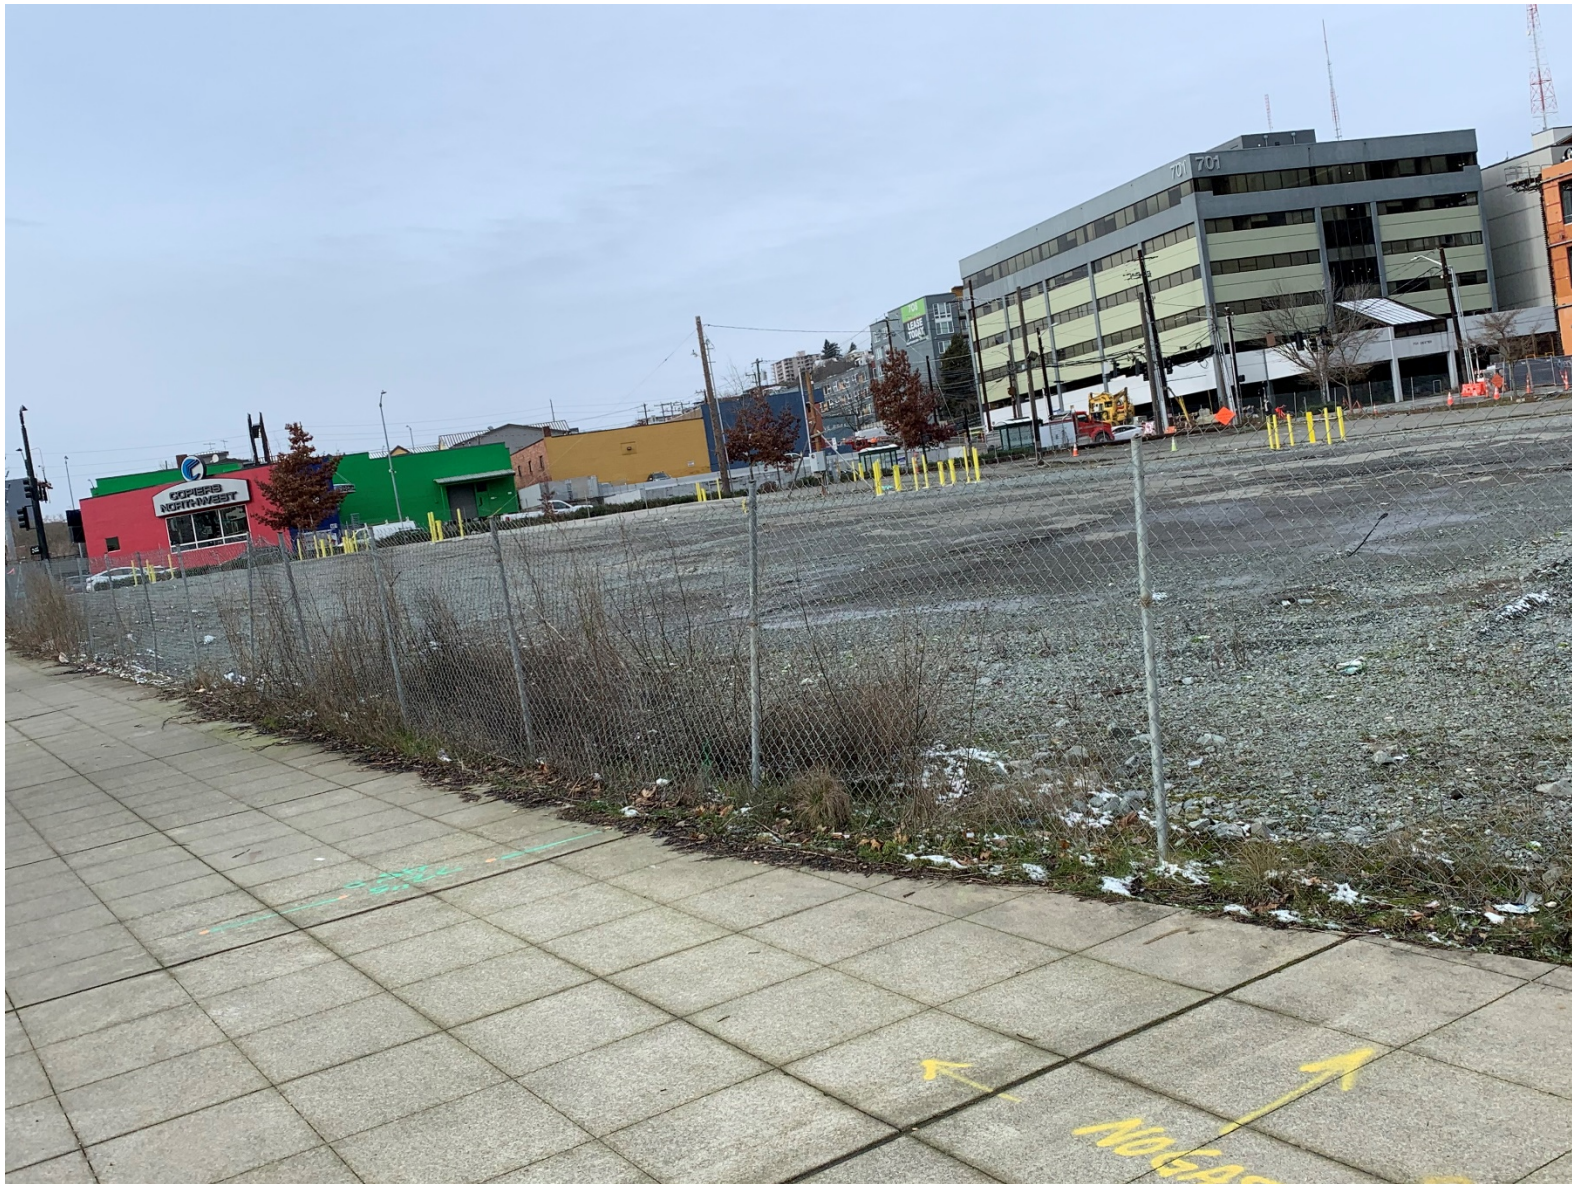
Figure 2. Seattle DOT Mercer Parcels looking west-northwest, February 2021. The Dexter Parcel site is in the background on the left.

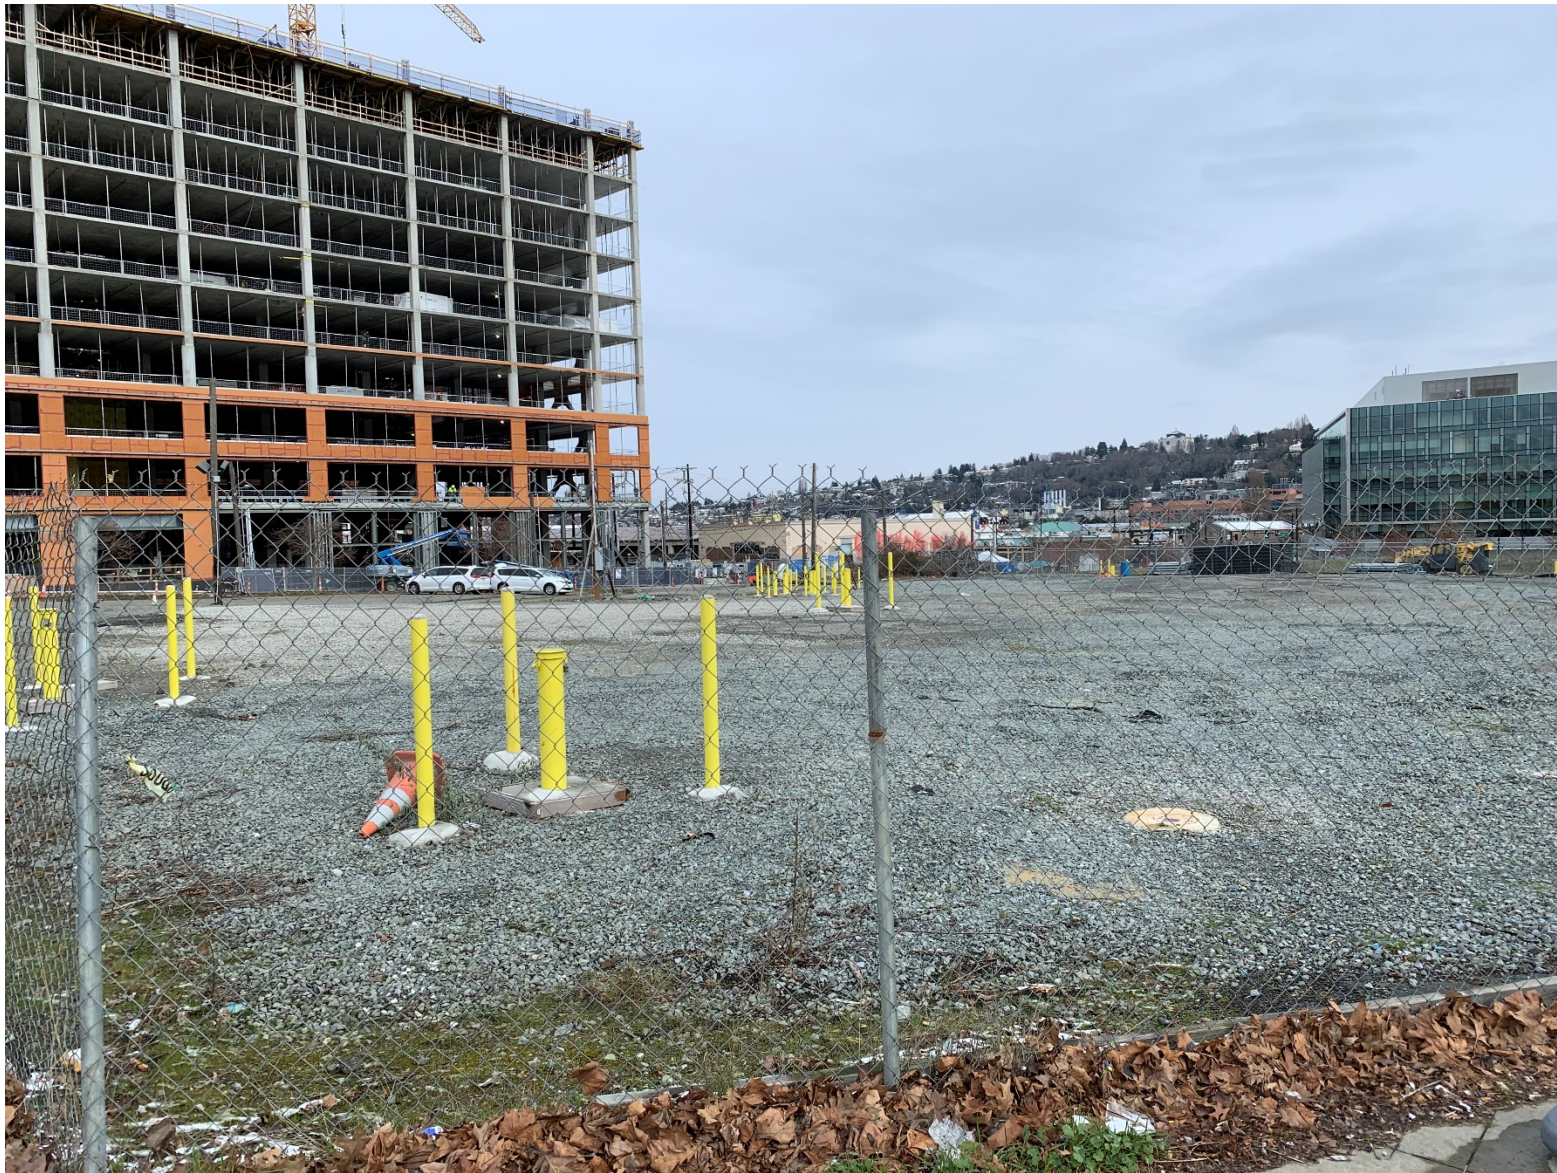
Figure 3. Seattle DOT Mercer Parcels looking northeast, February 2021. The redevelopment at the American Linen site is on the left.
