SITE HAZARD ASSESSMENT

Worksheet 1: Summary Score Sheet

SITE NAME: Seattle DOT Dexter Parcel

Cleanup Site ID: 14785

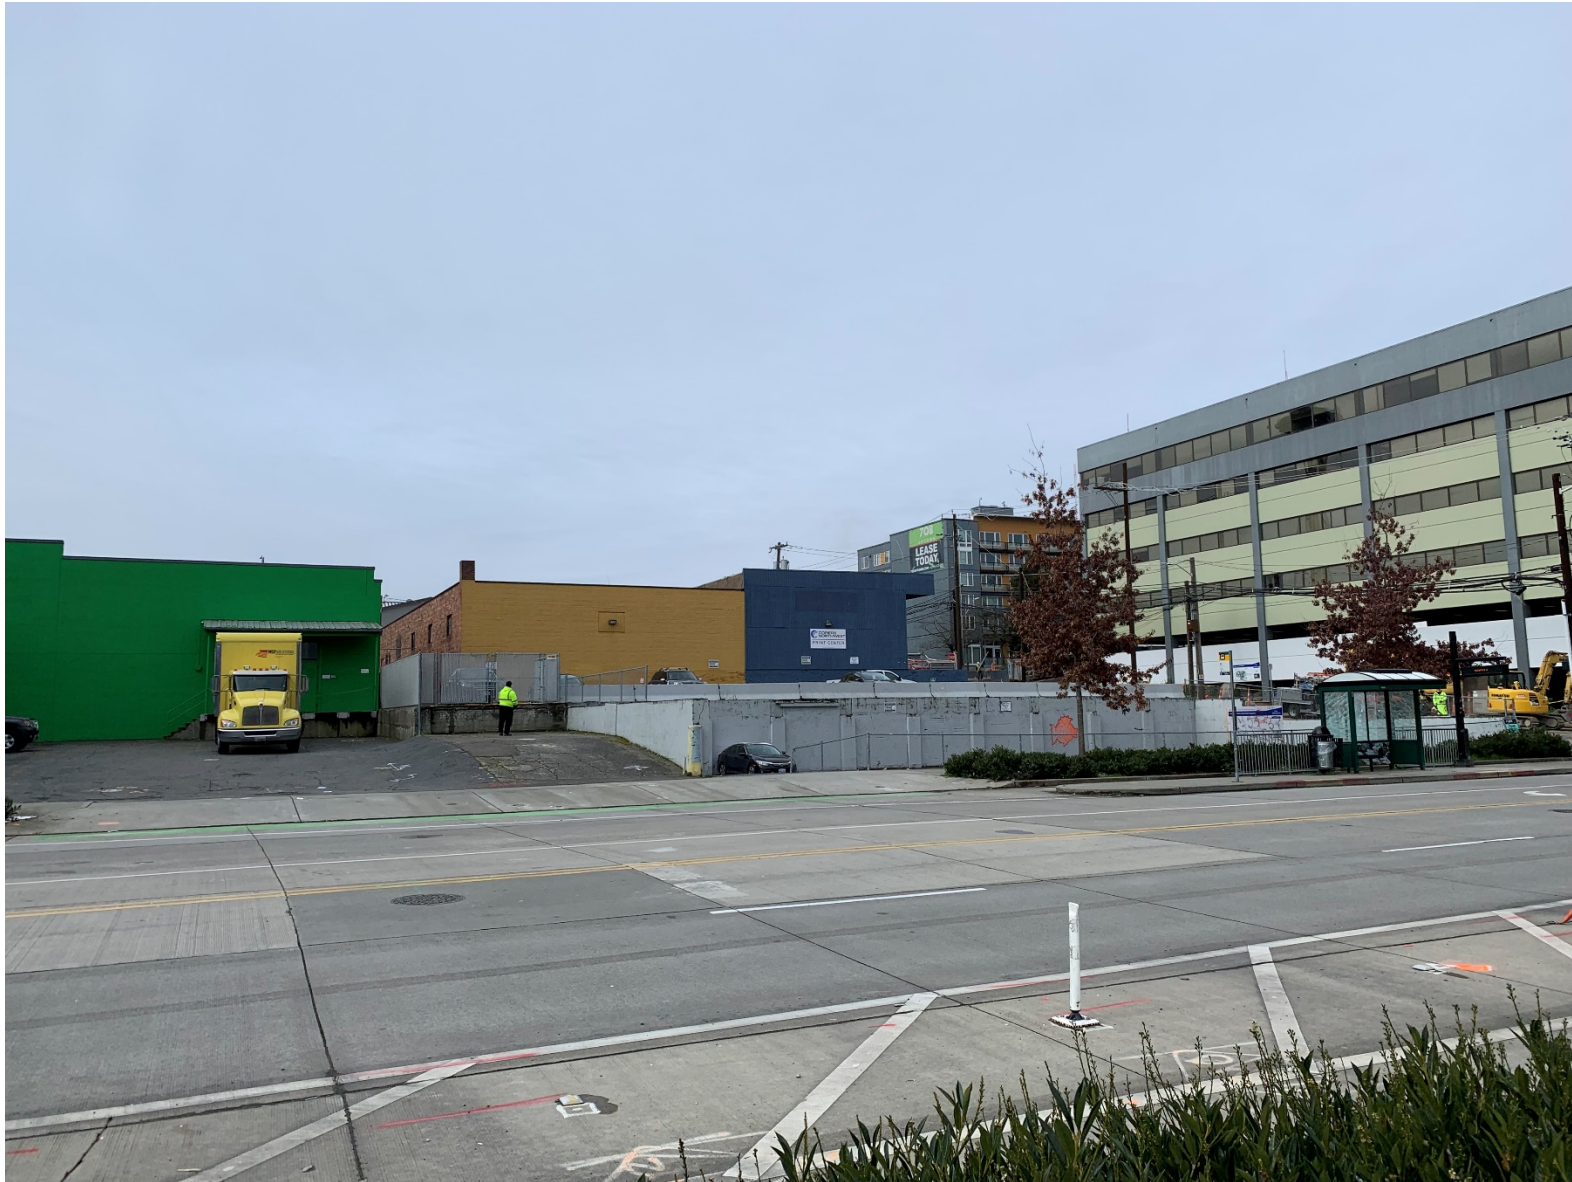
Figure 1. Dexter Parcel, looking west, February 2021.

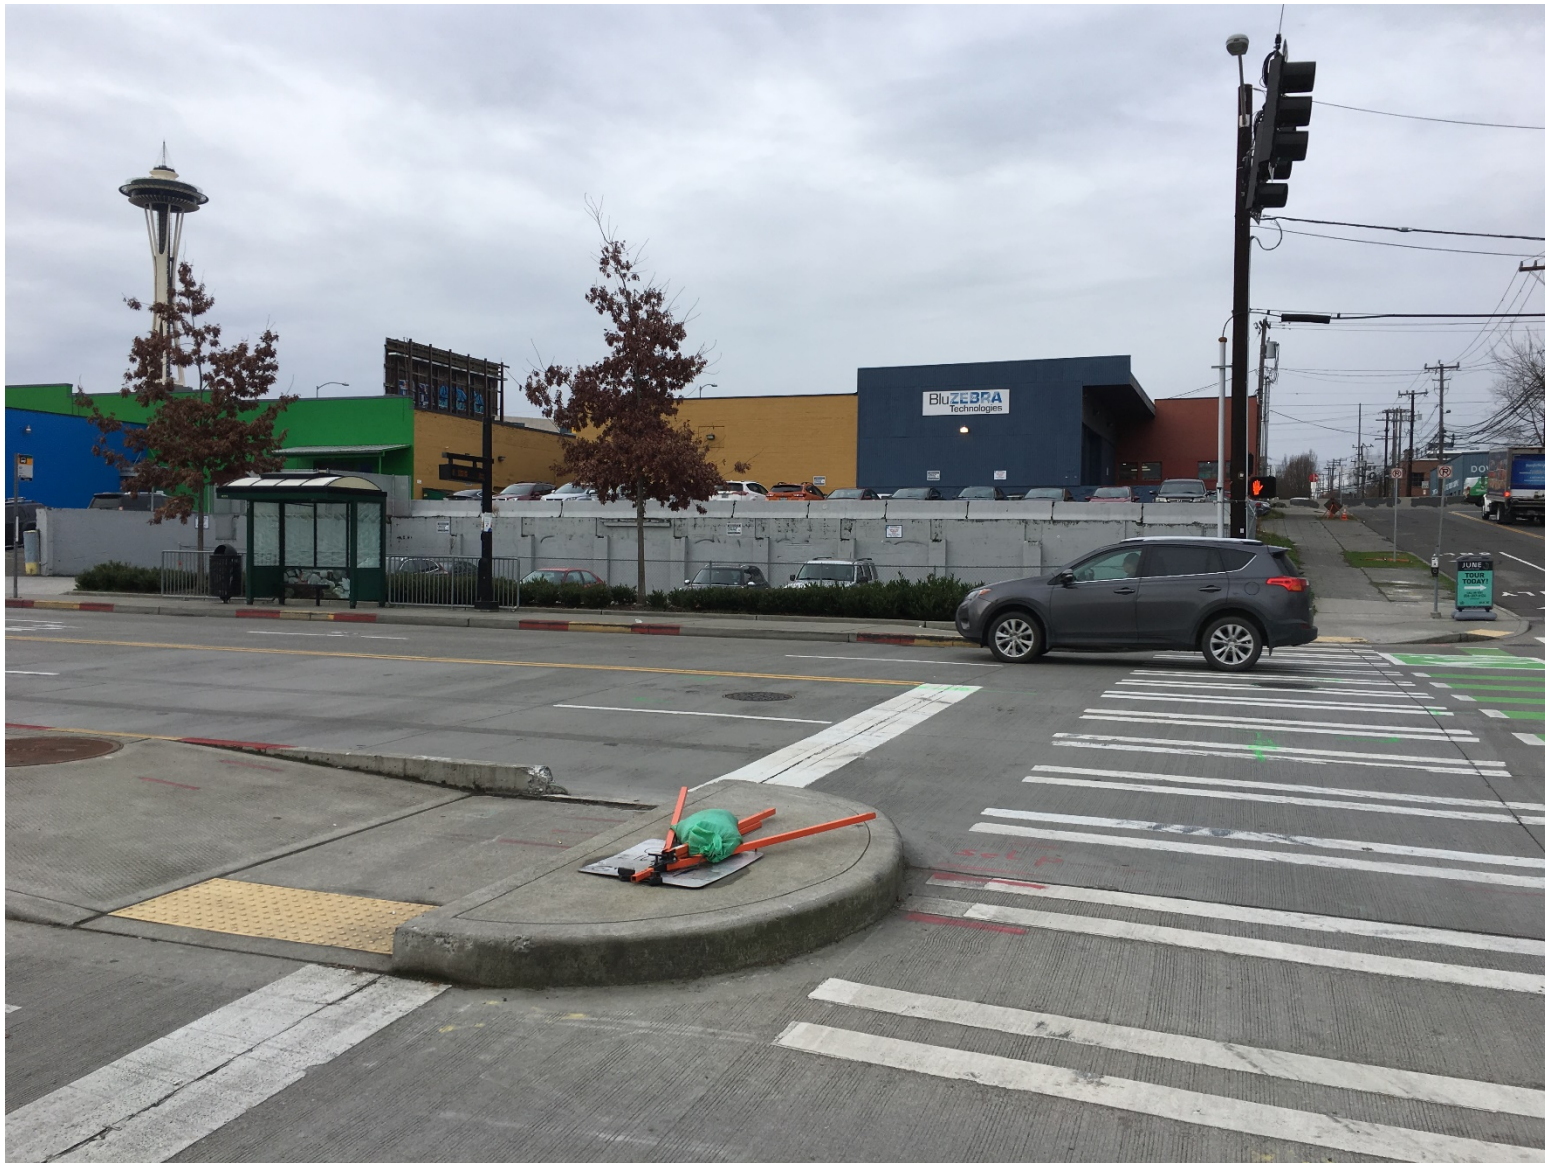
Figure 2. Dexter Parcel, looking west-southwest, December 2019.
