Phase II Environmental Site Assessment Report

2021 Boulevard Road SE
Olympia, Washington

August 2021

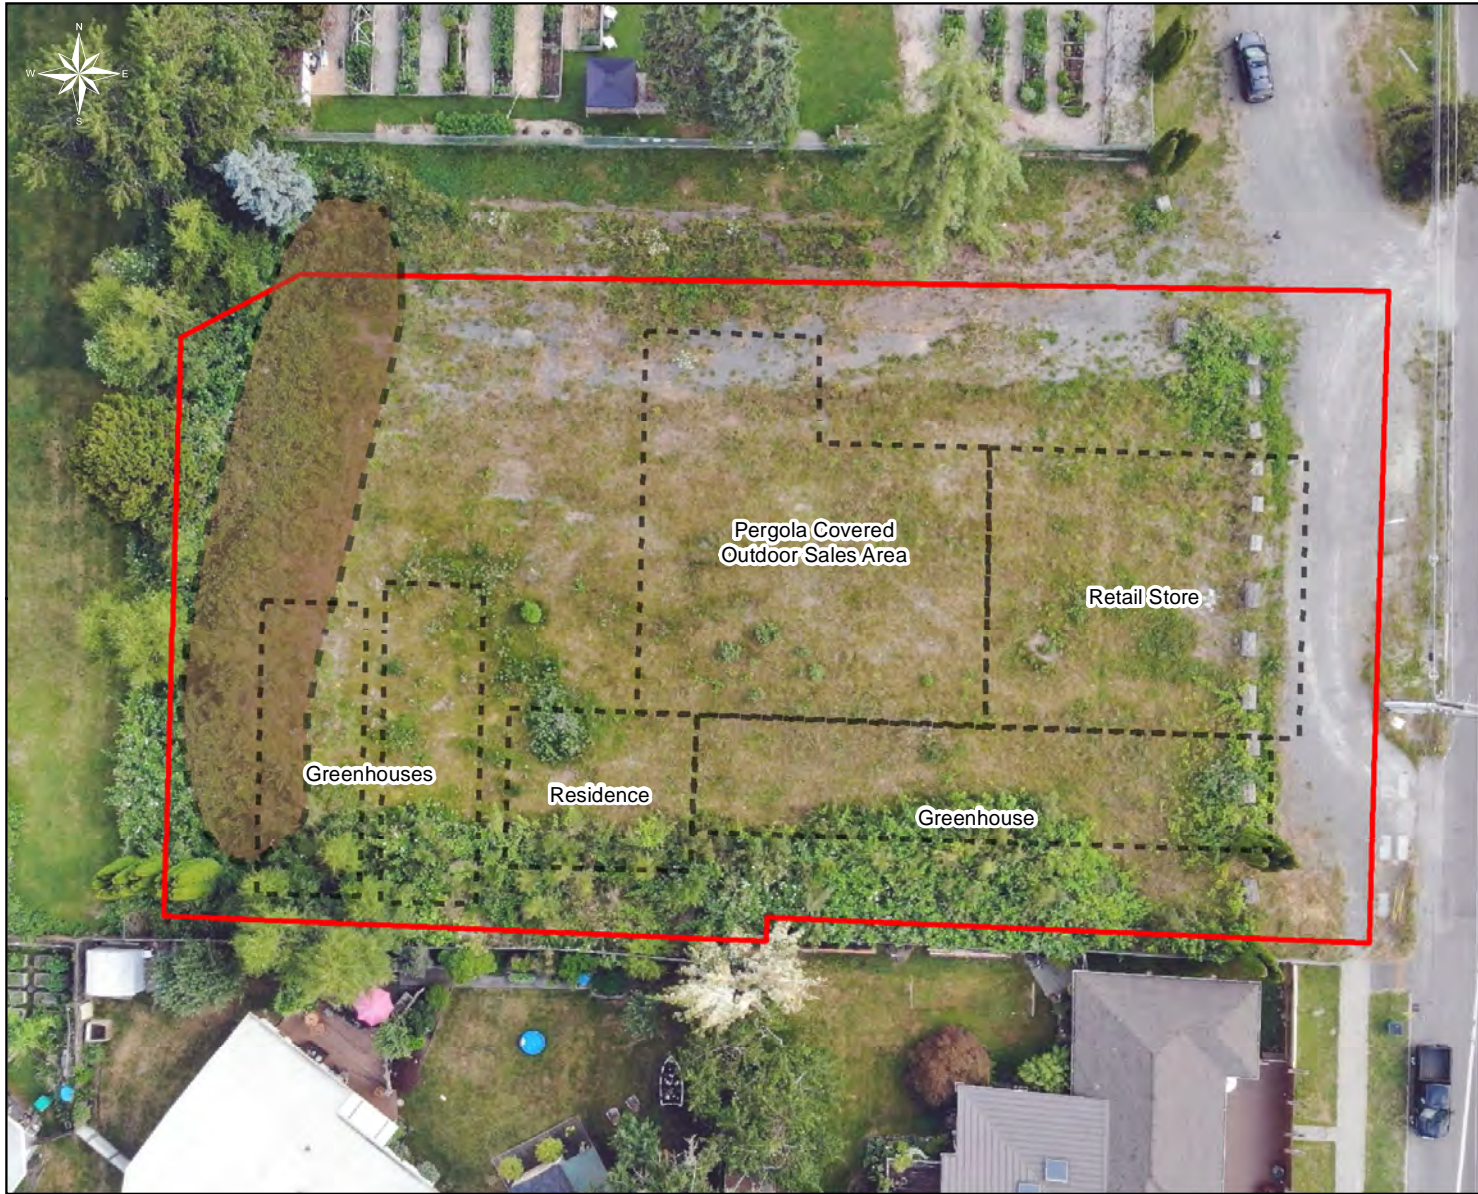
Figure 2

Current and Historical Features Diagram
2021 Boulevard Road SE
Olympia, Washington

The Property consists of 0.90 acres of vacant grass- and gravel-covered land with a soil berm along the western boundary. The Property is located in a residential area in the eastern portion of Olympia. Current Property features are shown on Figure 2.

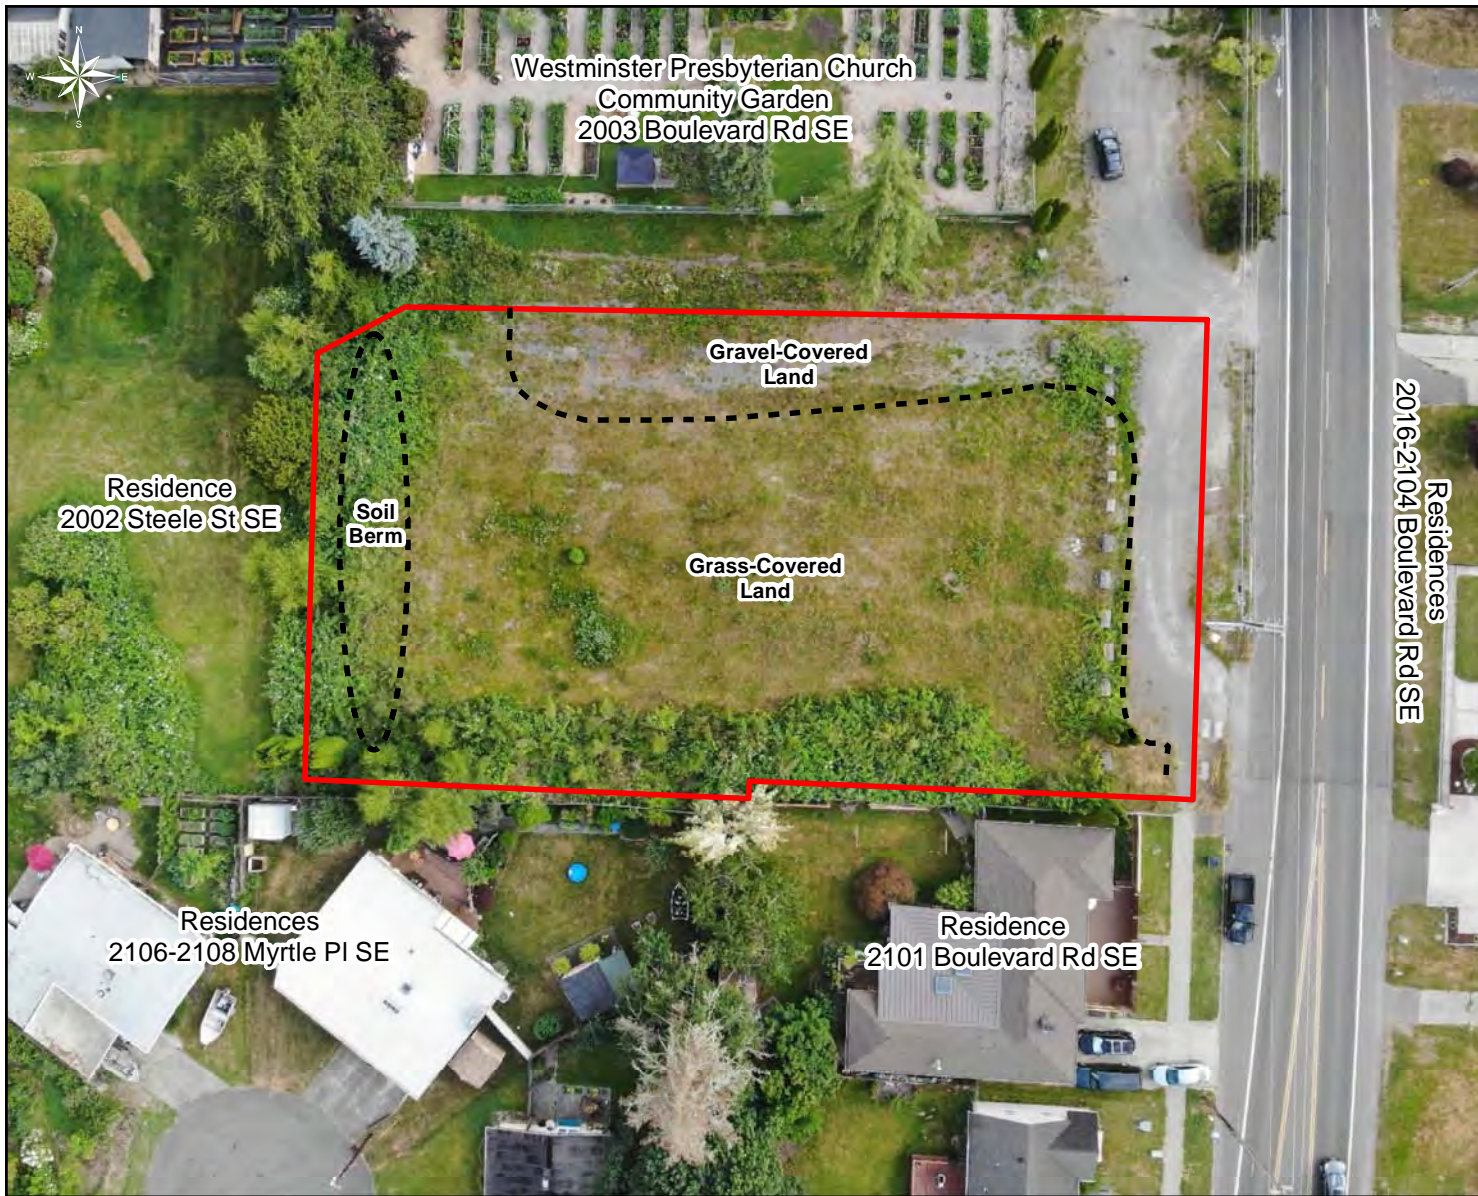
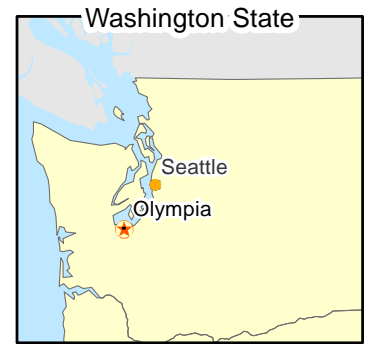
Figure 2

Current Property Features Diagram
2021 Boulevard Road SE
Olympia, Washington

As of the date of publication of this SAP, the Property consists of 0.90 acres of vacant grass- and gravel-covered land with a soil berm along the western boundary. The Property was located in a residential area in the eastern portion of Olympia. Current Property features are shown on Figure 2.
