West Bay Park RI/FS – Sediments

(Solid Wood Site – Agreed Order #DE-08-TCPSR-5415)

Site and Site Boundary Discussion

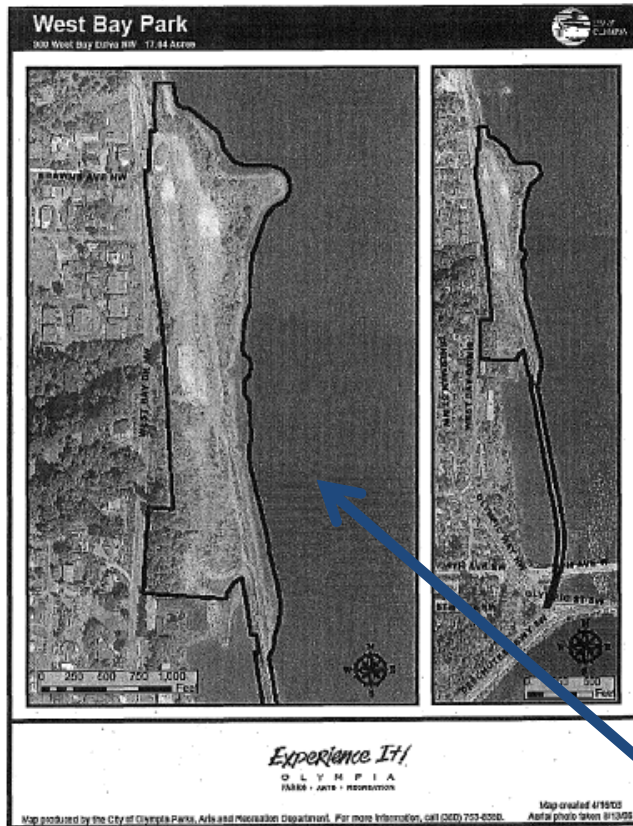
Agreed Order #DE-08-TCPSR-5415 – Initial Site Boundary (Exhibit A)

Observations: As indicated in the direct quote and figure presented above, at the time the Agreed Order was signed sediments were not included in the Site Boundary because there was no data available that indicated that they were impacted by hazardous substances. The decision as to whether or not to extend the Site Boundary was to be made after sediment samples were collected and evaluated.

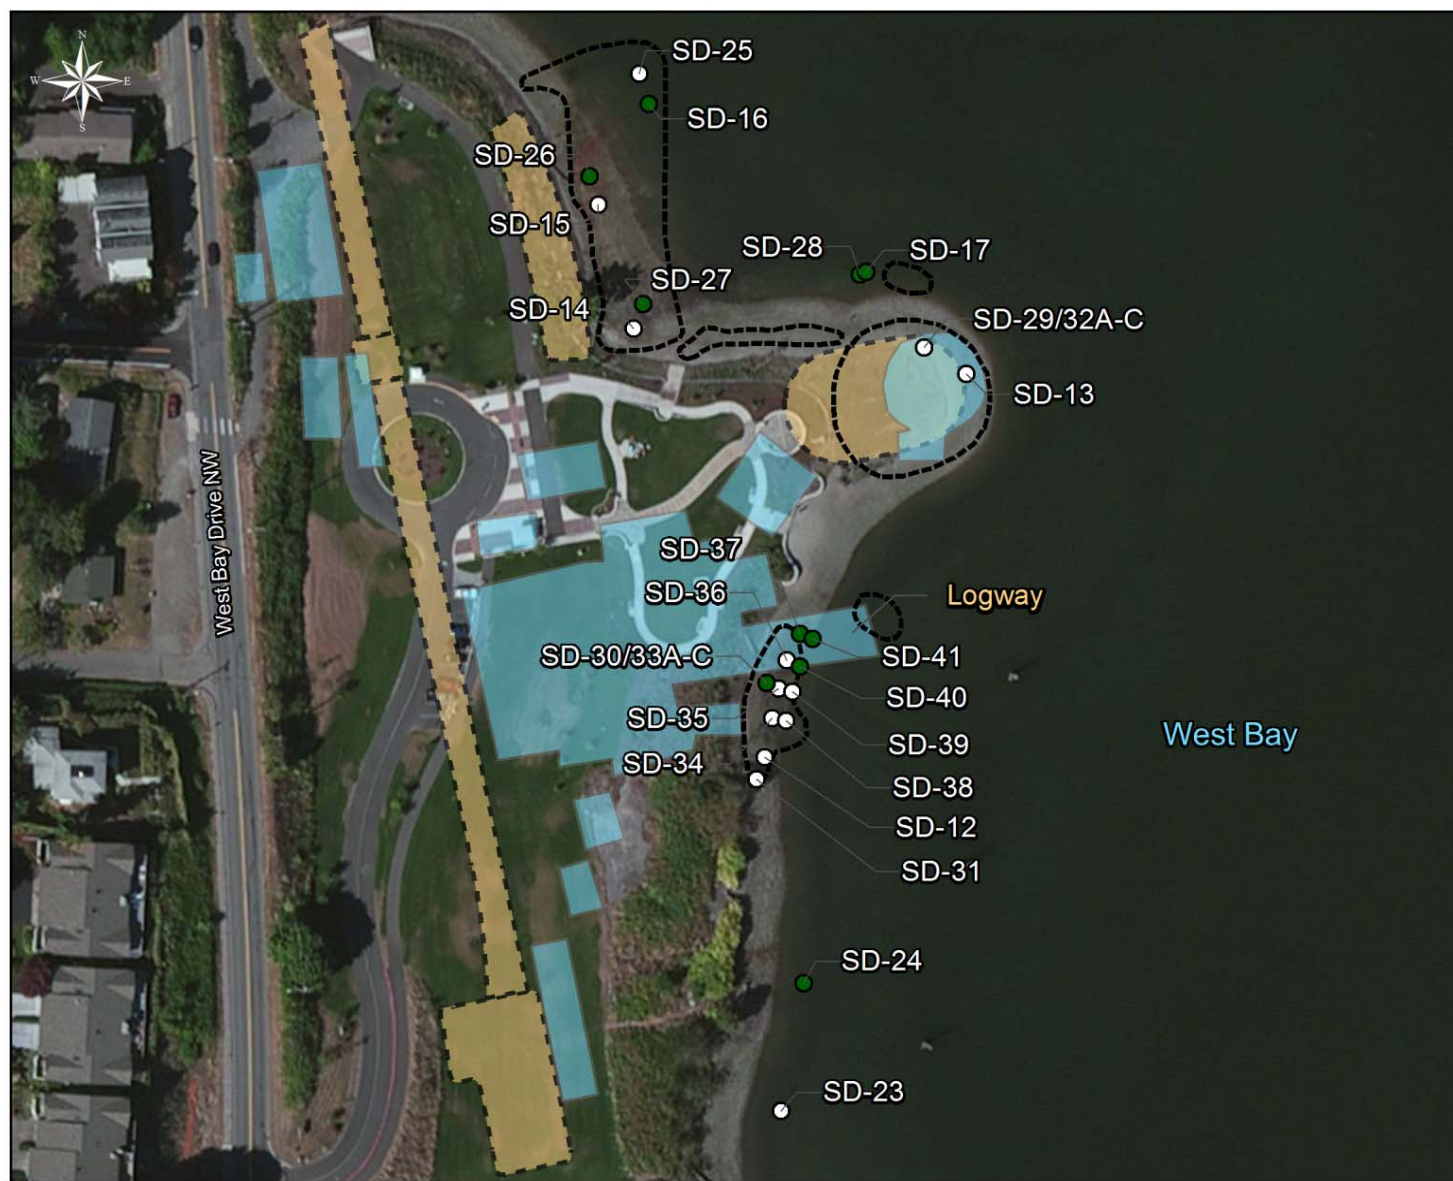
Figure 3

Sediment TPH-D Concentrations in Relation to Historic Operations
West Bay Park Site
Olympia, Washington

- The analytical results for all sediment samples were below all SMS criteria
 - The data indicate that the pilings were not treated with creosote
 - Of the first 100 pilings pulled, all still had the bark intact and none were treated
 - The remaining pilings were cut off below the mud line and none appeared to have been treated
 - Analytical data from sediment samples support this
 - For example, PAHs (LPAHs/HPAHs) and PCP were not detected in sediment at concentrations exceeding SMS criteria
- Ecology required that TPH-D and TPH-HO be compared to a 100 mg/kg screening level
 - The majority of sediment samples exceeded the screening level for TPH-HO but TPH-D concentrations were less than 100 mg/kg
 - Range of TPH-HO concentrations was ND to 1,500 mg/kg (detected in 35 of 48 samples).
 - Range of TPH-D concentrations was ND to 94 mg/kg (detected in 14 of 48 samples).

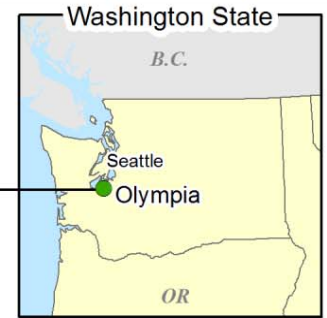
TPH-D Concentration (mg/kg)

- Ecology was concerned that the wood pilings and historical overwater, industrial activities could have resulted in hazardous substances being released to sediment
- The City collected and analyzed sediment samples for:
 - SMS constituents
 - PAHs
 - Pentachlorophenol (PCP)
 - Diesel (TPH-D) and TPH-HO

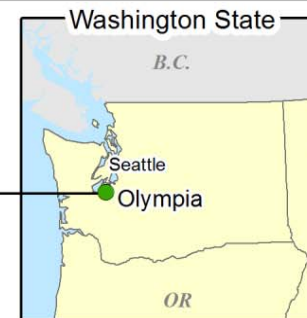
TPH-HO Concentration (mg/kg)
